**Weber County Emergency
Watershed Protection –
Ogden Bay Wildlife
Management Area Structures
Repair Project**

PRELIMINARY DESIGN REPORT

*Bowen, Collins & Associates
154 East 14000 South
Draper, UT 84020*

July 2013

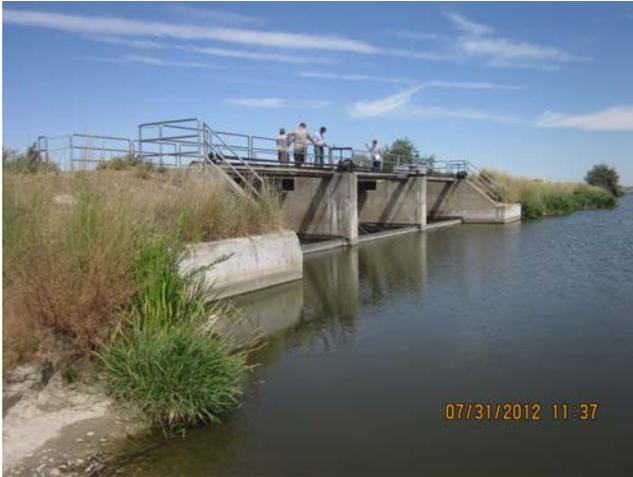
East side of existing South Run Structure

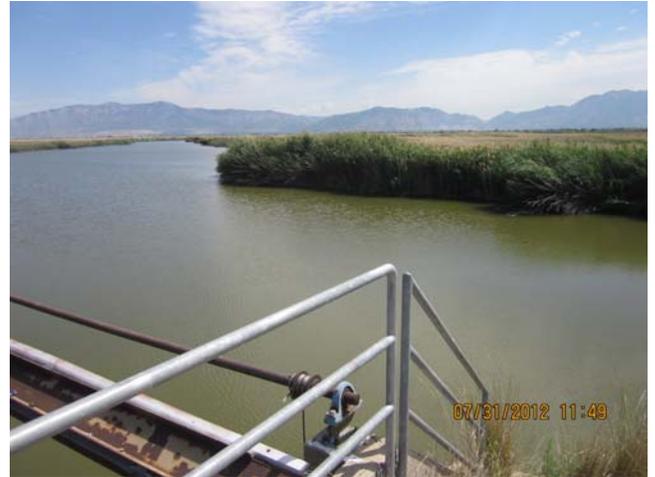
South Run Structure looking upstream (east)

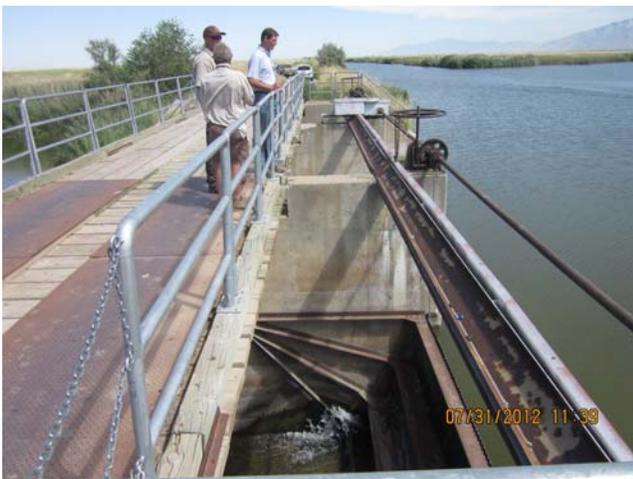
Existing South Run Structure Radial Gates

- Replace the side and bottom seals and the cable I-bolt connections on the existing South Run structure radial gates.
- Stabilize the 19-ft deep scour hole just downstream of the existing South Run structure that was discovered during recent field investigations by filling it with granular material and riprap.

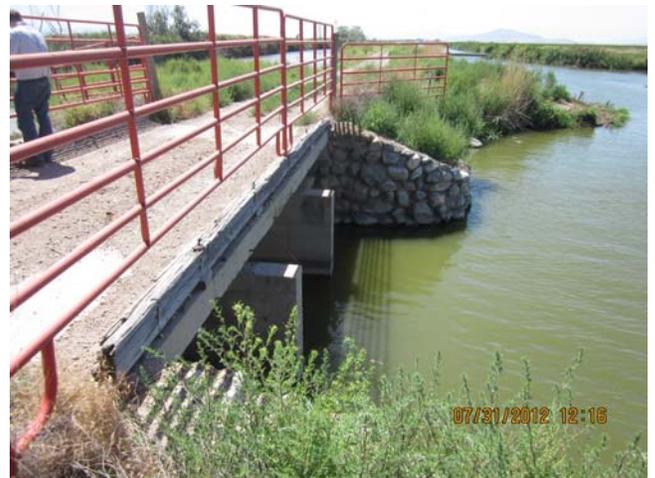
Downstream face of existing Middle Run Structure

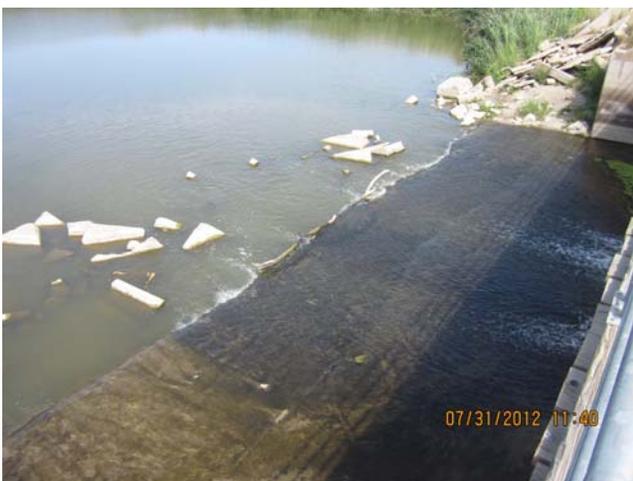
Existing South Run Structure Downstream Concrete Seal

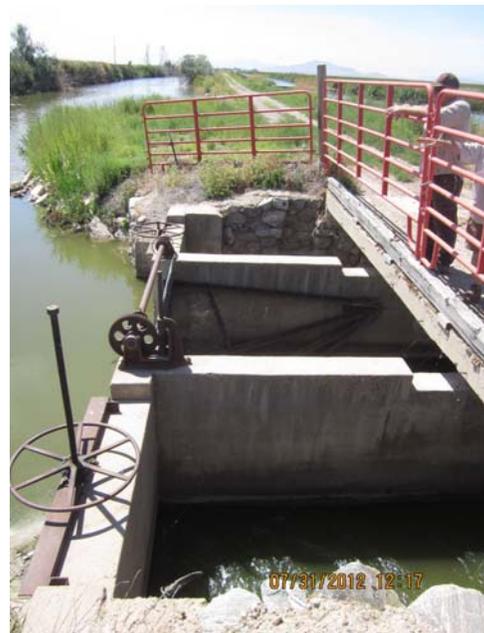
Upstream Face of existing Middle Run Structure

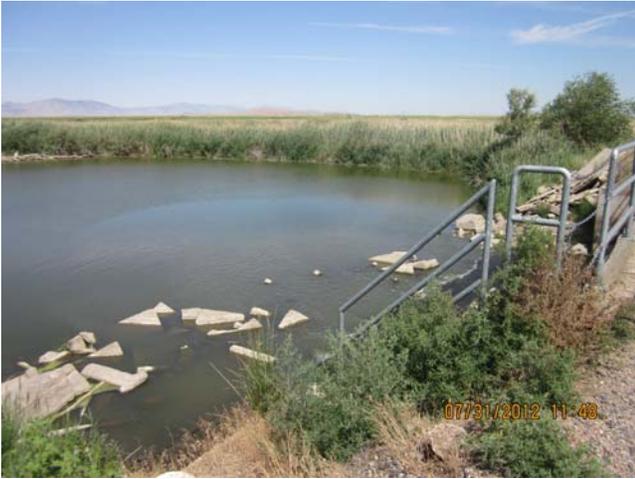
South Run Structure looking downstream (west)

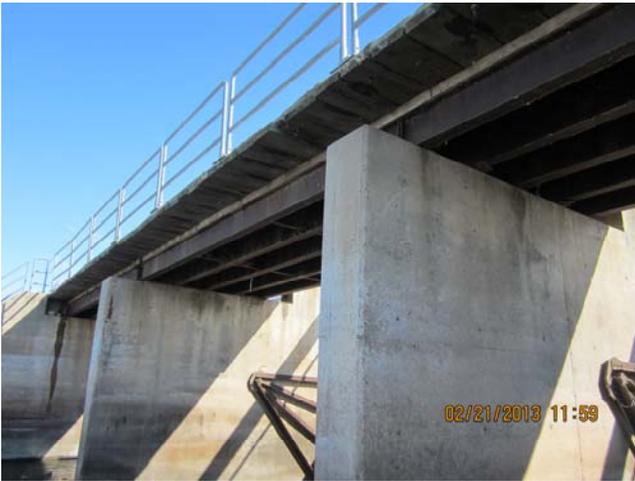
The existing bridge over the South Run structure is composed of 5 steel girders (W12x26) and a 3x12 timber deck. The timber deck is placed perpendicular to the steel girders and 4 additional 3x12 planks are then placed parallel to the direction of travel (perpendicular to the deck members) at the likely wheel locations. The steel girders appear to be in fair condition but are fully covered with rust. There is no evidence that these steel members were ever coated with a protective coating (paint or galvanized). The beams are cross-braced with 2 lines of transverse channel bridging placed at 1/3 points of each span. The girders are simple-span between the supporting substructure elements.

Existing South Run Structure deck

It is recommended that the existing bridge structure be repaired by replacing it with the precast/prestressed slabs. Because everything is concrete, there would be no long term maintenance issues. It is the strongest of the two options, provides the most clear vehicular space, and is slightly cheaper. The recommended bridge reconstruction plan and alternate deck section are shown on Drawing S-5 of the drawings set. Detailed cost breakdowns for the two alternatives are provided in Appendix D.
