NORTH BRANCH FOREST RIVER DAM NO. 1 (BYLIN DAM)

Appendix D-1: Existing Conditions Assessment Report

November 10, 2023

Walsh County Water Resource District

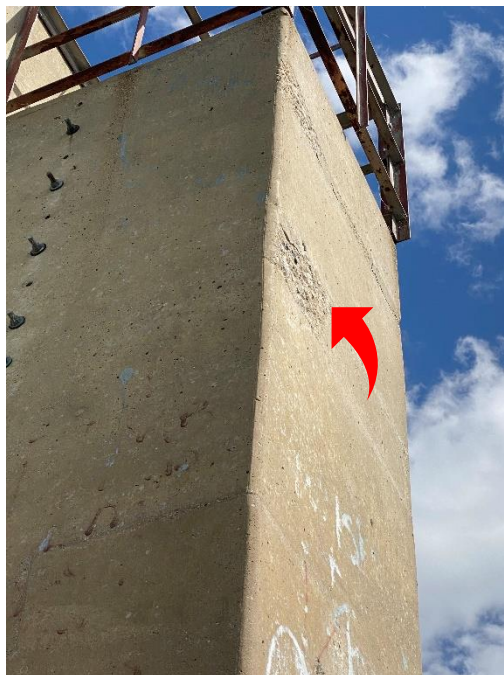
3. MINOR SPALLING WEST FACE OF RISER

For the purposes of the rehabilitation effort at Bylin Dam, the minor cracking and spalling noted on the principal spillway tower will be patched if the existing structure is to remain in place. Replacement of the trash rack would also be warranted due to the corrosion noted. The low-level drawdown gate would either need replacement or would need to be repaired as part of this rehabilitation effort if the existing principal spillway riser tower were to remain in place. With these modifications, the principal spillway inlet structure appears to be adequate to last through the expected dam rehabilitation design life of 50 years.

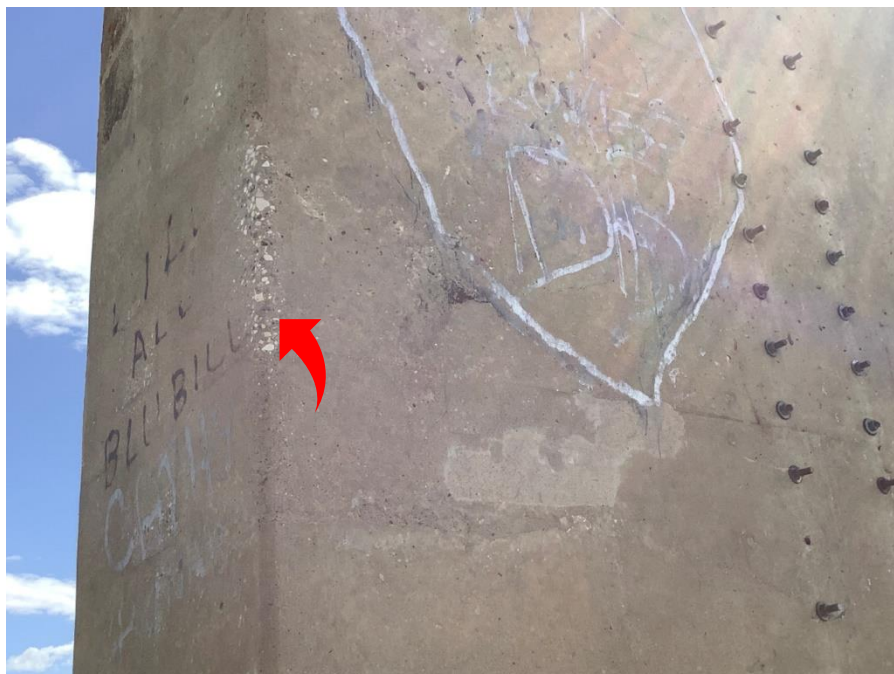
4. MINOR SPALLING NORTHEAST CORNER OF RISER

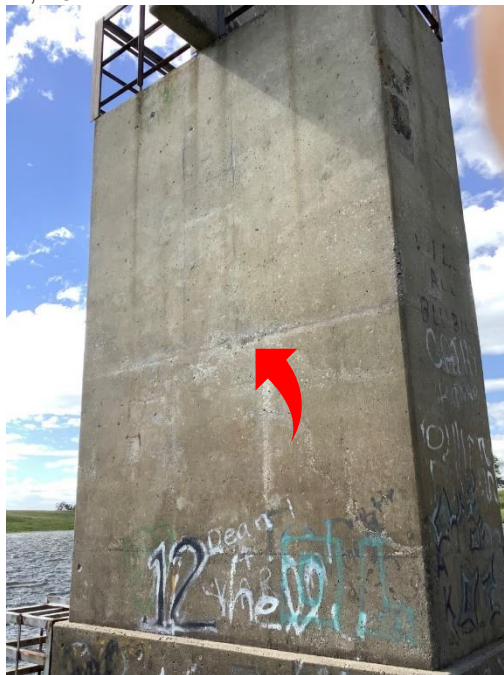
5. MINOR SPALLING SOUTH FACE OF RISER

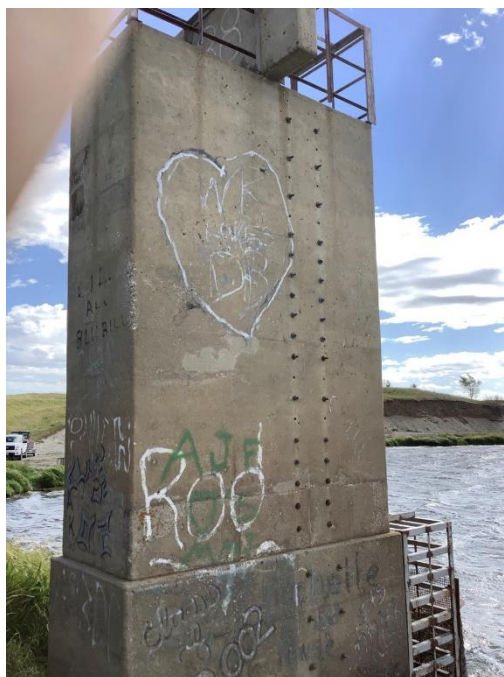
6. MINOR SPALLING NORTHEAST CORNER OF RISER

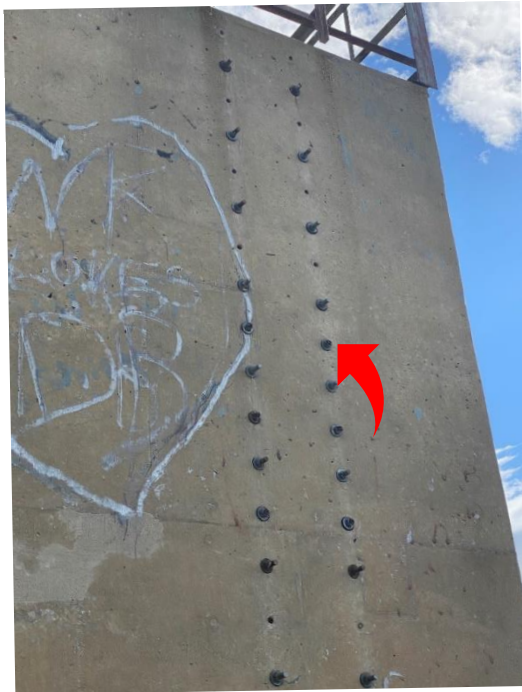
7. OPEN ANCHOR HOLES (NORTH RISER FACE)

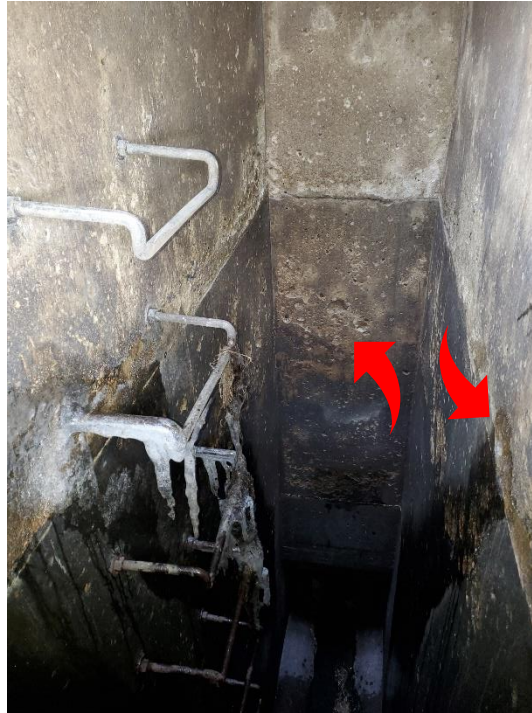
9. INTERIOR RISER MINOR SPALLING (LOOKING EAST)

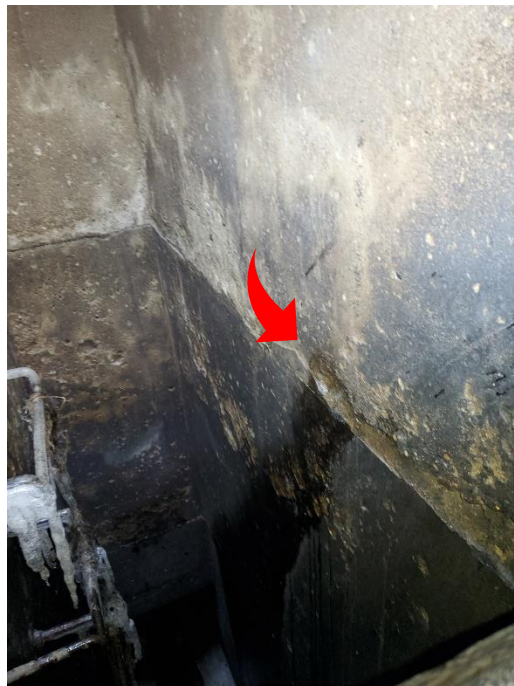
10. INTERIOR RISER MINOR SPALLING (SOUTH WALL)

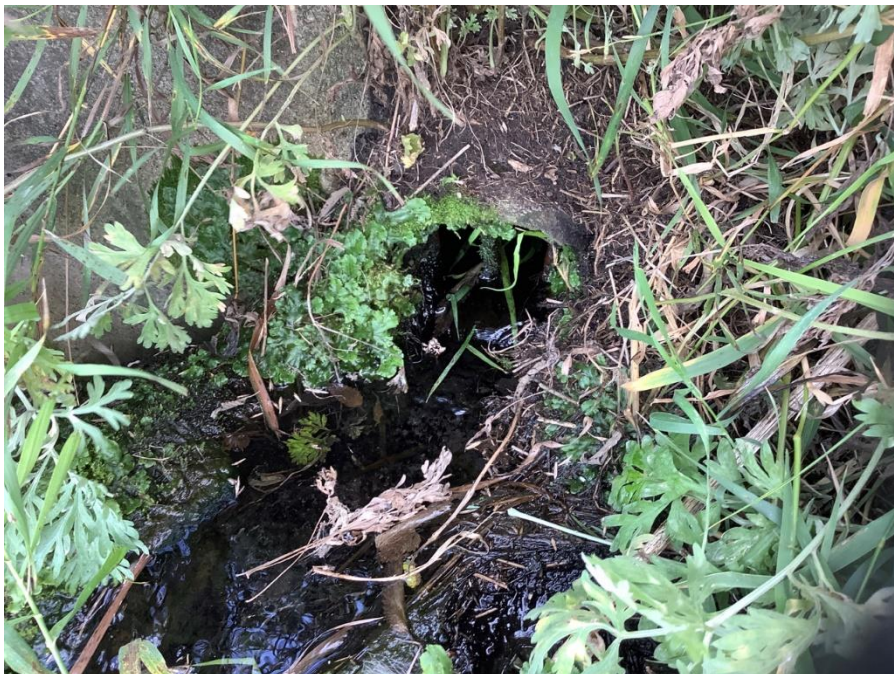
13. LEFT (NORTH) FOUNDATION DRAIN (MISSING RODENT SCREEN)

For the purposes of the rehabilitation effort at Bylin Dam, the outlet end of the principal spillway conduit would need replacement or repair work if the conduit were to stay in place. Additionally, a new animal guard on the outlet of the north toe drain would be added. With these improvements, the principal spillway conduit appears to be adequate to last through the expected dam rehabilitation design life of 50 years. All structural elements should continue to be monitored on a regular basis. Observations from the inspection associated with the principal spillway concrete inlet structure, conduit, and outlet are provided in **Table D-1-2**.

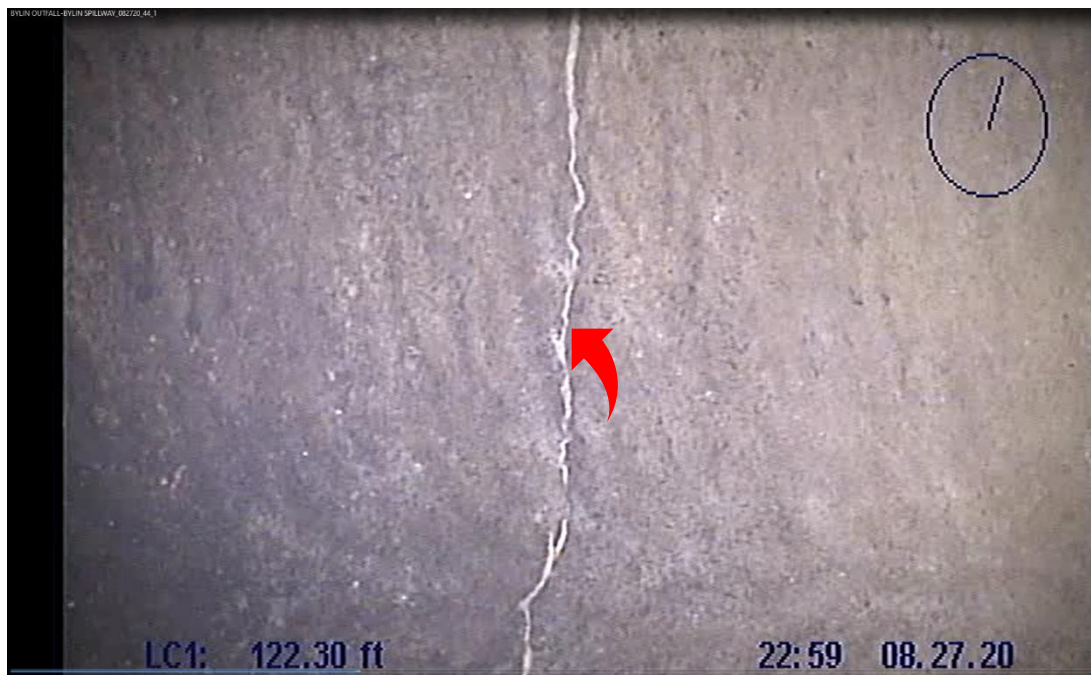
14. PRINCIPAL SPILLWAY CONDUIT PIPE CRACK (NEAR JOINT 4)

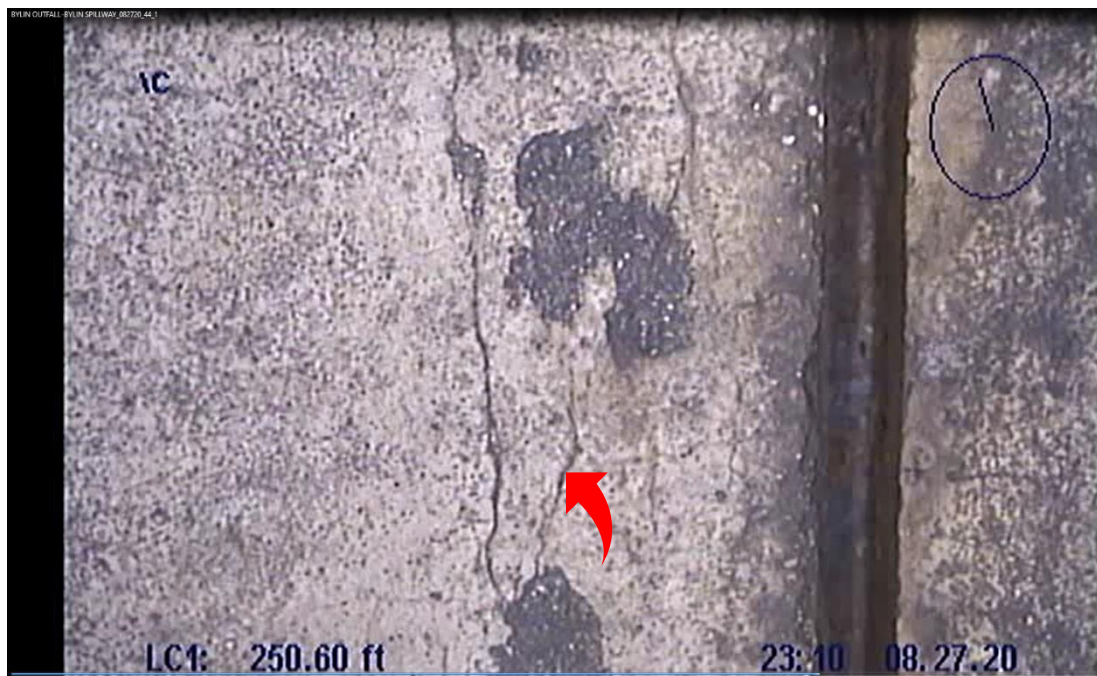
15. PRINCIPAL SPILLWAY CONDUIT PIPE CRACK (NEAR JOINT 11)

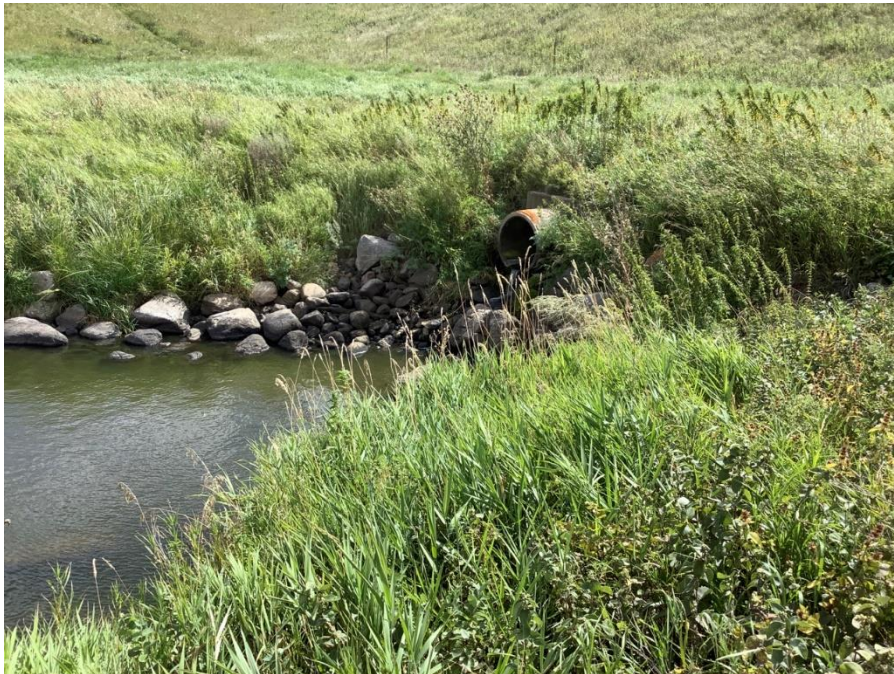
16. PRINCIPAL SPILLWAY OUTLET

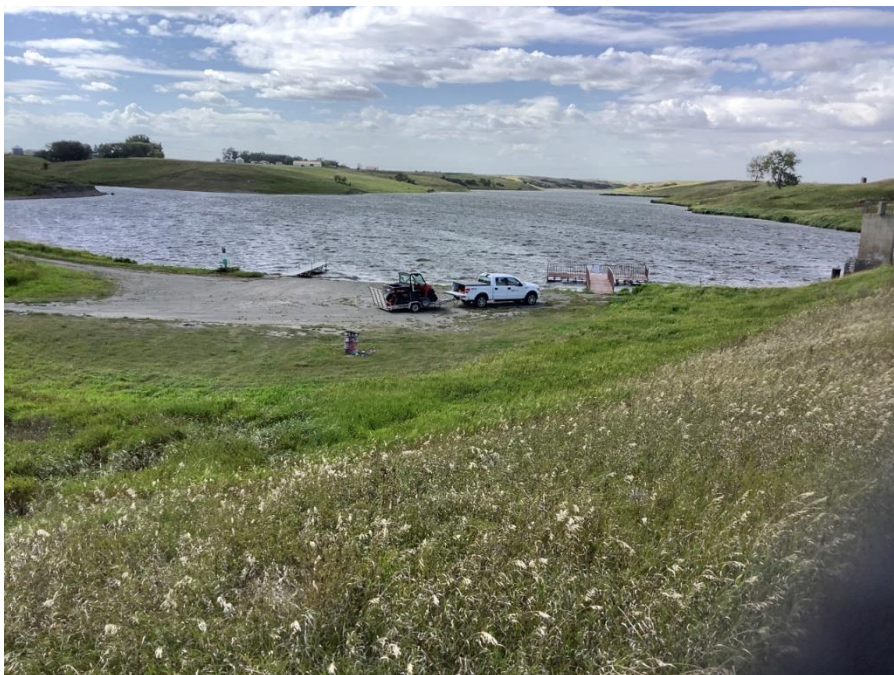
In addition to the embankment and auxiliary spillway inspection, it was noted that a section of the access road to the beach and boat ramp has eroded over a length of approximately 170 feet along with portions of the beach area. All deficiencies associated with the dam embankment and auxiliary spillway are noted in a Dam Inspection Form which can be made available upon request. **Attachment D-1-2** contains photographs of the embankment and auxiliary spillway of Bylin Dam.

25. BOAT RAMP, BEACH, AND FISHING DOCK
