APPENDIX D-2
GEOTECHNICAL ENGINEERING REPORT

North Branch Forest River Dam #1 (Bylin Dam)
Walsh County, North Dakota

Greenwood Village, Colorado
January 20, 2021
Revised February 28, 2022

**GEOTECHNICAL ENGINEERING REPORT
NORTH BRANCH FOREST RIVER DAM # 1 (Bylin Dam)
WALSH COUNTY, NORTH DAKOTA**

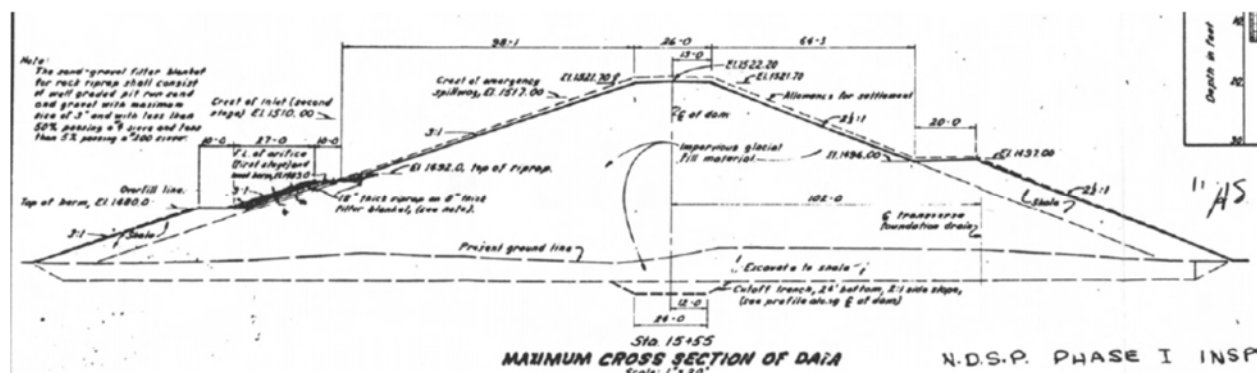
Figure 1. Typical Embankment Section from As-Built Drawings

The typical embankment section, reproduced from the As-Built Drawings (USACE, 1978) is shown in Figure 1 and indicates a homogeneous embankment comprised of glacial till with a shale buttress on the downstream slope.

The boring logs for BD2020-605 did not discern a difference between the embankment fill comprised of glacial till and embankment fill comprised of shale. It is assumed that the shale fill would have been substantially broken down into a mixture of gravel, sand, and fine-grained particles during placement. Therefore, engineering properties of the shale buttress are assumed to be similar to the rest of the embankment.

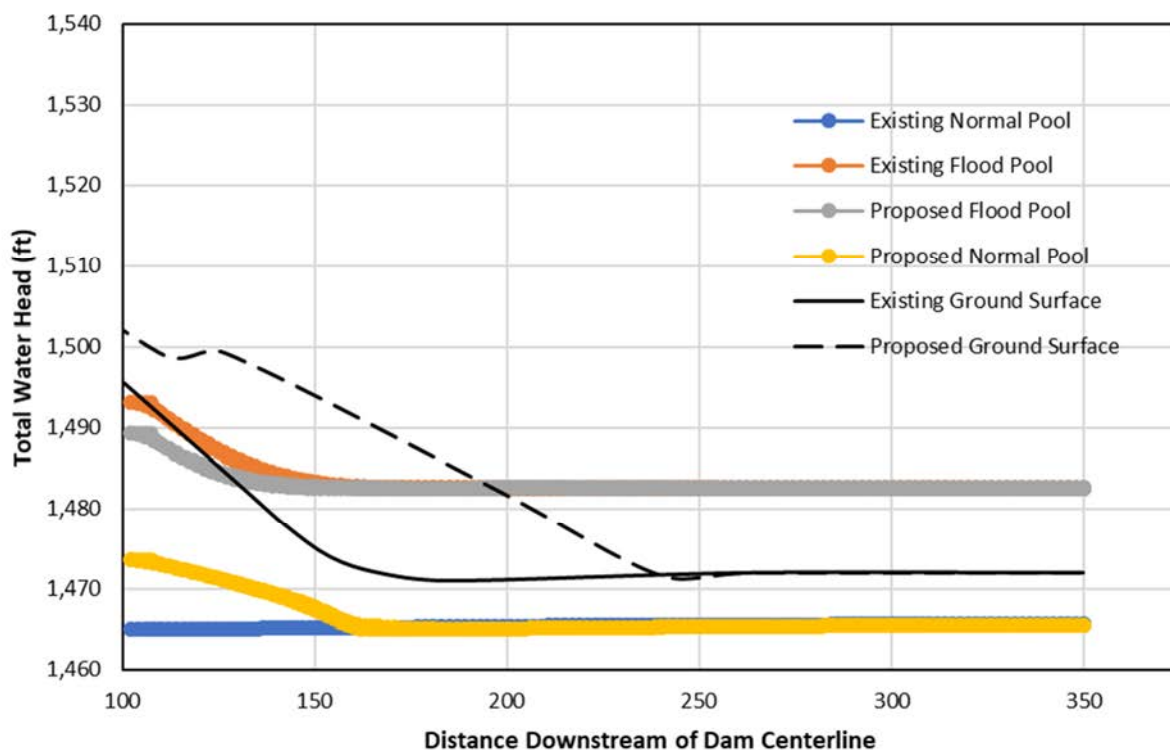
Figure 2. Total Water Head Modeled at the Toe of Dam

The gradient at the downstream embankment toe was reviewed in each model condition. It was determined that the critical gradient was not exceeded for any of the modeled conditions. A plot showing total water head at the downstream embankment toe for each modeled condition is presented in Figure 2.

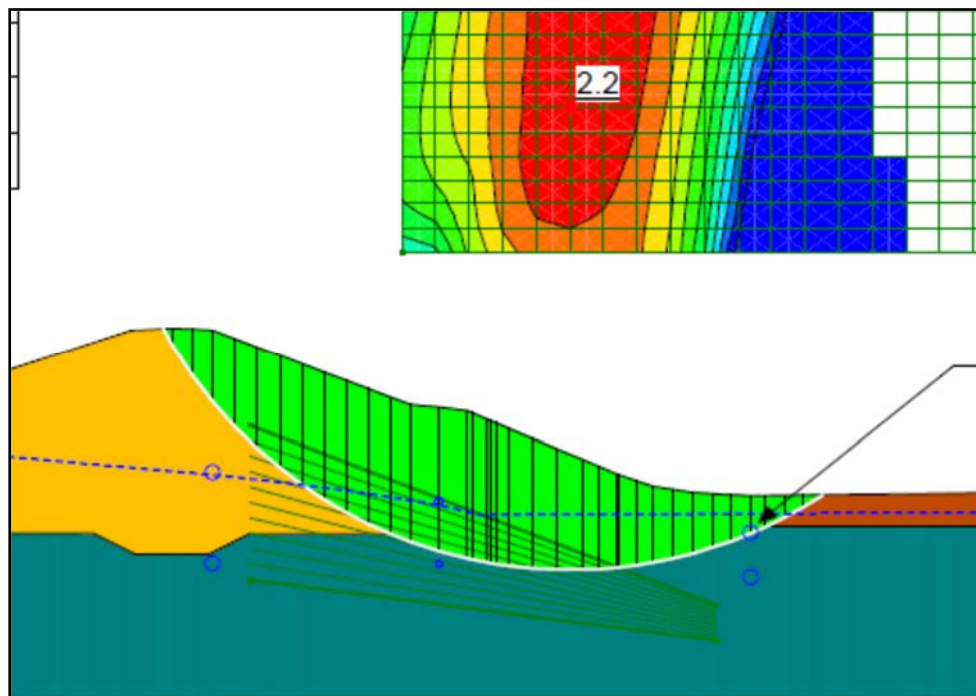
Figure 4. Slope Stability Failure Surface for Normal Pool, Existing Conditions

Analysis	Required Minimum Factor of Safety	Calculated Minimum Factor of Safety
Rapid Drawdown (Composite Strength Failure Envelope)	1.2	1.5
Downstream Slope (Existing), Normal Pool, Steady-State Seepage	1.5	2.2
Downstream Slope (Existing), Flood Surcharge Pool, Steady-State Seepage	1.4	1.1
Downstream Slope (Proposed), Normal Pool, Steady-State Seepage	1.5	2.5
Downstream Slope (Proposed), Flood Surcharge Pool, Steady-State Seepage	1.4	1.4

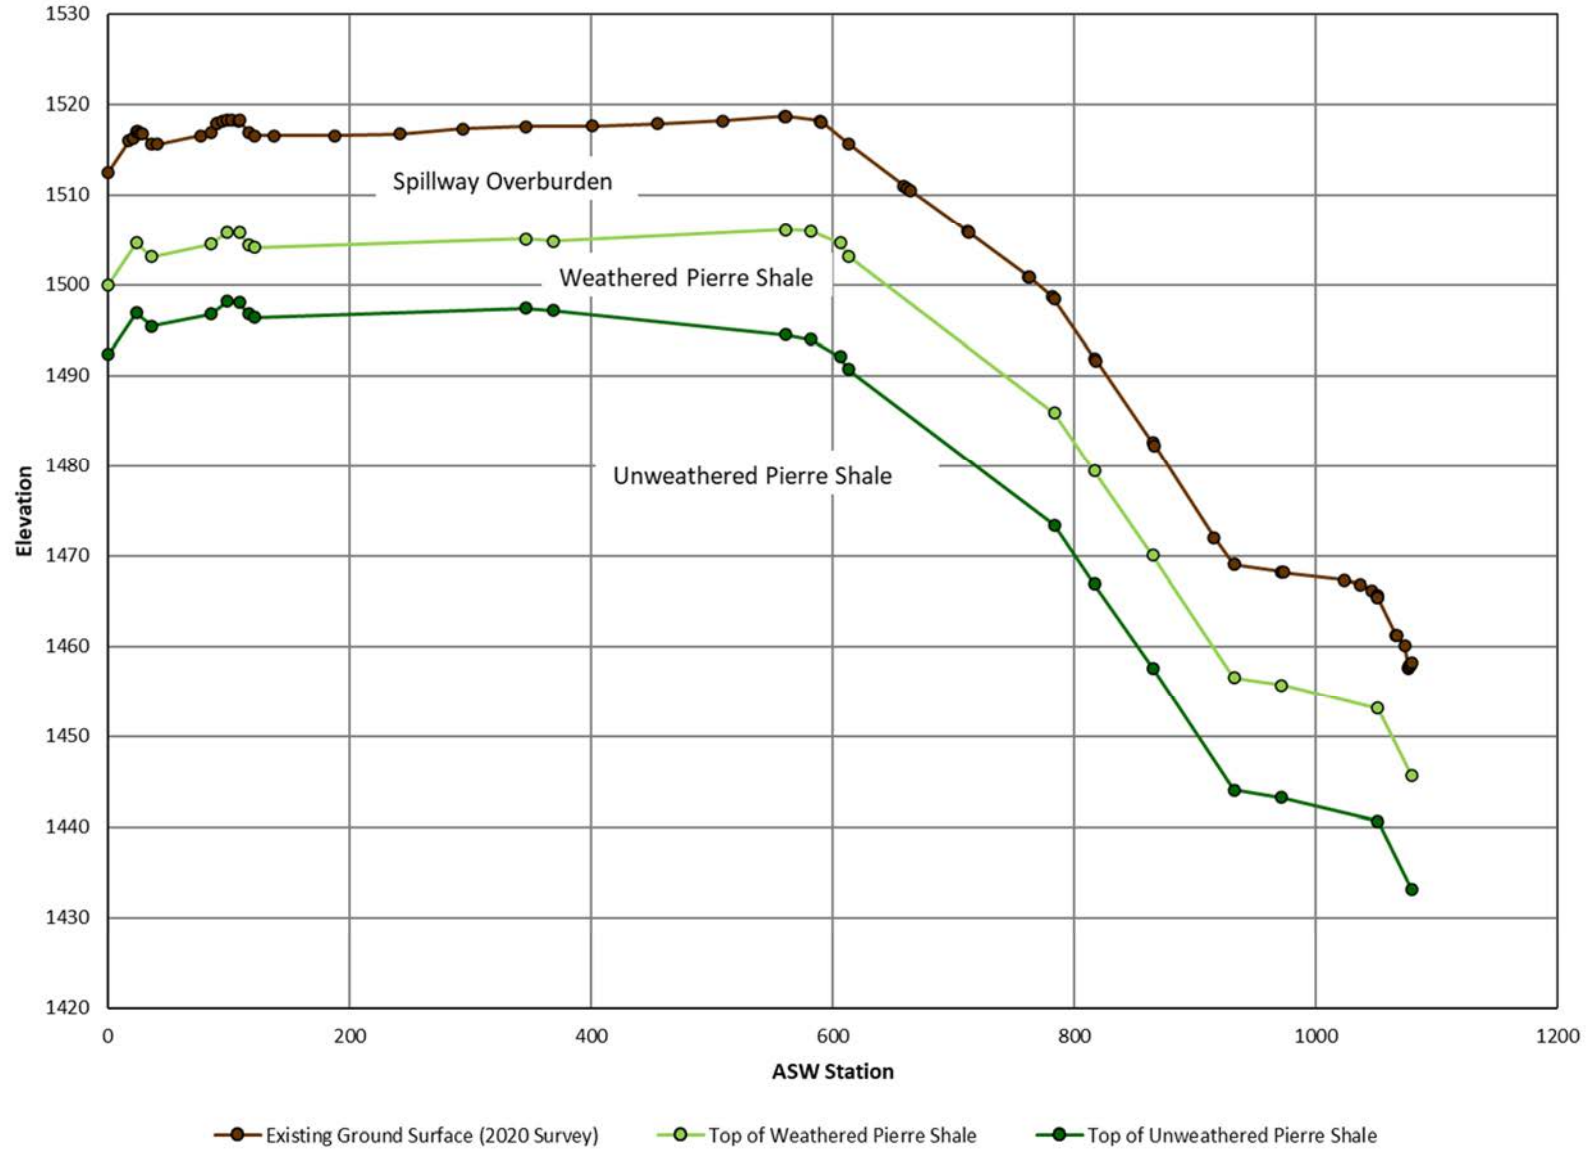
Exhibit 7. Auxiliary Spillway Profile for SITES Analysis

GF drilled six borings in June 23-July 2, 2020 to develop profiles and geotechnical data for evaluation of the spillway integrity and for characterization of the embankment and foundation soils. The locations of the six test borings are shown in Exhibit 6, hand-written field logs and typed boring logs are provided in Attachment A. The core run photos and split spoon photos can be made available upon request. A subsurface profile of the auxiliary spillway is shown in Exhibit 7.
