## Appendix E.2 Engineering Assessment Reports

### Birdwood Engineering Assessment Report Summary

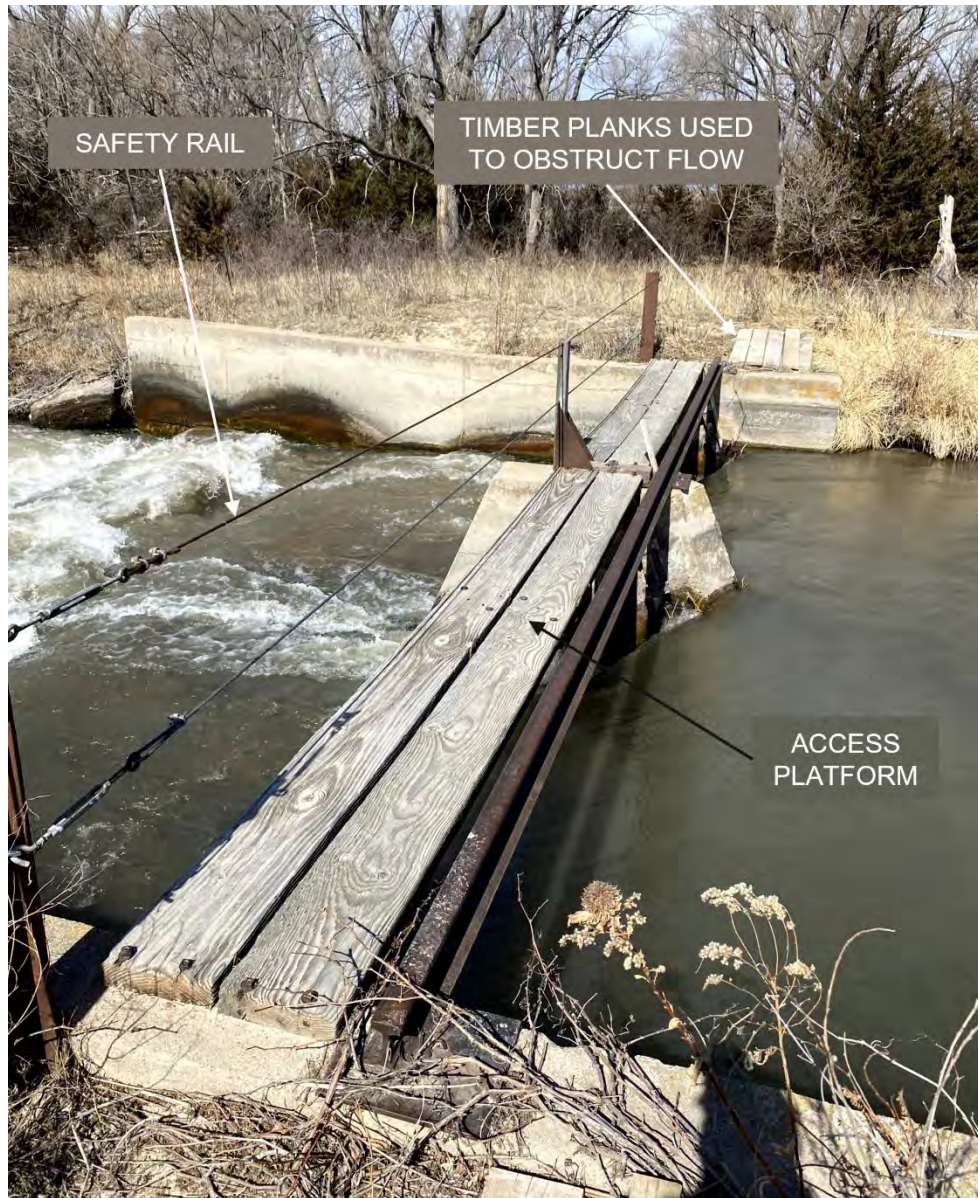
Figure 2. Looking Southeast Along River Control Gate Structure.

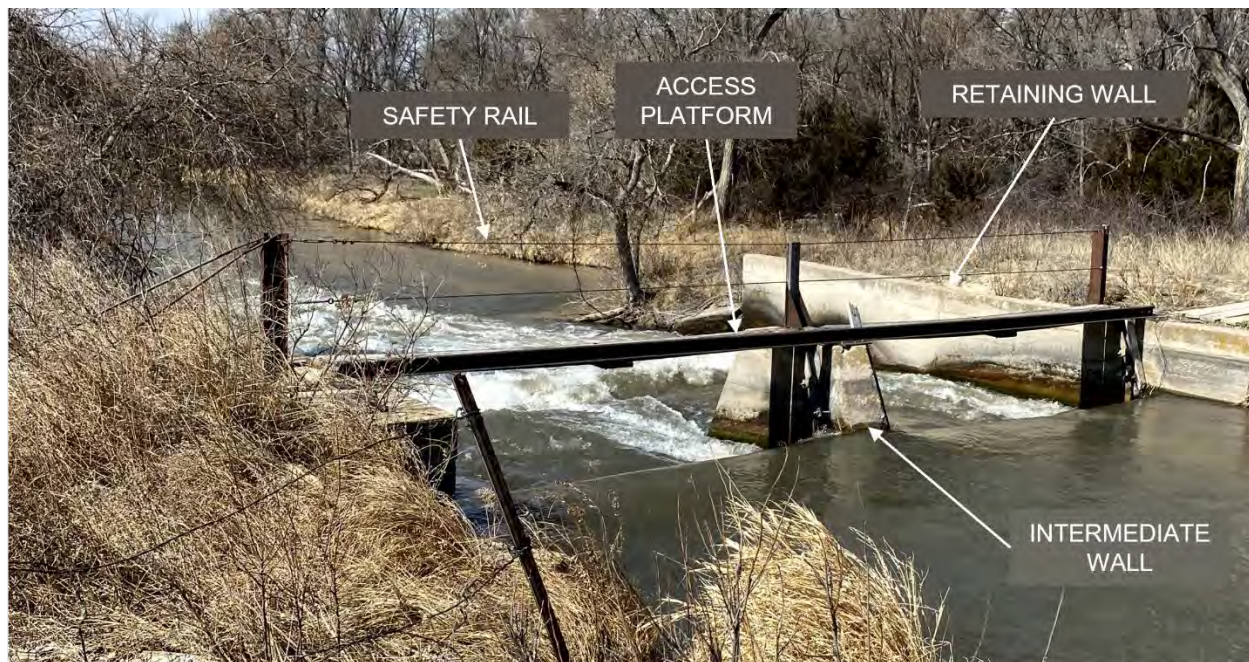
Figure 3. Looking Northeast Toward River Gate Structure – Upstream End

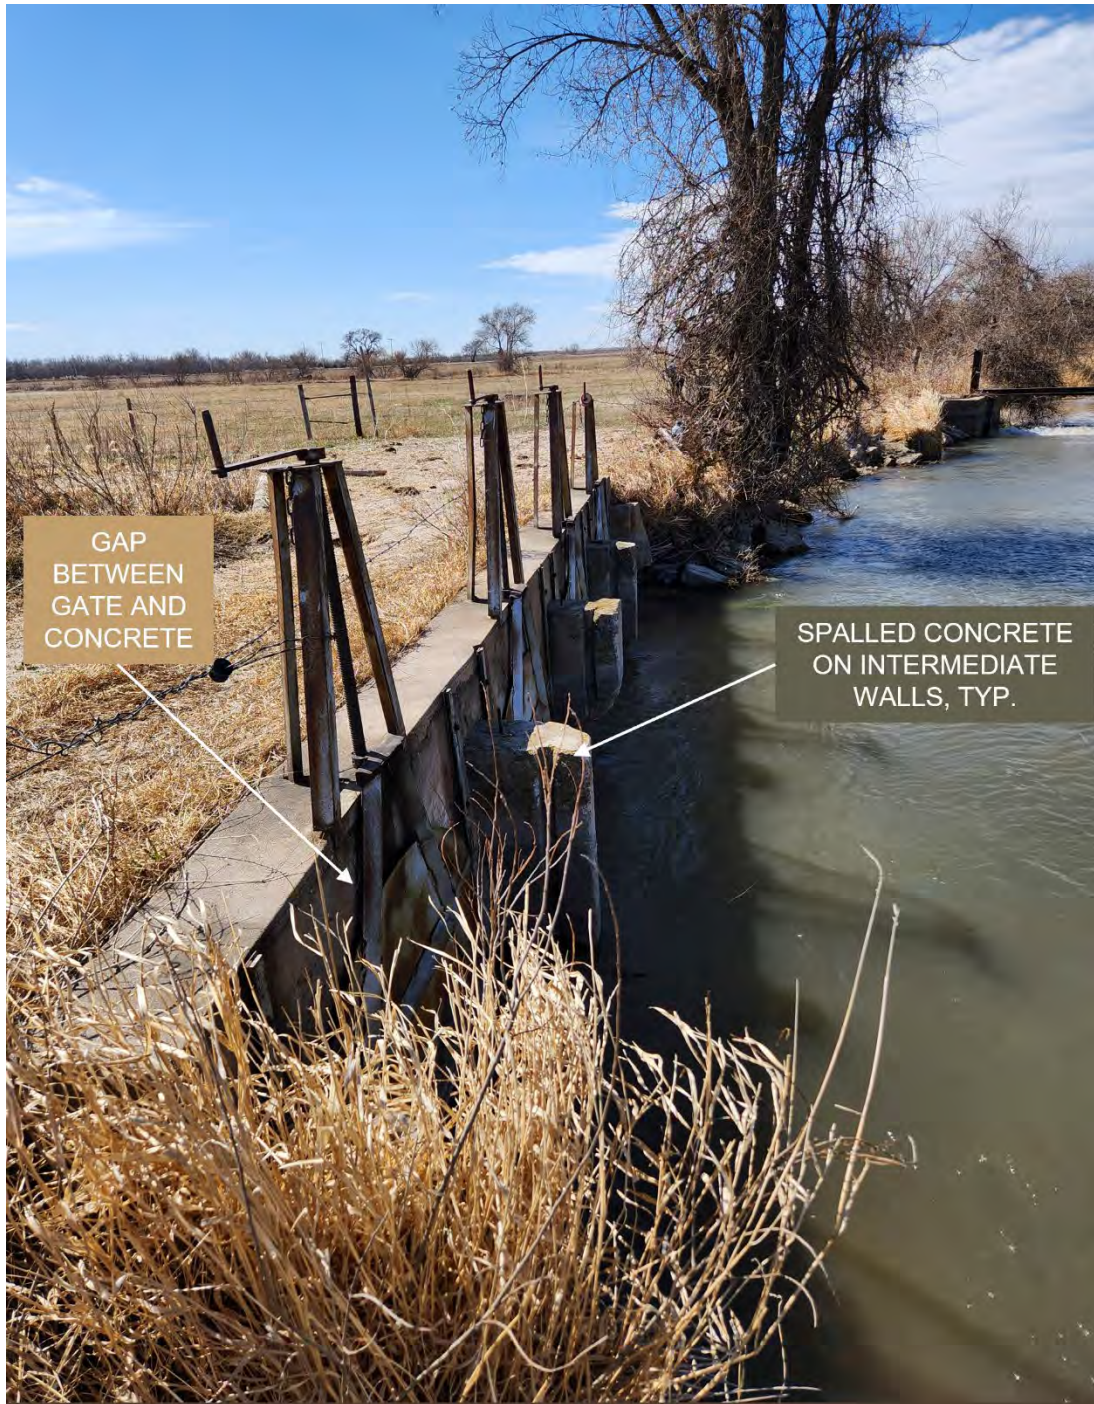
Figure 10. Inlet of Canal Gate Structure – Upstream side.

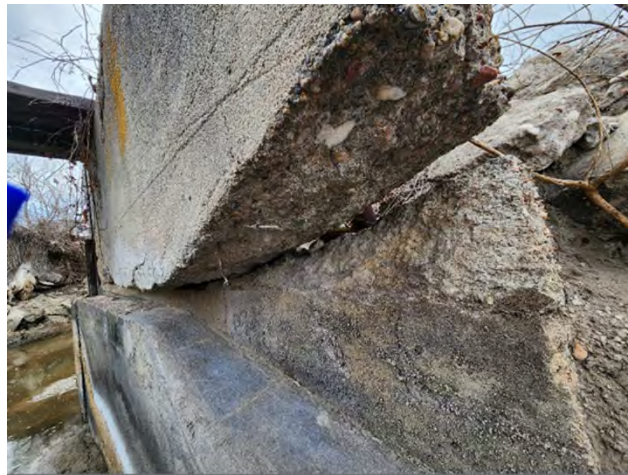
condition with minor concrete spalling and erosion of the concrete surfaces near the flowline. The return gate end walls are in worse condition. The west end wall exhibits the most extensive damage. The feeder canal wall segment exhibits cracking and spalled concrete, while the portion of the wall through the return has failed above the elevation of the repaired base (Figures 6 and 7). Large vertical and longitudinal cracks have developed beyond the stop log channel causing the wall to rotate inward several inches (Figure 6). Similar longitudinal cracking was seen in the eastern return structure wall (Figure 8) but at the time of the inspection, no noticeable deflection of the wall face was noted. Both end walls appear to have extended further toward the Platte River channel in the past but either failed or were intentionally removed near the end of the concrete apron. Remnant pieces of concrete now act as riprap along the outlet bank (Figures 7 and 8).

Figure 6. Close-up view of Wall Failure.

1. Replace the western side wall of the return gate structure including evaluation of extension of the wall end.
2. Evaluate end of east side wall of the return gate structure to determine if reconstruction of the wall end is necessary.
3. Improvements of Southern wall extending from the canal gate structure. This would include sealing the vertical crack between the wall and the canal gates as well as addressing the vertical crack at the wall bend.
4. Seal minor cracks in concrete walls.
5. Seal gaps between base concrete repairs and upper wall sections as needed throughout.
6. Patch spalled concrete as needed to maintain structure functionality.
7. Remove sedimentation of the canal structure apron.
8. Restore grade at wall ends and protect from future erosion.

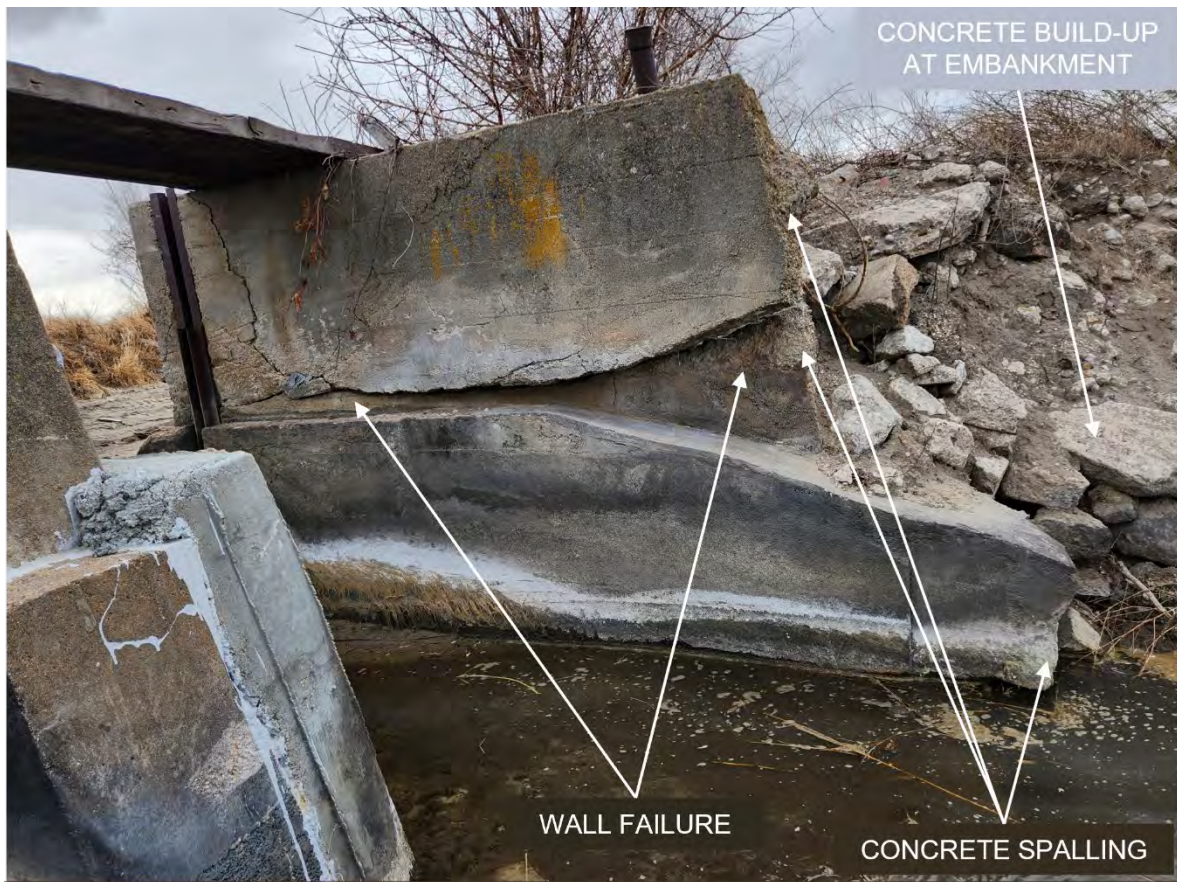
Figure 7. Southeast Retaining Wall at River Return Gate – Downstream side.

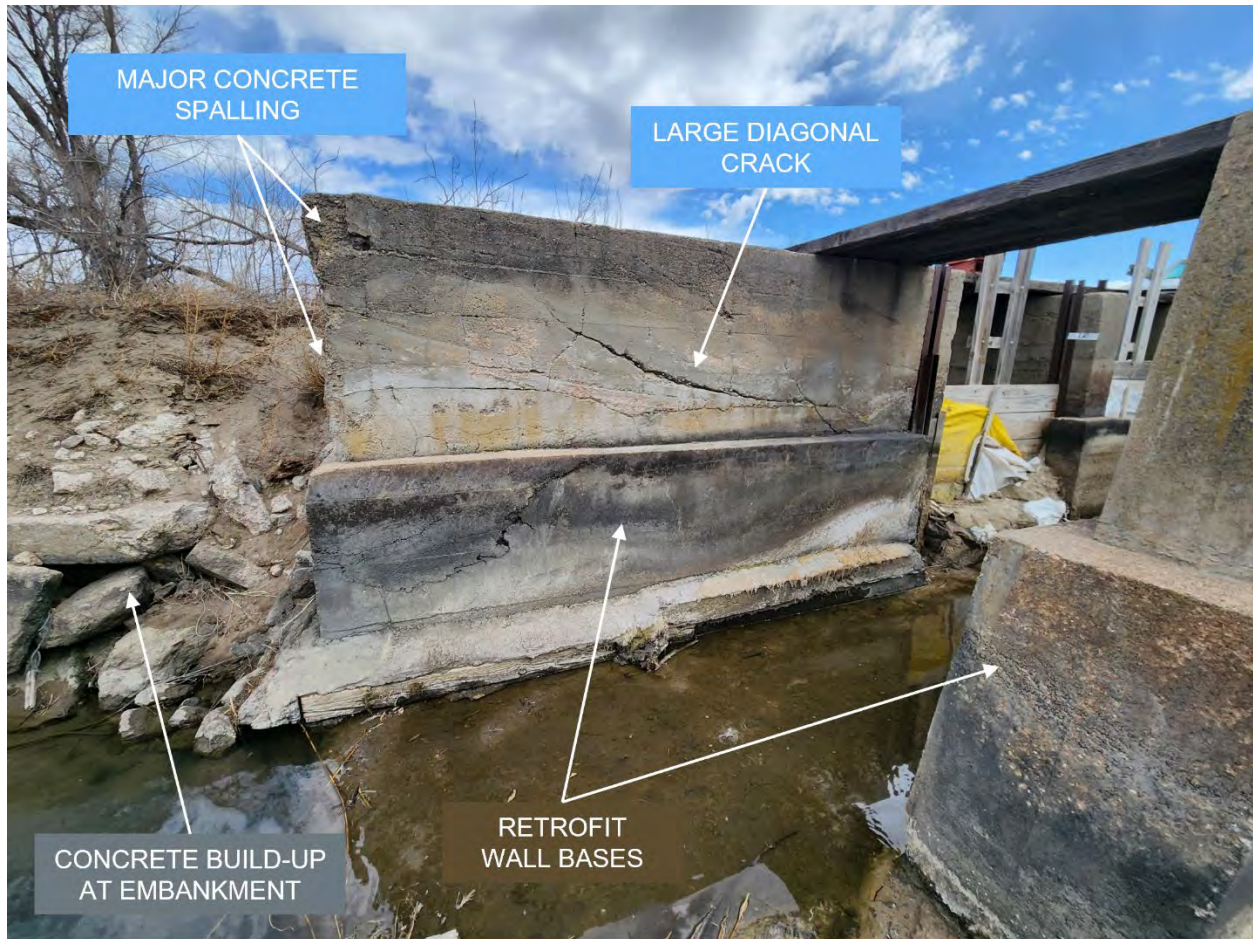
Figure 8. Northeast embankment and Retaining Wall at River Return Gate Structure – Downstream side

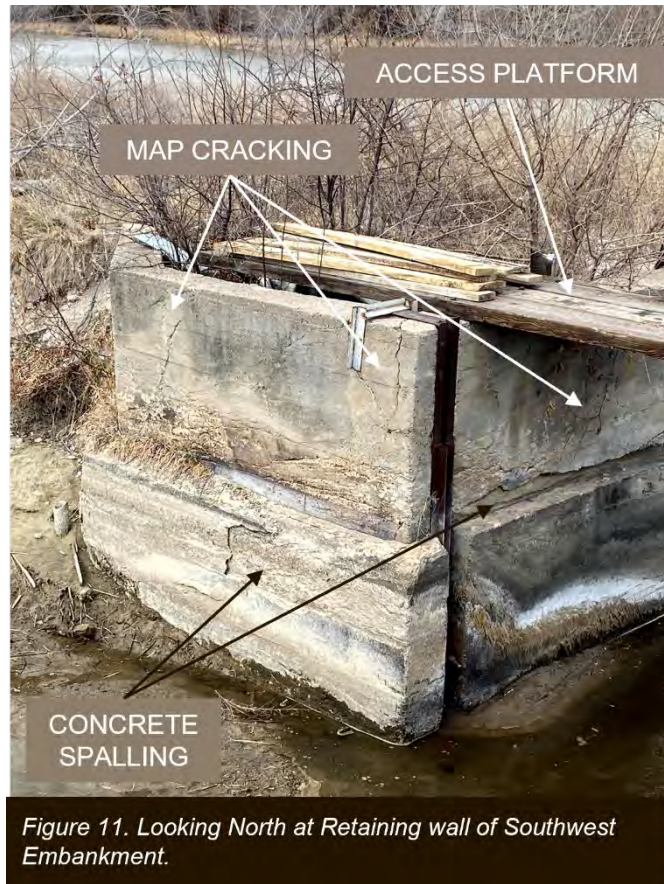
Figure 11. Looking North at Retaining wall of Southwest Embankment.

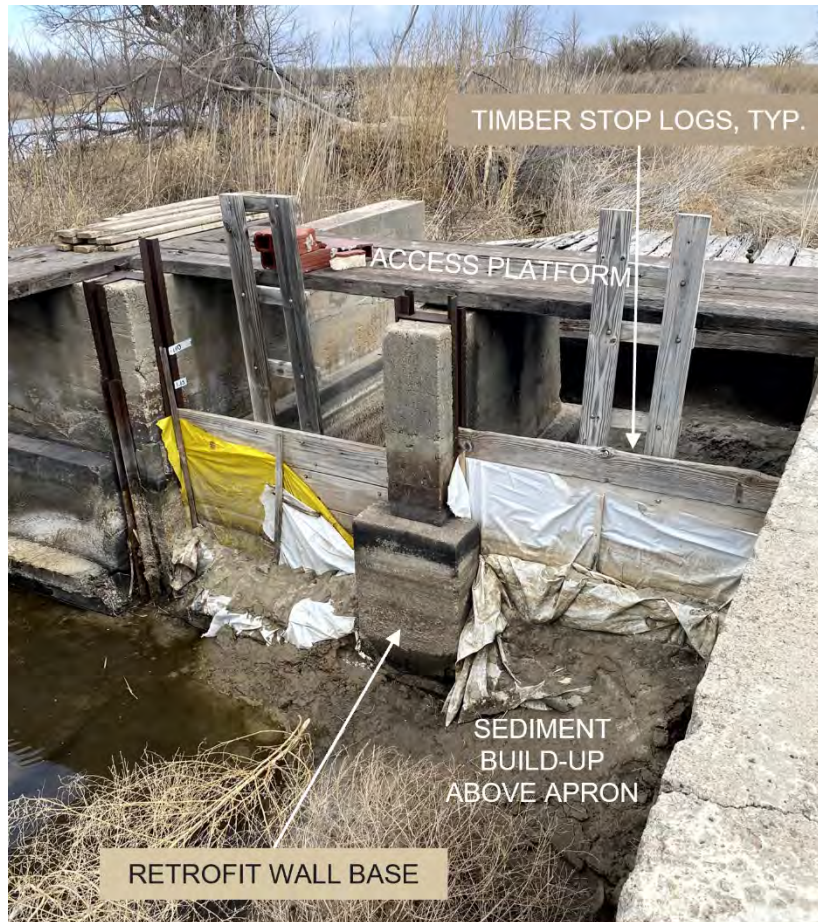
Figure 13. Canal Gate Structure Inlet – Upstream Side.

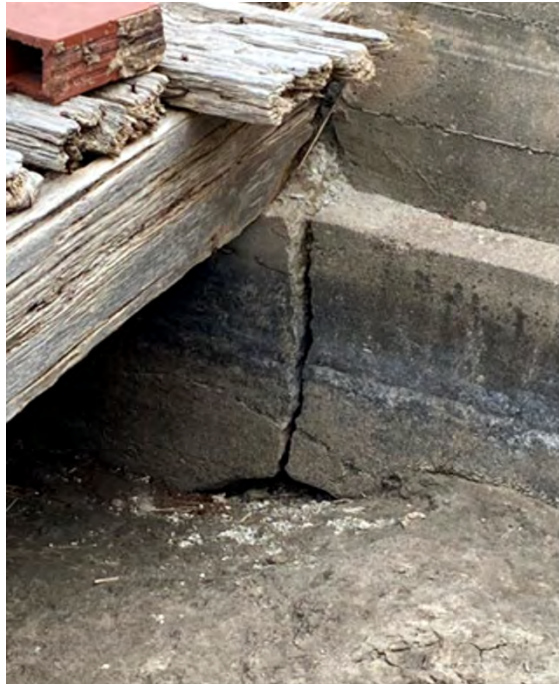
*Figure 16. Vertical Crack in Wall Base at Access Bridge.*

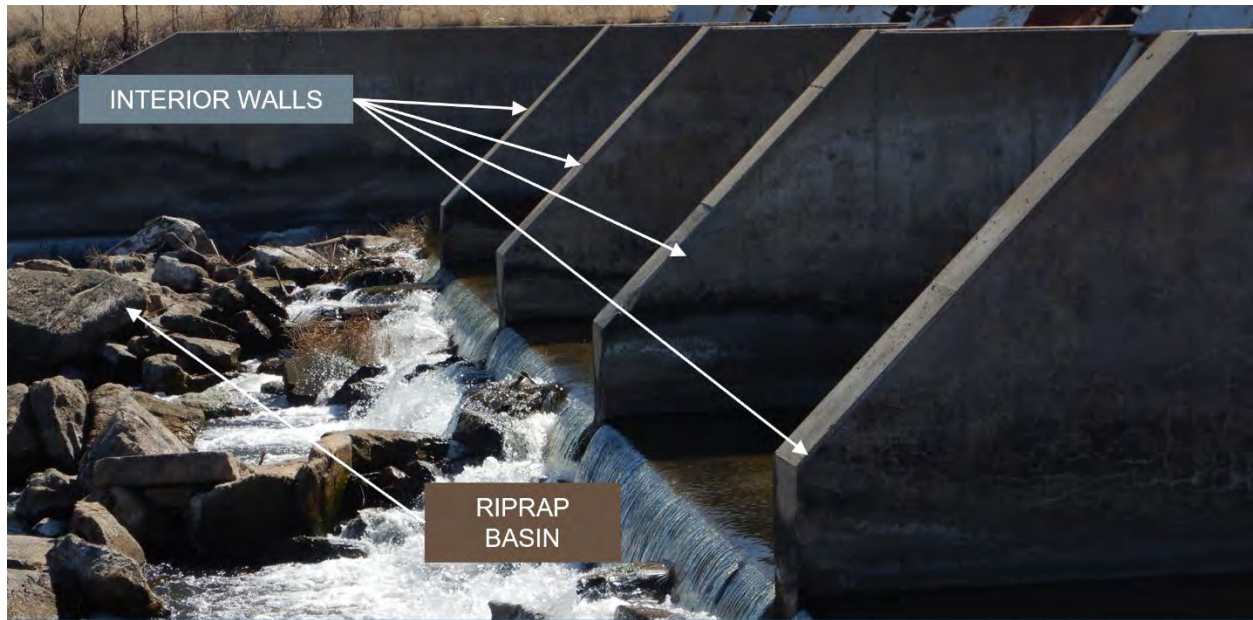
Figure 4. Interior Walls and Riprap Basin

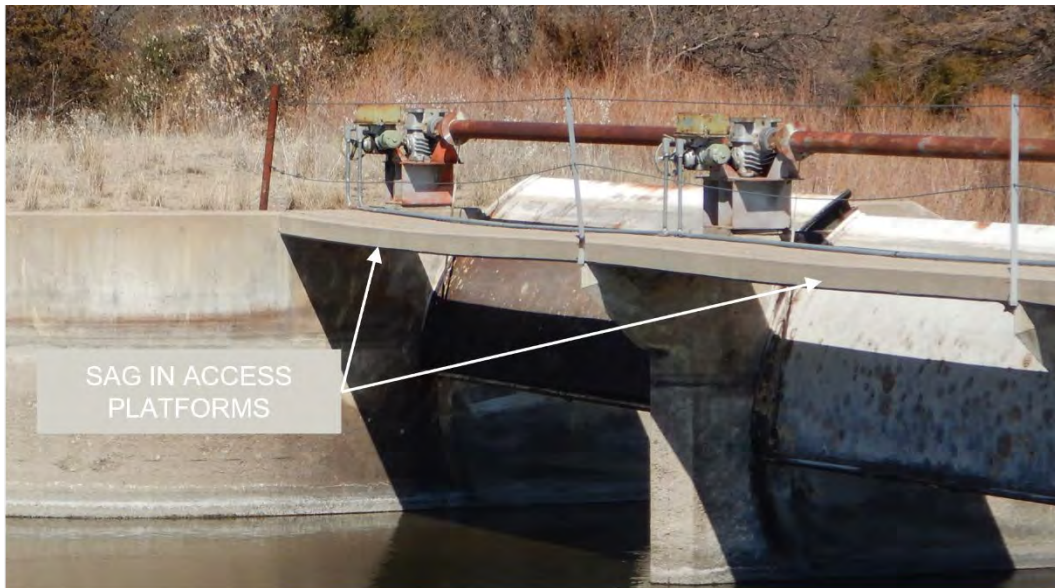
*Figure 8. Typical Access Platform Condition*

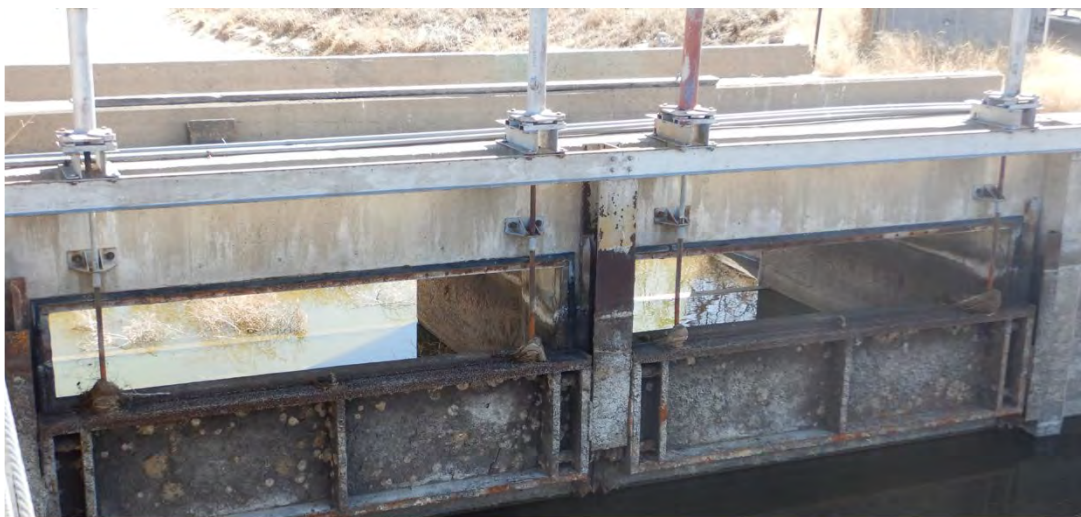
paint coatings and do not show signs of deterioration. The steel gates have surface rusting and other environmental build up consistent with the rest of the structural components exposed to the hydraulic flows as shown in Figure 9. There are no visible holes in the plates that would cause concern for leaking. Gate seals appear to be in fair condition with some locations where rubber gaskets looked dried out and cracked.

*Figure 9. Looking Southeast Towards Canal Structure Inlet – Upstream End*

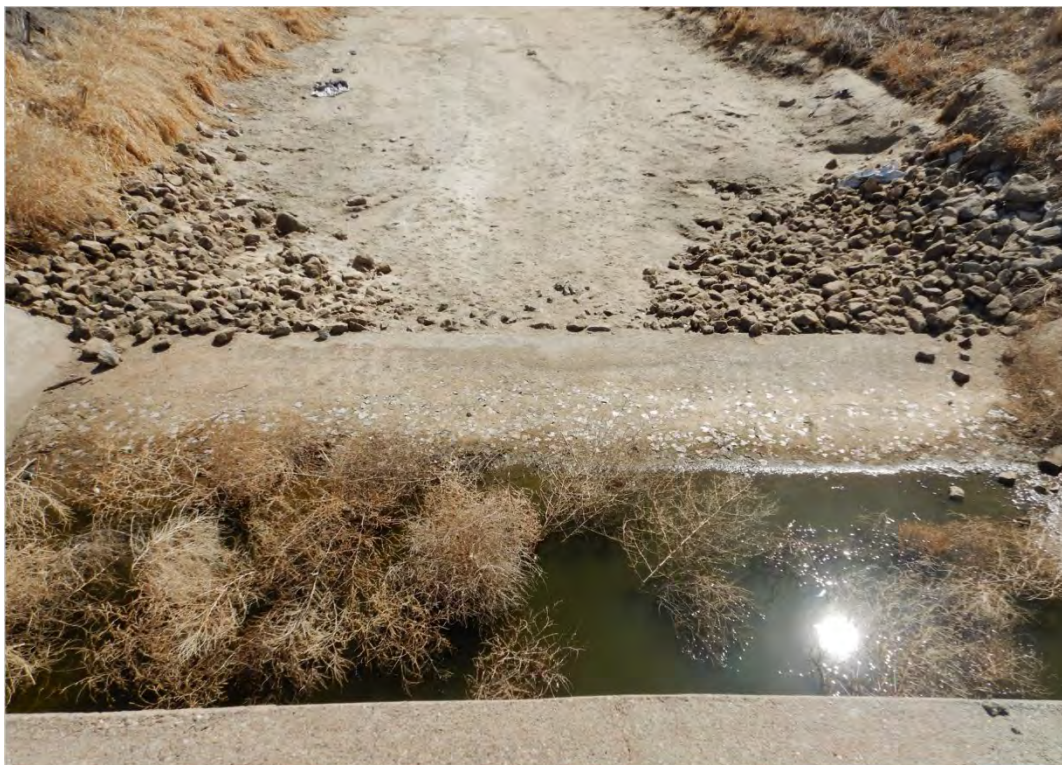
*Figure 11. Concrete Apron, Canal Channel Bed, and Ponding Water*

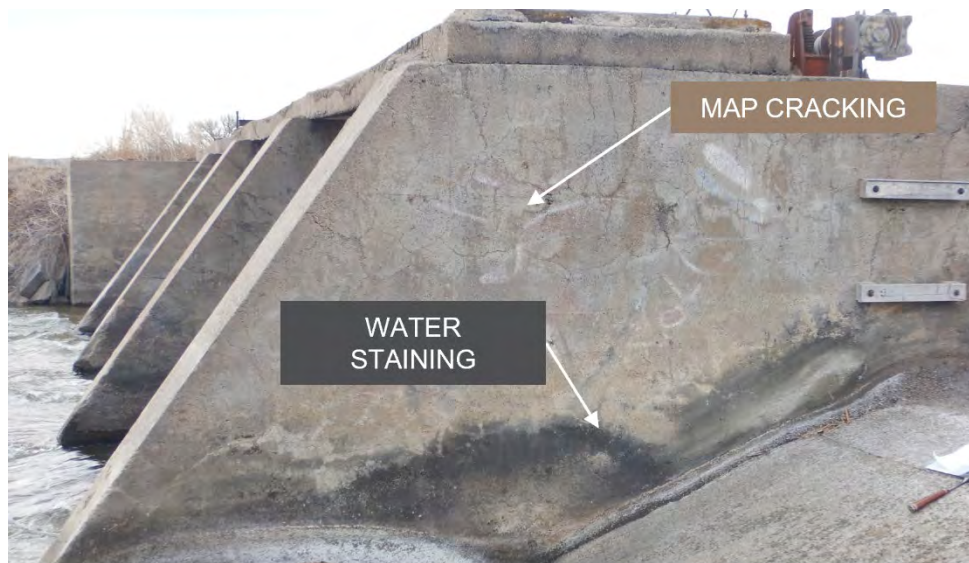
The river gate walls are generally in good condition. All walls exhibited map cracking, concrete spalling and water staining, with some walls exhibiting more significant or widespread damage as shown in Figure 7. Downstream faces of intermediate walls exhibited larger areas of concrete spalling at concrete corners, possibly due to debris that was previously transported through the gates. The gate walls also show signs of abrasion erosion deterioration near the base of the walls. The amount of section loss noted was not significant and no reinforcing steel was visible. The bottom of the north wall has been undermined at its downstream end at the connection to the overflow spillway as shown in Figure 8. It is assumed this erosion is connected to the previously failed section of spillway structure directly adjacent to the north wall. The concrete access platform across the river gates exhibited noticeable deflection and transverse cracking in the top slab near the interior and exterior walls as shown in Figures 9 and 10. The visible portions of concrete apron through the river gates appeared in fair condition with surface irregularities noted but no major signs of structural concern observed.

Figure 7. Typical River Gate Wall Condition

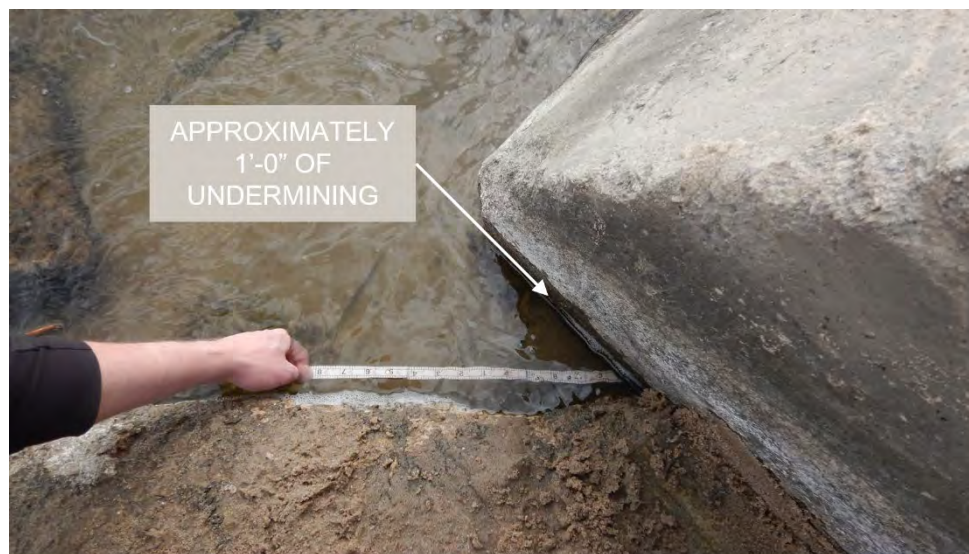
Figure 8. Undermining of North Exterior River Gate Wall

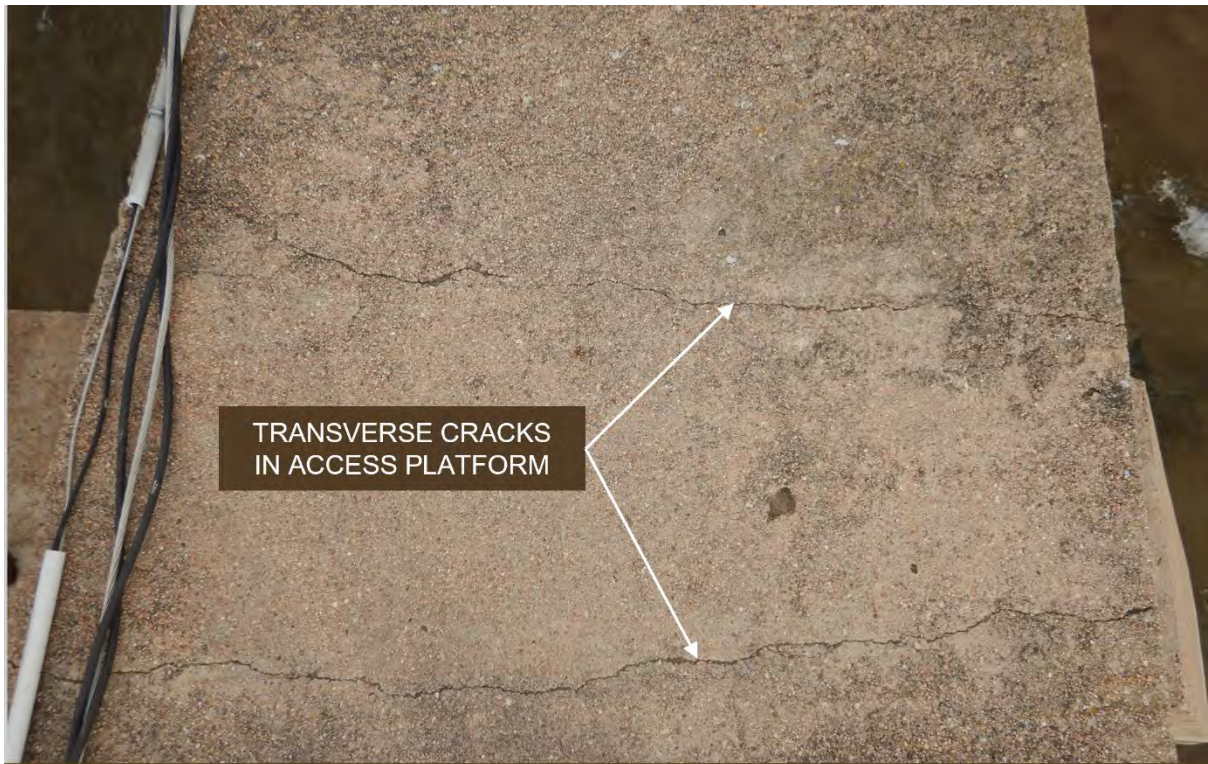
TRANSVERSE CRACKS  
IN ACCESS PLATFORM

Figure 9. Typical Top of Access Platform Condition

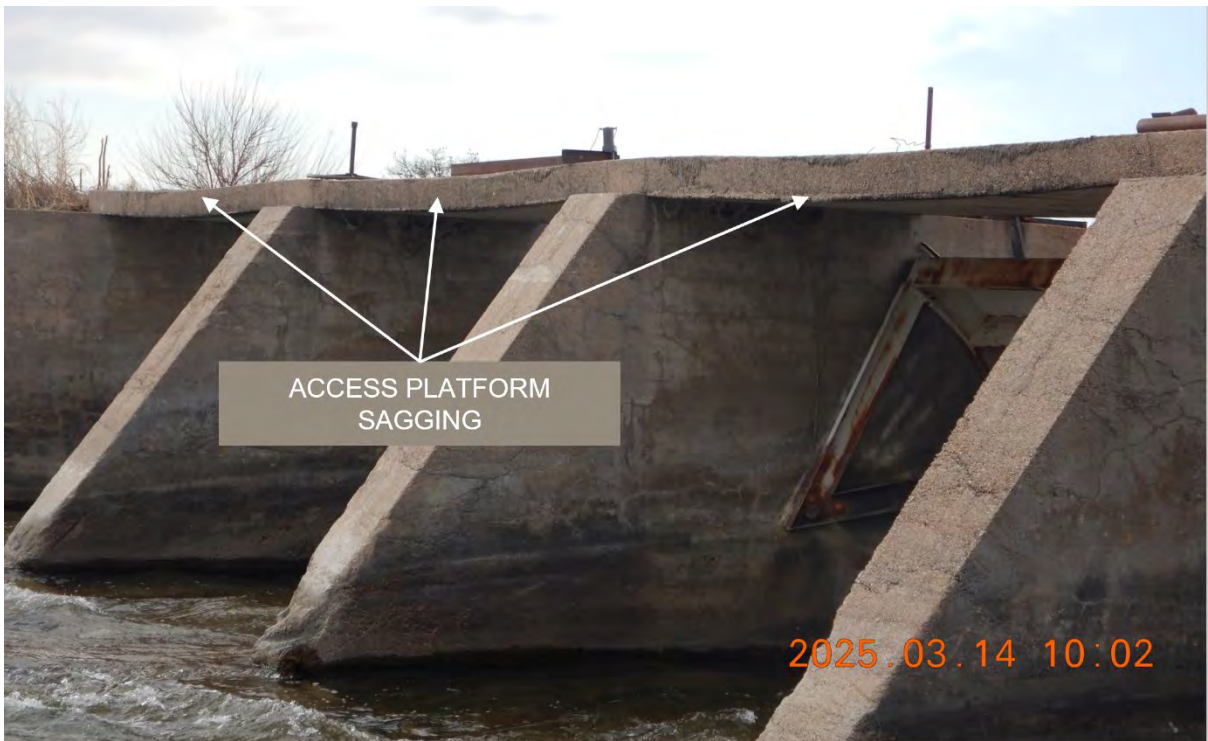
ACCESS PLATFORM  
SAGGING

Figure 10. Typical Access Slab Sagging

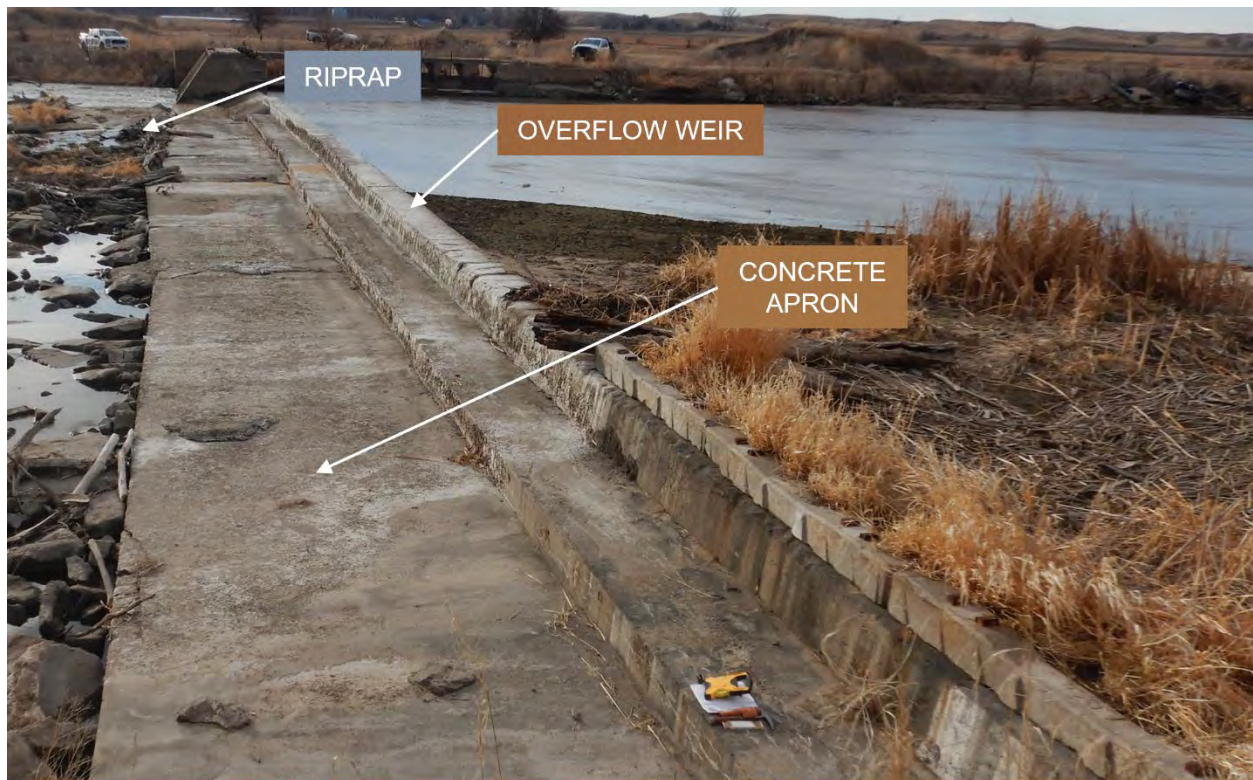
The overflow spillway consists of a 215'-0" long concrete apron with a weir wall at its upstream end as shown in Figure 11. The thickness of the concrete apron was unable to be determined. A 16'-0" long retaining wall is present at the north end of the spillway. The top and front portions of the wall appear to be a retrofit to the original wall intended to increase the height. The spillway and its components are generally in fair condition except for a 25'-0" long region of the apron and weir wall at the connection between the river gates and the spillway at the southern end of the spillway. Typical damage to the structure consists of concrete spalling, cracking and staining. The weir wall in this region has previously failed. Based on the observed condition it is estimated that the spillway apron in this region split directly downstream of the weir wall resulting in the wall tilting backward (downstream). Repairs were completed by pouring concrete behind the failed wall section to stabilize and, attempt to seal off the resulting opening as shown in Figures 12 and 14. The structure was stabilized with this repair, but water appears to still be migrating through the repaired opening due to standing water and saturated sand downstream of the repair. In addition to the failed section of weir wall, there are two regions near the middle of the spillway apron that appear to be sagging due to slab settlement as shown in Figure 16.

Figure 11. Looking Southeast Along Spillway Structure

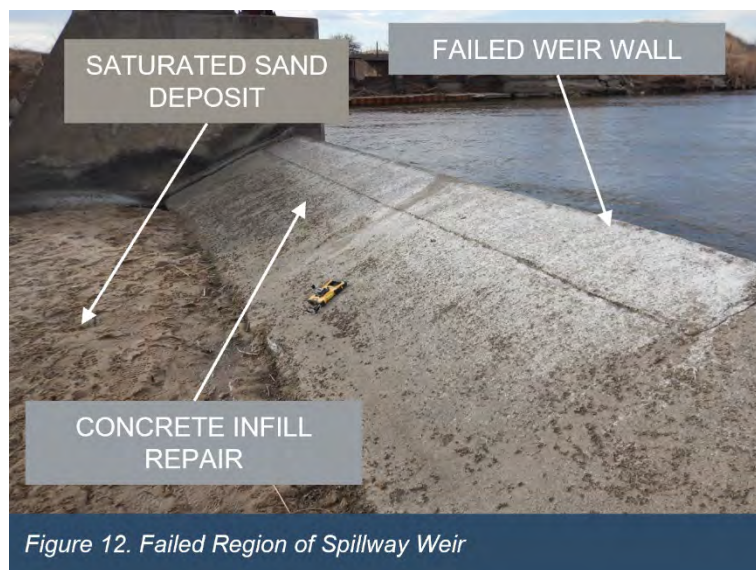
Figure 12. Failed Region of Spillway Weir

1. Reconstruct the downstream retaining wall of the river channel.
2. Replace failed spillway section directly north of the river gates.
3. Replace canal gate structure and reconnect to the existing river gate structure.
4. Install scour mitigation sheet pile cut off walls at upstream and downstream portions of the structure and connect to existing structural aprons or walls.
5. Concrete patching at spalled locations throughout all walls and slabs of the structures as required.
6. Patch and seal construction joints in the spillway structure to prevent further water seepage.
7. Replace seals at all radial gates.
8. Patch and recoat radial gate surfaces that have experienced excessive section loss.
9. Restore downstream riprap basin at the overflow weir structure.
10. Restore locations of structure embankment erosion and armor against future deterioration.

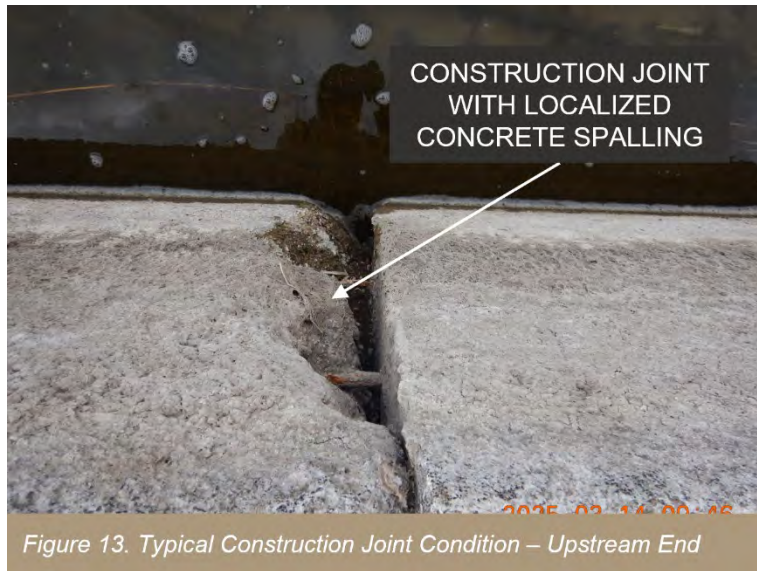
Figure 13. Typical Construction Joint Condition – Upstream End

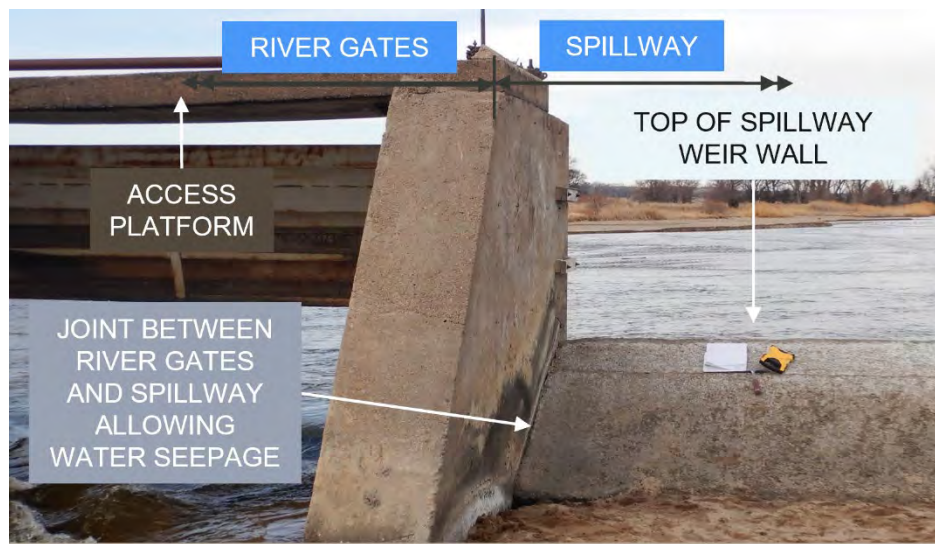
A gap at the connection between the north wall of the river gates and spillway has formed which is allowing water to pass through, potentially contributing to the erosion at the base of the north wall as shown in Figure 14. Larger cracks were present at construction joints between slab and weir wall sections and minor concrete spalls were present on corners of construction joints as shown in Figure 13. Water was present at construction joint locations throughout the spillway. It could not be determined if water was present because it has pooled up due to cracks and spalls forming low points, or because of water seepage through construction joints in the weir wall.

Figure 14. Interface of River Gate and Spillway – Downstream End

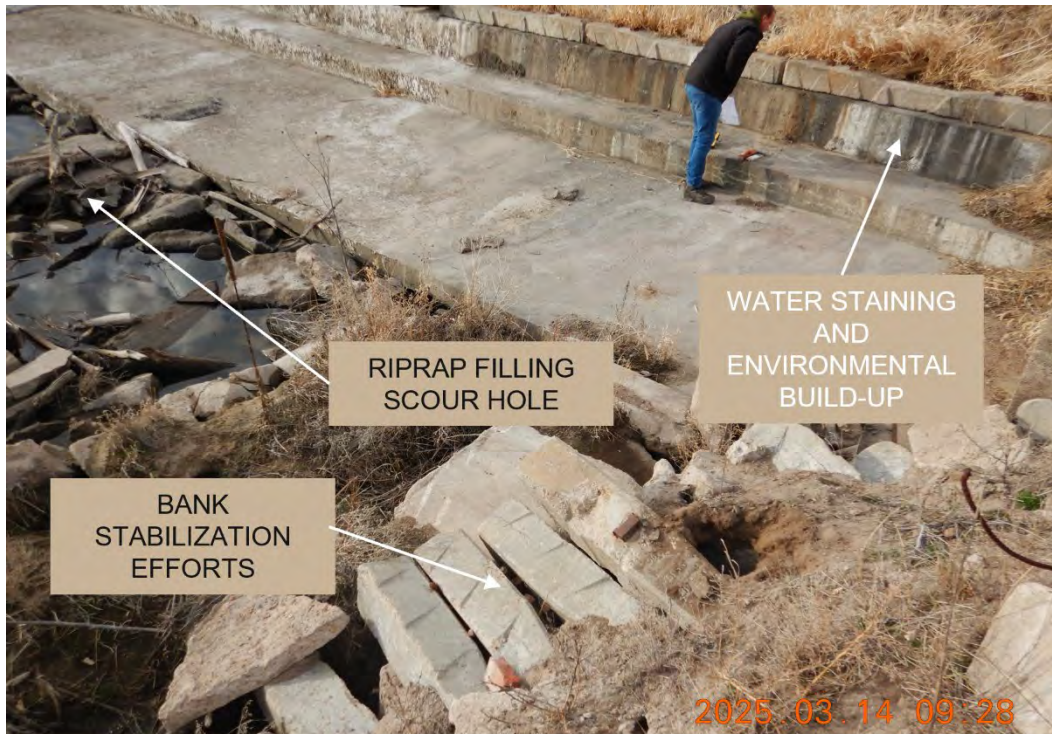
Figure 15. Typical Apron Condition and Environmental Buildup – Downstream End

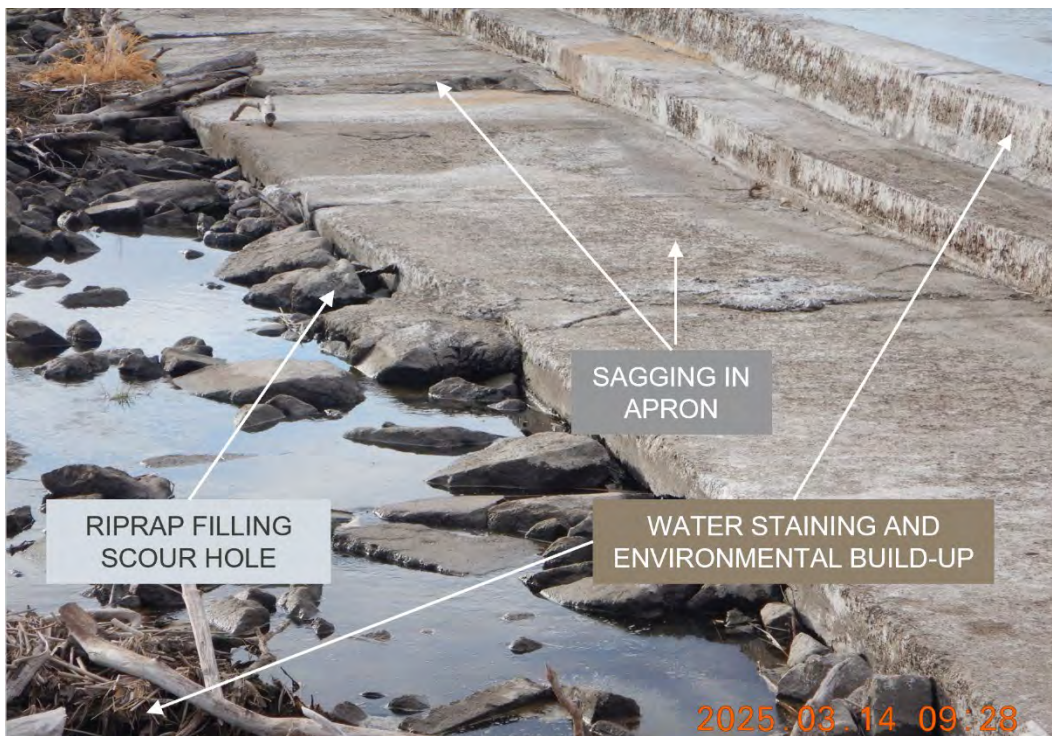
Figure 16. Typical Apron Condition and Environmental Buildup – Downstream End

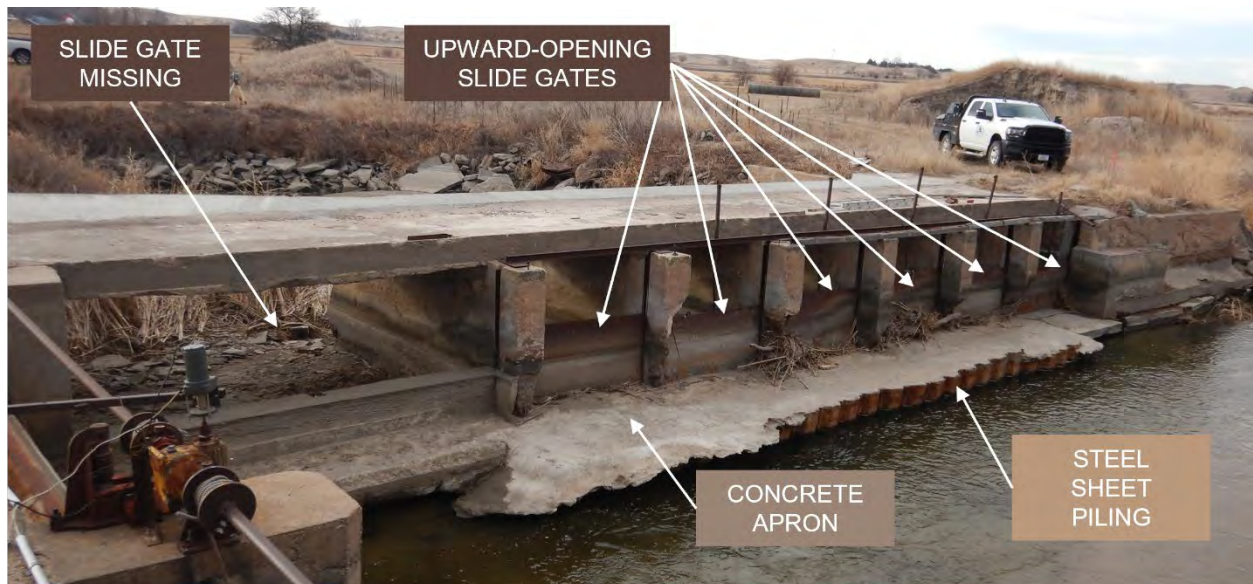
The canal gates consist of seven cells with a concrete apron floor present in some of the cells and a concrete access platform as shown in Figures 17 and 18. Overall, the canal gates and their components are in very poor condition. The cell at the east end of the gates is 13'-6" wide, and all other cells are 5'-9" wide. The 13'-6" cell has a wall at its inlet that extends to approximately mid height of the cell. The top slab of the cells consists of two cast in place concrete slabs that are used as access platforms to reach the river gates. One concrete slab is original to the structure, and the adjacent slab was a retrofit to widen the platform. The retrofitted slab was constructed utilizing steel railroad rails as reinforcement with timber planks spanning between them to create a bottom surface to pour concrete on. The original portion was constructed using temporary formwork. An additional concrete apron is present at the inlet of the canal gates. This apron was constructed by installing steel sheet piling and pouring concrete between the sheet piling and front face of the inlet. The original and retrofit apron have been undermined at the downstream end at the connection to the river gates. The thickness of the apron could not be determined. The west exterior wall of the canal gates extends 10'-0" south into the canal channel (Figure 18), and a retaining wall extends 11'-0" west of the canal gate inlets along the riverbank (Figure 17). Concrete facing has been poured at the bases of all exterior walls.

Figure 17. Looking Southwest Towards Canal Structure Inlet – Upstream End

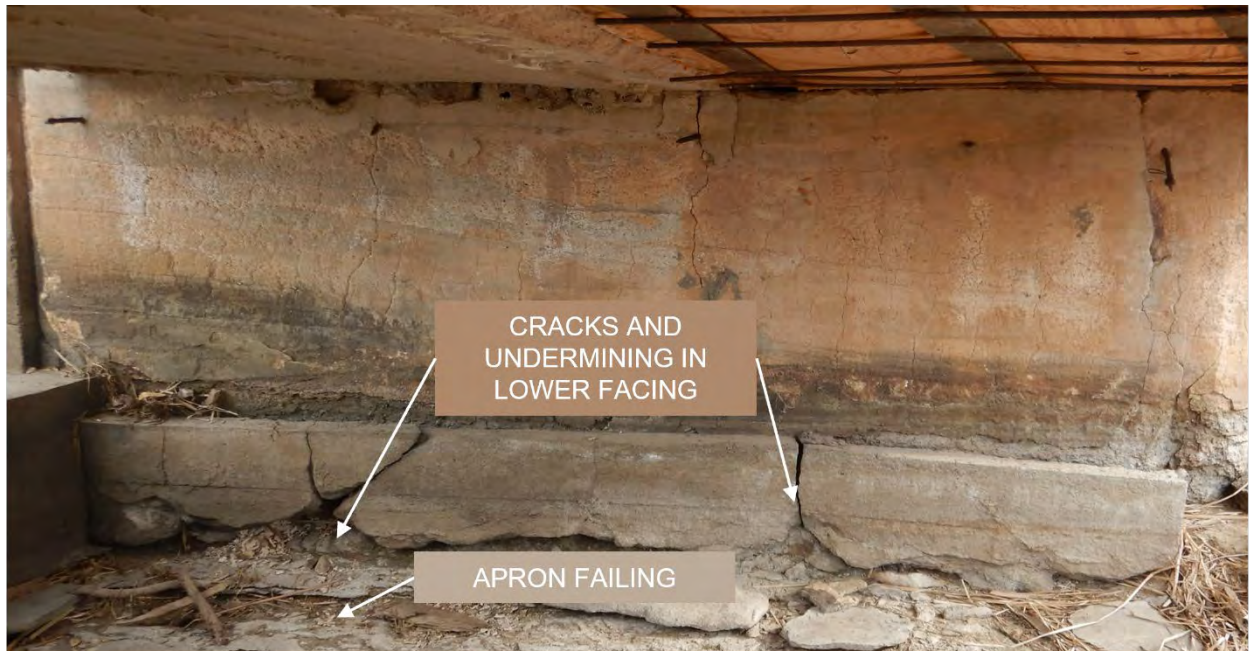
Figure 21. North Exterior Wall of Canal Gate Structure and Apron

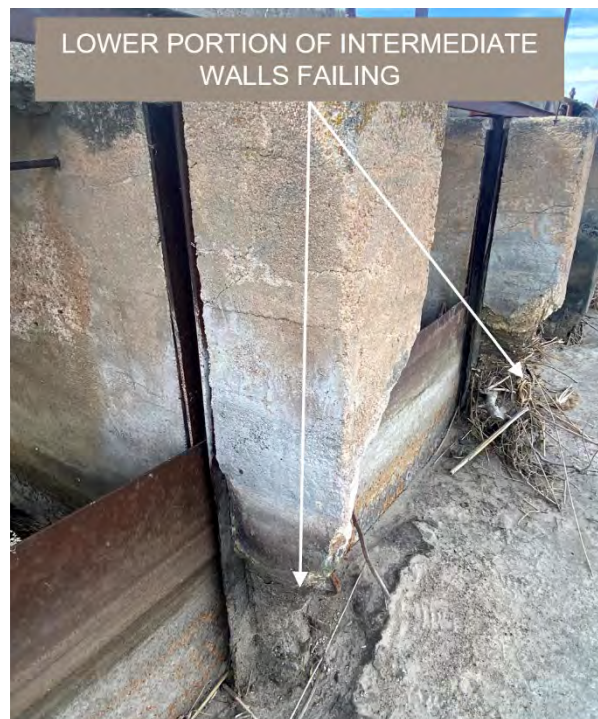
Figure 22. Typical Canal Gate Intermediate Wall Condition – Upstream End

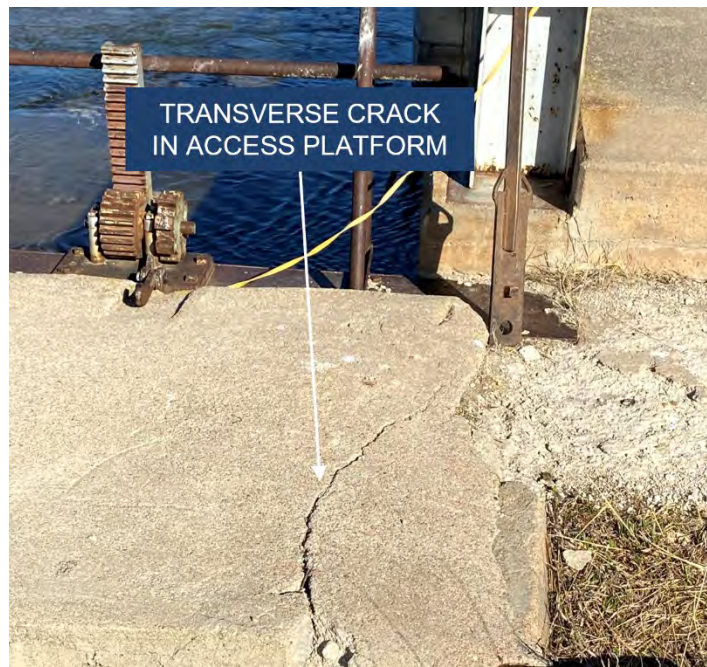
*Figure 22. Transverse Crack in Access Platform*

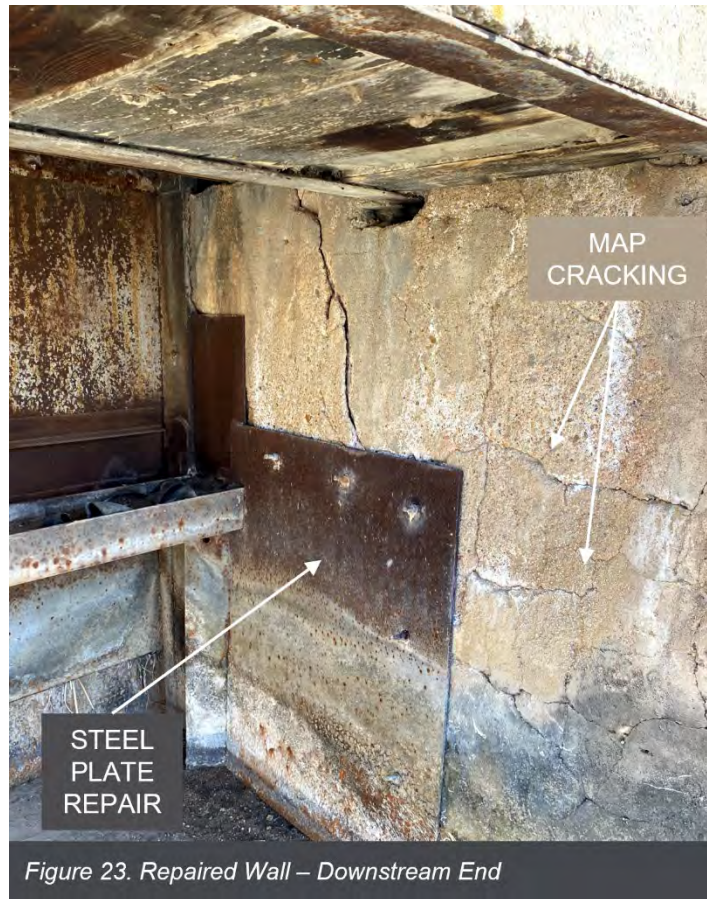
Figure 23. Repaired Wall – Downstream End
