## Appendix E.2 Engineering Assessment Reports

### Birdwood Engineering Assessment Report Summary

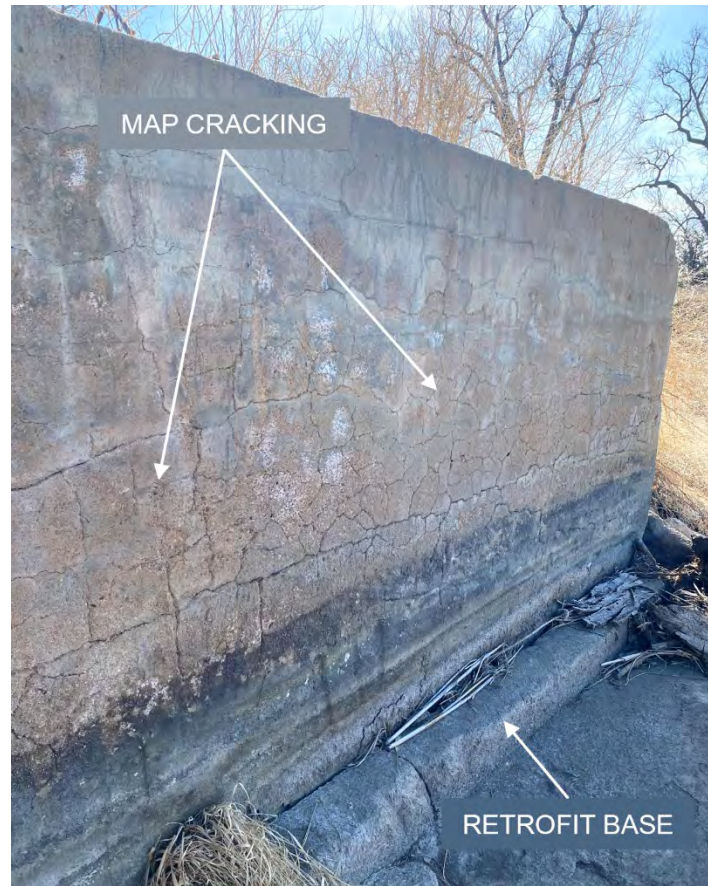
*Figure 24. Typical Map Cracking and Spalling*

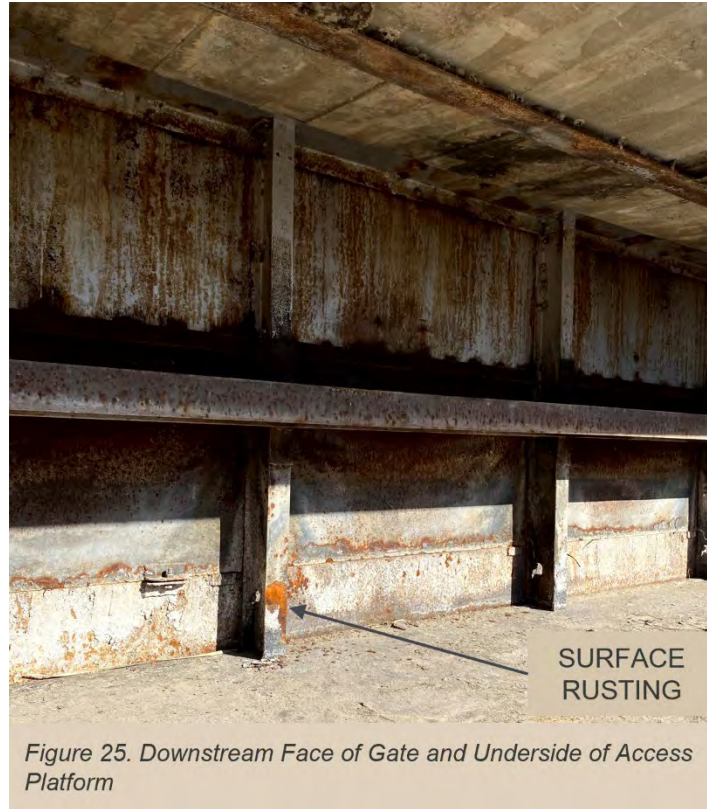
*Figure 25. Downstream Face of Gate and Underside of Access Platform*

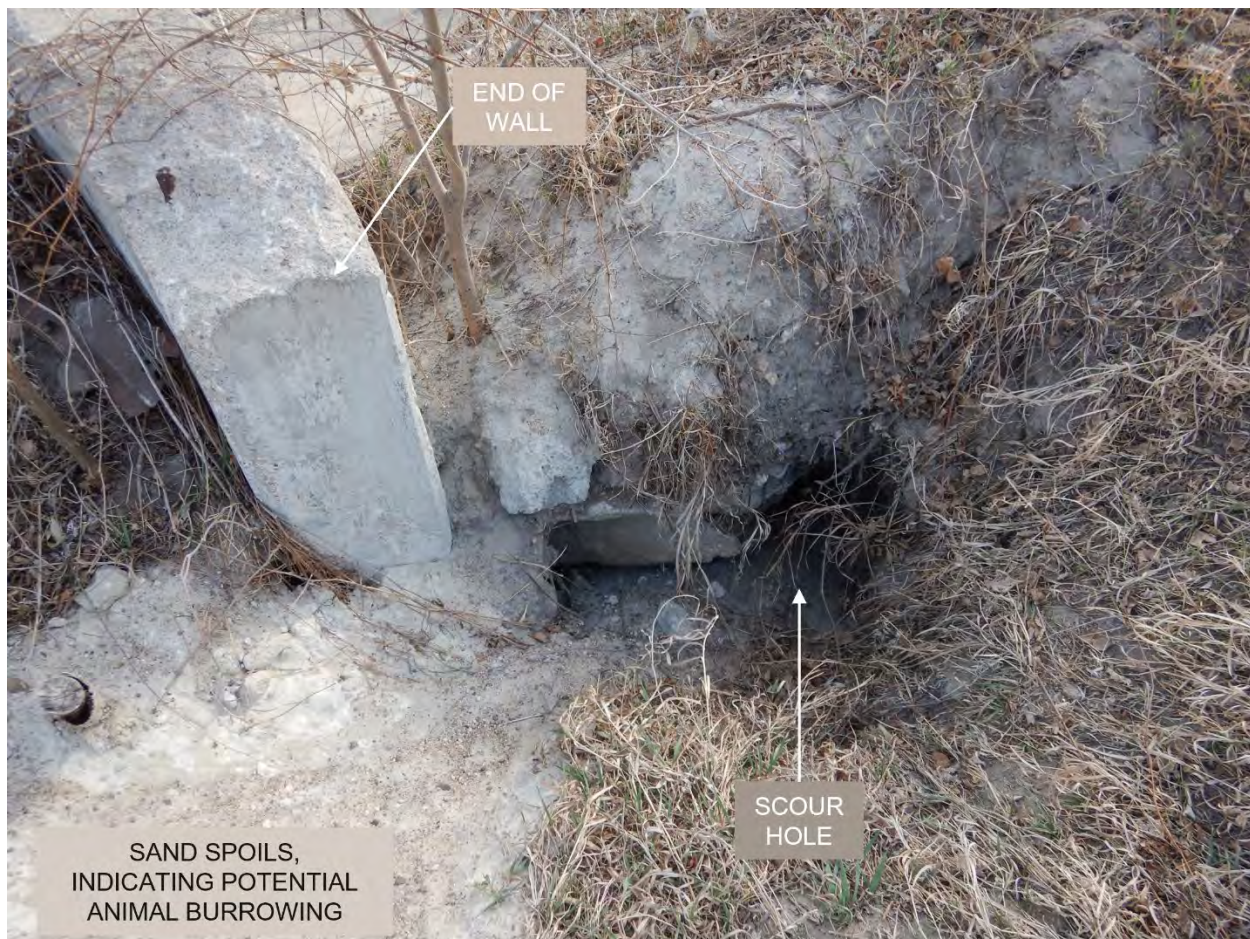
Figure 11. Upstream end of Northern River Control Gate Wall.

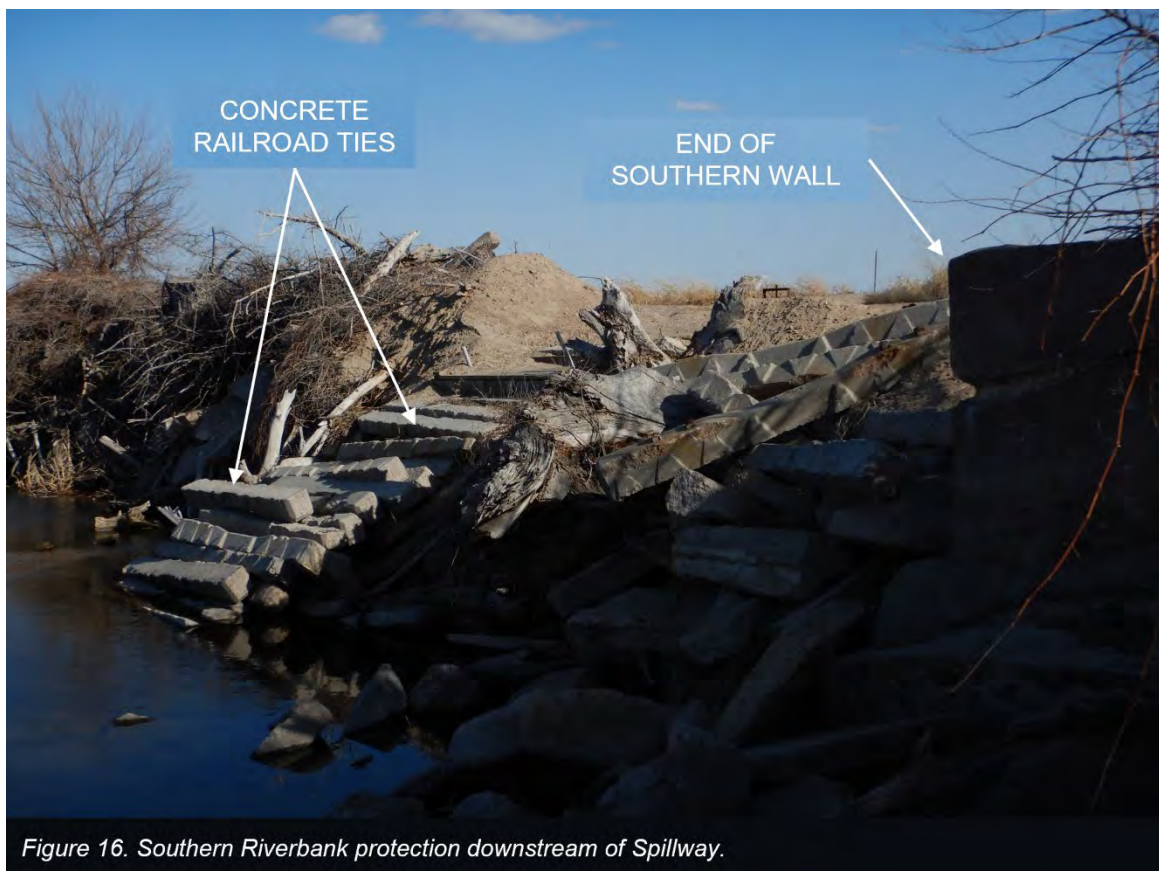
*Figure 16. Southern Riverbank protection downstream of Spillway.*

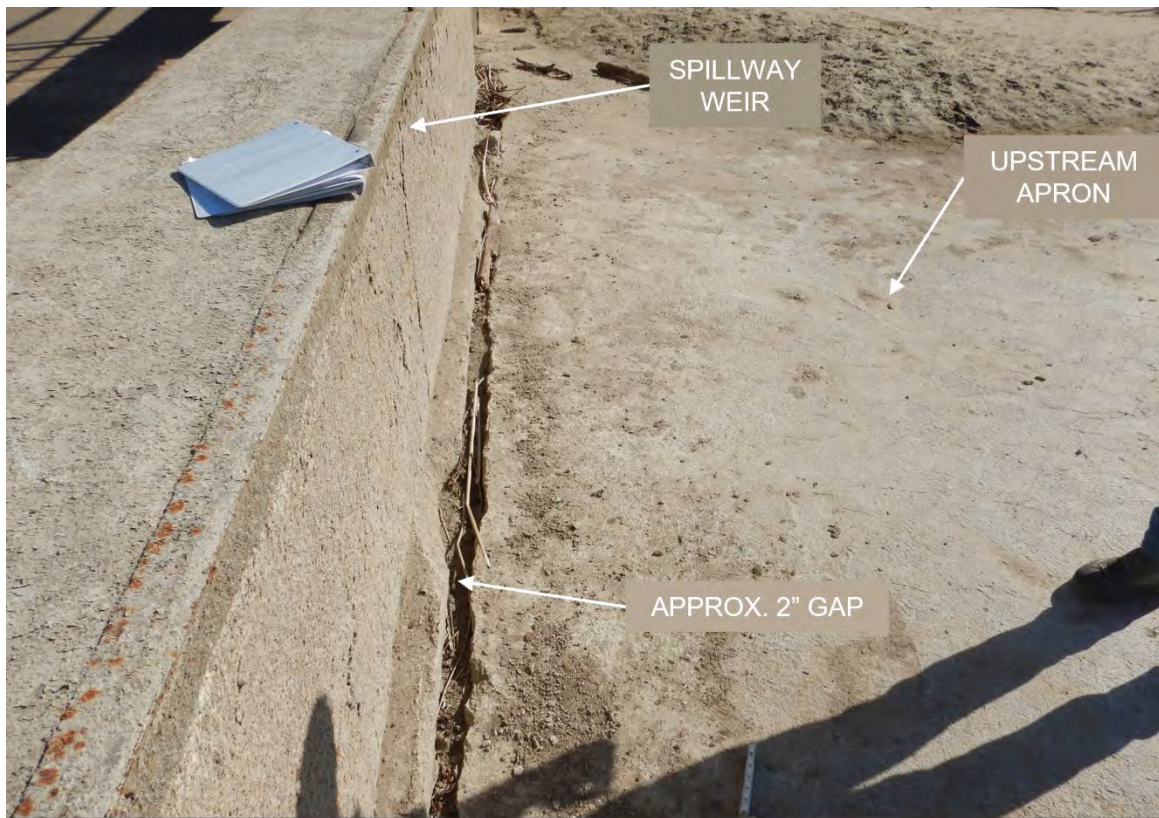
*Figure 17. Gap between Weir Wall and Upstream Concrete Apron.*

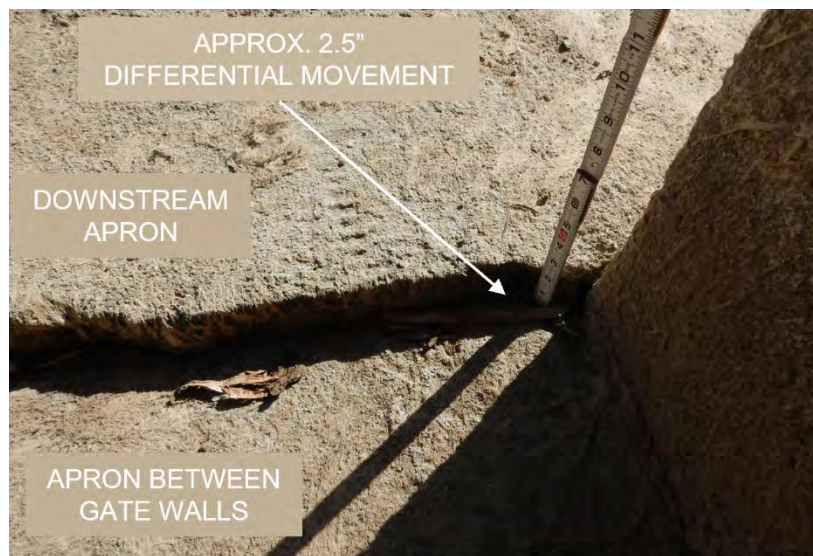
Figure 25. Apron Crack Differential Movement.
