# Soil Science Division

### Buffalo, WY Soil Survey Office

## Howell Reservoir Dam Riser Failure

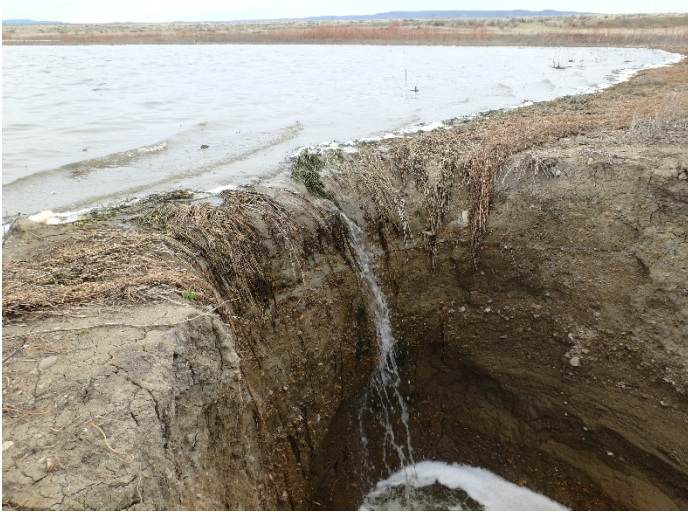
Figure 1. Water from Howell Reservoir Dam pours into the hole created by the riser failure.

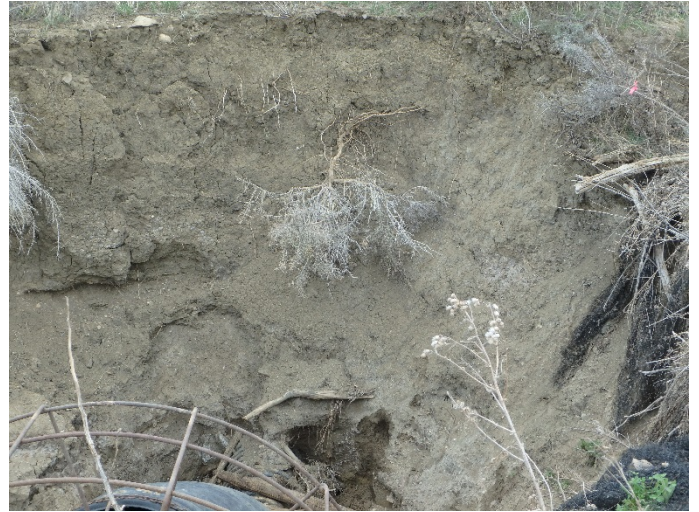
Figure 2. A view into part of the hole created by the failed riser, with the damaged riser at the bottom left.

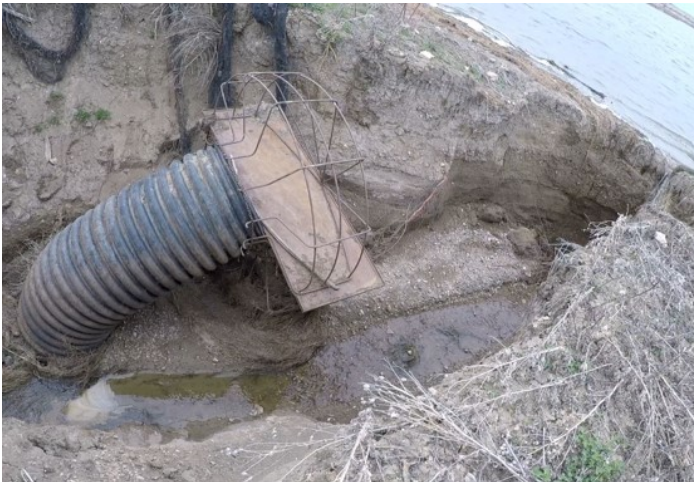
The Buffalo soil survey office was asked to help determine the cause of the failure for the Howell Reservoir Dam. The staff did soil investigations, looking at the amount of clay and salts in the soils used for building the Dam. They determined that the soils contained more than 35 percent clay and were dispersed due to the amount of salts in the soils.

Figure 3. Dam riser failure at Howell Reservoir Dam in Wyoming.

The Buffalo SSO worked with the NRCS Engineering staff to determine that HSG D would be the best rating for this Dam to use in the rebuild. The Soil Scientists were able to give the Engineering staff on-site advice to aid in a better and faster decision process, saving money and time for the rebuild of Howell Reservoir Dam.
