TN-PLANT MATERIALS-70

## **Review of paper “Napa River Flood Management Project – Willow and Cottonwood Revegetation”**

# Napa River Flood Management Project

# Willow and Cottonwood Revegetation

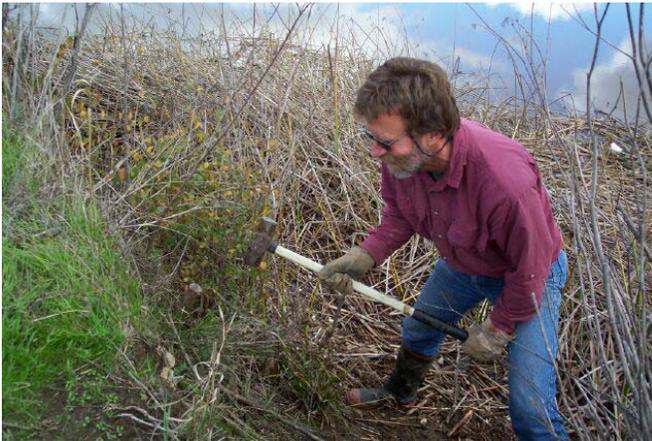
The location observed was willow sprigs planted at multiple elevations along an eroding bank to protect the bank were observed. Of 27 sprigs observed, all had good first growth, but suffered from drought or salt later in the dry season. In response to withering leaves, some irrigation was applied in August. Only 4 of the sprigs remained alive in October, with sprouts ranging from 12" to 18" in length. Although there was some apparent salt damage to the leaves, lack of soil moisture appeared to be the limit to viability.

Willow cutting being driven into streambank at Huichica Creek

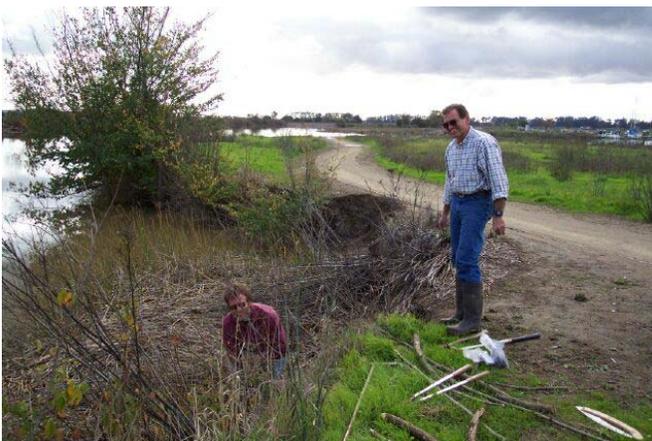
“North site” – no growth was seen on any of the 20 sprigs; the lower elevation row of sprigs was gone. “South site” – former growth was seen on two of the 9 sprigs found, with sprouts had reached 18” in length, although these were dead when observed. The lower sprigs may have been disturbed or removed by fishermen that frequently use the site.

Yacht Club willow plot. Cuttings on top of bank are ready to plant.
