## Appendix D-10

### Class III Cultural Resources Survey

North Branch Park River Cart Creek Site 1

Park River Joint Water Resource District

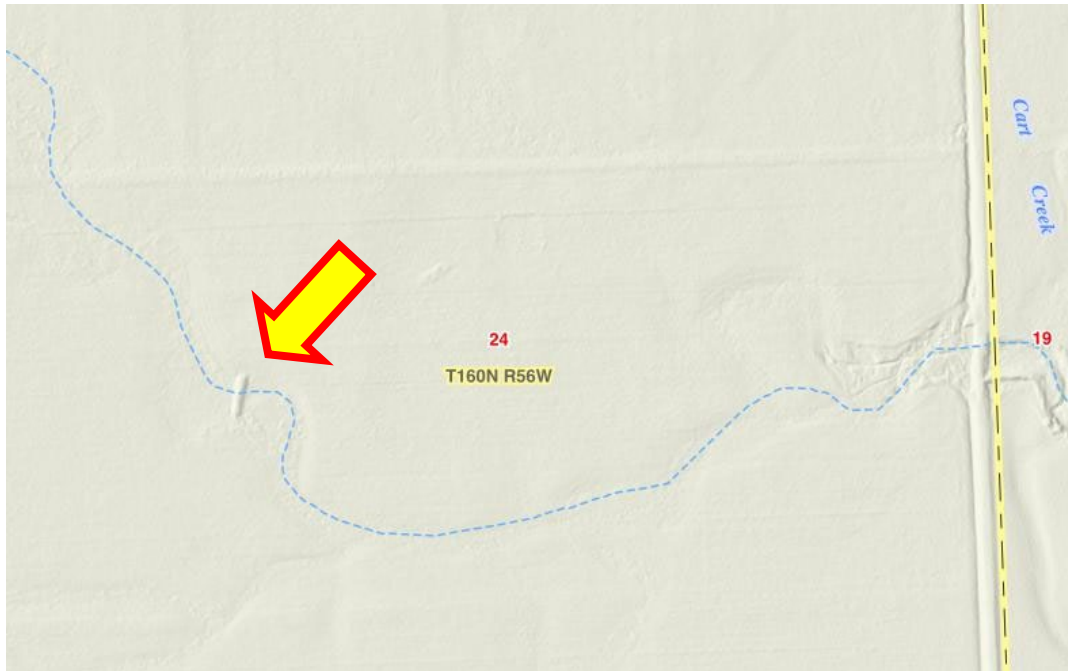
Figure 5: LiDAR indicated structure.  
Source: North Dakota State Water Commission.

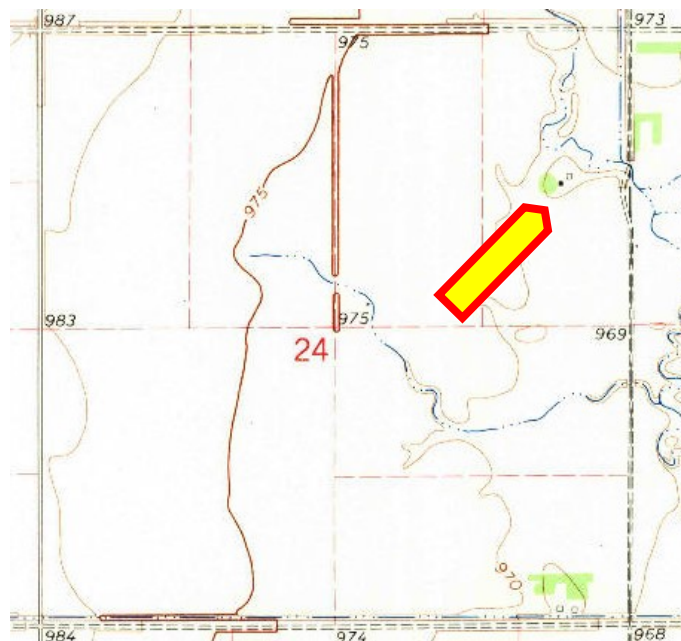
Figure 6: Unknown structure. Mountain 7.5 minute topographic (1964).  
Source: <https://ngmdb.usgs.gov/topoview>.

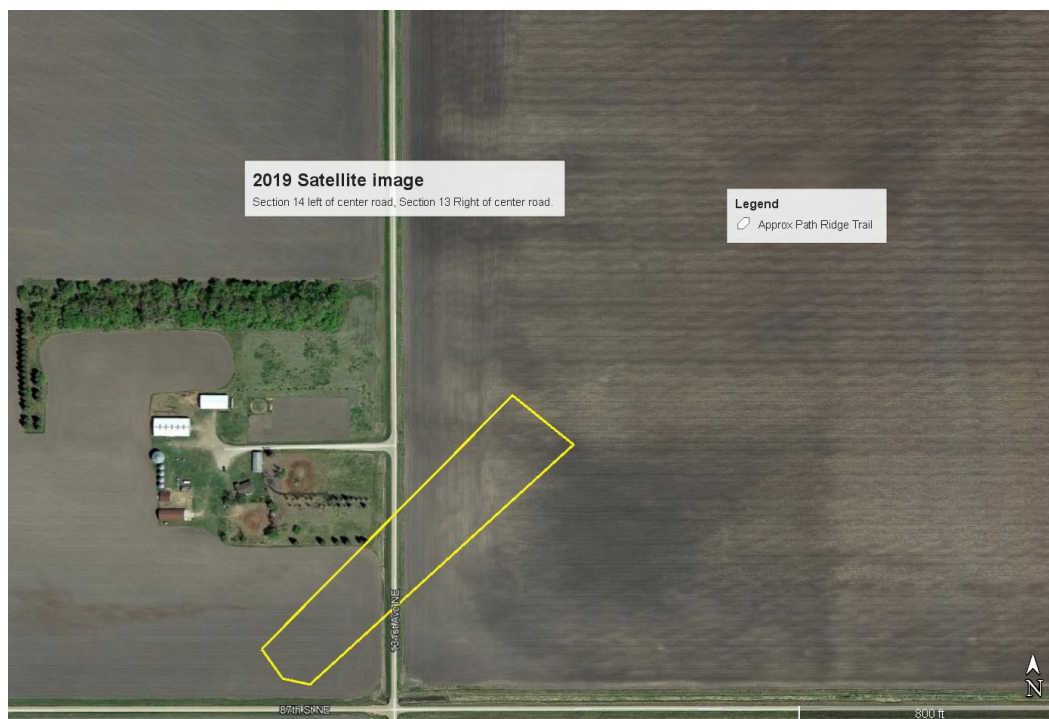
The 1881 GLO map shows that the Ridge Trail crosses the APE at the boundary of SW  $\frac{1}{4}$  SW  $\frac{1}{4}$  of Section 13 and the SE  $\frac{1}{4}$  SE  $\frac{1}{4}$  of Section 14 (Figure 4). No evidence of the trail was observed. The construction of 131<sup>st</sup> Avenue NE and decades of agricultural use (Figure 8) have obliterated any remnant of the trail.

Figure 8: Possible path of Ridge Trail  
Image Source: Google Earth 2020

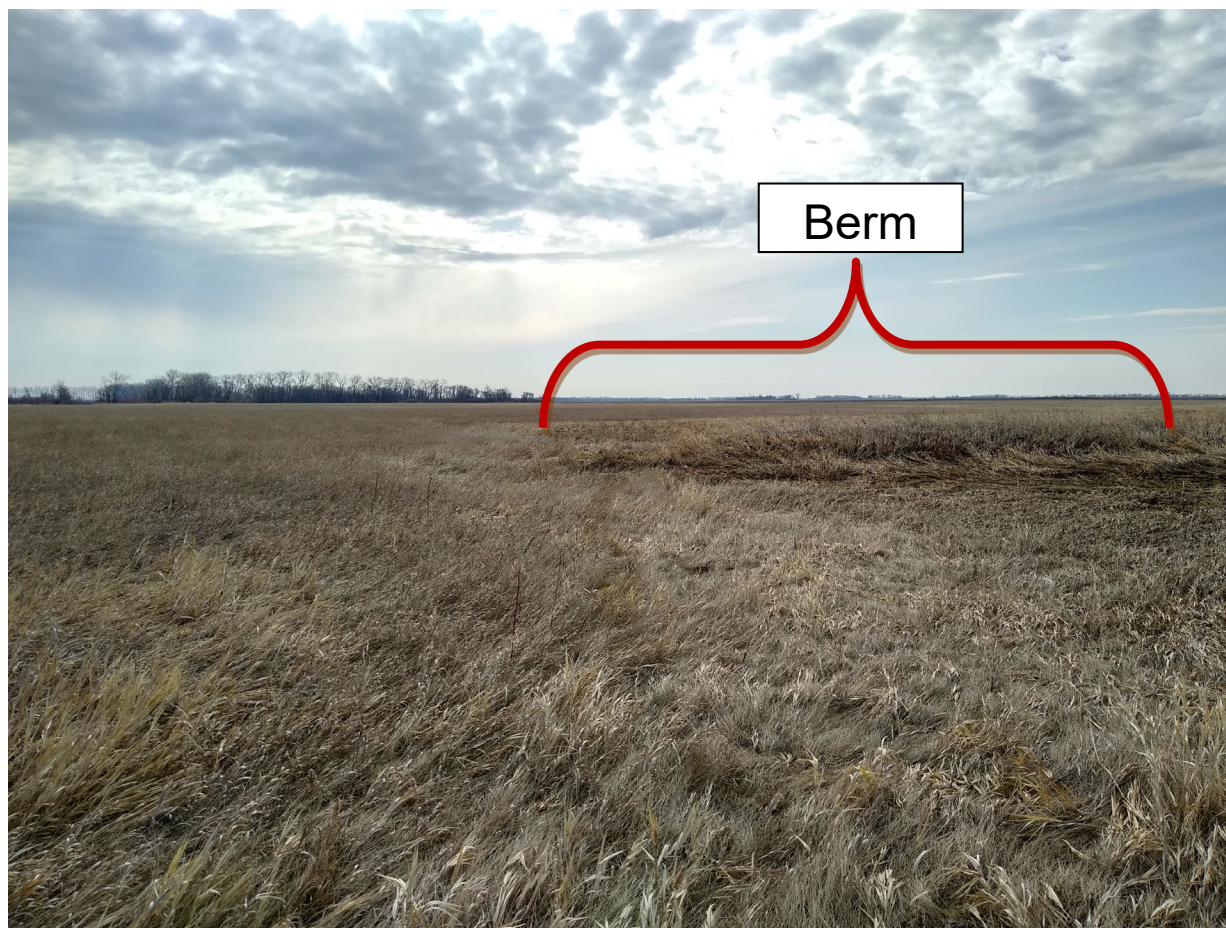
The rectangular structure visible on LiDAR (Figure 5) was explored. Interview with the landowner (Hannesson) and on-site inspection revealed the rectangular structure shown on LiDAR (Figure X) is a

seasonal dam used to control intermittent flooding. The landowner informed the field team that a skid steer or similar equipment is occasionally used to construct an earthen diversion dam during periods of high rainfall. The structure is frequently rebuilt using the surrounding soil as borrow (Figure 9). Records discovered after the field work supported Mr. Hanneson's claim (Figure 10).

Figure 9: Berm structure; flattened and in need of seasonal repair.

The Class III survey conducted by NRCS resulted in no discovery of cultural resources or properties eligible for the National Register of Historic Places within the APE. The structure visible on LiDAR was resolved to be a manmade water control berm that is regularly reinforced with surrounding topsoil and plant material. It has no historic value.

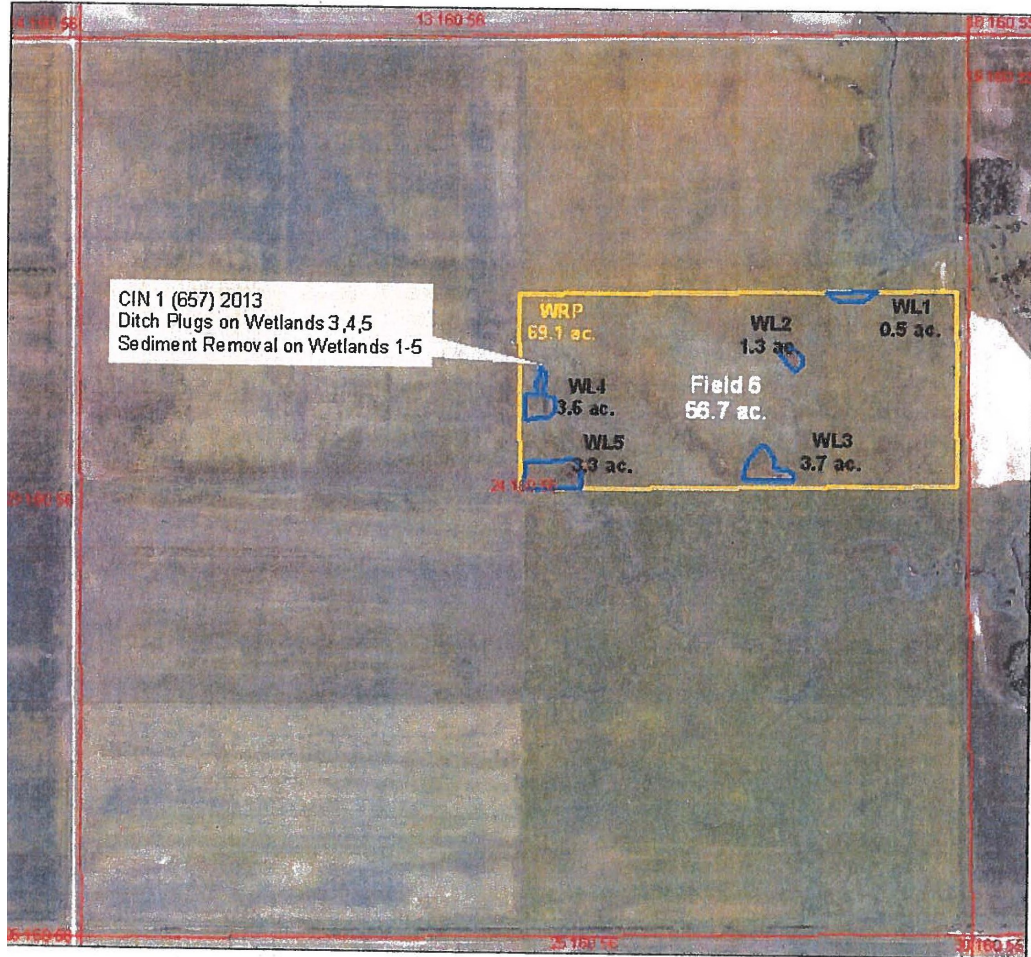
Figure 10: Area of berm structure (WL5) showing areas of sediment removal.  
Image Source: NRCS Archives.

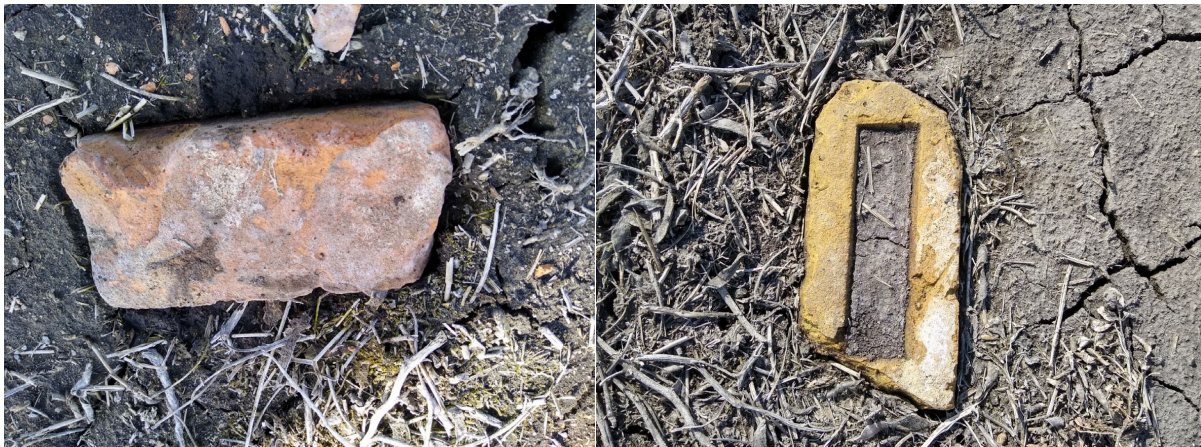
The unknown structure shown on the Mountain 7.5 minute (1964) topographic map (Figure 6) was determined to be the remains of a farmhouse. A number of artifacts were scattered across a wide area. Red and cream bricks (Figure 11), a cartwheel hub (Figure 12), pieces of laminate floor tile, and metal fragments were strewn about the surface. Various shards of thick brown bottles and glass containers, none with markings, were readily evident. Mr. Hanneson proffered that the farmhouse had been razed and the remains burned in the 1980's.

Figure 11: Red and cream brick at razed farm site.

North Branch Park River Cart Creek Site 1 has no cultural resource concerns that may delay action on the undertaking. Farmhouse artifact scatter should be left in situ and no collection of artifacts or additional investigation is recommended. The undertaking, as designed, should proceed and a determination of “*no effect*” to historic properties is recommended.

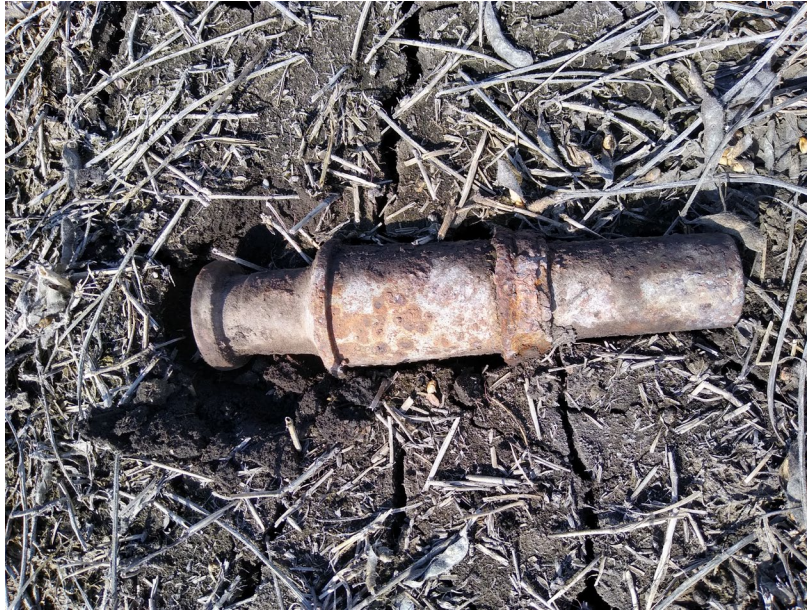
Figure 12: Wheel hub at razed farm site.

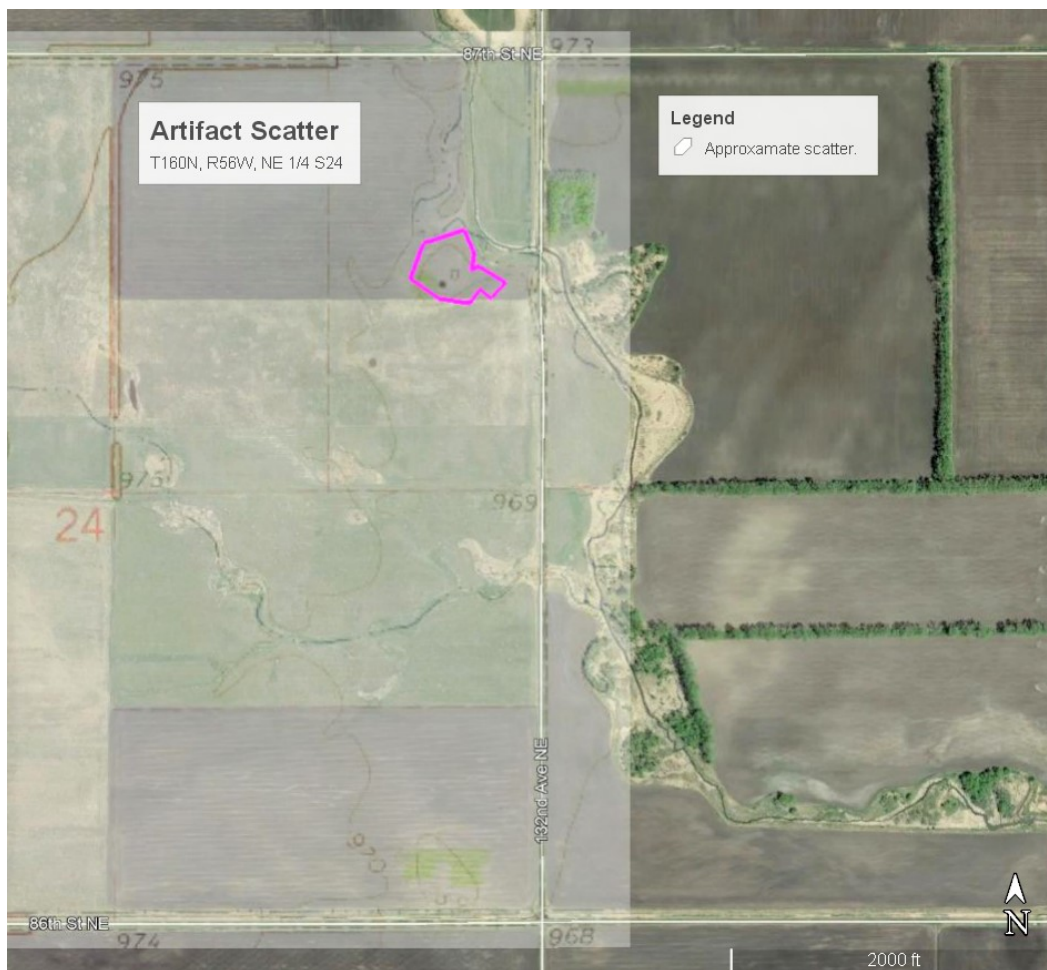
The potential site has endured heavy ground disturbance. The heaviest concentration of surface artifacts was plotted (Figure 13) but are unlikely to provide meaningful context to the former farmhouse. In addition to a subsurface drain system and 40 years of agricultural production, figure 10 shows that sediment removal intersects the southernmost artifact area further disturbing the potential site. Temporal/stratigraphic integrity is unlikely due to heavy ground disturbance and the former home site is unlikely to provide "...demonstrable intact, subsurface cultural deposit(s)" (NDCRS Archaeological Site Form Manual pg. 10).

Figure 13: 1964 topo overlaid with 2018 satellite imagery. Artifact scatter shown in red.

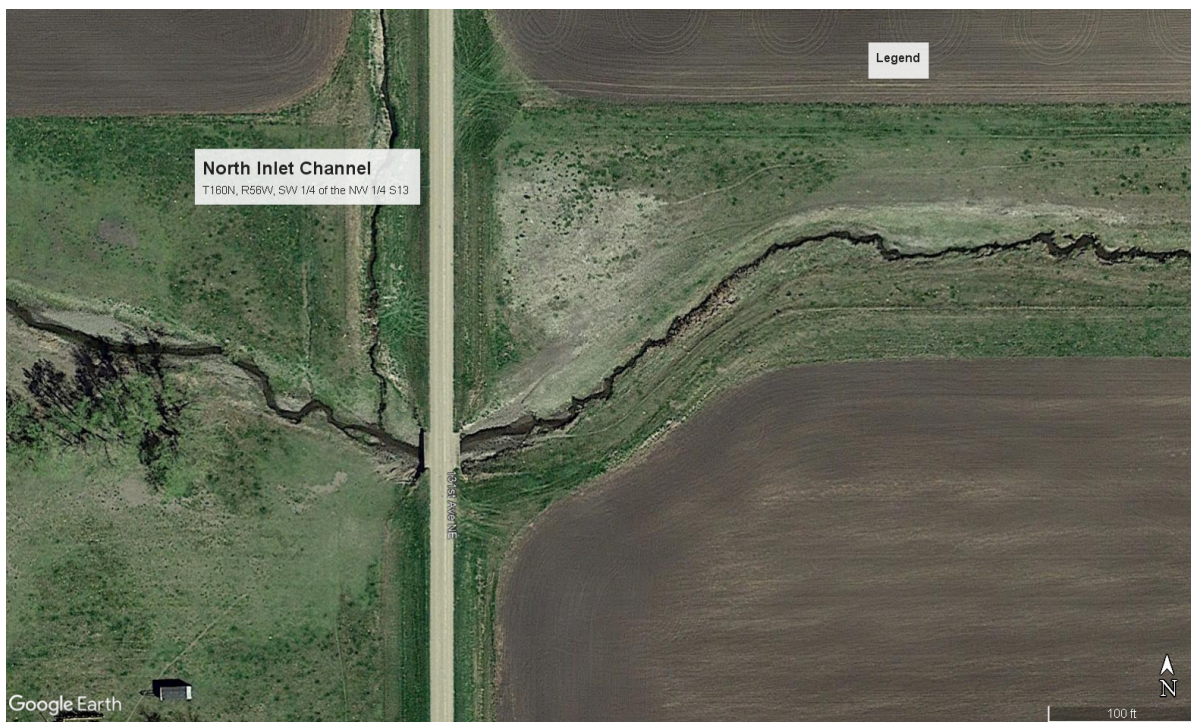
The North Inlet Channel will replace extant culverting (Figure 14) and will follow the previously excavated area south of Cart Creek, into the agricultural field. Pedestrian survey revealed no cultural material but evidence of heavy erosion due to flood events was apparent. The creek ditching and field are separated by a three-wire barbed wire fence with portions in disrepair. Areas described are readily visible on satellite imagery

Figure 14: Extant structure at proposed North Inlet Channel.  
Image: Google Earth 2019

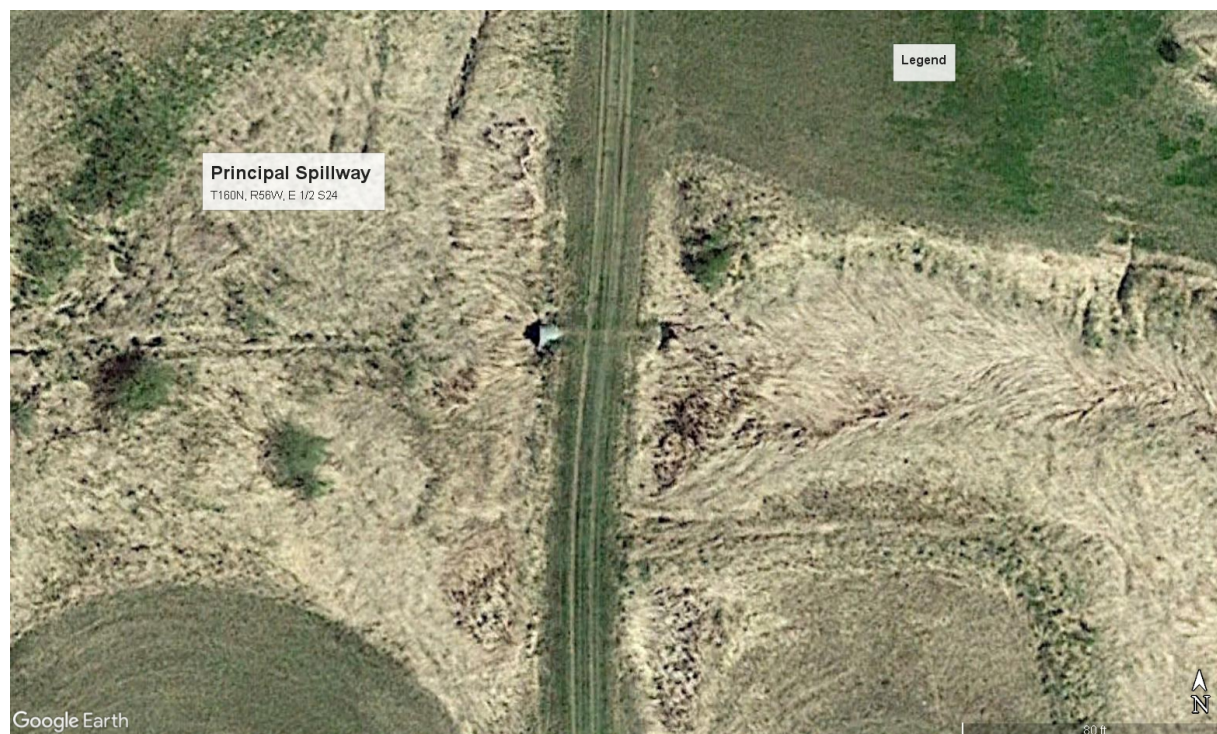
The principal spillway will rehabilitate the visible culvert system (Figure 15) and clear and expand the extend the flood zone/drainage infrastructure. Pedestrian survey was hindered due to the knee high, brown grass and “gumbo” like sediment build up on the culverts west side. Prior flood events were apparent due to the quantity of modern detritus (beer cans, Styrofoam, plastic bags) in the area. Ground visibility was less than ideal but the conditions of the area make inadvertent discovery of cultural resources unlikely.

Figure 15: Extant structure and flood zone at proposed Principal Spillway.  
Image: Google Earth 2019

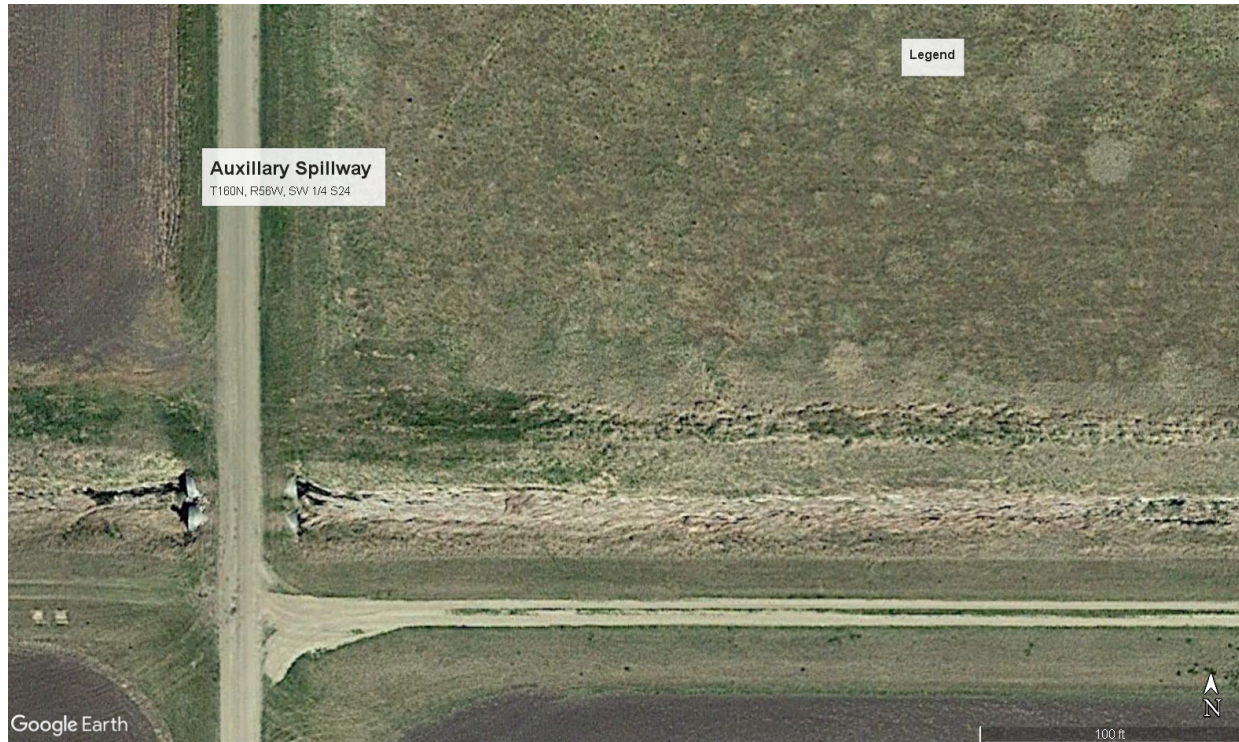
The Auxiliary Spillway will rehabilitate the visible culvert system (Figure 16) and deepen the existing flood zone/drainage infrastructure with a berm on the north side. The extant structure is 8 feet (2.43 m) deep and 35 feet (10.72 m) wide. At the undertaking will not exceed the current footprint, visual examination from the top of the structure was deemed sufficient. Due to the volume of water that transits the canal, inadvertent discovery of cultural resources is unlikely.

Figure 16: Extant ditching at proposed Auxiliary Spillway.  
Image Source: Google Earth 2019

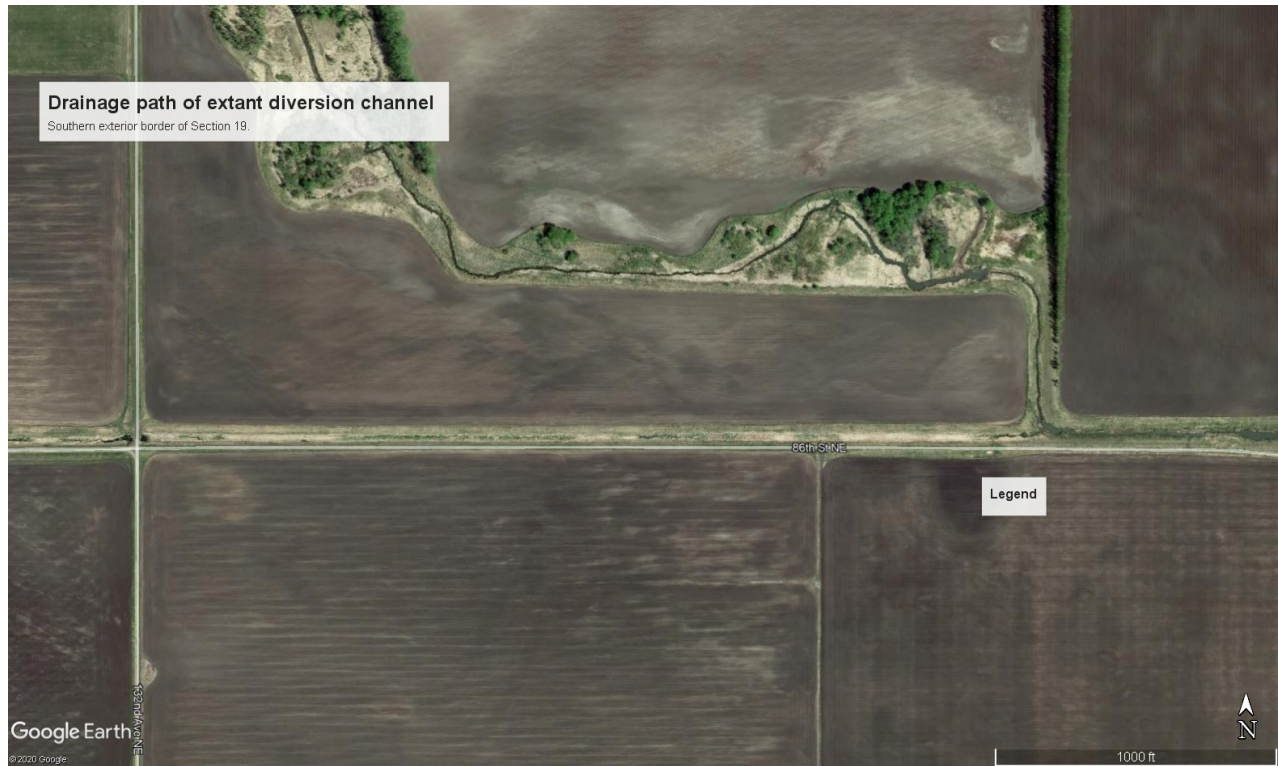
The proposed undertaking in T160N, R55W, S  $\frac{1}{2}$  Section 19 consists of deepening the extant drainage canal (Figure 17) between 132<sup>ND</sup> Avenue and 86<sup>th</sup> Street NE. The APE will act as improved drainage for flood events into Cart Creek. Overgrown shrub, rubbish removal and culvert replacement will occur within the existing footprint. The structure is a continuation of the drainage canal previously described and shown in figure 16. It is 8 feet (2.43 m) deep and 35 feet (10.72 m) wide. No ground disturbance is anticipated beyond the outlined APE (Figure 18).

Figure 17: 2019 Satellite view of Section 19 existing drainage improvement.  
Image Source: Google Earth.

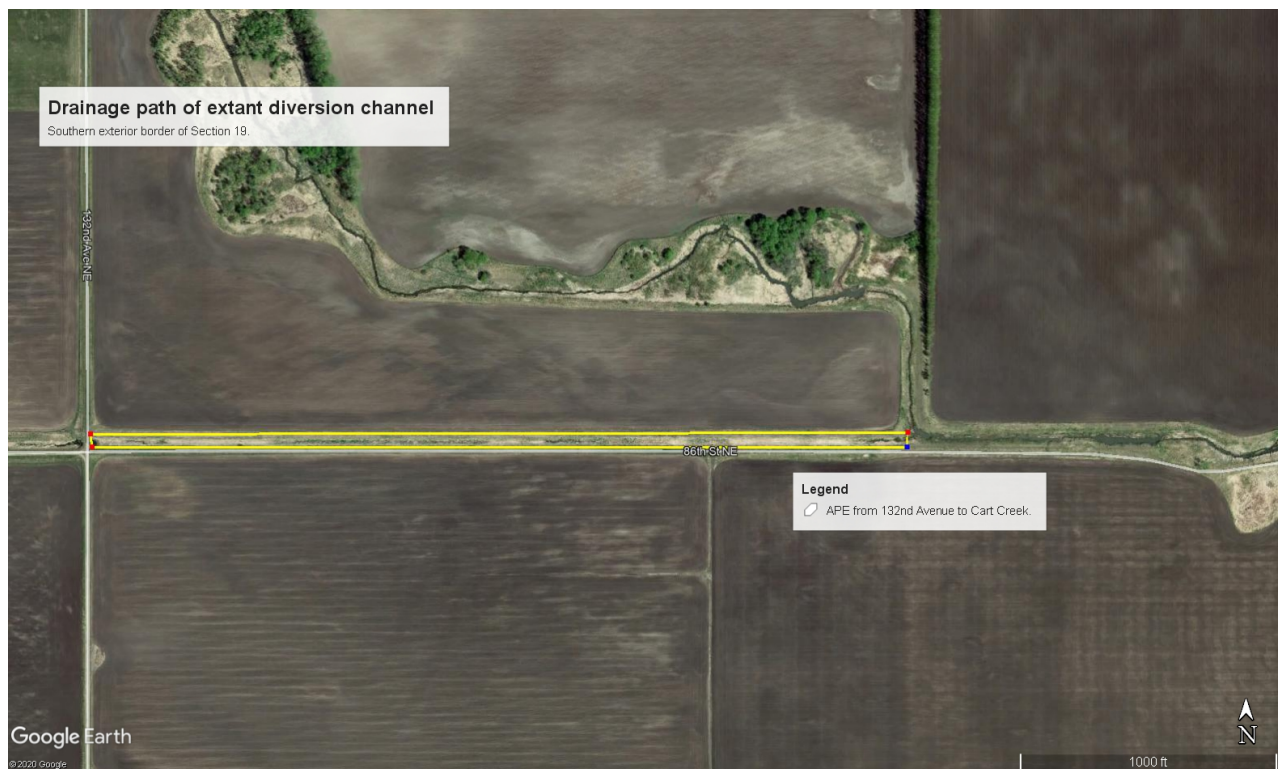
Figure 18: Section 19 existing drainage improvement highlighted in yellow.  
Image Source: Google Earth.
