Stream Corridor and Reach Factors Affecting Stream Corridor Conditions

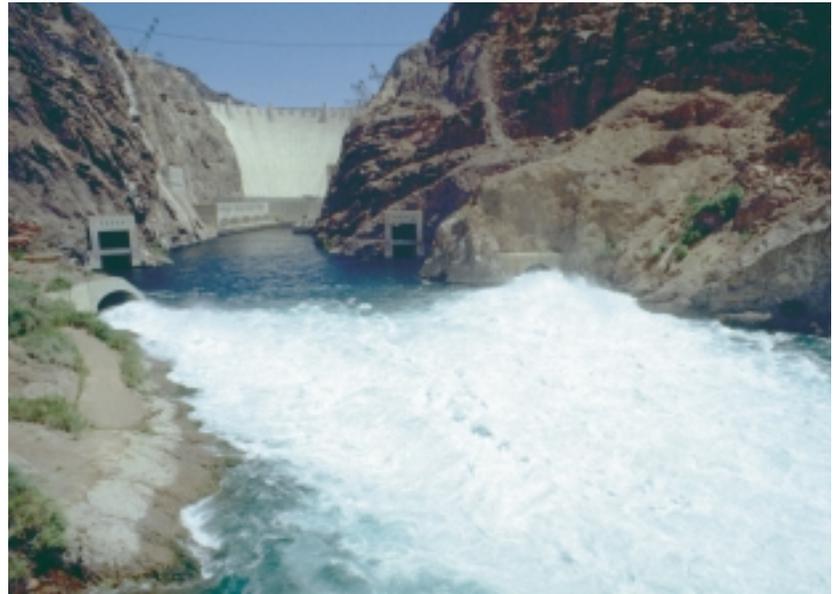
Figure 4.13: Water releases below a dam. Altering the flow regime of river below Hoover Dam altered the stream condition.
