Another Conservation Success Story...

Carroll County, Georgia

November 2006

Cattle and Poultry Farming in Lower Little Tallapoosa Watershed

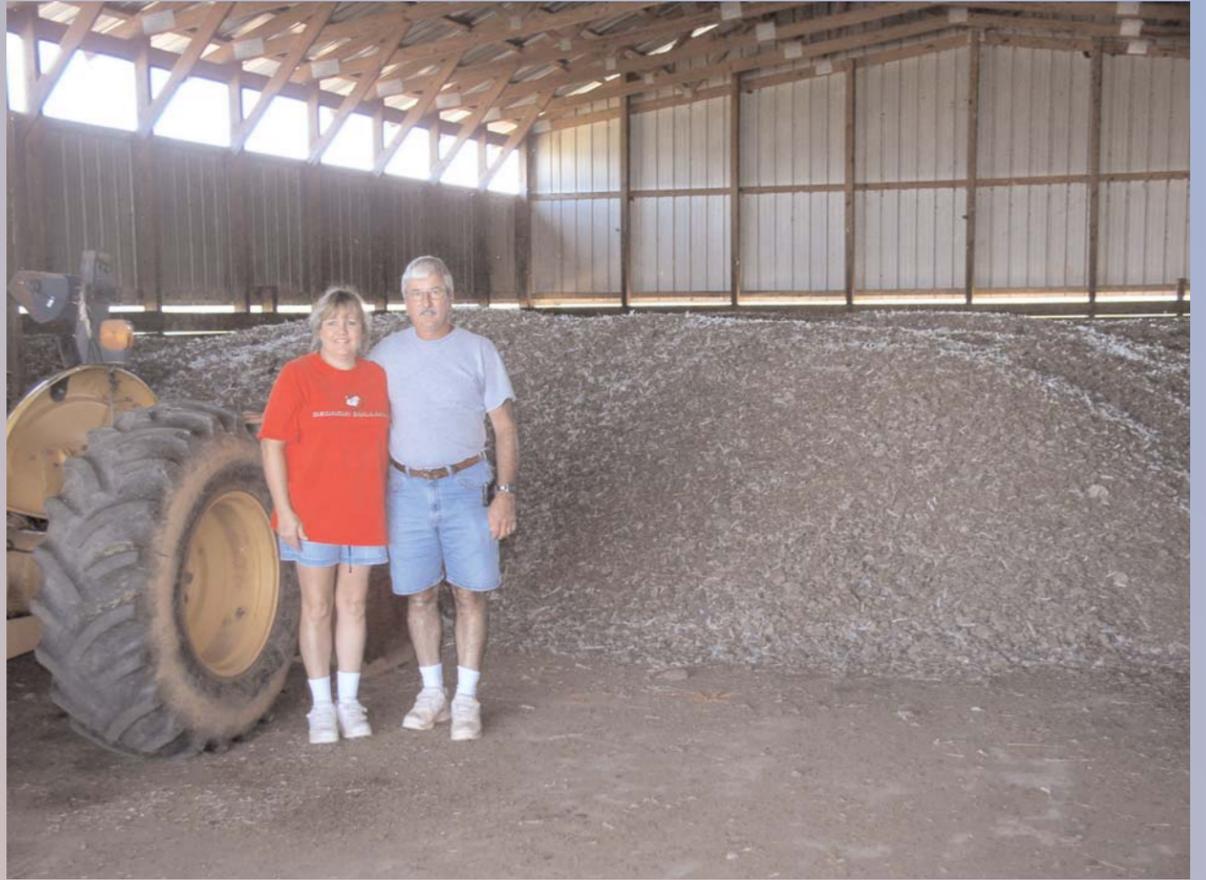
Steve and Gail Lovvorn stand by poultry litter in their new dry stackhouse.

Lovvorn has also installed a Dead Bird Compost Facility and a Dry Stack Facility to handle the poultry mortality and poultry litter generated by the operation.

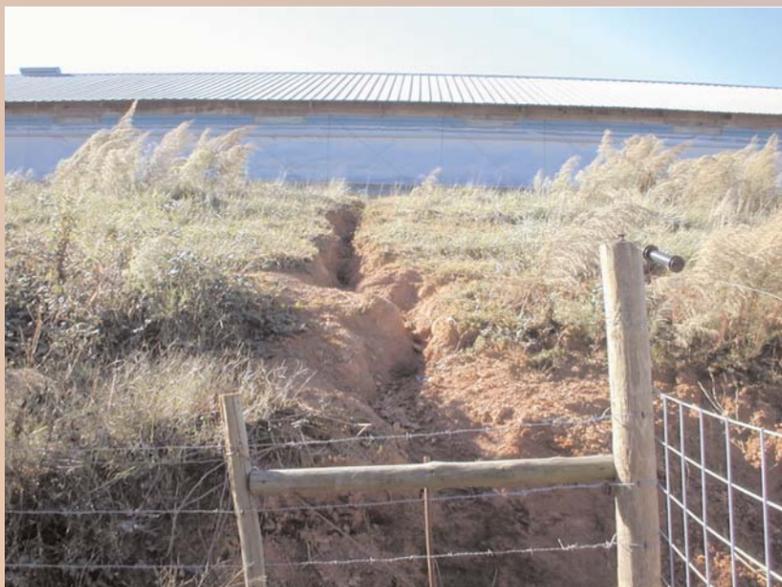
The construction of the poultry houses on the rolling topography in Carroll County resulted in substantial fill being required for several of the houses. The concentrated roof runoff from the houses caused erosion on the side slopes of the pads.

"Before" picture showing erosion of the slope.

Grade stabilization structures were installed to collect the roof runoff water at the top of the slope and safely pipe the water to the bottom of the slope.

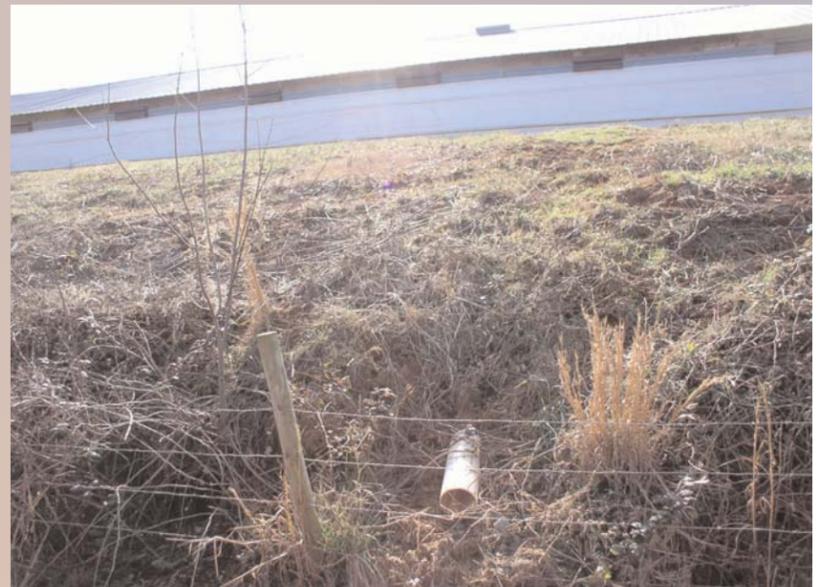
"After" photo of grade stabilization structure.
