# EWP Funds Help the City of Jackson Repair Infrastructure

by Julie A. Best and Randall East,  
Natural Resources Conservation Service

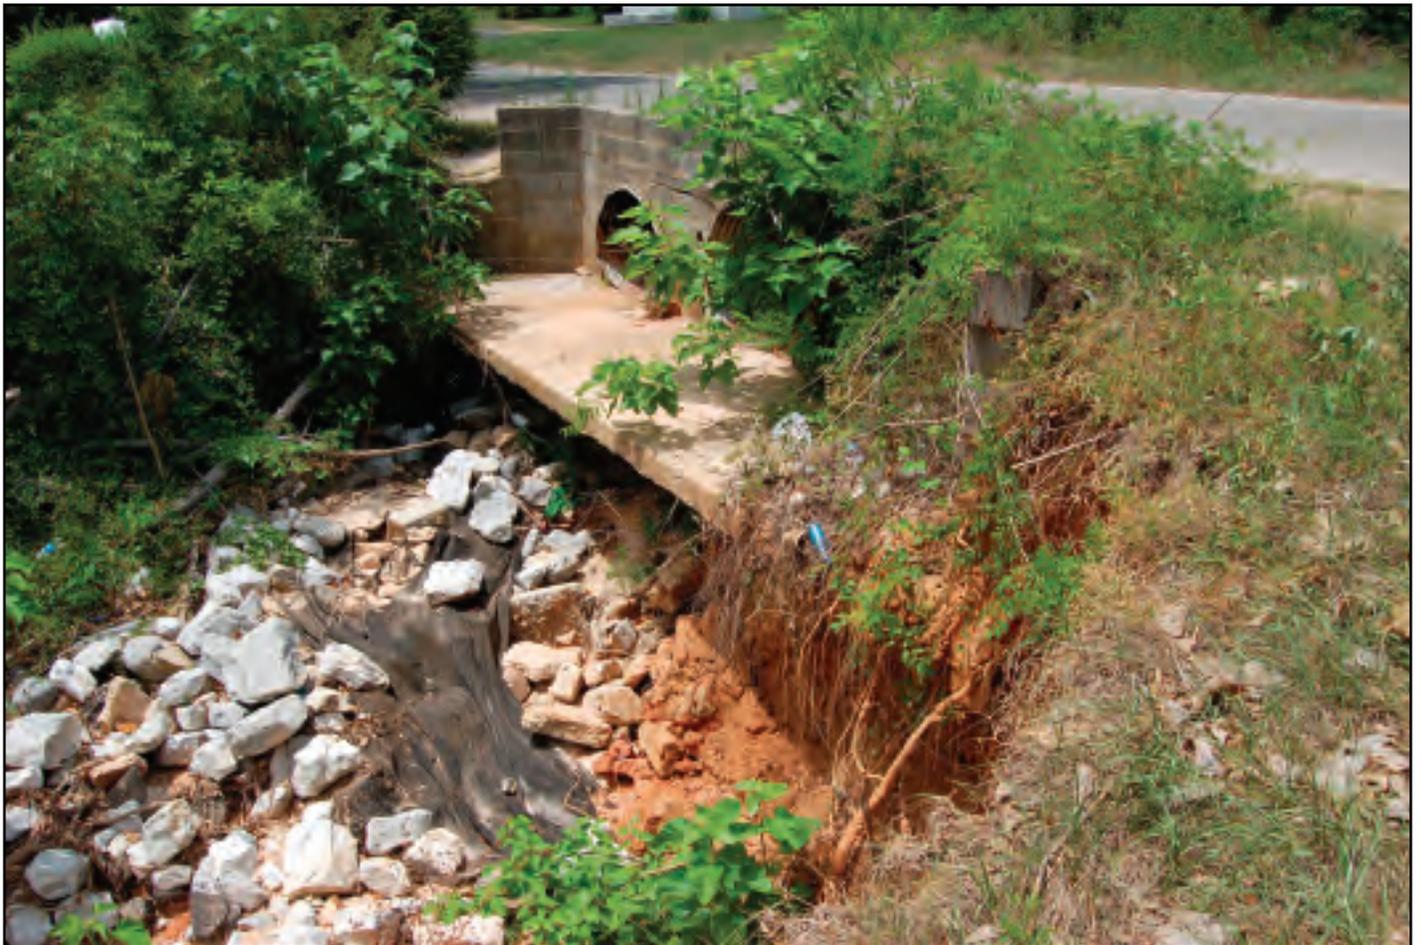
Stormwater from Hurricane Katrina caused erosion problems along several streets in the City of Jackson, Alabama. With financial and technical assistance from the Emergency Watershed Protection Program, which is administered by USDA-Natural Resources Conservation Service, several of these sites were repaired.

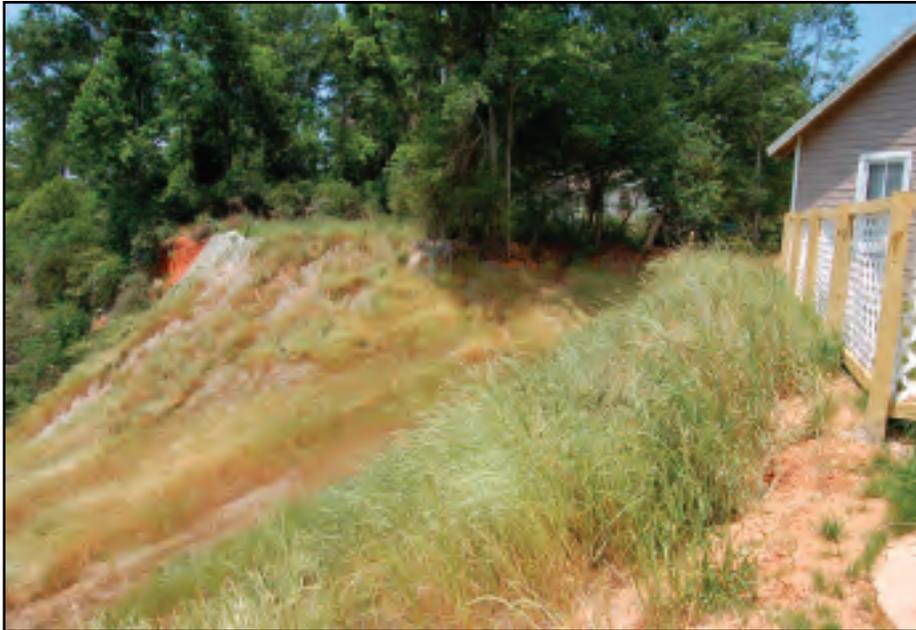
Houses were in jeopardy from several of the sites where the gullies had serious erosion.

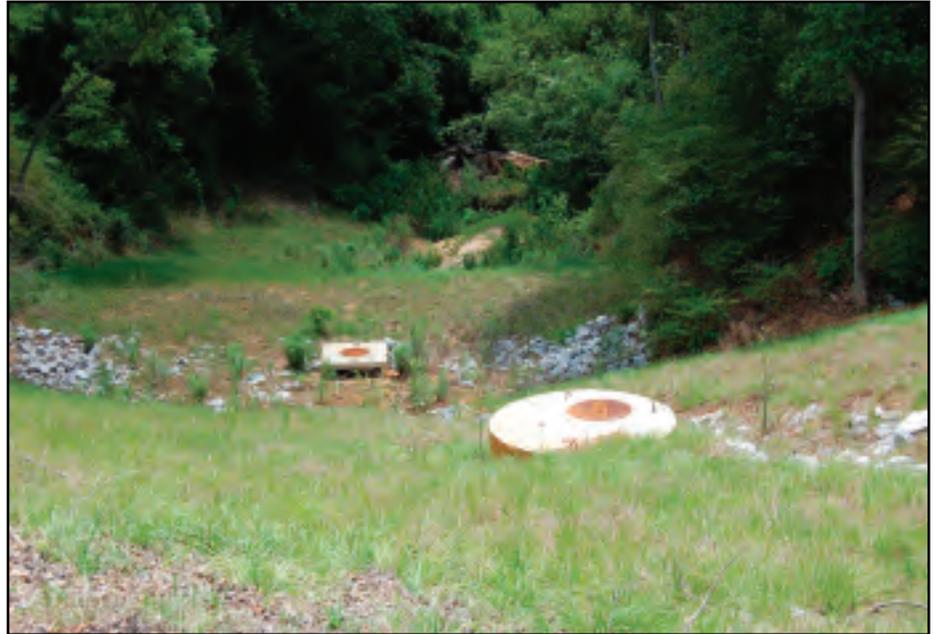
**To carry the water to a stable outlet, a series of stepdown drains were installed on several sites.**

city's engineer to determine the most cost-efficient method that will remove the hazard. In some situations we faced in Jackson, we had to install a pipe drop structure to get the water to a stable outlet. Getting the water to a stable outlet prevents erosion by moving the water safely down the slope in a mechanical structure. Using pipe, rock, or concrete in the proper situation allows the velocity and concentration of water to be controlled and prevents erosion of the in place material."
