Do BMPs Really Work?

by Julie A. Best, Public Affairs Specialist, USDA-NRCS, Auburn AL

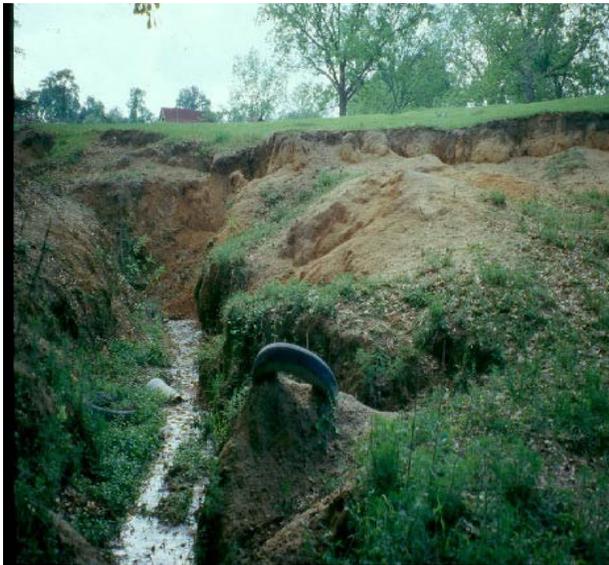
A head cutting gully caused by run off from the road was an area that needed treatment.

Conservationist with NRCS said, "This was a head cutting gully caused from a lot of run off from the road. It was contributing to the sediment loads. We decided to start as high up as possible to cut off the gully. We designed the sediment control basin to collect the water and the pipe lets the water down to a stable outlet to stop the head cut of the gully."

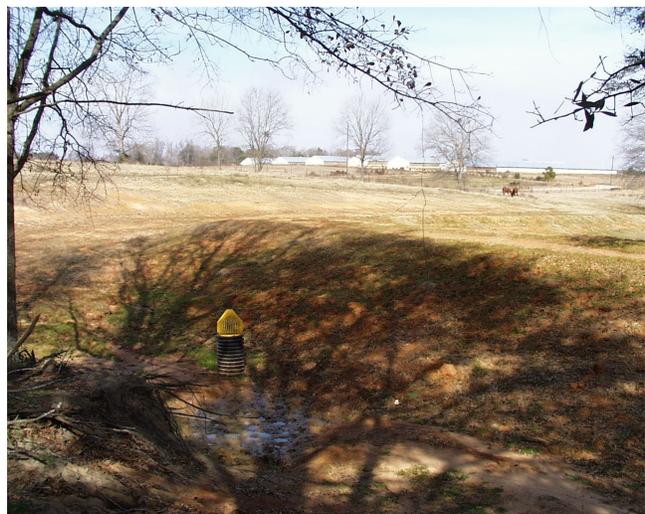
A sediment control basin was constructed to control the gully erosion.

Five critical eroded areas, identified as primary sources for sediment, received treatment. A sediment retention structure was constructed in late July 1999 in a critical area in the headwaters of the stream. Steve Yelverton, Covington County District

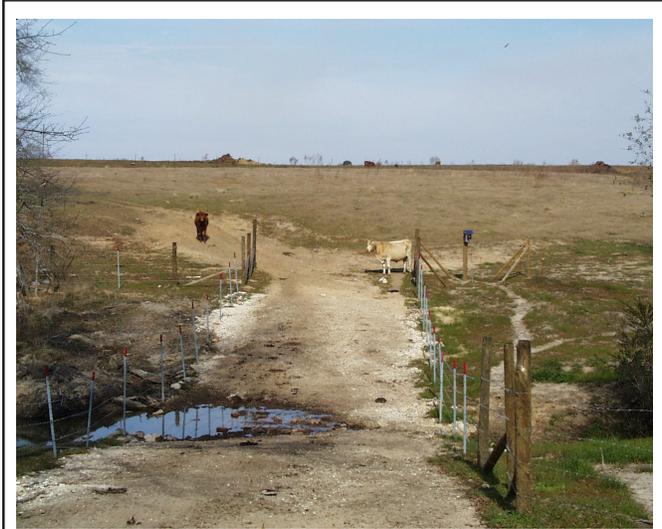
Cattle were fenced from the stream and a cattle crossing was installed.

In September 1999, fencing was installed to prevent cattle access to the stream. A stream crossing, which provided a hard surface for cattle and vehicle traffic, was constructed.

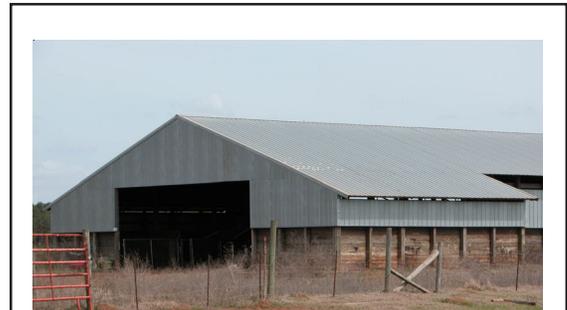
A combination composteer/dry stack was constructed to handle disposal of dead birds and storage of litter until it could be land applied.

The procedure for disposing of dead birds was changed. The practice of underground disposal was terminated. The landowner built a poultry composteer and dry stack structure. Dead birds were composted and the litter was stored in

the dry stack until it was spread on the pasture and hayland according to NRCS specifications.
