**Stream Restoration Improves Water Quality** by Julie A. Best, Public Affairs Specialist, USDA-Natural Resources Conservation Service, Auburn, AL

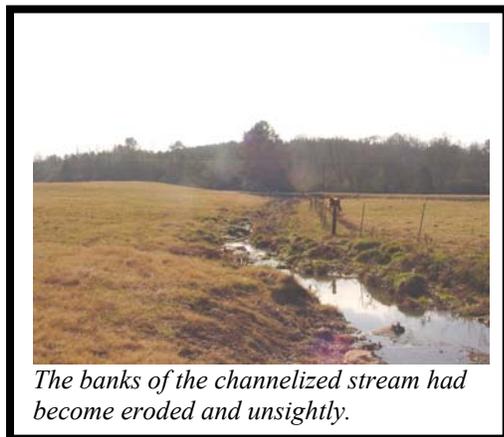
*The banks of the channelized stream had become eroded and unsightly.*

Many years ago, the small stream that runs through the Waldrop property had been channelized. Over time, the cattle and nature had caused the stream banks to erode. The ditched stream was unsightly. Since the cattle had access to the stream, the area was also a contributor to nonpoint source pollution, such as, sediment, pathogens and organic enrichment. The

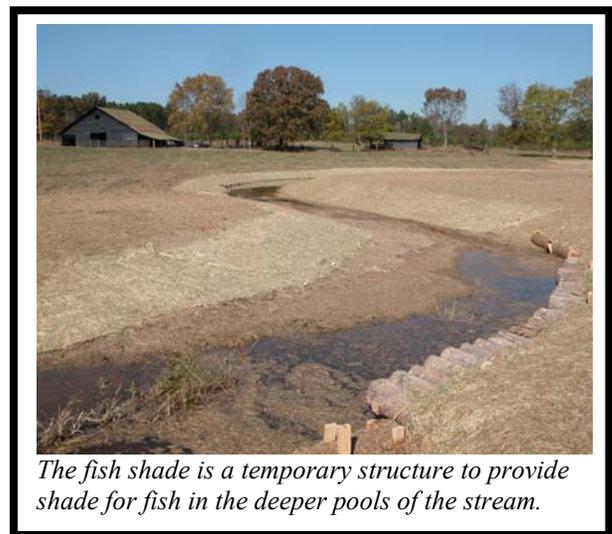
The restored stream will improve the quantity and quality of aquatic habitat. In addition to having the natural meander of a stream, the restoration plan called for the installation of fish shade structures in the deeper pools of the stream. According to Howell, “The stream runs through the pasture, and there is little natural shade. The fish shade structures will provide cooler water and

protection for the aquatic life.” The fish shade structures are designed to be temporary. They are constructed of six foot logs that are placed side by side along the outside bank of the deeper pools.

hardwood trees and shrubs to make the floodplain a wildlife refuge. These best management practices will be funded in part with cost-share assistance from EQIP. “The fish shade structures are expected to last for several years. Eventually, those logs will decay and the structure will disappear. By that time, there should be some natural shade from the trees that will be planted in the floodplain,” says Howell.

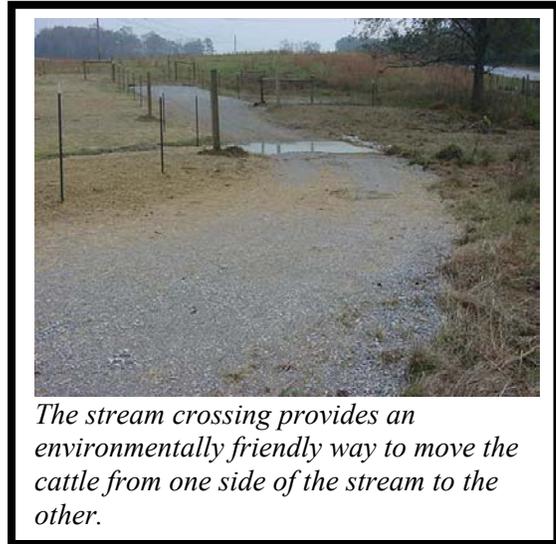
With assistance from EQIP, a stream crossing has been installed. This is an environmentally friendly way of moving cattle from one side of the stream to another by limiting their access to the stream and providing a non eroding surface. The program will also install water troughs and heavy-use areas. All of these best management practices will help improve water quality.

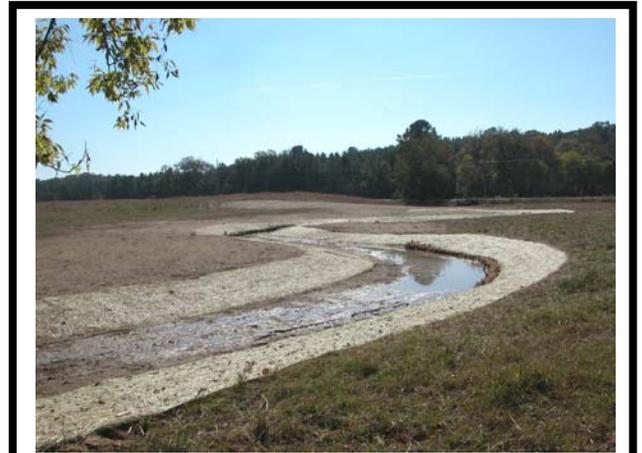
*When vegetated, the restored stream will not only be beautiful to the eye but will enhance the water quality and wildlife habitat.*

Even without vegetation, the newly reconstructed stream is pleasing to look at. What was once an unsightly, eroded ditch will soon be an attractive, meandering stretch of stream. The area is being restored to a place that appeals to the human eye. The improved stream conditions are also conducive to good water quality and wildlife habitat.
