Assessment Report

**American Fork – Dry Creek Watershed
Tibble Fork Dam
Utah County, Utah**

**Natural Resources Conservation Service
Salt Lake City, Utah**

September 10, 2004

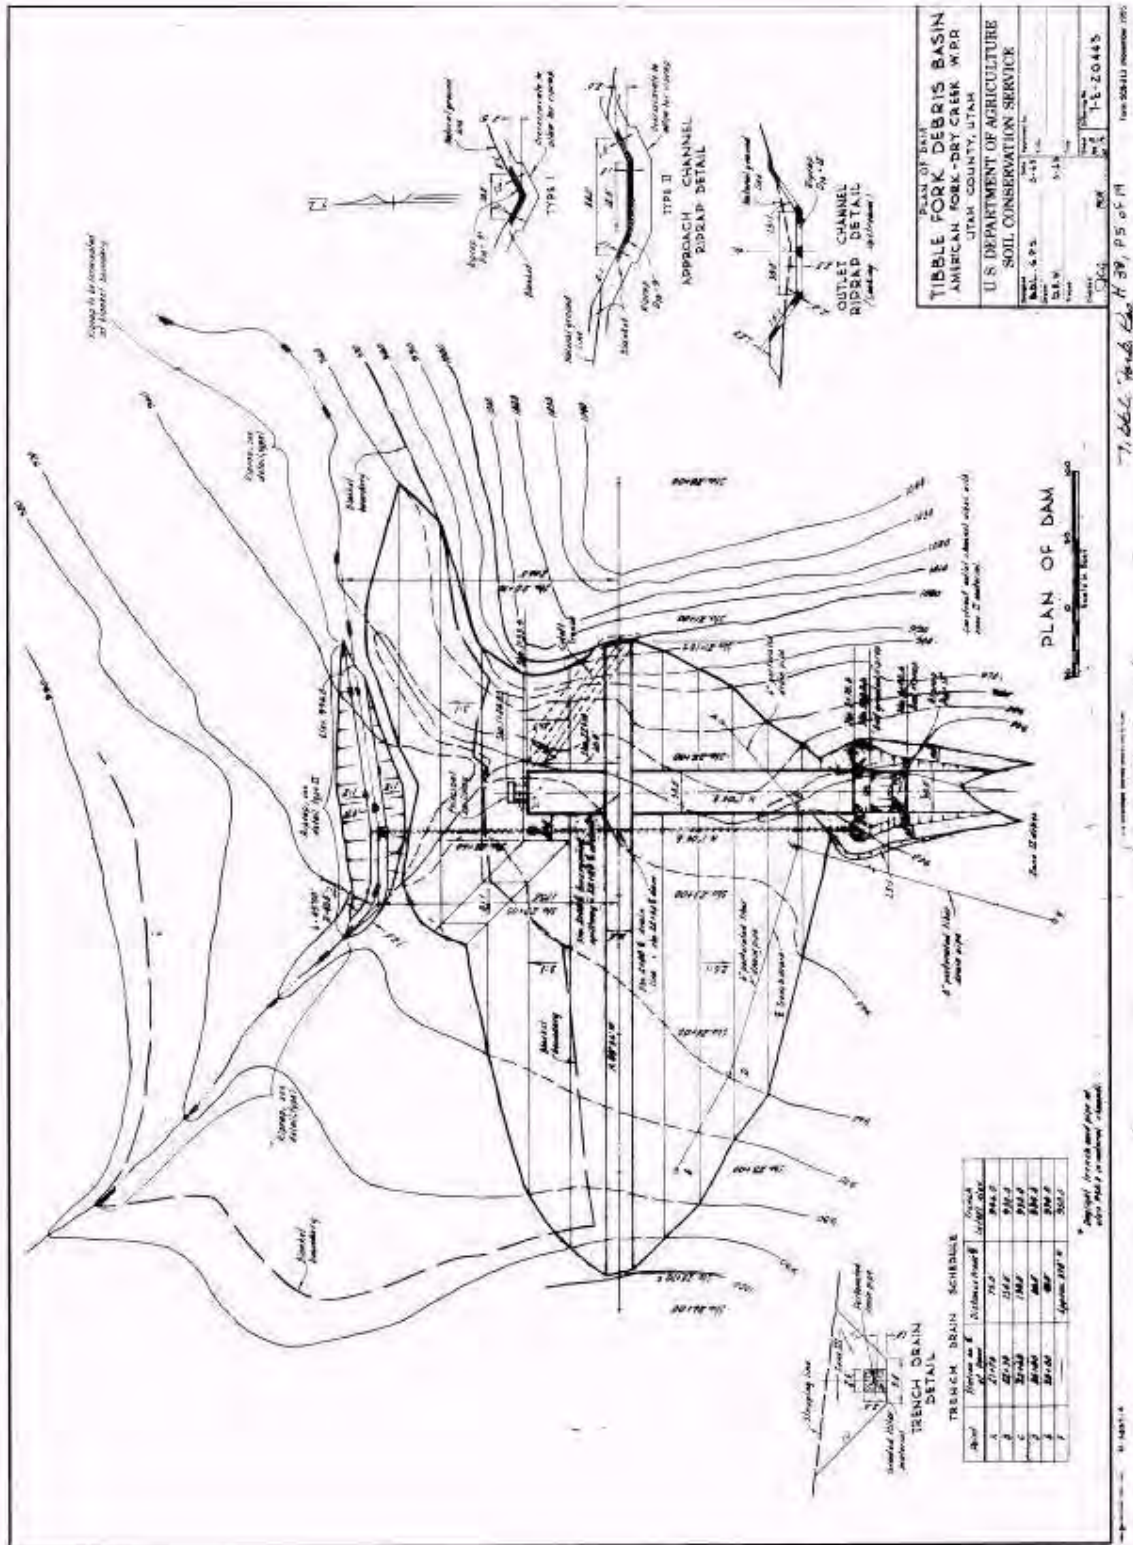
Plan View of Tibble Fork Dam

Tibble Fork dam is a 48-ft. tall earthen embankment with a drainage area of 31 square miles. The dam is 455-feet long and is located on the North Fork of the American Fork River at an elevation of 6,380 feet. This dam is in series with Silver Lake Dam, which is approximately 4 miles upstream. The watershed is in the Uinta National Forest with the watershed divide at 10,200 feet MSL. This area was historically a silver mining area. The reservoir is designed to store 234 ac.ft. At the spillway crest elevation the site has the capability to store 166 ac-ft. of sediment with a surface area of 11.5 acres and 68 ac.ft. of water for a surface area of 13.9 acres.. The principal spillway system consists of a 30 in. diameter reinforce concrete pipe passing through the dam with a concrete intake structure in the pool area of the reservoir.

This system controls the release of floodwater. The pipe discharges into a reinforced concrete outlet works. Potential seepage alongside the pipe system is controlled with 25-ft x 30-ft concrete anti-seep collars surrounding the principal spillway pipe. Foundation seepage control measures include an 8-ft wide slurry trench, located 220-ft upstream from centerline of dam and a cutoff trench with 30-ft bottom width with 1:1 sideslopes, also upstream from centerline of dam. Embankment seepage control includes a zone fill cross section with a downstream chimney drain.

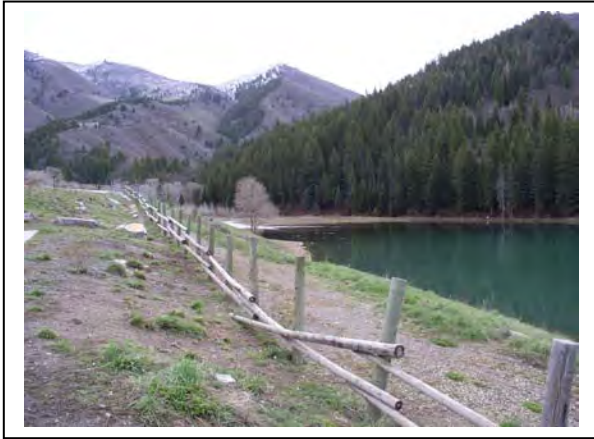
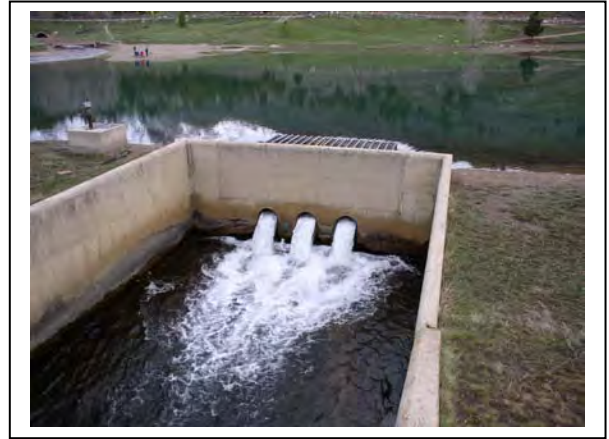
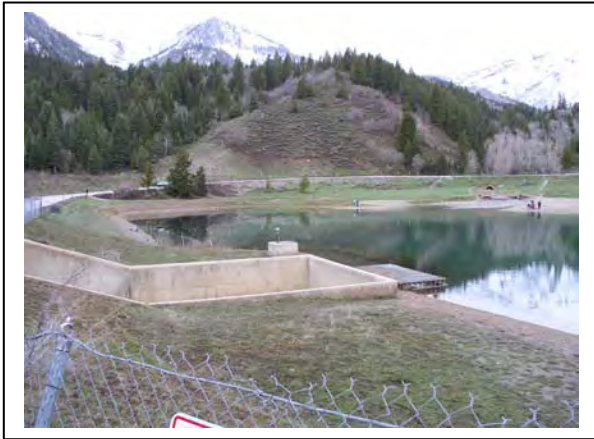
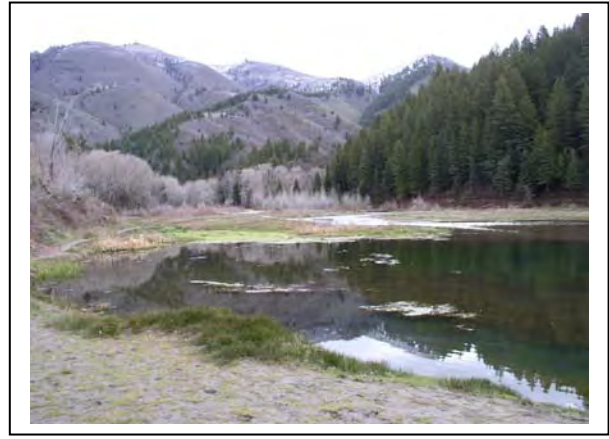
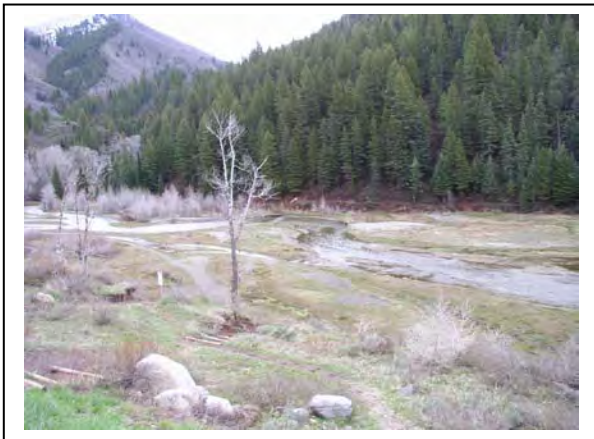
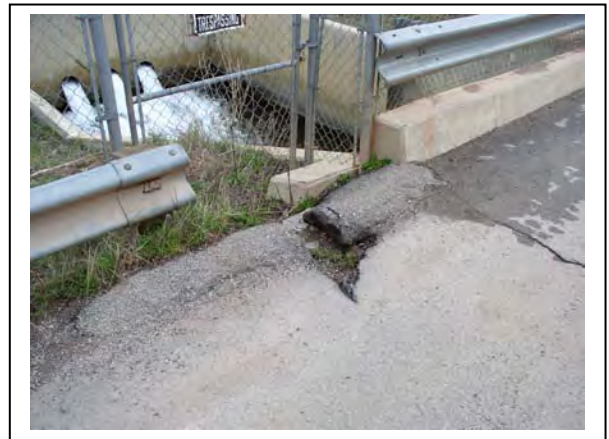
**Pictures of Existing Conditions at American Fork – Dry Creek
Watershed Tibble Fork Dam**

The site has been generally well maintained. Minor rilling was seen on the embankment.
