**Supplemental Watershed Plan-Environmental Assessment
for the
Pohick Creek Watershed**

Supplement No. 3 to the original watershed plan for the rehabilitation
of Pohick Creek Watershed Dam No. 4 (Royal Lake)

Fairfax County, Virginia

September 2006

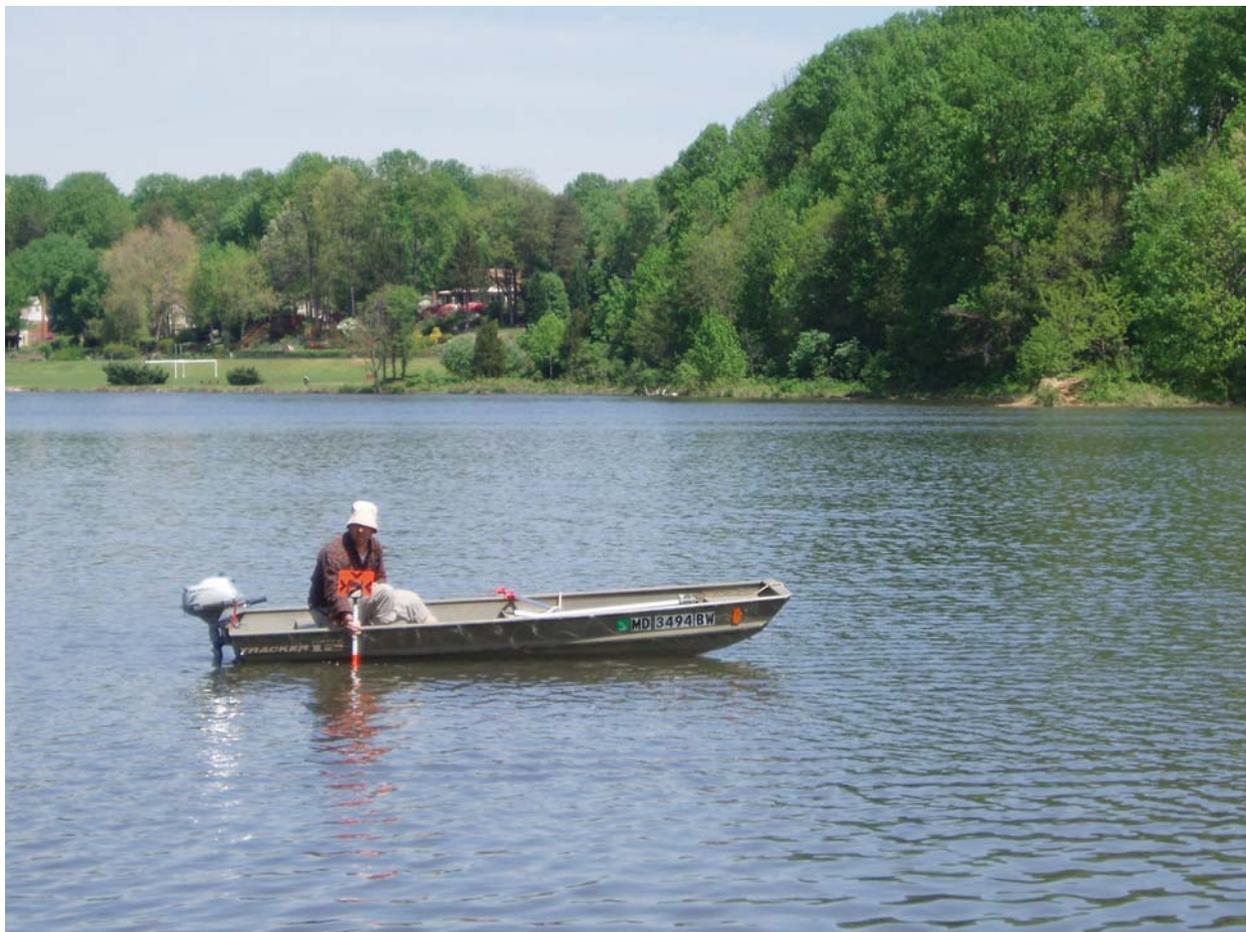
Figure 1 – Sediment Survey of Royal Lake.

Erosion and Sedimentation : As of 2006, Royal Lake had reached about 29% of its planned service life. According to the 2006 sediment survey conducted of the lake, the volume of sediment (both submerged and aerated) in the Royal Lake reservoir and its tributaries was about 23% of the original amount planned in the design. As expected, most of the sediment observed is present in the inlet channel areas of the structure. This material is primarily deposited sediments plus leaf and other organic debris. Note that another 7.5% of the sediment material was dredged from the impoundment from 1985 to 1990 by Fairfax County. Samples of the sediment have been taken and will be tested in case Fairfax County decides to conduct any dredging operations on their own. Federal funds will not be provided for dredging as part of the dam rehabilitation project because the reservoir has more than the minimum storage capacity of 50 years that is mandated by the rehabilitation program.

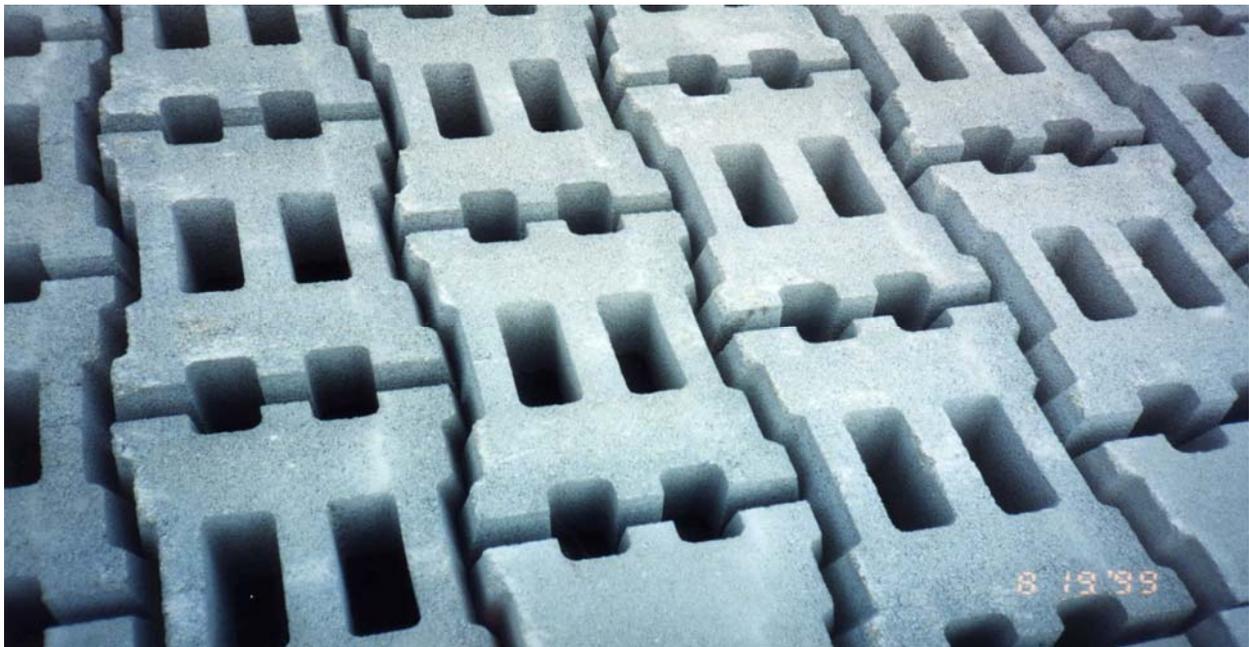
Figure 2 - Open-Cell Articulated Concrete Blocks

Design and installation of Articulated Concrete Blocks would cost about \$3,059,000. This includes the realignment of the spillway and building the training dikes.

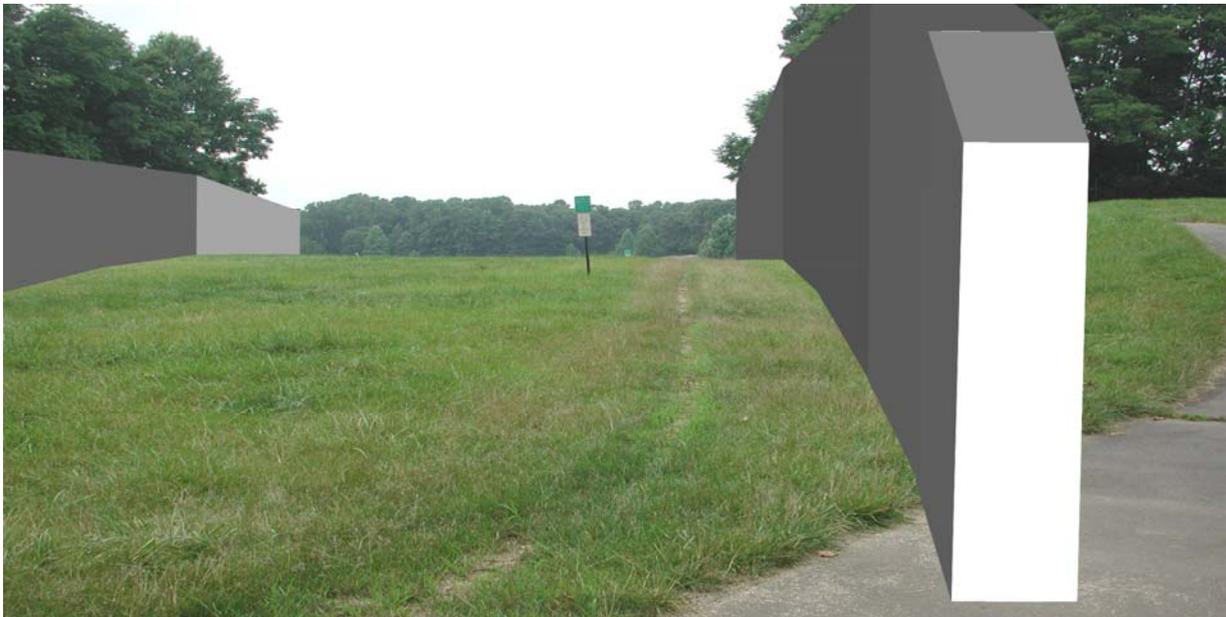
Figure 5 – Projected Appearance of a Concrete Training Dike

Option 2: The training dikes could also be made with a vertical concrete wall. This wall would be about one foot wide and would take up very little space along the spillway. However, it is visually unappealing, would be difficult to keep people off of, and would be vulnerable to vandalism by graffiti. The Royal Lake Task Force determined that this option was undesirable. See Figure 5.

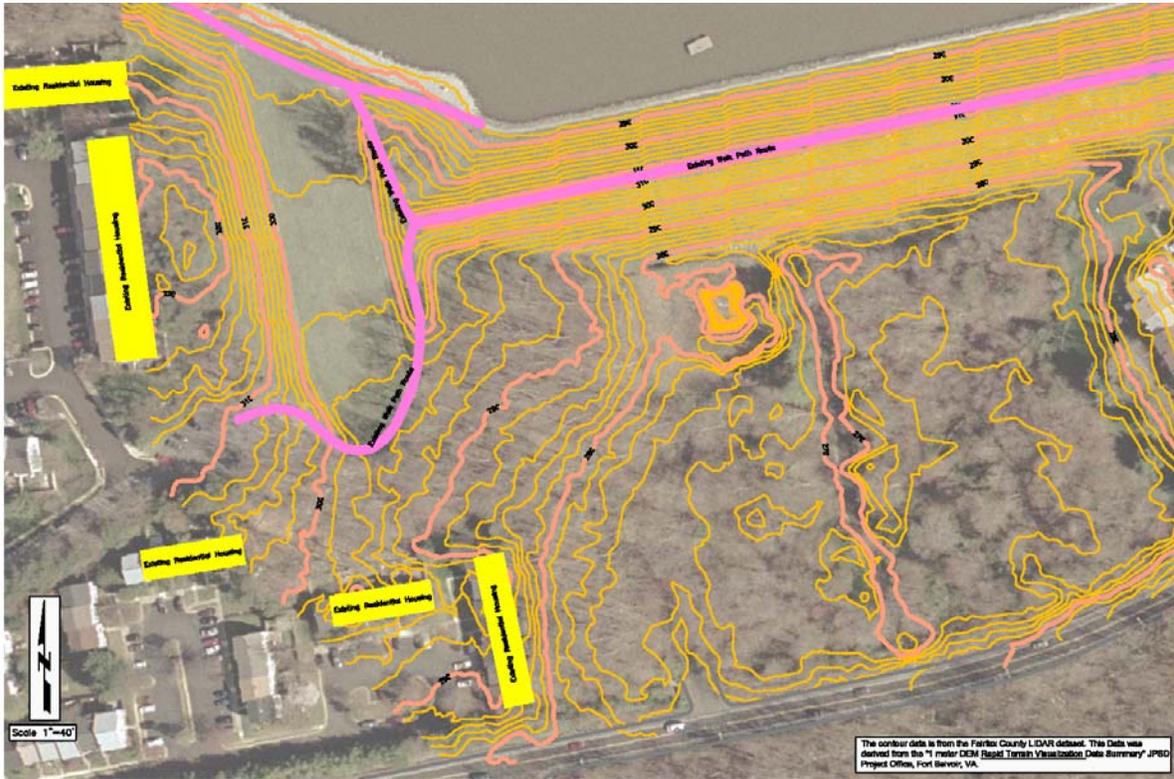
Figure 6 - Plan View Showing Existing Alignment of Auxiliary Spillway.

Another issue of concern is the existing alignment of the auxiliary spillway. At the present time, the water exiting the spillway is directed toward a group of townhouses that were built after the dam was completed. The results from the SITES computer model indicate that the townhouses potentially could be impacted. The model does not predict the width of an earthen auxiliary spillway breach; it only indicates that a breach will occur for a given event. Therefore, it is possible that the townhouses would be damaged from flooding, from undermining of the foundation, or both.

The potential solutions were evaluated for cost and engineering feasibility. This information was presented to the Sponsors at meetings on May 24, 2006 and June 7, 2006 and to the public at a meeting on June 20, 2006. The selected alternative for Royal Lake is to realign the auxiliary spillway, install earthen training dikes to control the flow direction of the water, and armor the spillway and interior slopes of the training dikes with ACBs. The design and construction cost for this solution would be \$3,059,000. Figure 6 shows the existing alignment of the auxiliary spillway. Figures 7 and 8 show two different views of the recommended alternative.

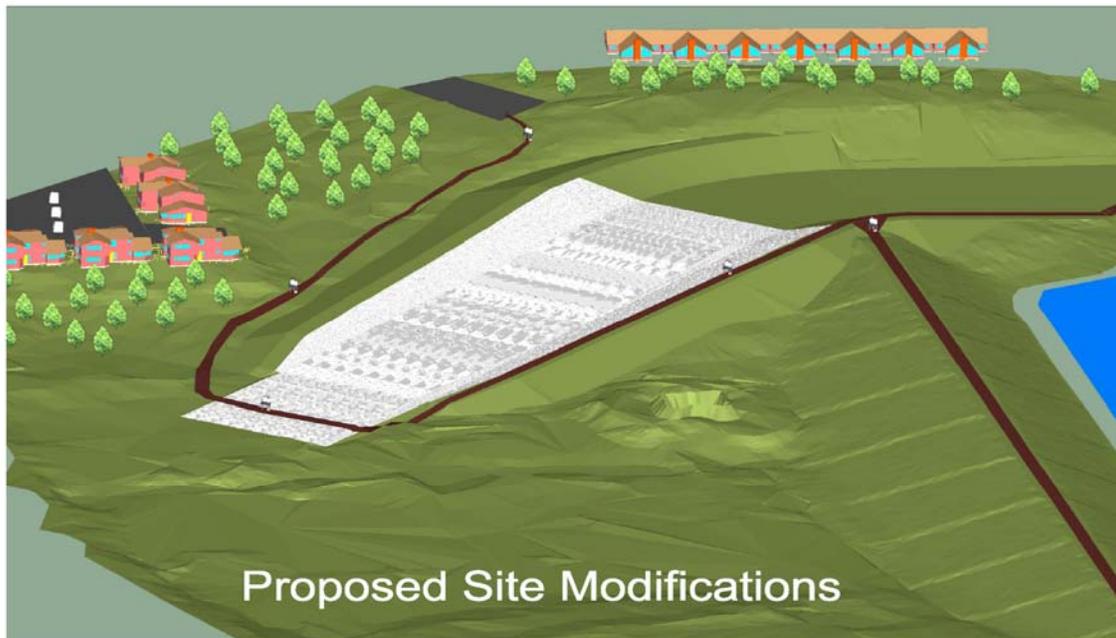
Figure 8 - Perspective View of Recommended Alternative. The ACBs are shown as they will appear before the topsoil is installed and seeded. Once the site is vegetated, the ACBs will not be seen at all.

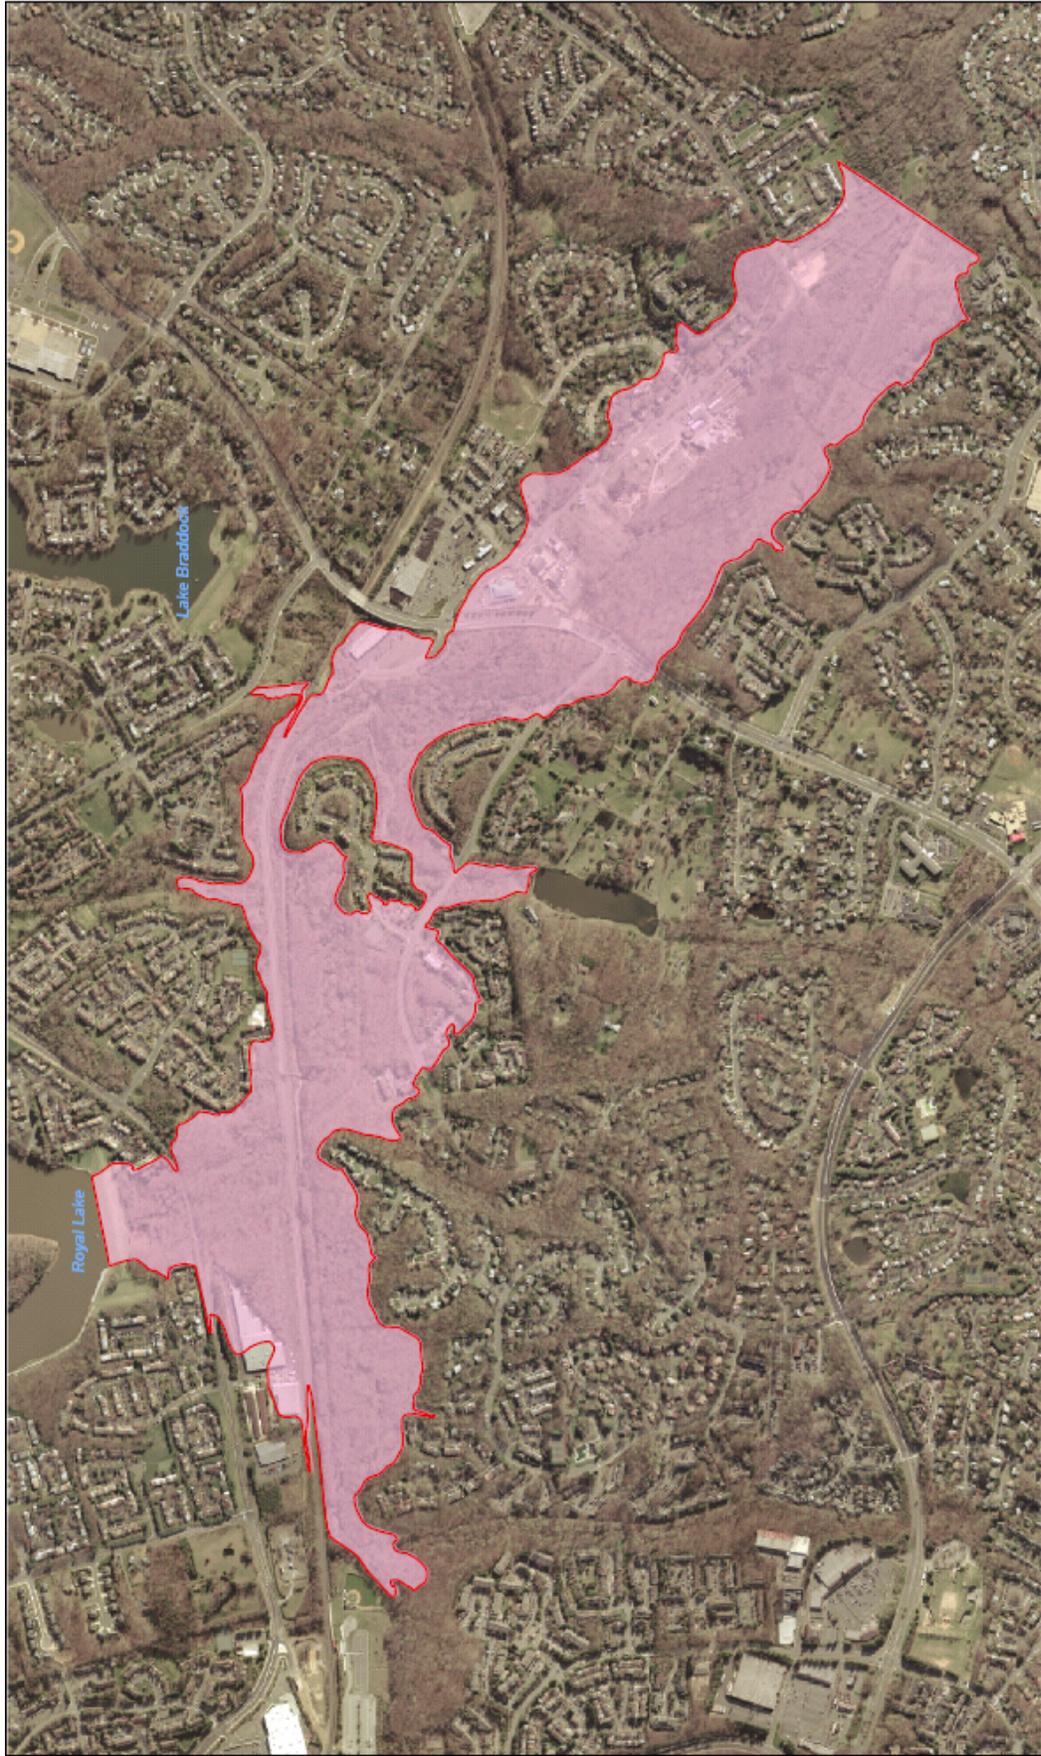
ROYAL LAKE BREACH INUNDATION ZONE

This map was produced at the Virginia Natural Resources Information Center – The USDA Natural Resources Conservation Service in Harrisonburg, Virginia on 6/28/06. The imagery was derived from USGS High resolution imagery for Northern Virginia. This is one foot ground resolution and is from April 2002 photography. The inundation zone was based on calculations made by the USDA-NRCS planning team. This map is projected in VA- State Plane Coordinates – VA north Zone, NAD83 Datum and US feet. This is a "Draft" copy, and is subject to change.

The breach inundation zone analysis will be used by the Sponsors to update the Emergency Action Plan (EAP) that currently exists for the dam. The purpose of an EAP is to outline appropriate actions and to designate parties responsible for those actions in the event of a potential failure of the dam. The Sponsors will update the EAP annually with assistance from local emergency response officials. As resources allow, NRCS will provide technical assistance with updating the EAP. The NRCS State Conservationist is to ensure that a current EAP is prepared prior to initiation of construction.
