Animal Enhancement Activity – ANM18 – Retrofit watering facility for wildlife escape

Wisconsin Supplement 1/3/2012

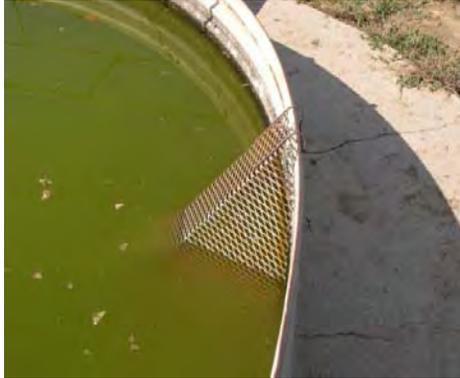
Retrofit existing watering facilities (troughs, tanks, etc.) to allow for the escape of wildlife that becomes trapped while trying to drink.

1. Extend into the water and meet the inside wall of the watering facility,
2. Reach to the bottom of the watering facility,
3. Be firmly secured to the rim of the watering facility so as not to be displaced by livestock
4. Be built of graspable, long-lasting materials, such as painted or coated metal grating, roughened fiberglass, concrete, rock and mortar, or high-strength plastic composites,
5. Have a slope no steeper than 45 degrees,
6. Be located to cause minimal interference with livestock drinking, and
7. One structure for every 30 linear feet of watering facility edge.
