RICELAND WETLAND RESTORATION PROJECT

A Multi-Purpose Wetland Restoration Project – Freeborn Co.

- 2,060 acre Drainage Area
- 157 Acres of Wetland Restored (3 Main Pools)
- 2 Primary Outlet Structures
- 100 yr – 24 Storm
 - 304 acre-ft of Detention Storage
 - 58 Percent Reduction in Peak Flows (718 cfs to 304 cfs)

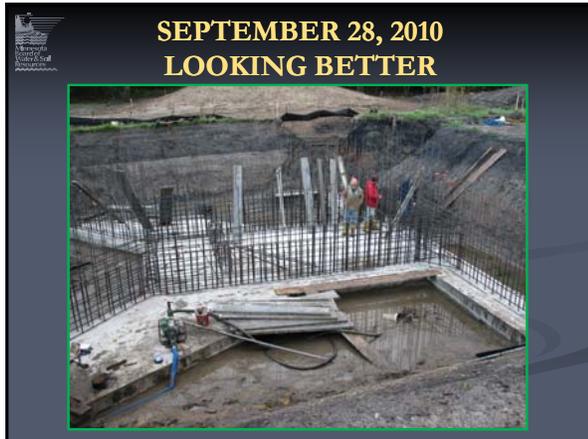
SEPTMBER 28, 2010
LOOKING BETTER
