# The Rise and Fall of Mid-Atlantic Streams: Buried Soils and the History of Valley Bottom Sedimentation and Erosion

Dorothy Merritts, Robert Walter, and Mike Rahnis (F&M College)

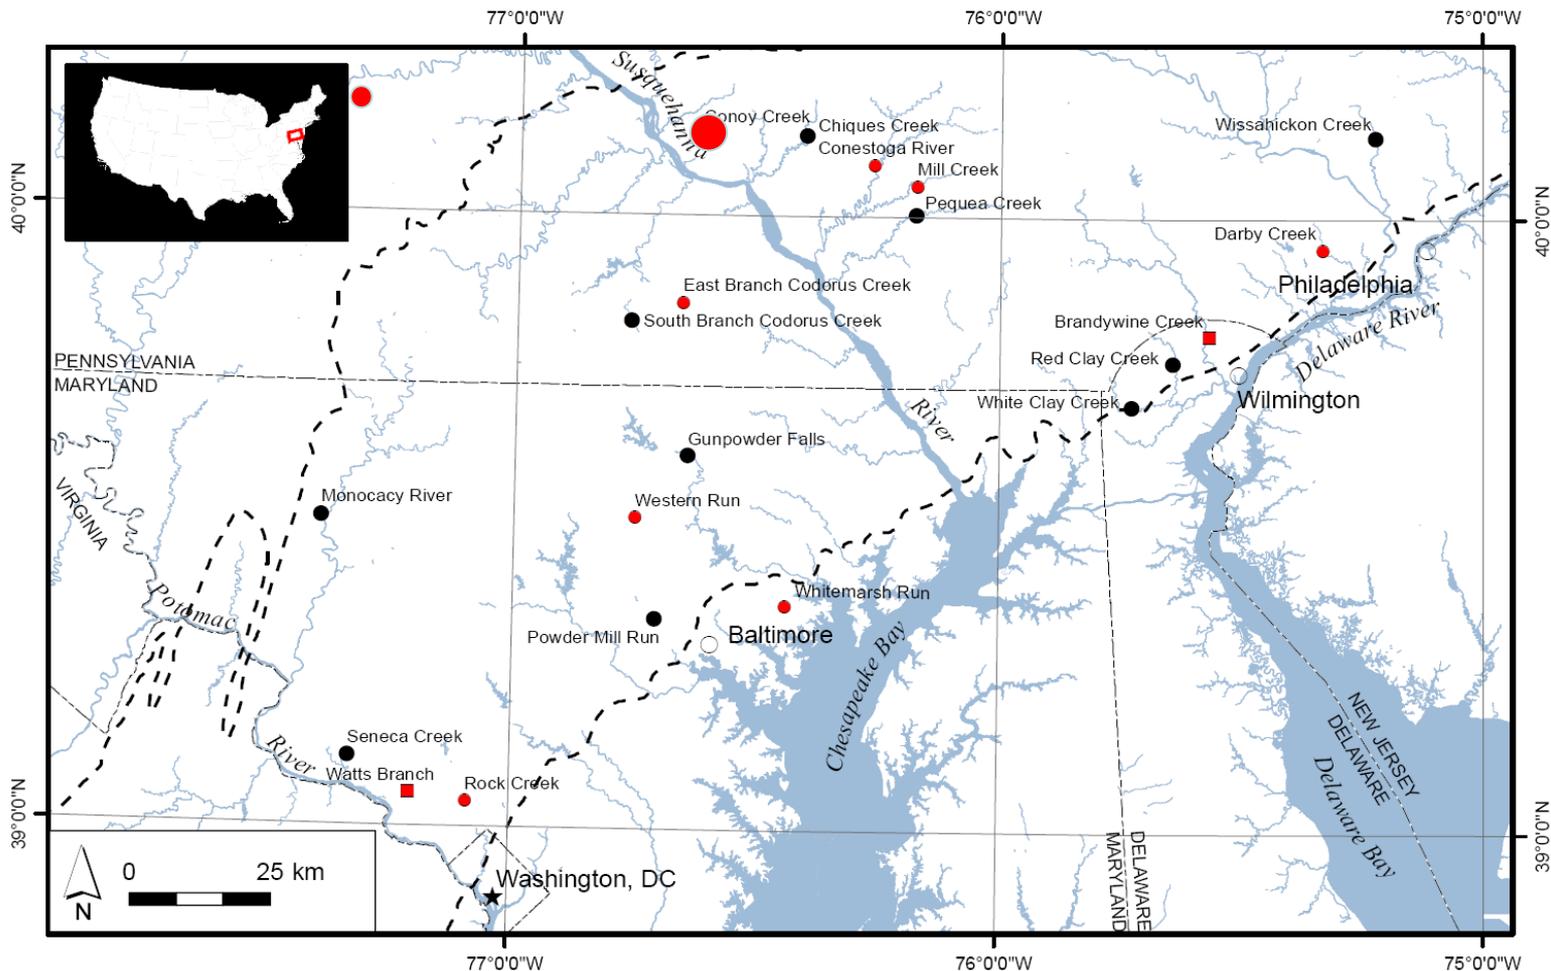
Study Region includes 21 Mid-Atlantic Watersheds  
(Sites depicted in red have radiocarbon age control)

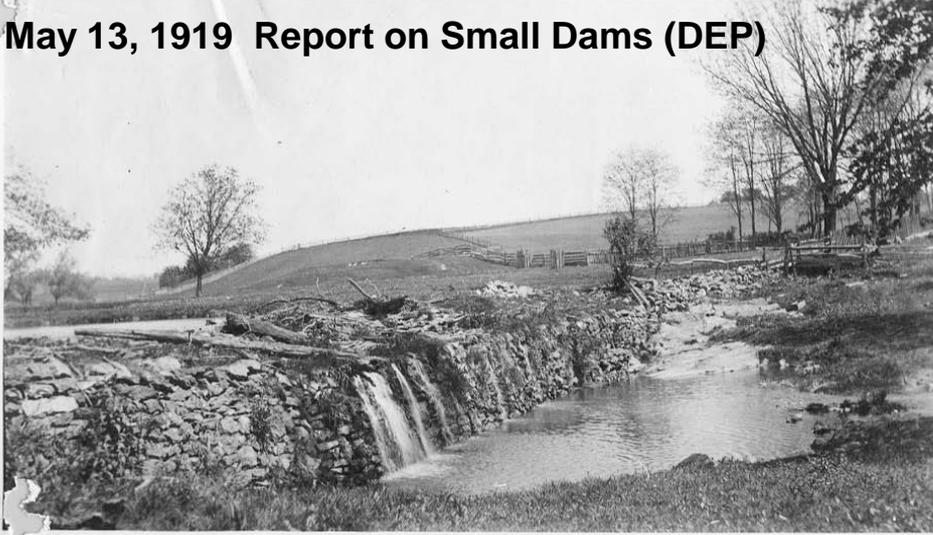
Bender's Mill Dam—"dry masonry, overflow...watertight"

May 13, 1919 Report on Small Dams (DEP)

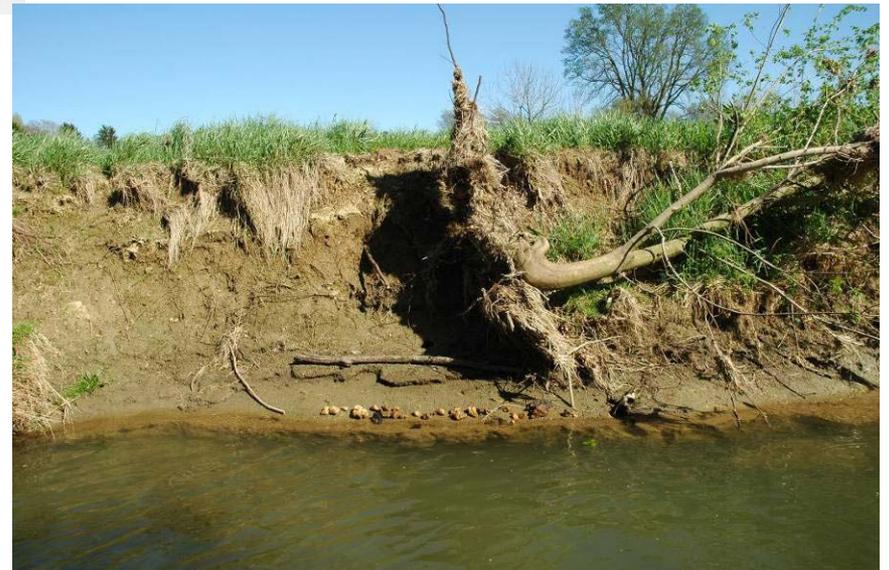
Historic sediment stored along valley bottoms (with help from breached dams, incised/straightened streams, and changes in grade).

150 m upstream of breach; seeds 7200 yrs BP at base

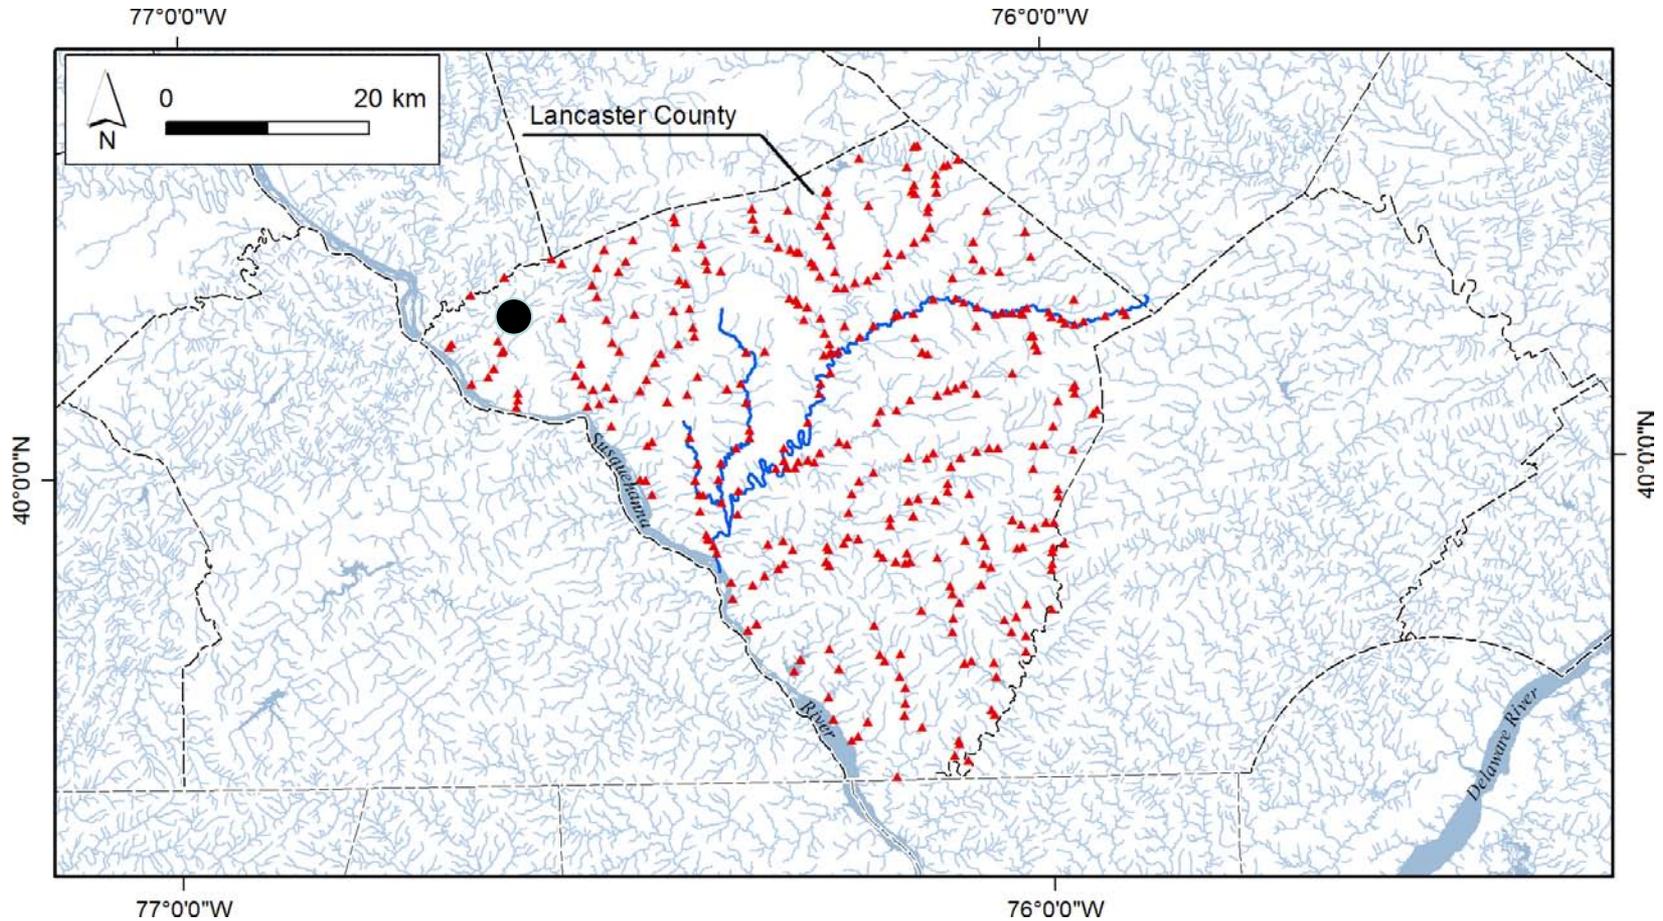
**~400 mill dams in 19<sup>th</sup> C. Atlases of Lancaster County**

**▲ Location of mill dams**

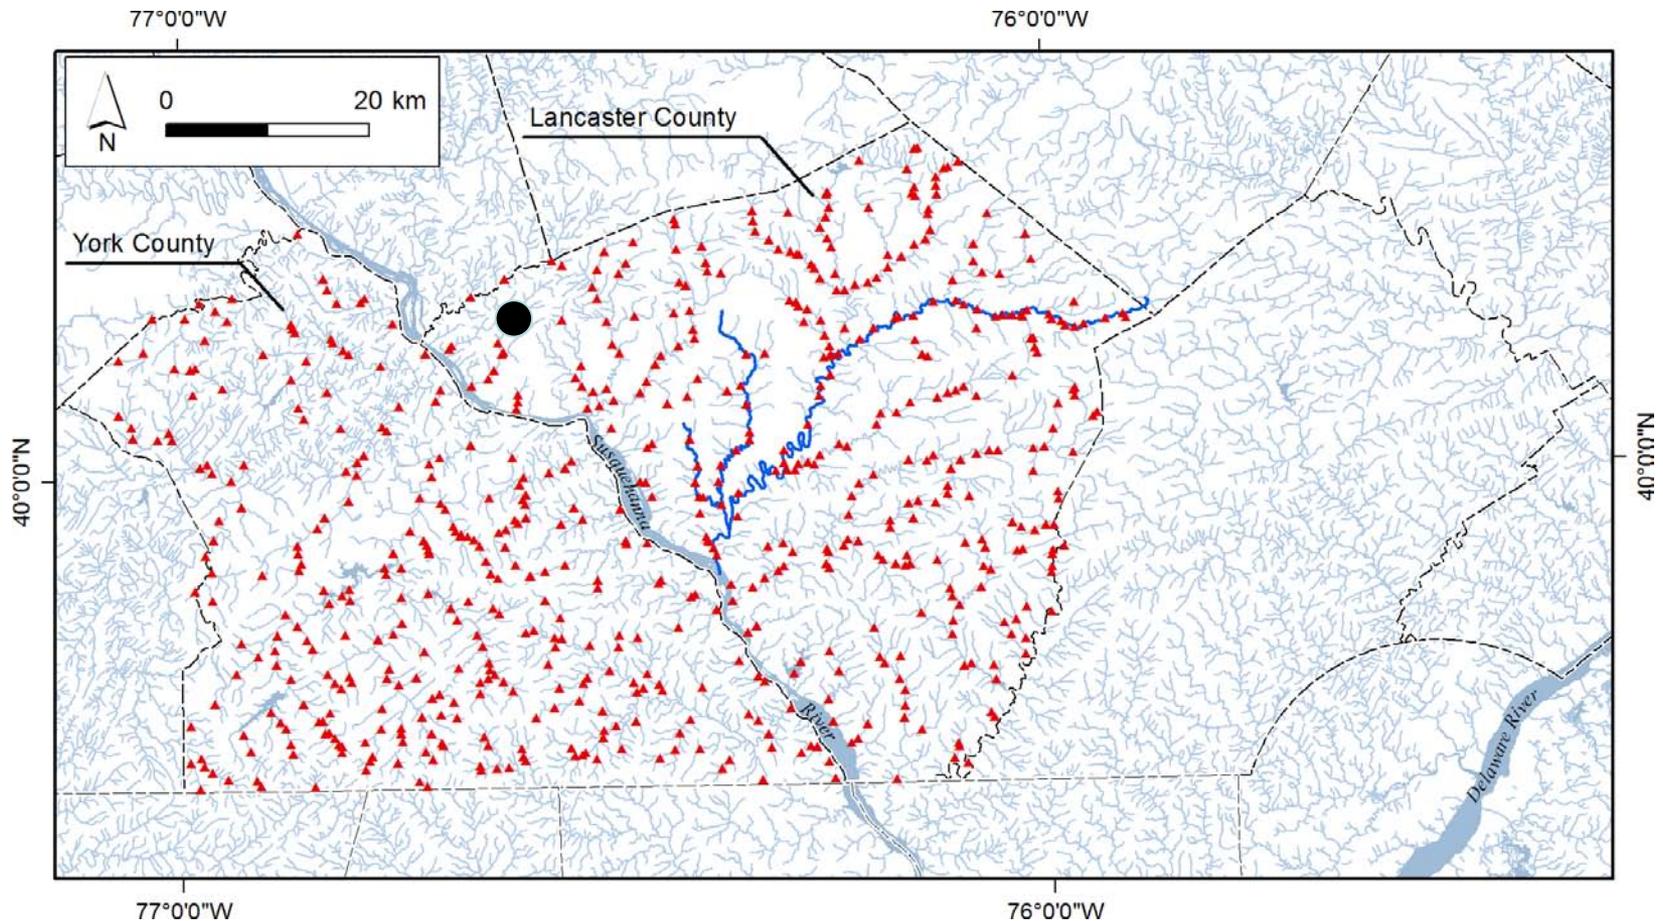
**~800 mill dams in 19<sup>th</sup> C. Atlases of York and Lancaster Counties**

**▲ Location of mill dams**

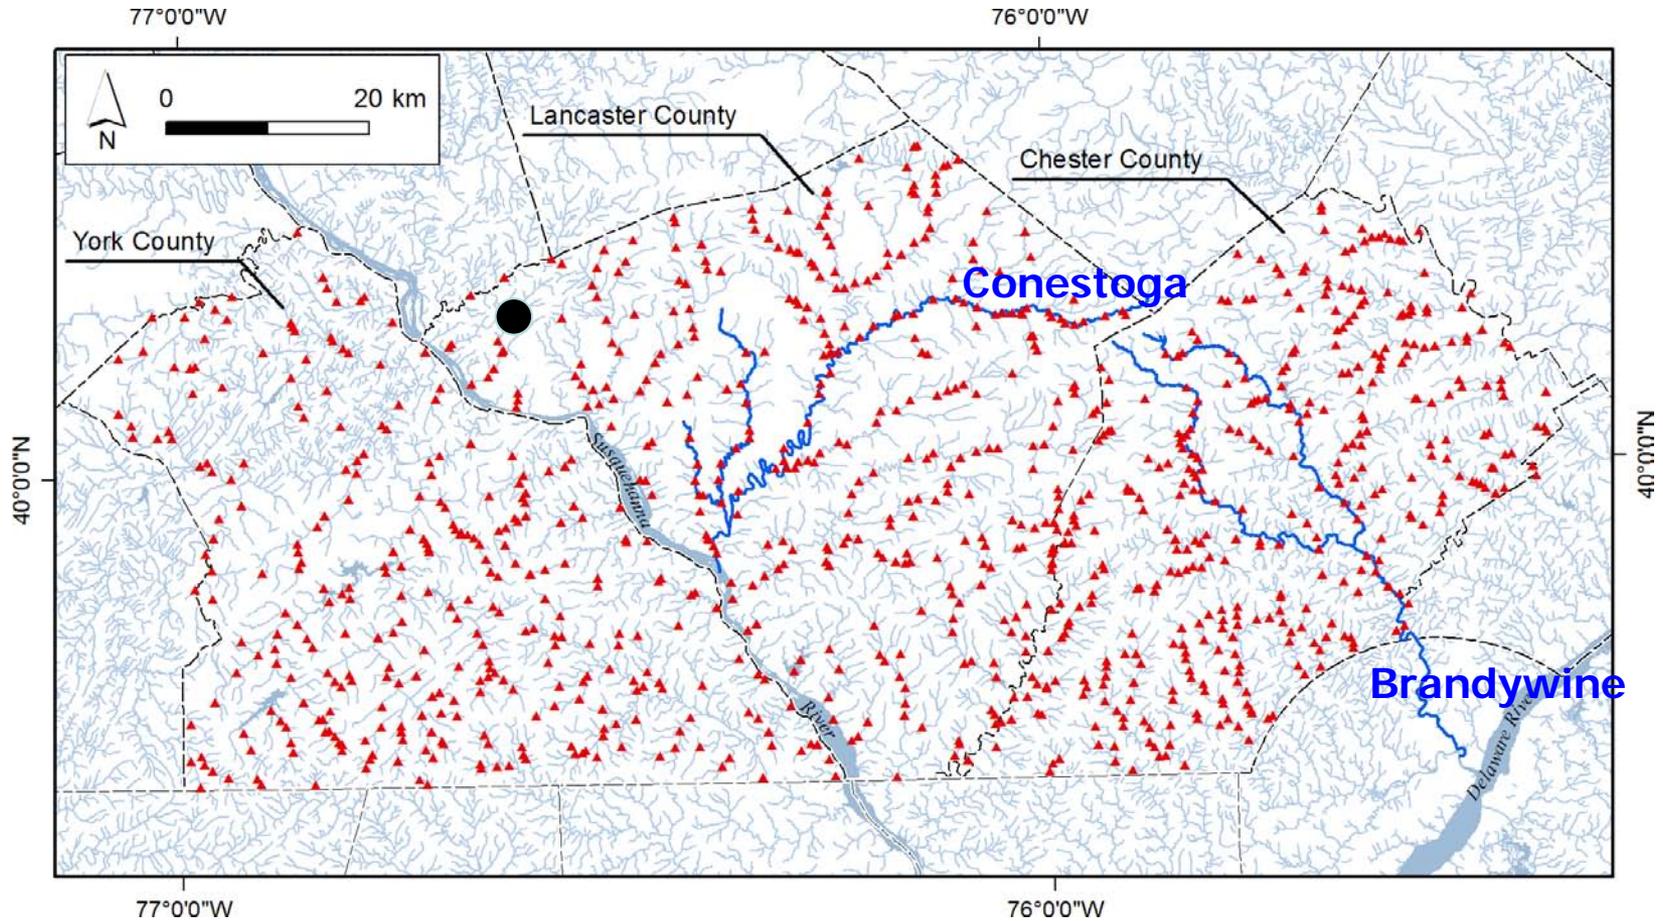
**Over 1,000 mill dams in 19<sup>th</sup> C. Atlases of York, Lancaster & Chester Counties**

▲ Location of mill dams

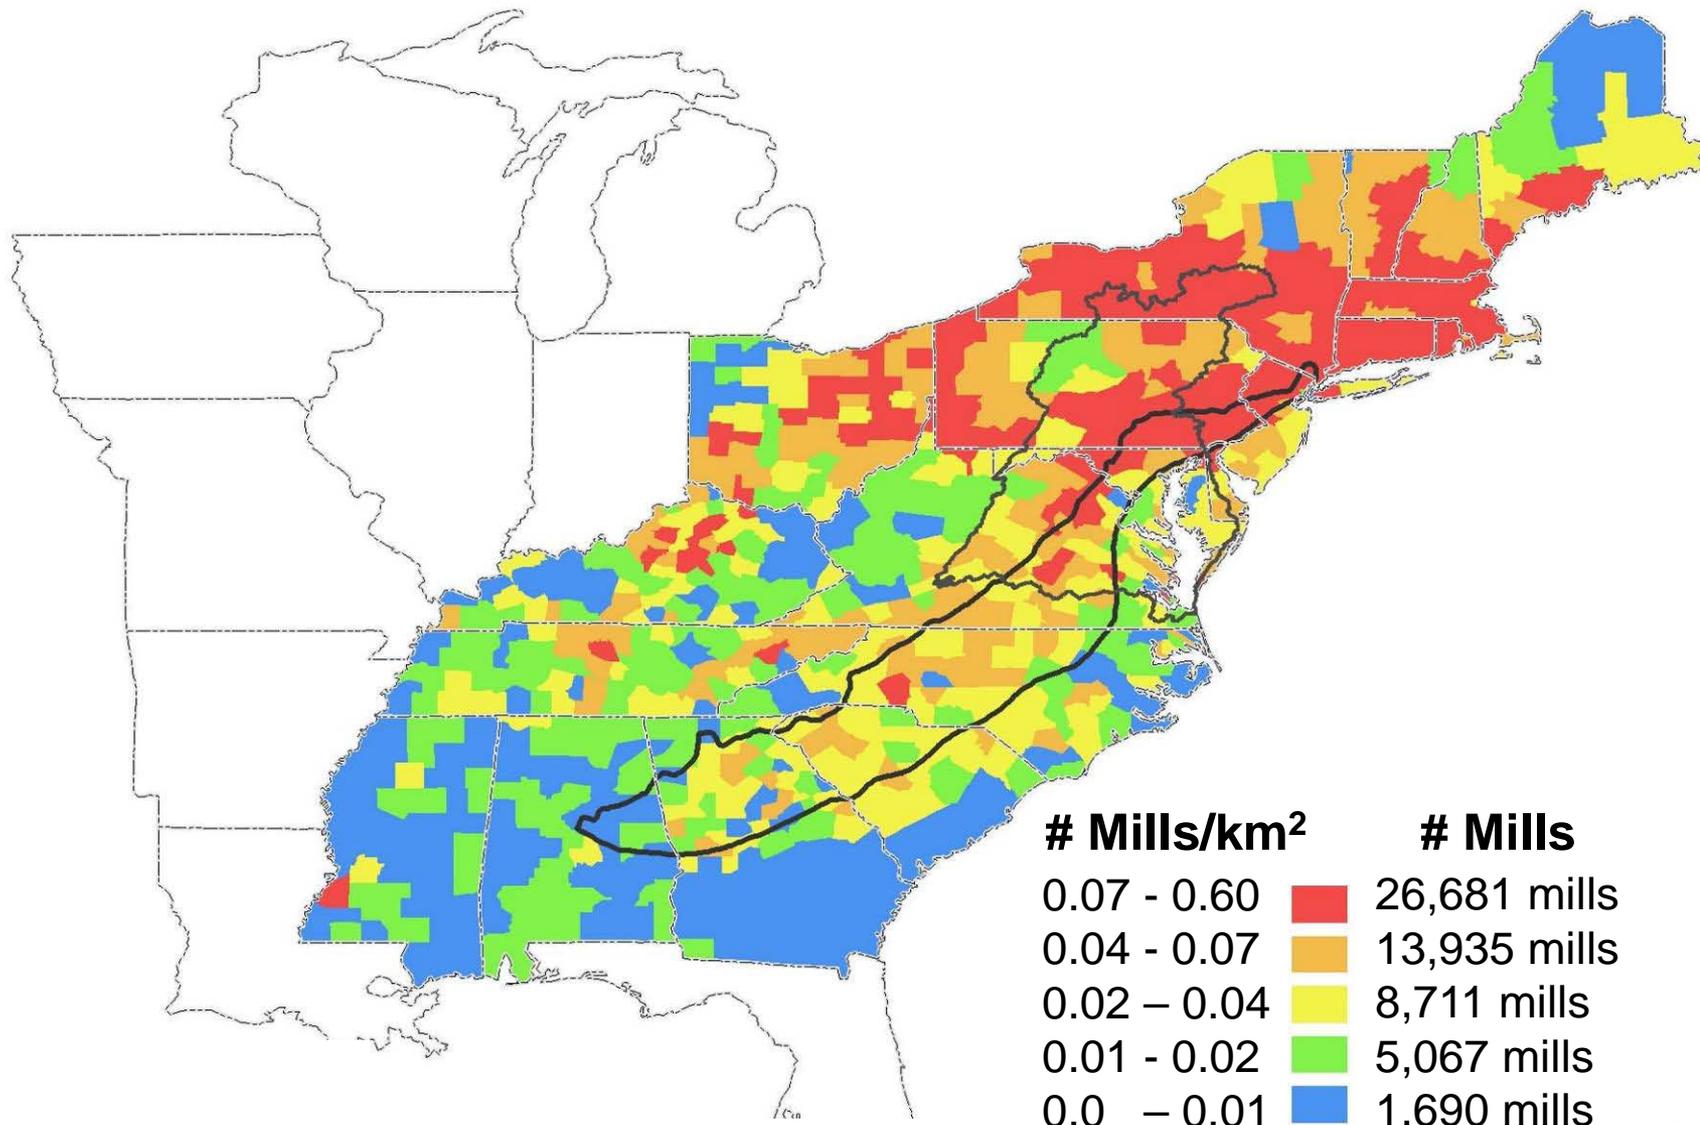
**Mill Density from 1840 US Census**  
**~65,000 Water-powered Mills**

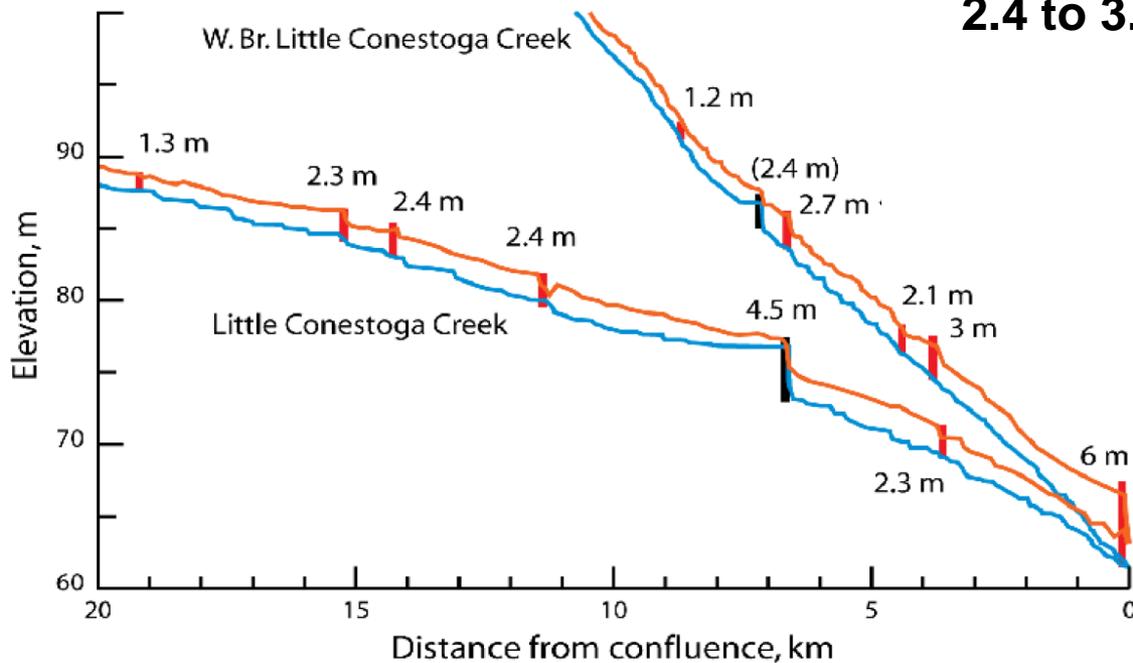
**Average dam height 2.4 to 3 m;  
Average mill pond length  
2.4 to 3.3 km**

**Lidar analysis (15 cm vertical resolution)**

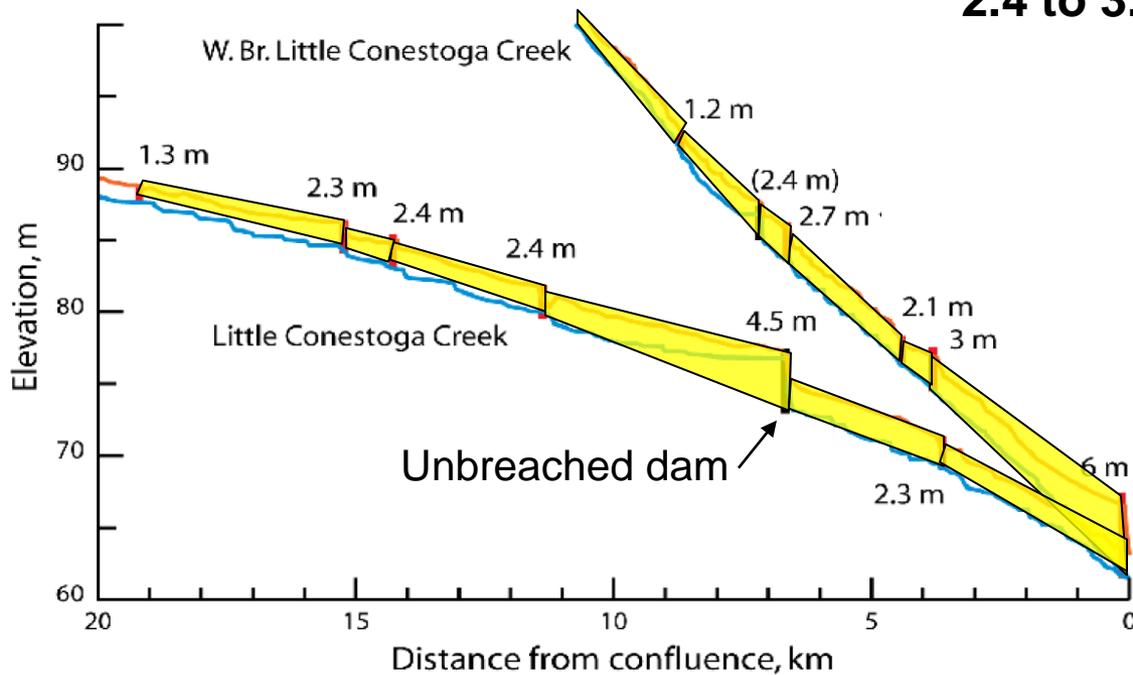
Average dam height 2.4 to 3 m;  
Average mill pond length  
2.4 to 3.3 km

Lidar analysis (15 cm vertical resolution)

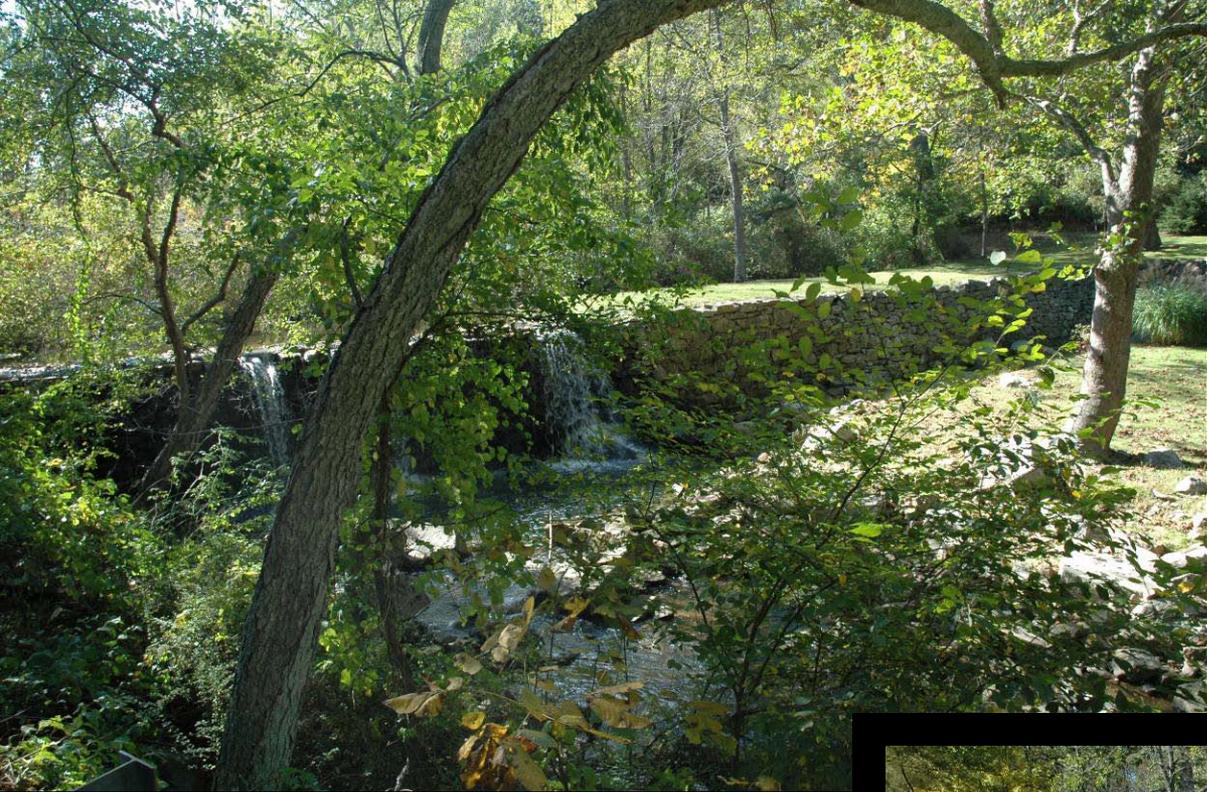
**Unbreached dam:  
Pickering Creek  
Mill Dam (~3 m),  
Chester County, PA**

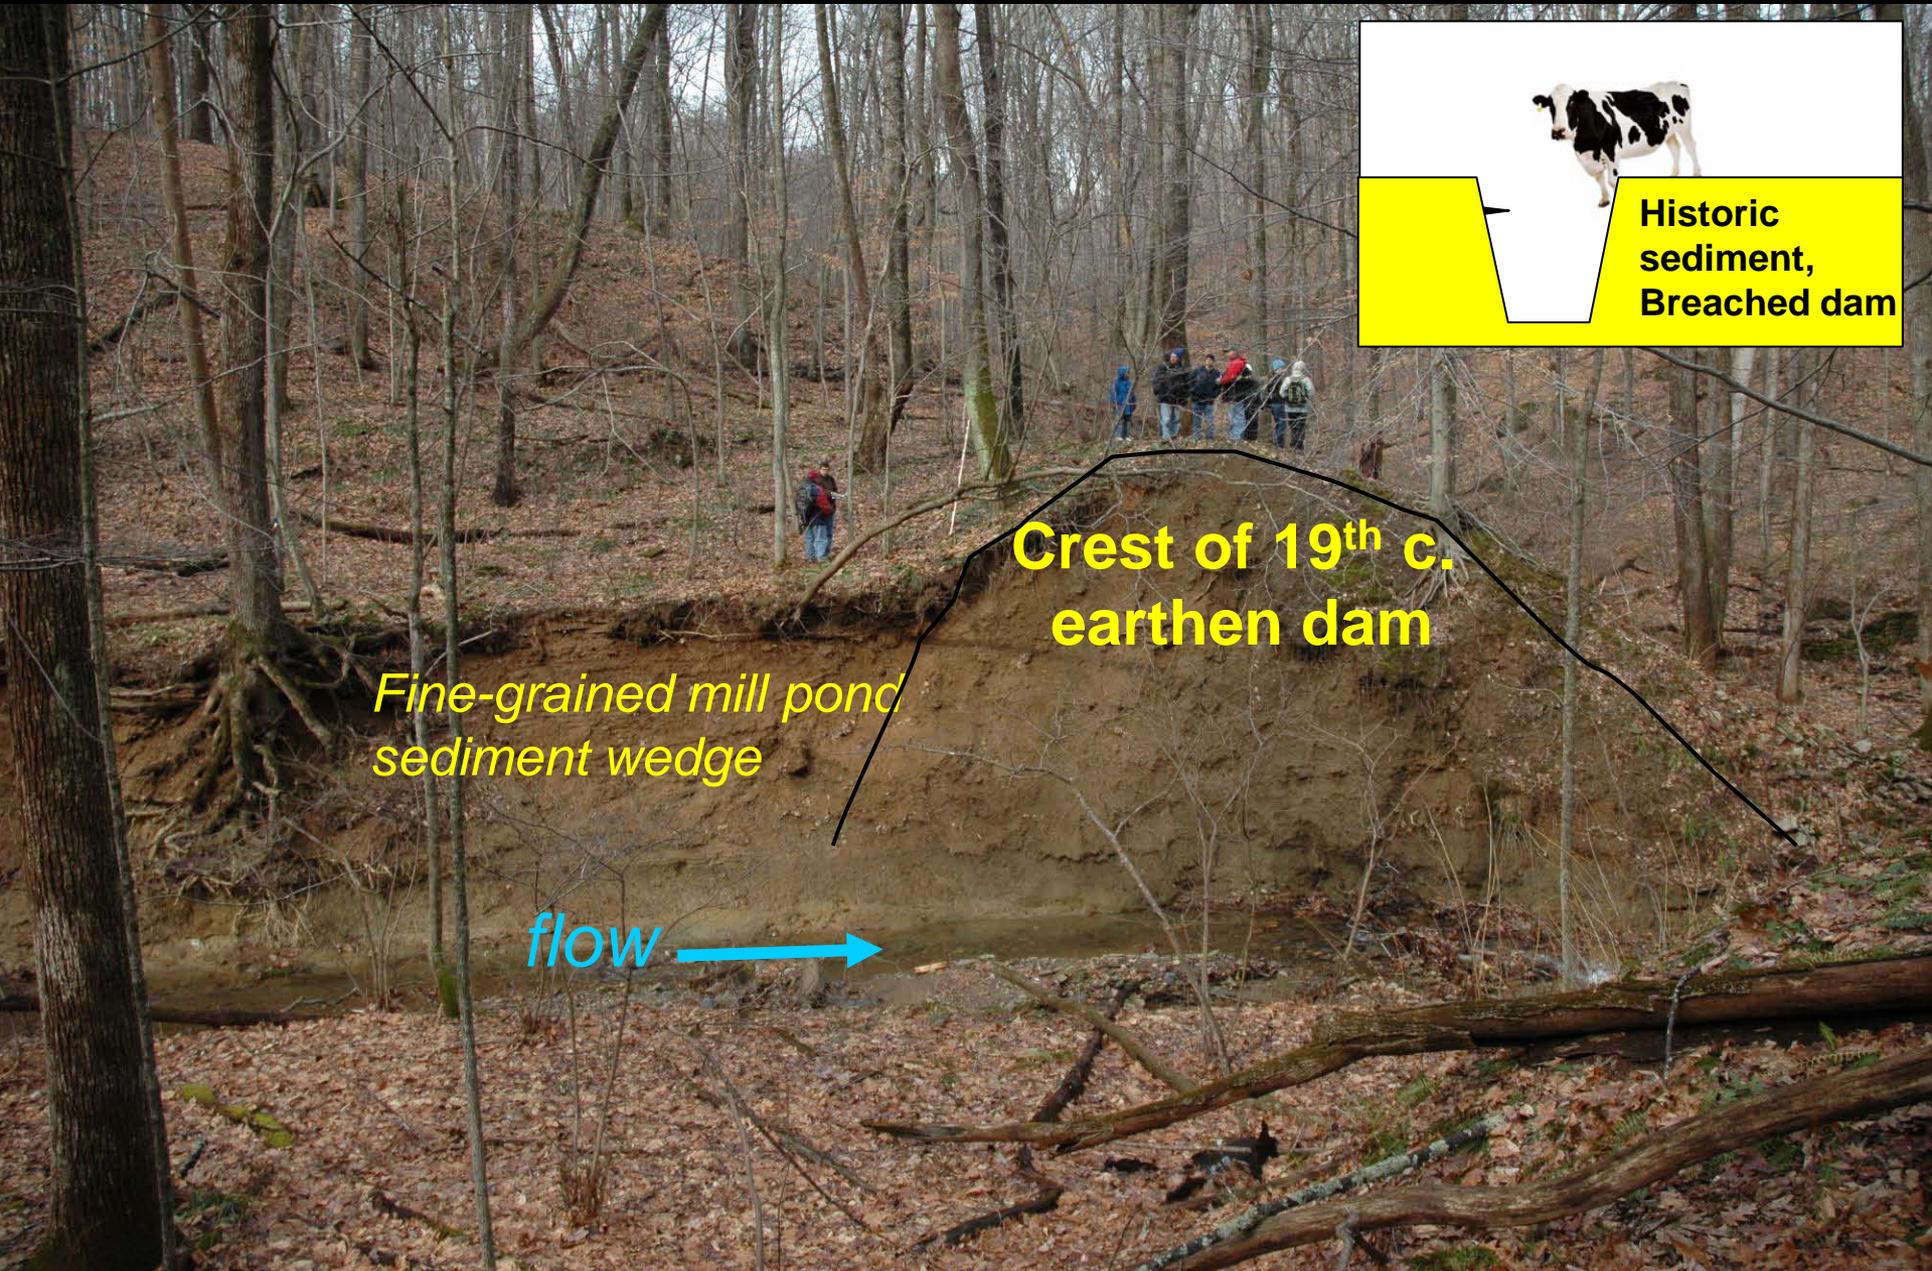
# Breached Earthen Dam: Panther Branch, MD

Historic sediment, Breached dam

Crest of 19<sup>th</sup> c. earthen dam

*Fine-grained mill pond sediment wedge*

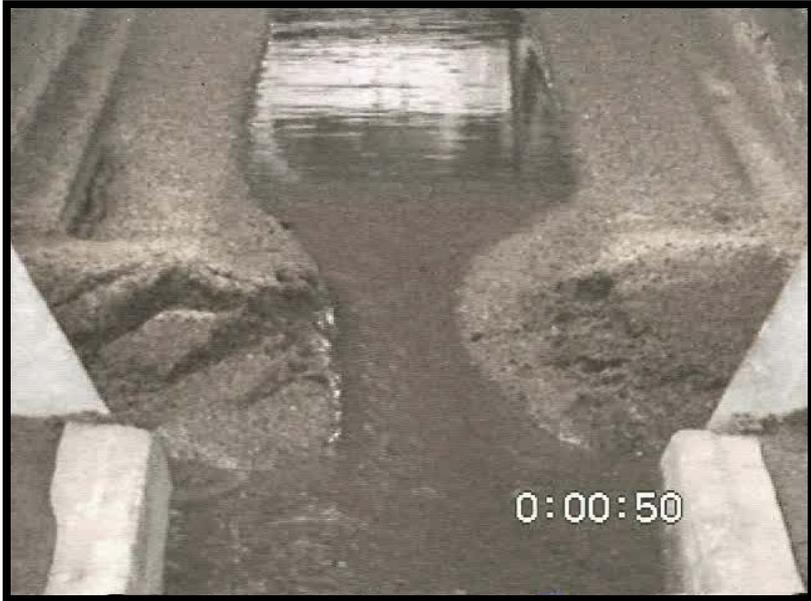
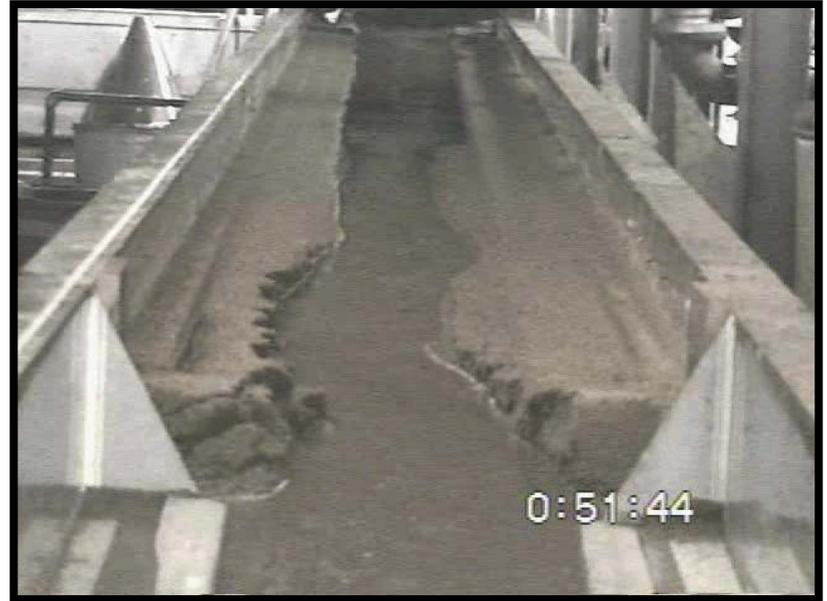
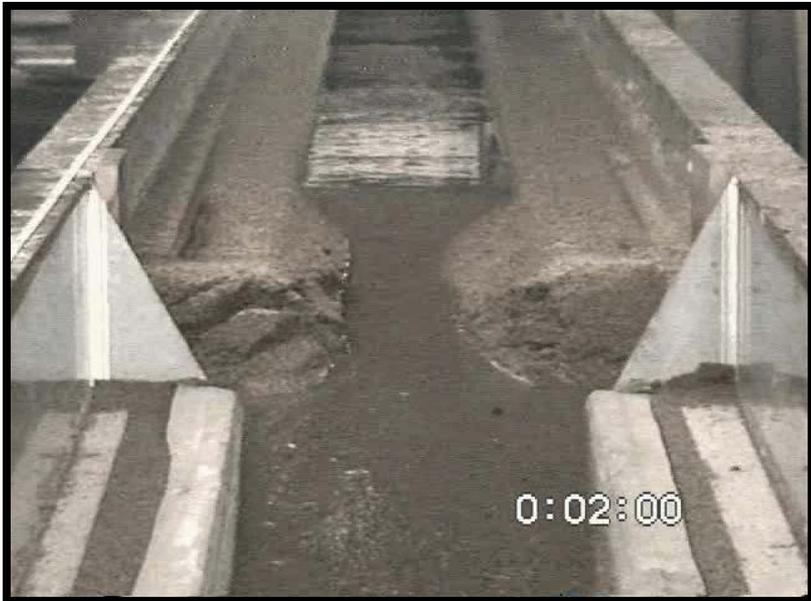
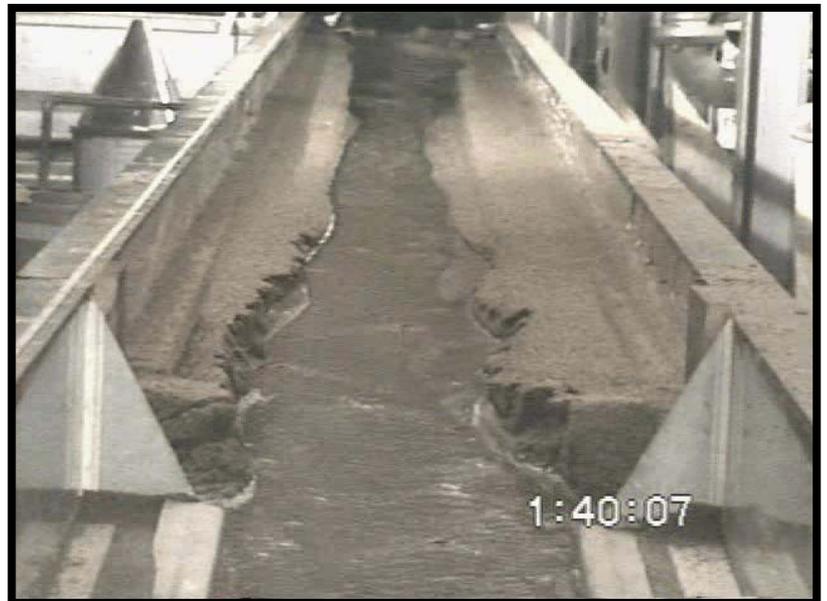
# Flume Studies: Base level matters for dam removal and breaching

What happens once a mill dam breaches?  
Flume experiments provide experimental analogs.

Flume experiments and video footage from  
Dr. Allesandro Cantelli, University of Minnesota  
[http://www.nced.umn.edu/Stream\\_Restoration\\_Toolbox.html](http://www.nced.umn.edu/Stream_Restoration_Toolbox.html)

Resembles a Typical Piedmont Stream

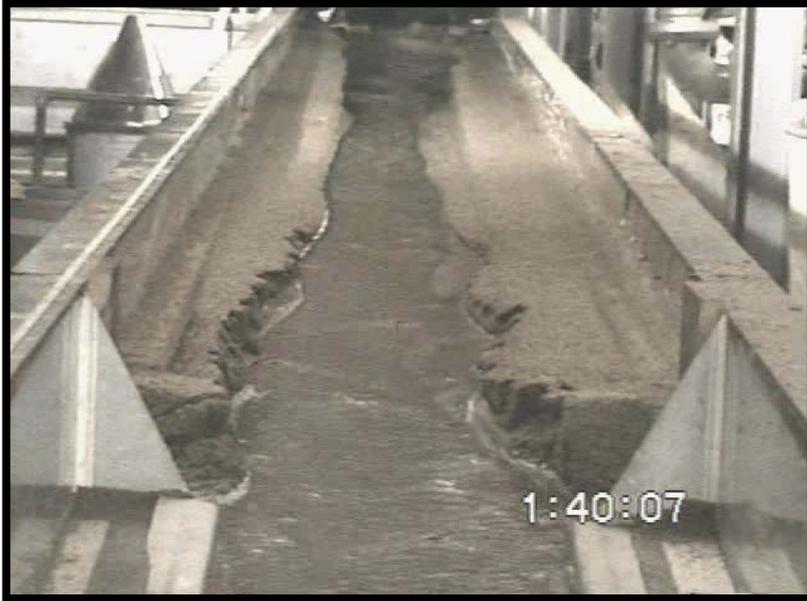
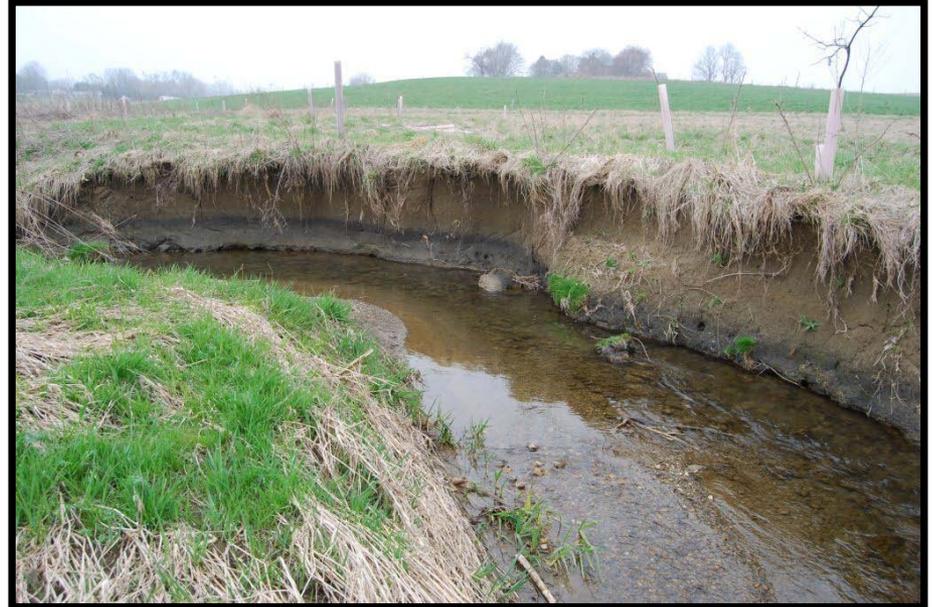
## Base level drops with dam removal and breaching

**Big Spring Run: Typical Piedmont Stream**

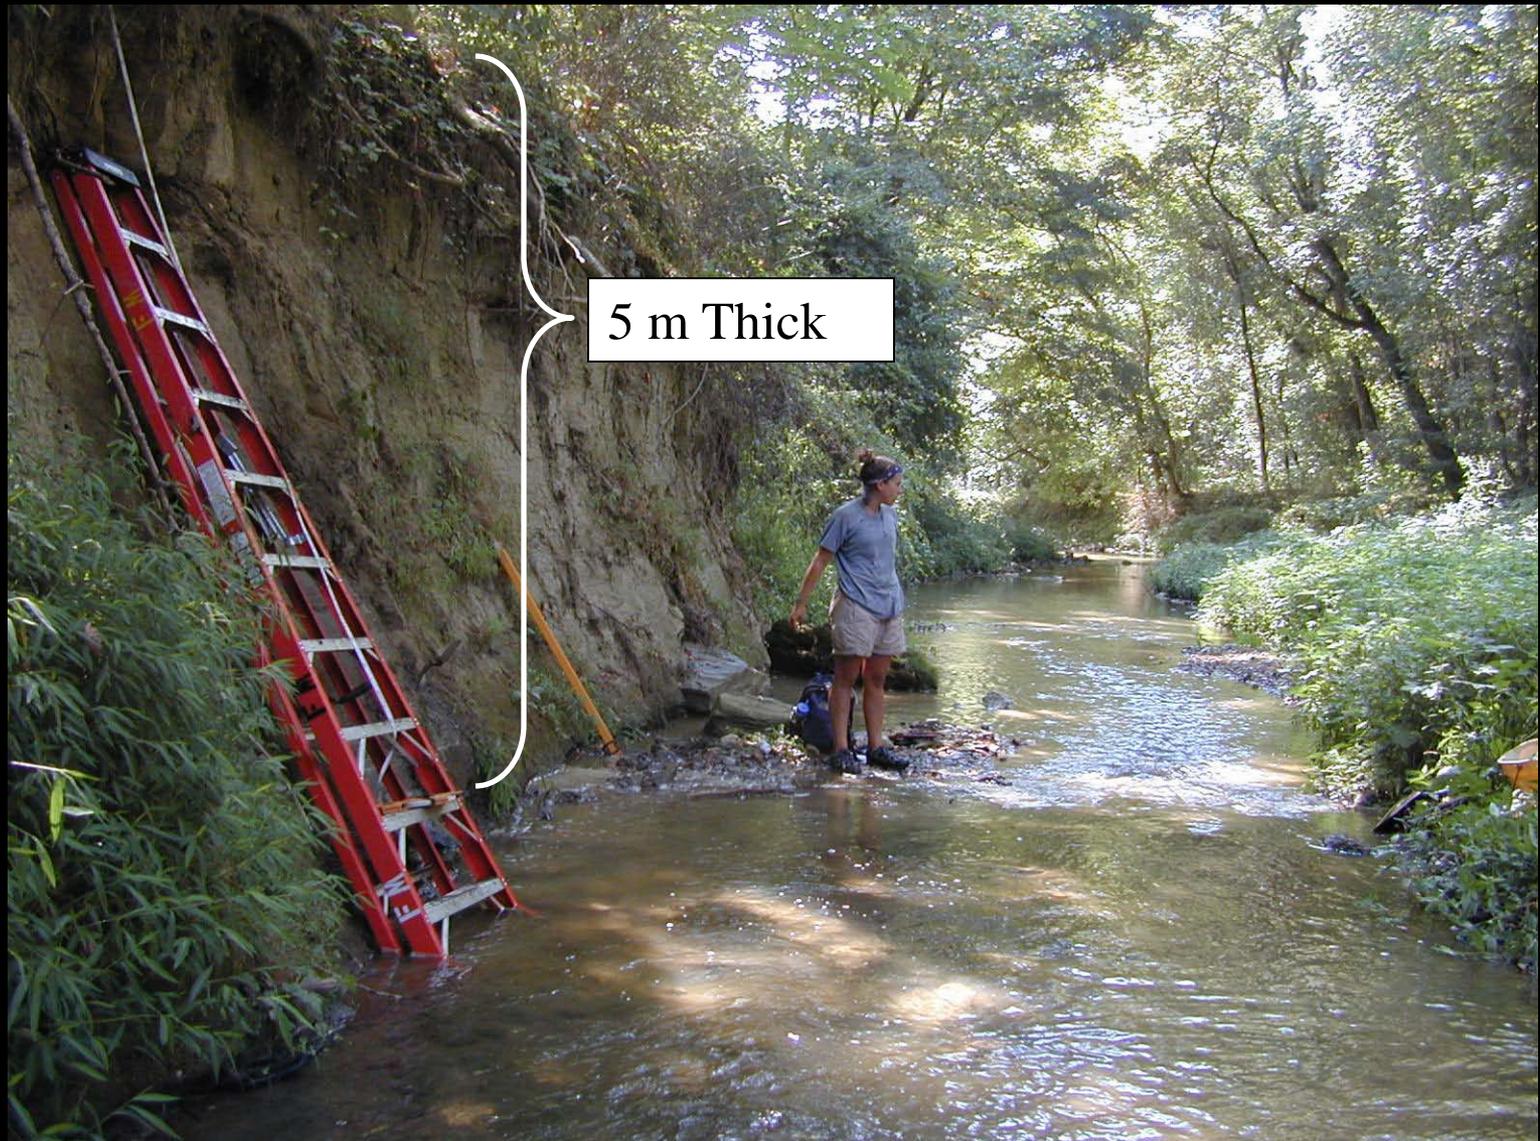
# Mill Pond Reservoir Sediment Stack

**Denlinger's Mill, W. Br. Little Conestoga, PA**

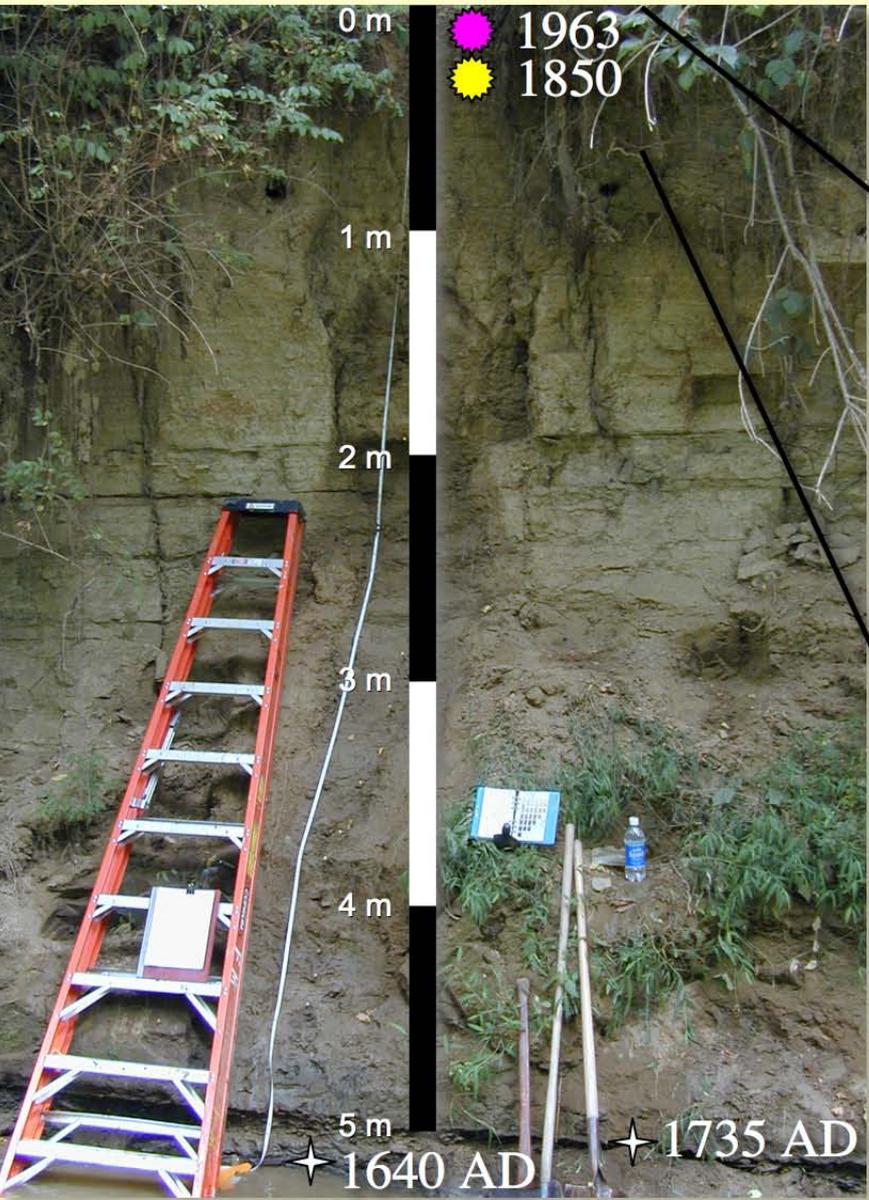
# Geochronology

$^{210}\text{Pb}$

$^{137}\text{Cs}$

✦ AMS Dates

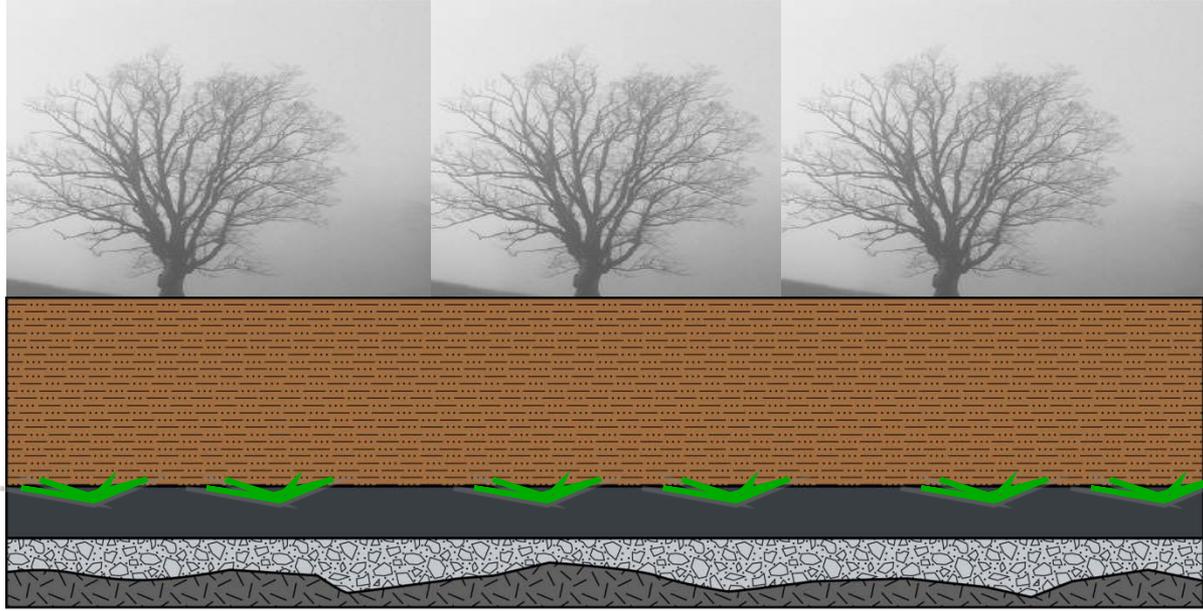
# Post-settlement millpond mud on Holocene wetlands on Pleistocene gravel

**Millpond mud**

**Wetland  
Gravel  
Bedrock**

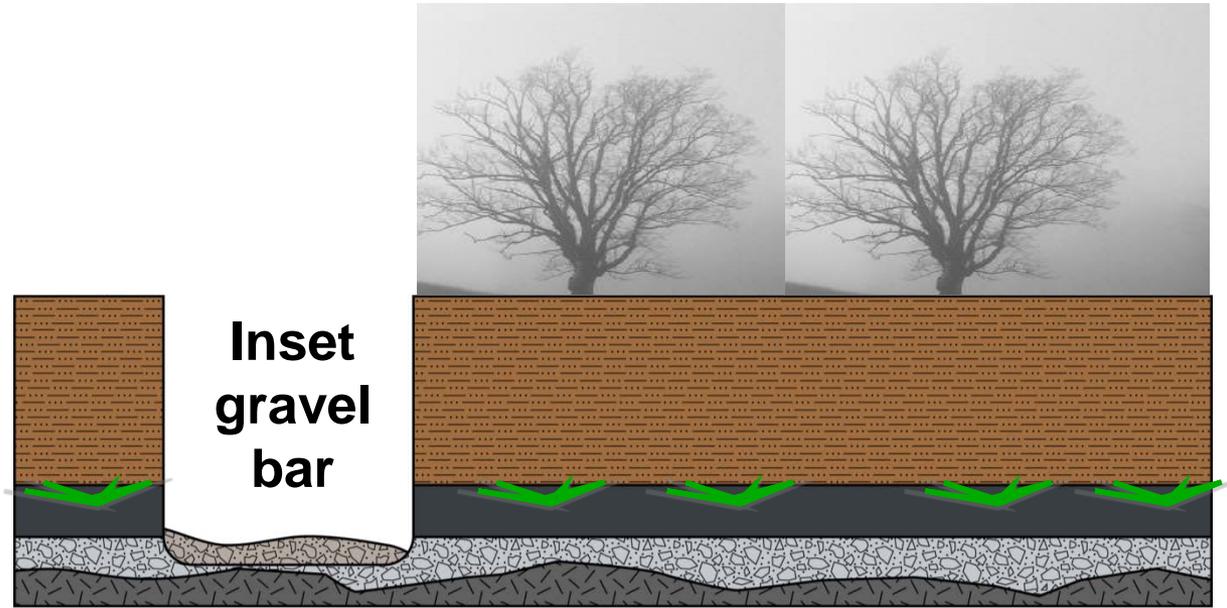
# Post-settlement millpond mud on Holocene wetlands on Pleistocene gravel

Modern inset  
sand/gravel bars

**DAM BREACH**

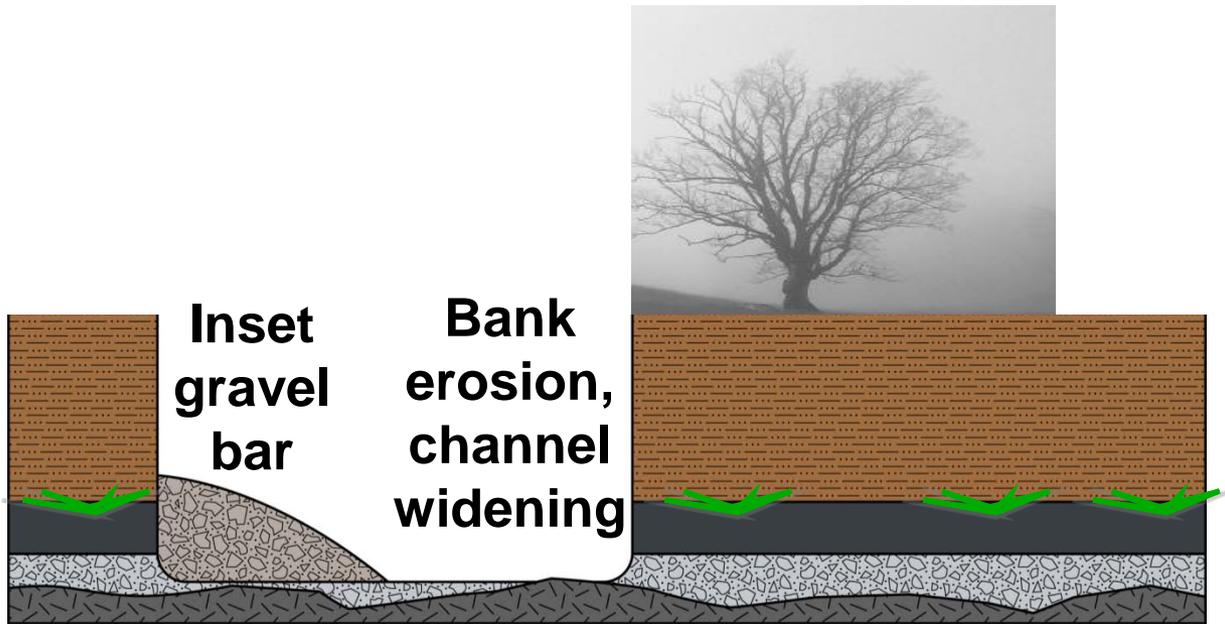
**With time, width increases and depth decreases for a given runoff event, thus shear stress decreases.**

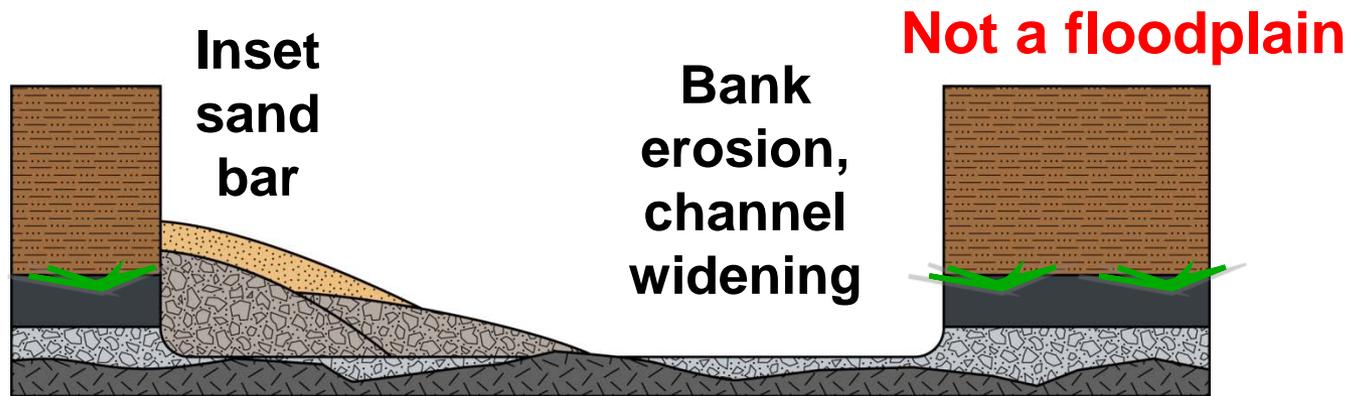
# Post-settlement millpond mud on Holocene wetlands on Pleistocene gravel

With time, width increases and depth decreases for a given runoff event, thus shear stress decreases.
