# The Rise and Fall of Mid-Atlantic Streams: Buried Soils and the History of Valley Bottom Sedimentation and Erosion

Dorothy Merritts, Robert Walter, and Mike Rahnis (F&M College)

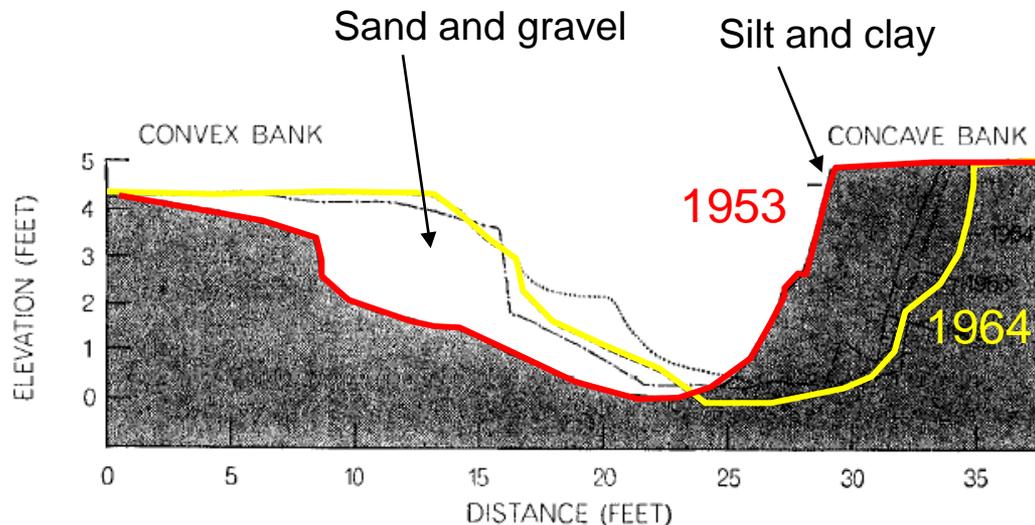
Lateral migration at “typical meander” from 1953 to 1964, Watts Branch, small tributary to Potomac River. *“The lateral migration of meanders by erosion of concave banks and deposition on convex banks over many years results in a river channel’s occupying every possible position between valley walls.”*

Meandering streams and bank erosion are natural, long-term processes.  
Streams erode one bank and deposit bars on the other.

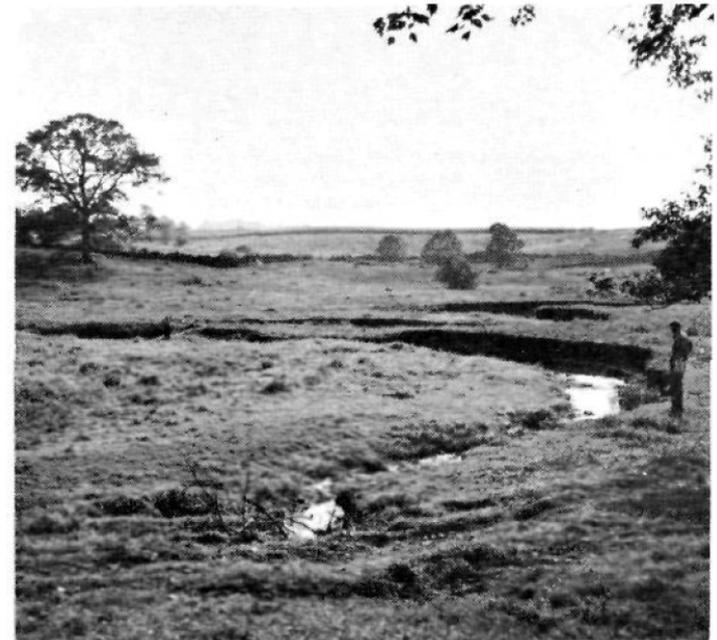
Floodplain of Watts Branch with point bar (Wolman and Leopold, 1957). Basis for classic conception of meandering streams was breached 19th c. mill pond.

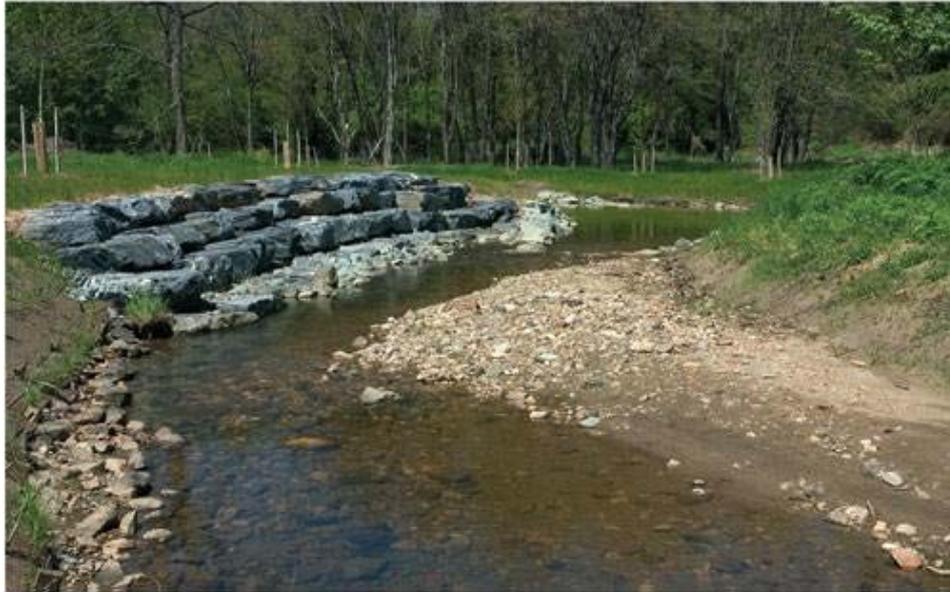
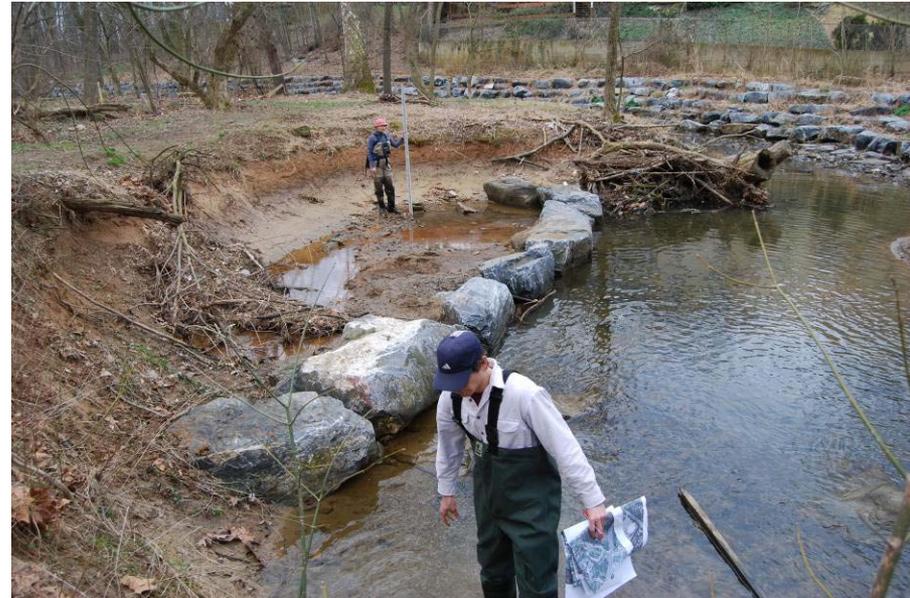
**Restoration Rationale: Urbanization leads to incision, accelerated meander migration, and channel widening. Unfortunately, the problem was mis-diagnosed. The actual problem was a partially breached mill dam, and a 2-m stack of mill pond silt and clay.**

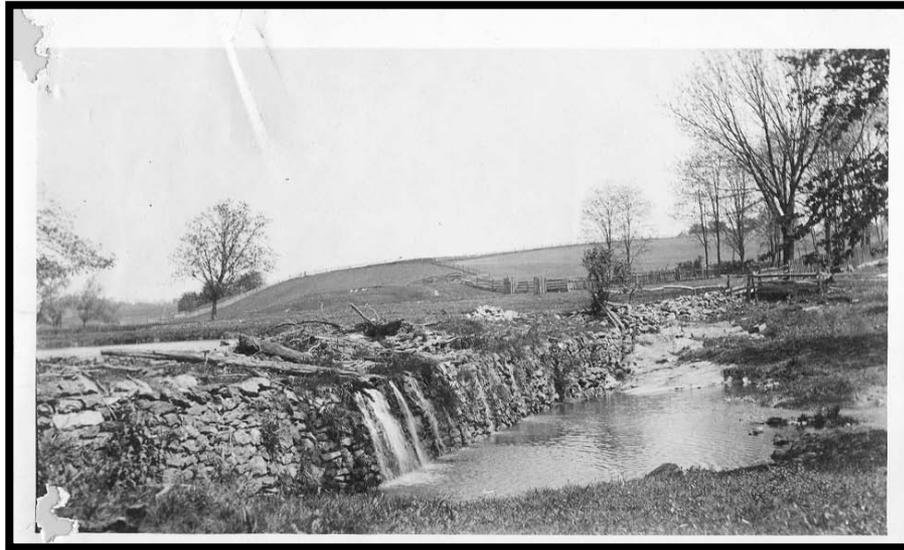
# Base-Level Rise and Fall: Example of Dam Building and Dam Breaching

1. Graded stream profile

3. Reservoir filling

2. Base level rise / Dam building

4. Base level fall / Dam breaching

This dam is shown in the center of the lidar image in slide # 23; it breached circa 1960-1975.
