CONSERVATION Showcase

The Emergency Watershed Protection Program restores stream bank, protects community from future erosion

*Kelly Sprute, NRCS Washington
April 2007*

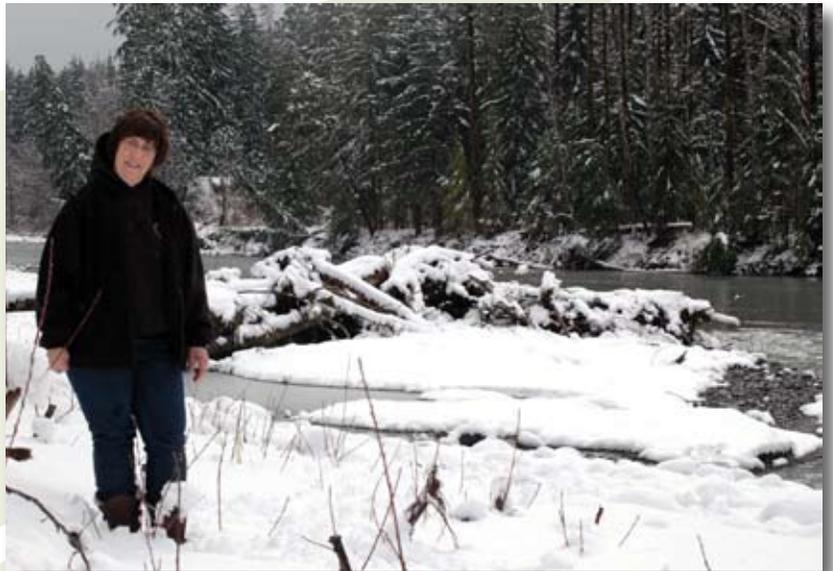
Michele Whitt Smith, Robe Valley Flood Control District Commissioner, walks near a rock vane water control structure. This structure and others, were part of the NRCS' emergency watershed protection project.

“The Robe Valley EWP project has five rock vanes which jet out from the bank to the center of the river,” says Dean Renner, NRCS Stream Mechanics Engineer. “It is designed to withstand the effects of a 100-year flood and force the river current away from a dangerous bend in the river aimed at residents of Robe Valley,” he says.

“The vanes are designed to collect sediment and logs to resemble a natural bank,” says NRCS’ Renner.

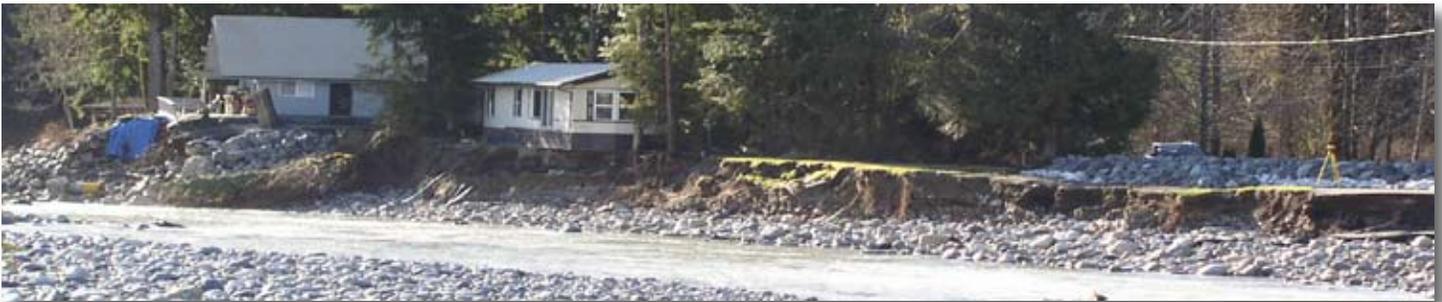
Rushing flood waters of the South Fork of the Stillaguamish River resulted in significant stream bank erosion. Homes were lifted off of their foundations, sending several floating down the river.

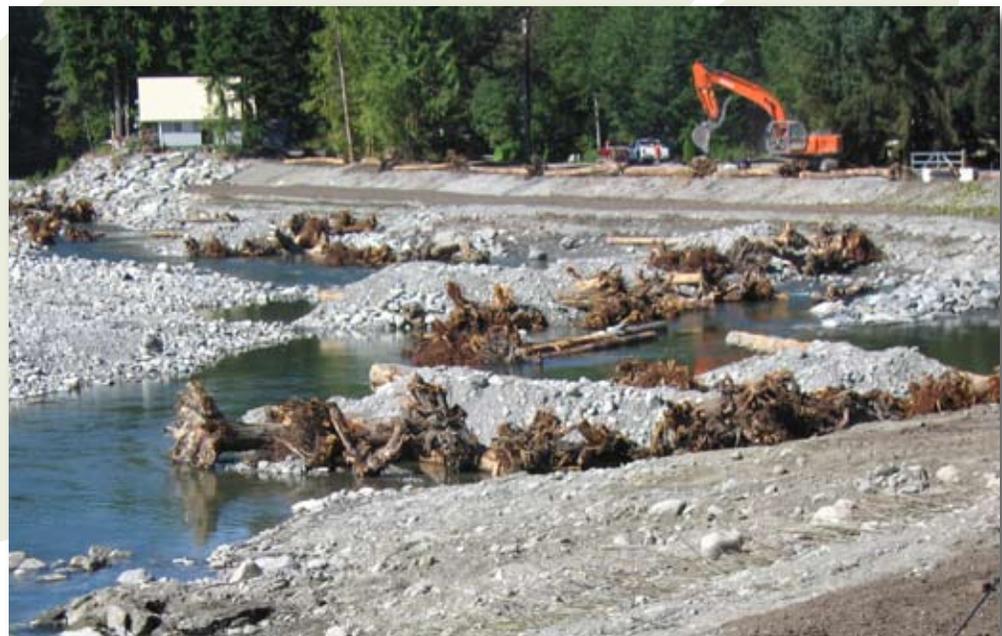
During construction of the rock vane water control structures, placement of the large rootwads will create habitat for aquatic wildlife. (Photo taken by Rick Bolger.)

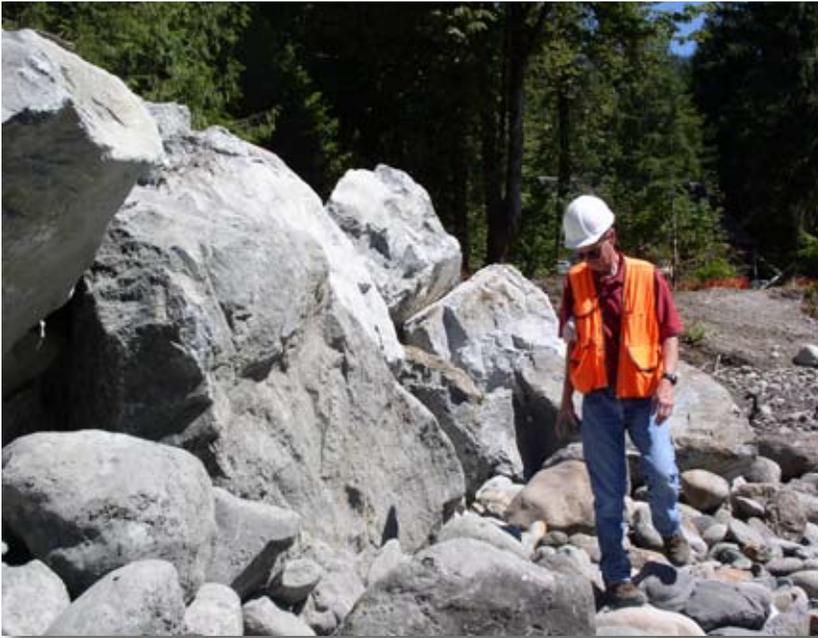
Dean Renner, NRCS Stream Mechanics Engineer, examines the rock vane structures designed to prevent further erosion of the river bank by diverting the water current.

According to Renner, river currents tend to cut out the bottom of a bank on an outside bend in a river. “More erosive power comes from the bottom of the stream channel. By deflecting this force away from the bank into the center of a channel we protect the bank,” he says.

According to Mr. Renner, the project is designed to keep the main force of the river in the channel with slow moving water at the bank’s surface. The project will prevent stream bank erosion, not flooding. “Floods are supposed to go over the top of the bank. Vegetation will protect the top of the banks from eroding away,” he says.
