# Atsma-Cameron Dairy

Andy Atsma sought NRCS help to deal with dairy manure solids accumulating in his storage ponds.

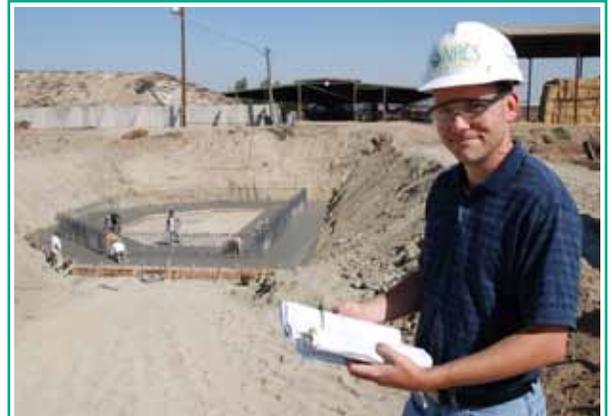
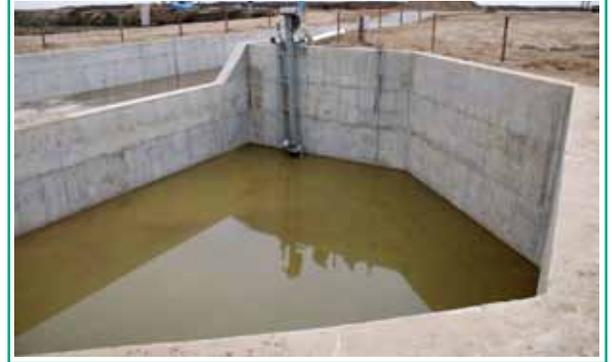
NRCS Engineer Jon Chilcote provided quality assurance during construction of the sediment basin and processing tank he designed. The finished structure is seen below. Photos by Brian Ziegler

“He was interested in building a processing tank where he could run water from the tank over a mechanical separator to remove the solids,” said NRCS Engineer **Jon Chilcote**. “After brainstorming, he decided to add a sediment basin to reduce abrasive solids contacting the separator screen. So we incorporated both into one large structure, which he can pump out of and prevent solids from accumulating in his ponds.”

The structure Chilcote designed is 12 feet deep and has a maximum volume of 177,000 gallons. That’s roughly one-quarter the size of an olympic-size swimming pool. To help pay for it, Atsma applied for and received an **Environmental Quality Incentives Program (EQIP)** contract. Surveying the site, designing the structure and giving quality assurance during construction were all provided by NRCS.

Chilcote was faced with a number of design challenges including a construction site that was originally submerged under an existing dairy pond and constrained site conditions due to adjacent ponds. An additional challenge was designing a watertight tank shaped like half an octagon adjacent to the sediment basin. Such a shape makes the tank stronger and allows for better circulation inside it, but it made construction and preventing cracks in its concrete more difficult. Now that it’s finished, the benefits are plenty. Sand is being separated from flush water and is easily removed using the structure’s access ramp. The water is agitated and pumped over a mechanical solid separator, resulting in less pond loading. The water is also being re-used on flush lanes before bacteria levels peak. “It took some time because the design had to be just right,” said Atsma. “But in the end, construction went smoothly. I look at the separator pit every morning and it’s working fine. I’m very happy.”
