Socorro County Mitigation Planting for the Albuquerque Army Corps of Engineers

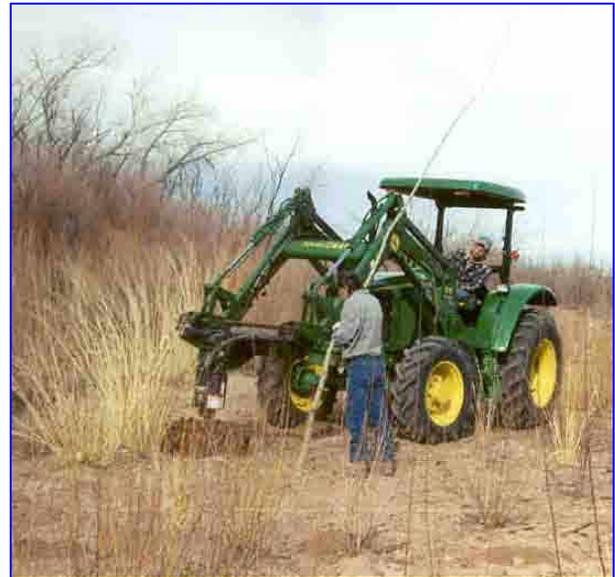
Fig 1: Planting cottonwood poles on the Rio Grande in Socorro County, February 2004

The Rio Grande cottonwood cuttings were originally collected from Bosque del Apache Wildlife Refuge and established in a pole production plantation at the LLPMC. As directed, the harvested cottonwood pole cuttings (12–15 feet in length) were planted on 20-foot centers throughout the site with the exception of the inner arroyo area. At time of planting, the site had an approximate 5-foot water table. The soil seemed to be sandy. The cottonwood pole cuttings were planted with an 8-foot augur attached to a front-end loader on a 65 hp farm tractor (Fig. 1). The cuttings were placed in the

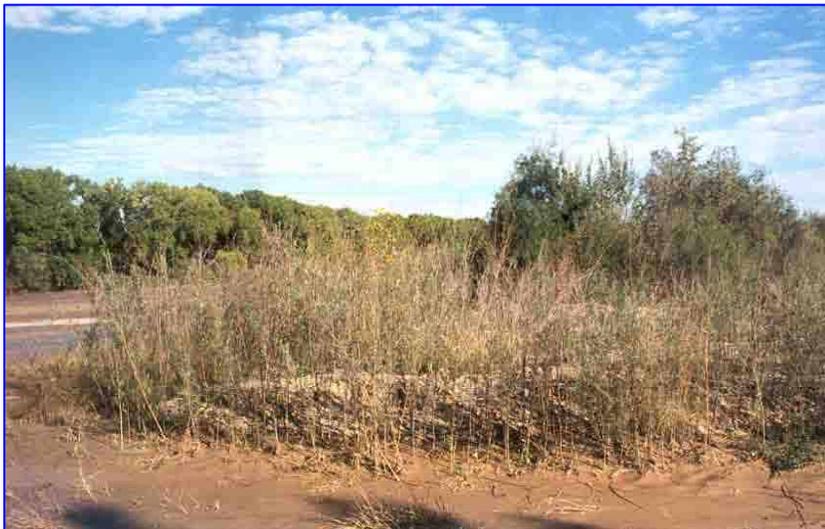
By June of 2002, the coyote willow cuttings had broken dormancy and had become rooted (Fig. 2). The survival rate was estimated at higher than 80 percent. Those cuttings that had died were located either at the base of the arroyo or river bank where they possibly were flooded more than their tolerance of time, or at the top of the arroyo or river bank where, even at a 30-inch depth, the soil was dry.

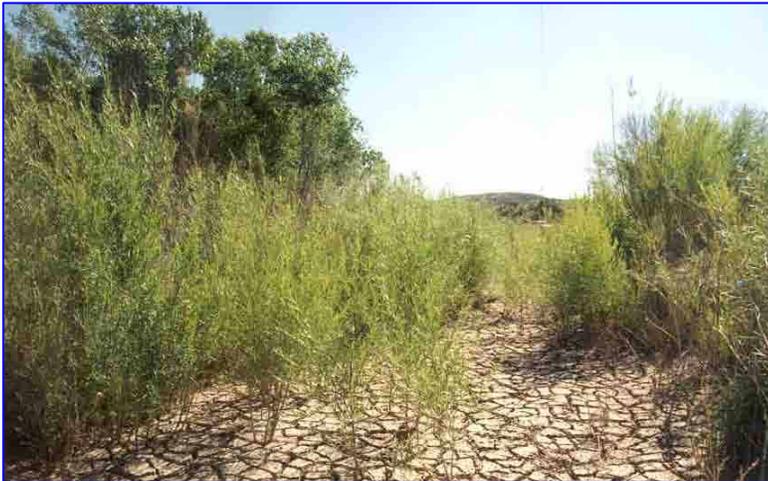
Fig 3: Coyote willows were well established by June of 2004 with root-sprouts spreading across the arroyo.

arroyo (Fig. 3). The willows had begun spreading by root-sprouts.

By 2004, the coyote willow stand was well established on the banks of the river and the

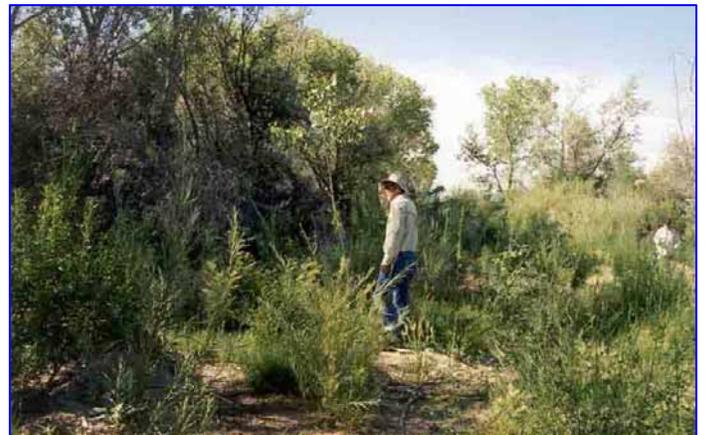
Fig 4: Cottonwood pole cuttings were growing vigorously by June of 2004

The cottonwood pole cuttings were growing vigorously and were well rooted by June of 2004 displaying a 94-percent survival rate

when they evaluated by Ernie Janke, Patty Phillips and Greg Fenchel (Fig. 4). Five pole cuttings planted outside the enclosure and had broken trunks at the base due to cattle damage. However they did appear to be re-sprouting

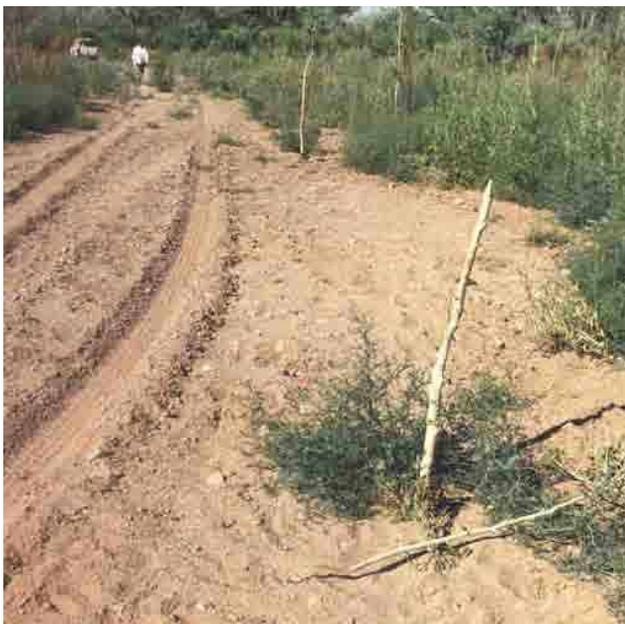
Fig 5: Cottonwood pole cutting that was damaged by cattle, but it has since re-sprouted.

when they evaluated by Ernie Janke, Patty Phillips and Greg Fenchel (Fig. 4). Five pole cuttings planted outside the enclosure and had broken trunks at the base due to cattle damage. However they did appear to be re-sprouting vigorously (Fig. 5).
