Rapid Watershed Assessment El Paso- Las Cruces Watershed

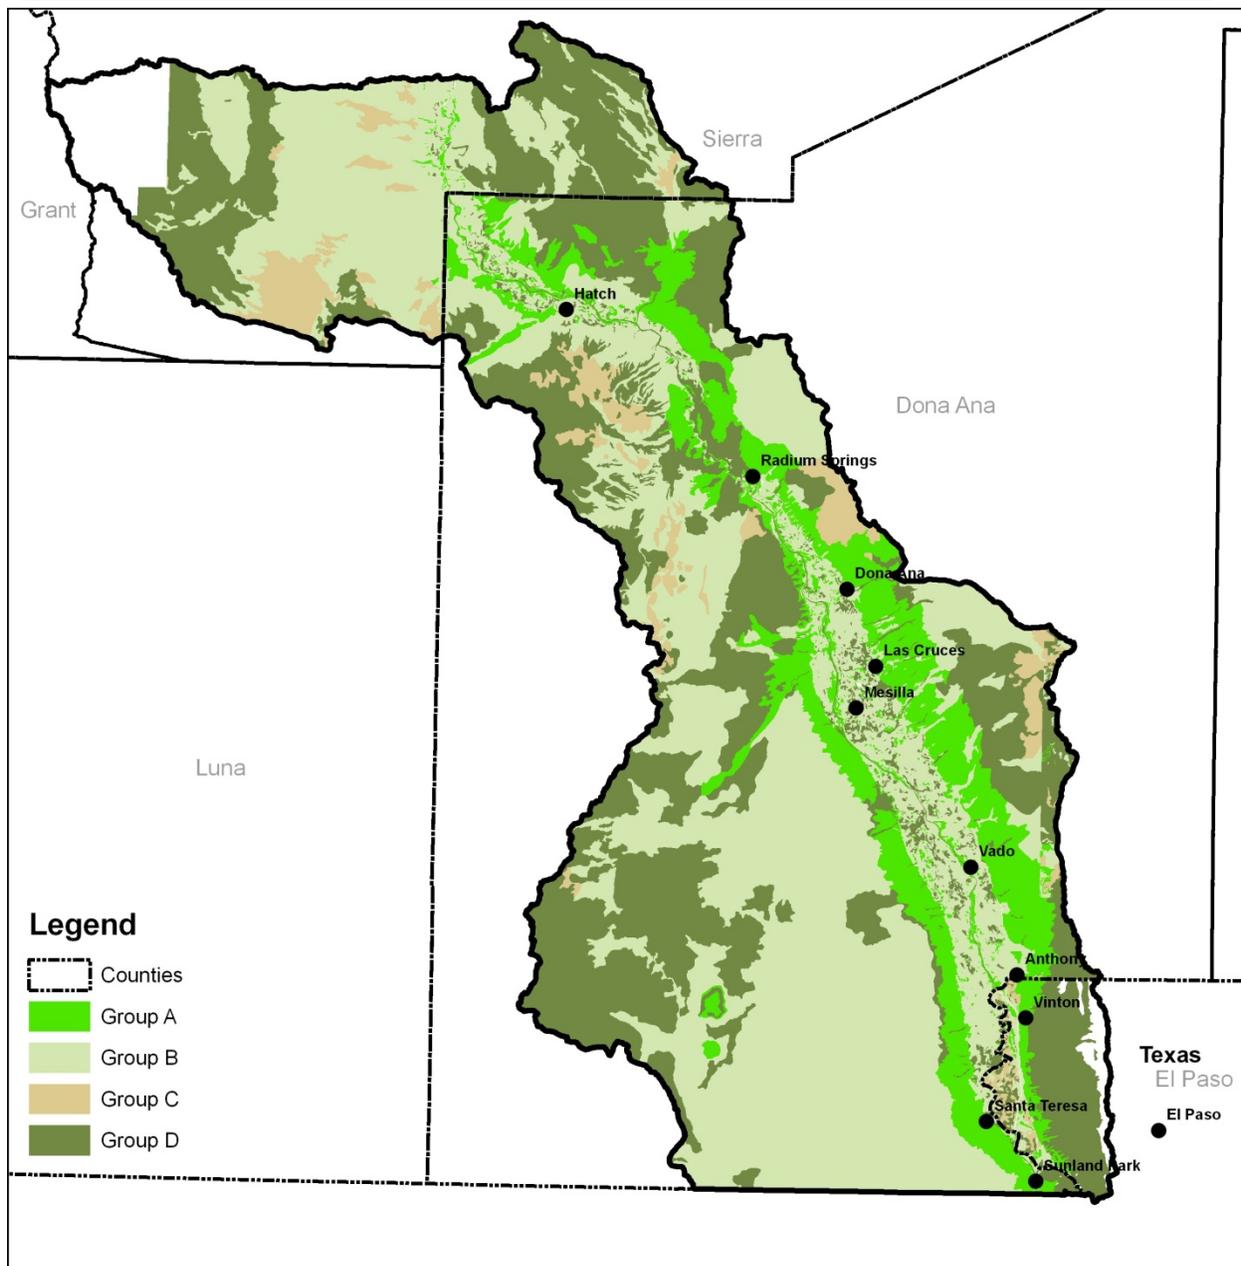
Figure 2. Hydrologic Soil Group

Hydrologic soil groups are based on estimates of runoff potential. Soils are assigned to one of four groups according to the rate of water infiltration when the soils are not protected by vegetation, are thoroughly wet, and receive precipitation from long-duration storms.

The soils in the El Paso-Las Cruces watershed are assigned to four groups (A, B, C, and D).

Group A. Soils having a high infiltration rate (low runoff potential) when thoroughly wet. These consist mainly of deep, well drained to excessively drained sands or gravelly sands. These soils have a high rate of water transmission.

Group B. Soils having a moderate infiltration rate when thoroughly wet. These consist chiefly of moderately deep or deep, moderately well drained or well drained soils that have moderately fine texture to moderately coarse texture. These soils have a moderate rate of water transmission.

Group C. Soils having a slow infiltration rate when thoroughly wet. These consist chiefly of soils having a layer that impedes the downward movement of water or soils of moderately fine texture or fine texture. These soils have a slow rate of water transmission.

Group D. Soils having a very slow infiltration rate (high runoff potential) when thoroughly wet. These consist chiefly of clays that have a high shrink-swell potential, soils that have a high water table, soils that have a claypan or clay layer at or near the surface, and soils that are shallow over nearly impervious material. These soils have a very slow rate of water transmission.

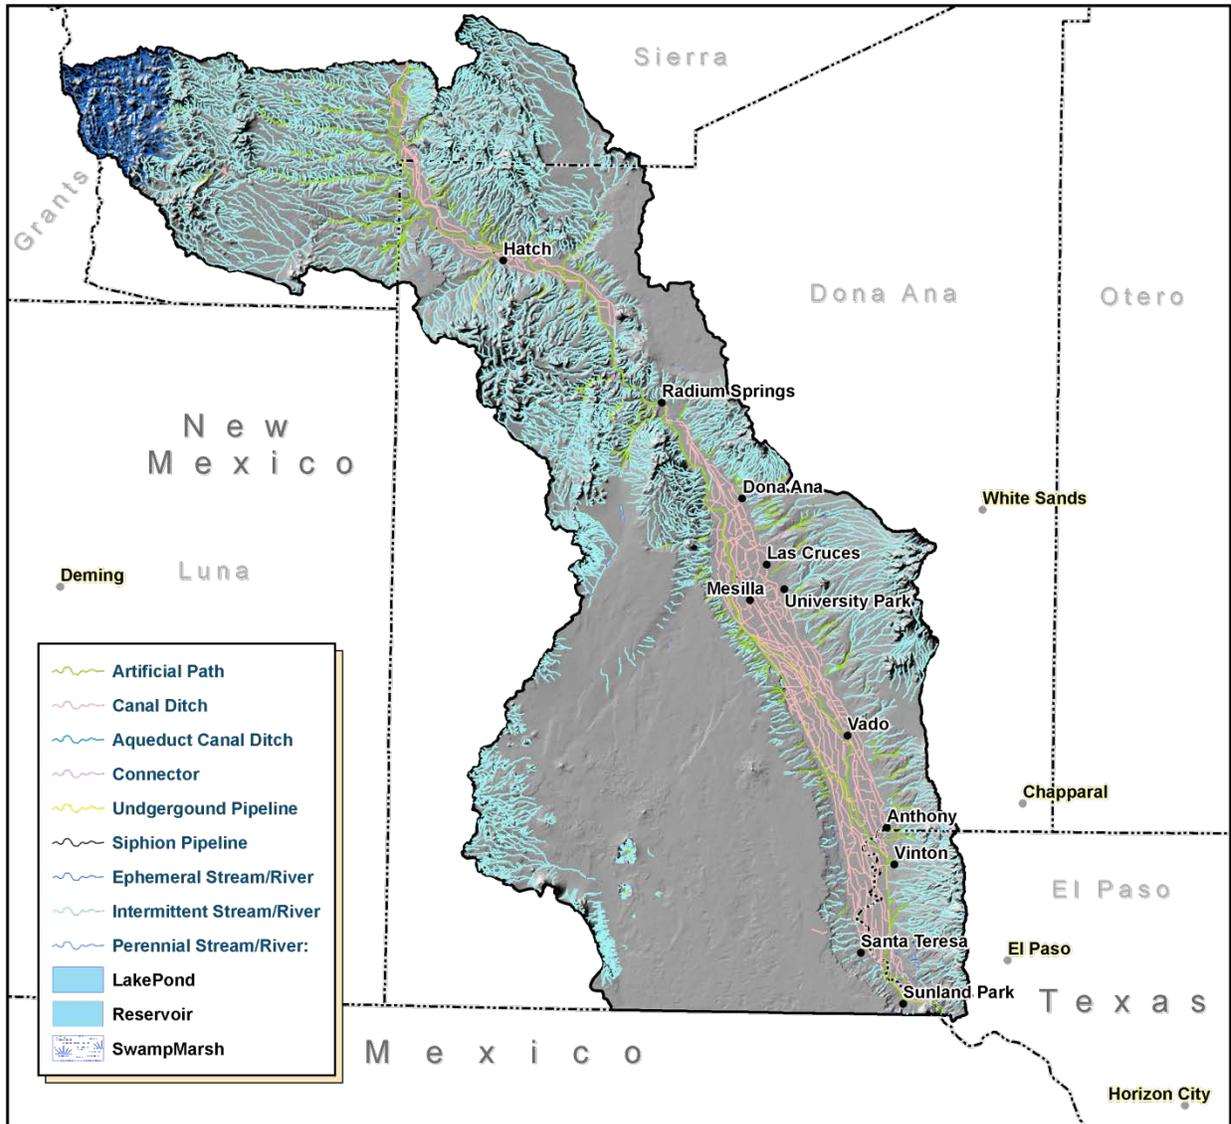
Figure 8. National Hydrologic Dataset (NHD) of the El Paso-Las Cruces Watershed.

The National Hydrography Dataset (NHD) is a comprehensive set of data that encodes information about naturally occurring and constructed bodies of water, paths through which water flows, and related entities. The NHD identifies 5,563 miles (8,953 km) of water courses in the El Paso-Las Cruces River Watershed. The majority of these courses typically flow intermittently in summer months during periods associated with high intensity convective thunderstorms.

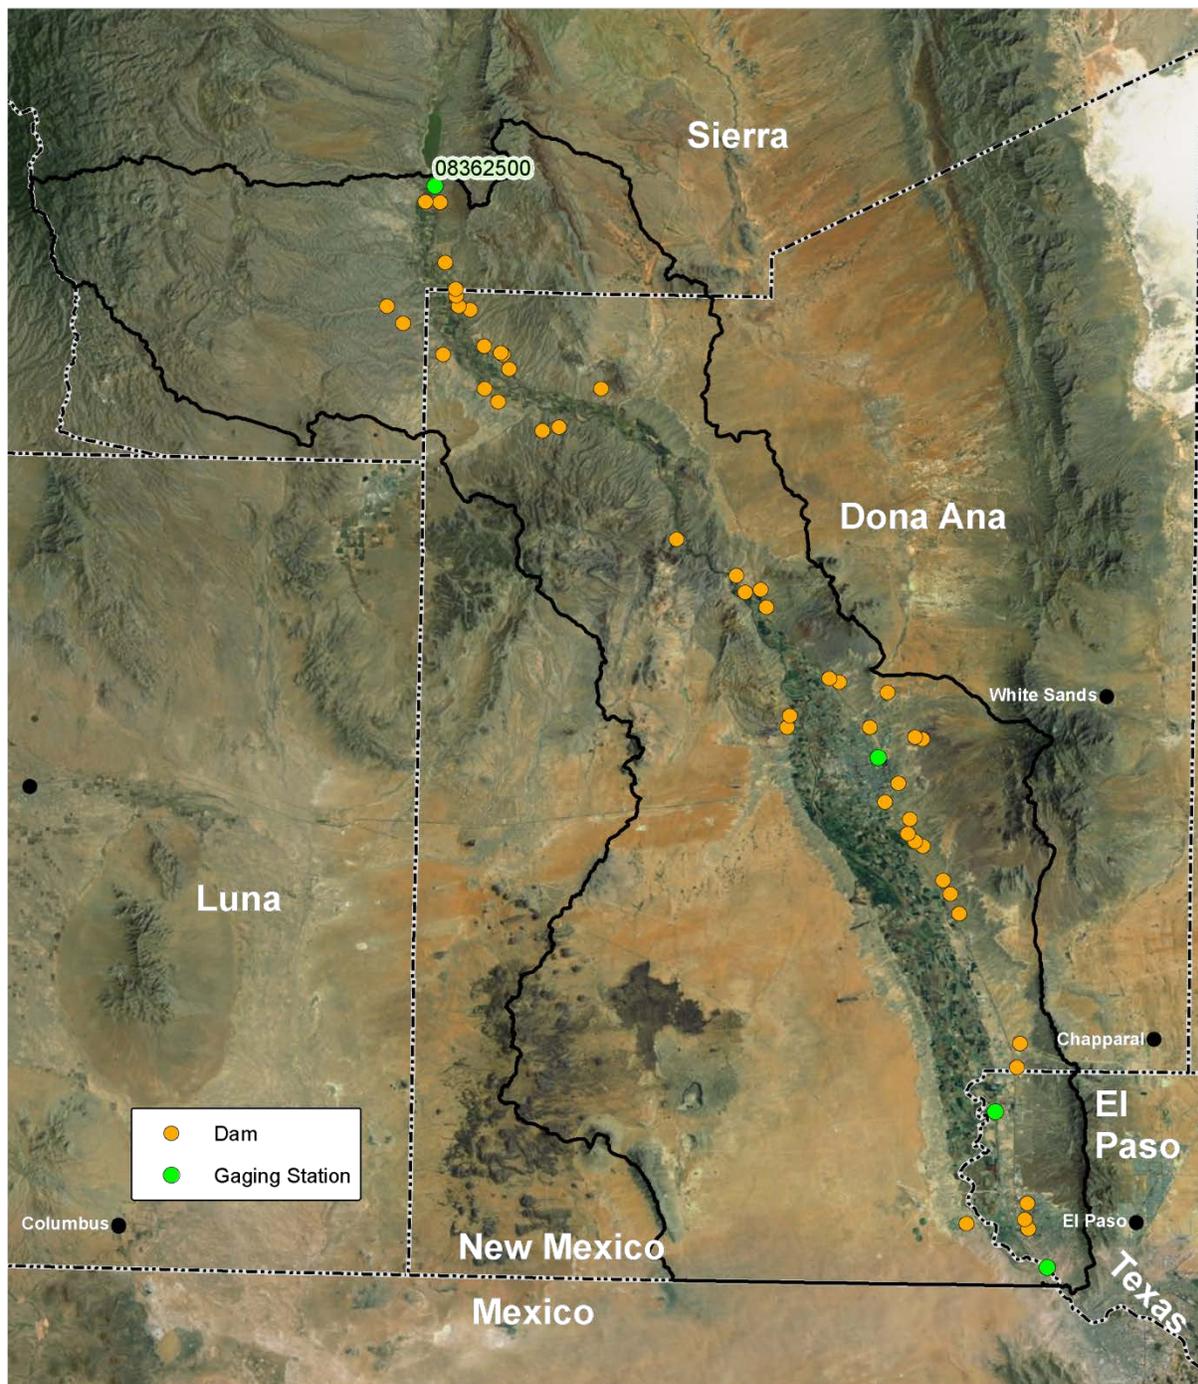
Figure 9. Gauging Stations in the El Paso- Las Cruces Watershed.

There are 51 water gauging stations in the watershed. USGS Site 08362500 is located in the NW corner of the watershed on the Rio Grande BLW at Caballo Dam. During the period 1938 – 2009, this site has had mean annual discharge of 26,298 cubic feet per second ranging from 0.203 (1972) to 4,075 (1995) cubic feet per second. (See picture next page).

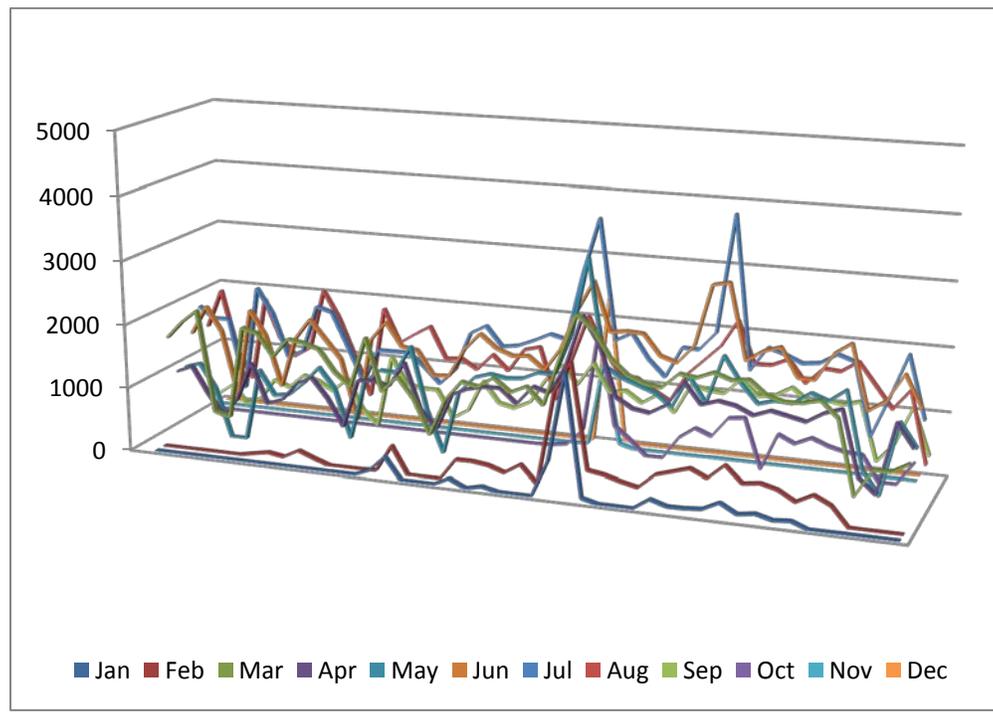
Figure 10. Monthly average of Mean Daily Flow on the El Paso-Las Cruces at Rio Grande BLW at Caballo Dam, NM. Period of observation: 1938-2009.

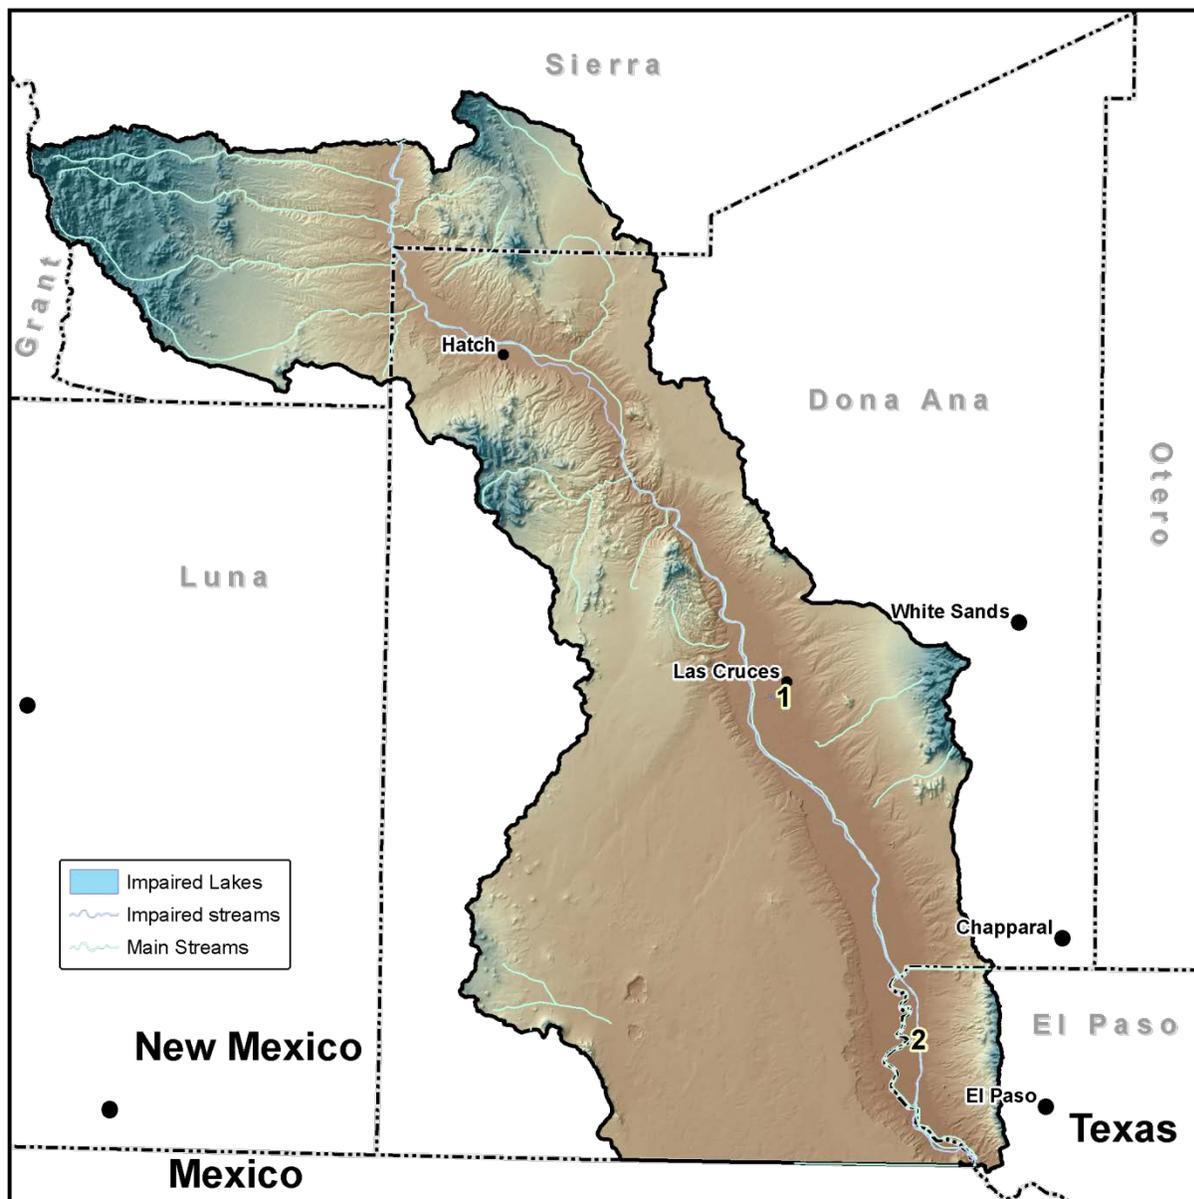
Figure 11. 303(d) Impaired Waters

Under section 303(d) of the Clean Water Act, states, territories, and authorized tribes, are required to develop lists of impaired waters. These are waters for which technology-based regulations and other required controls are not stringent enough to meet the water quality standards set by states. The law requires that states establish priority rankings for waters on the lists and develop Total Maximum Daily Loads (TMDLs), for these waters. A TMDL is a calculation of the maximum amount of a pollutant a water body can receive and still safely meet water quality standards. Within the El Paso- Las Cruces Watershed, there is one water body that is listed as impaired as of the 2010-12 listing cycle (Burn Lake Dona Ana).

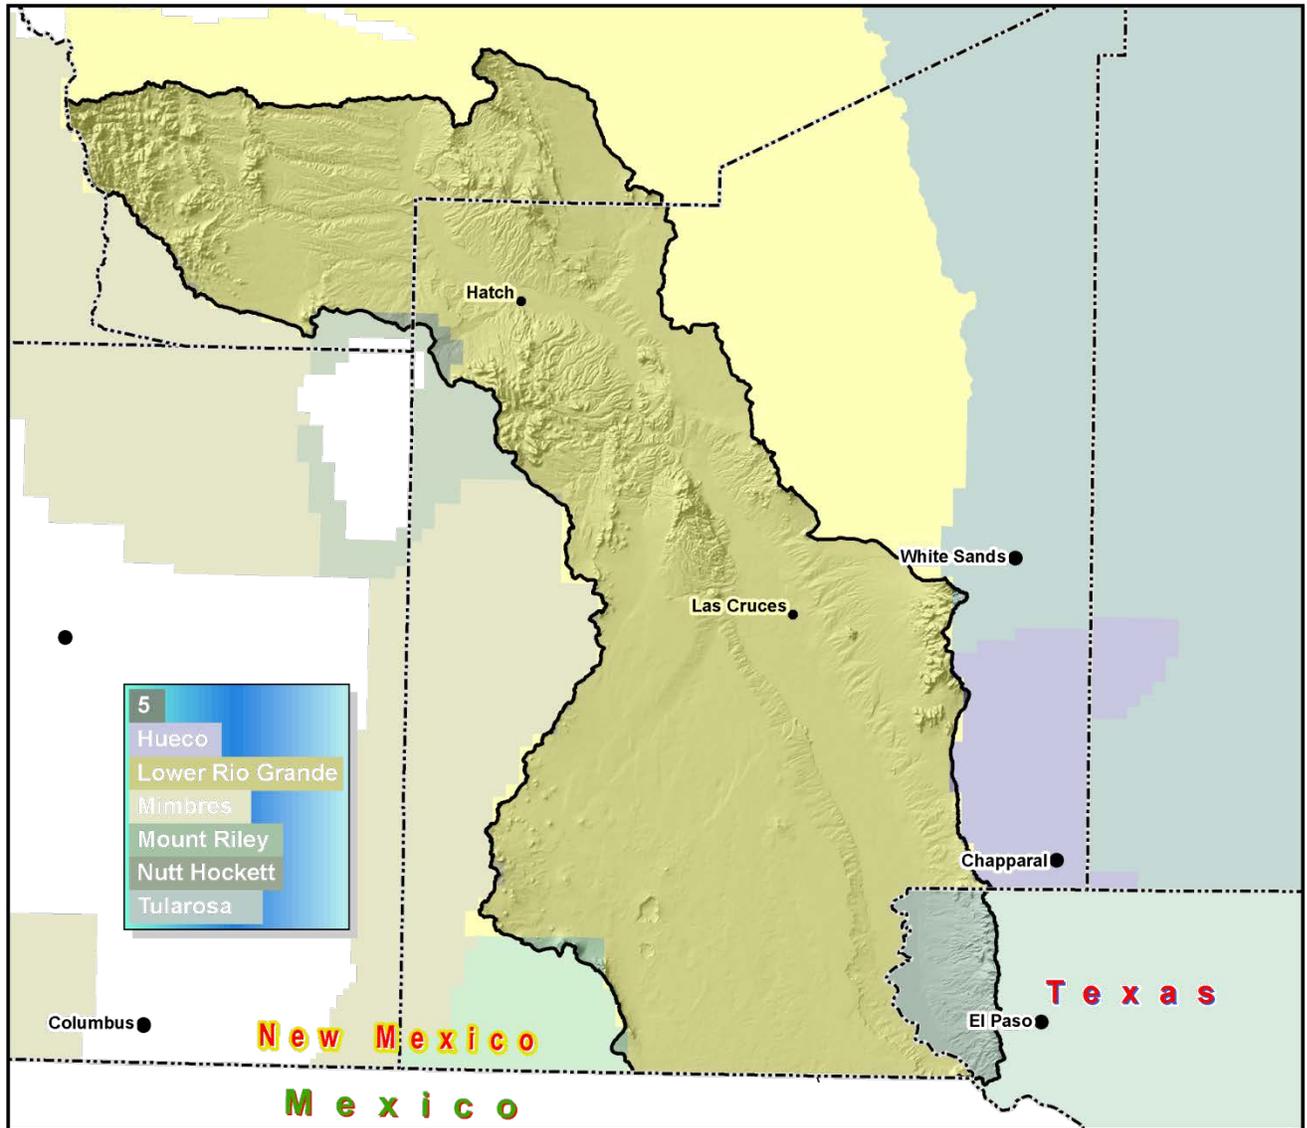
Figure 12. Declared Groundwater Basins of the El Paso-Las Cruces.

A declared groundwater basin is an area of the state proclaimed by the State Engineer to be underlain by a groundwater source having reasonably ascertainable boundaries. By such proclamation the State Engineer assumes jurisdiction over the appropriation and use of groundwater from the source. There are seven declared groundwaters in the El Paso- Las Cruces watershed: 5 (Five), Hueco, Lower Rio Grande, Mimbres, Mount Riley, Nutt Hockett, and Tularosa. The surface watershed in NM covers 1,500,767 and with a small portion of surface watershed in TX covers 63,524 acres and the approximately million acres of the 9,458,280 underground water basins in NM and TX.

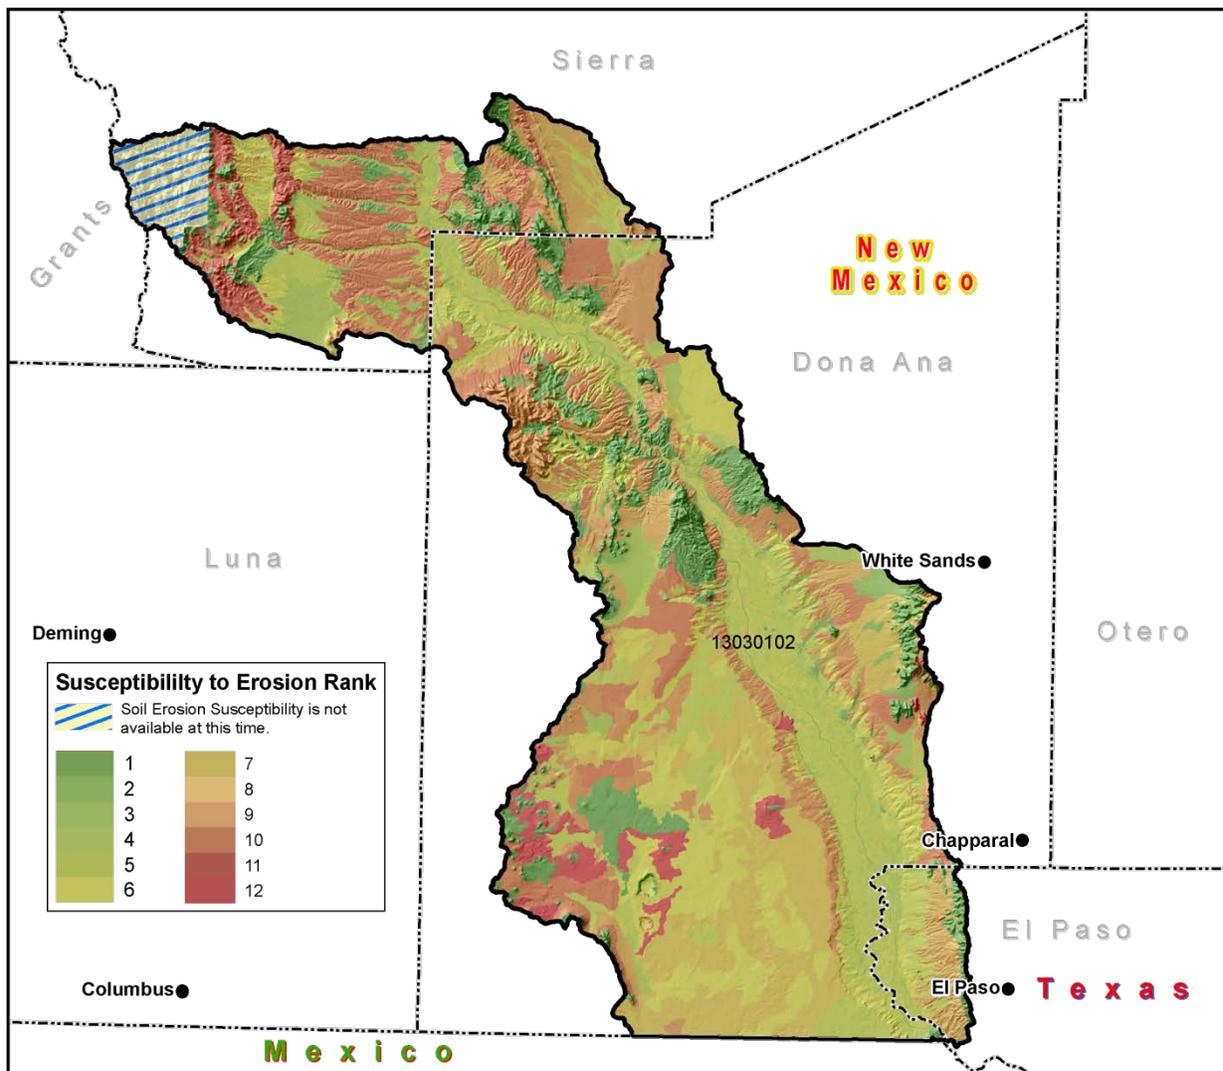
Figure 15. El Paso-Las Cruces Watershed Erosion Potential.

In order to evaluate the susceptibility of erosion within the El Paso-Las Cruces watershed, a model was developed using Soil Survey Geographic Database (SSURGO) information. The soil properties saturated hydraulic conductivity, soil loss tolerance, and wind erodibility group were used in conjunction with slope to assess soil map unit potential for erosion. Saturated hydraulic conductivity and slope are reported in SSURGO databases as interval/ratio data whereas wind erodibility and soil loss tolerance are ordinal data. Data transformations for the model are listed -

For each soil map unit (discrete delineation), the soil properties (named above) of the dominant soil type was used as the condition to be evaluated in the susceptibility to erosion model. Miscellaneous areas such as gravel pits, water, riverwash, etc. were excluded from evaluation. Possible range of values for each map unit are 0 – 16. Increasing values represent a higher susceptibility to soil erosion. Forest Service Soils are not able to be included in the model at this time.

<u>Rank</u>	<u>Acres</u>
1	5,835
2	9,760
3	3,117
4	99,630
5	284,220
6	210,026
7	180,918
8	100,149
9	175,537
10	192,313
11	39,022
12	38,430
Sum(Σ)	1,338,957
