Rapid Watershed Assessment Eastern Estancia Watershed

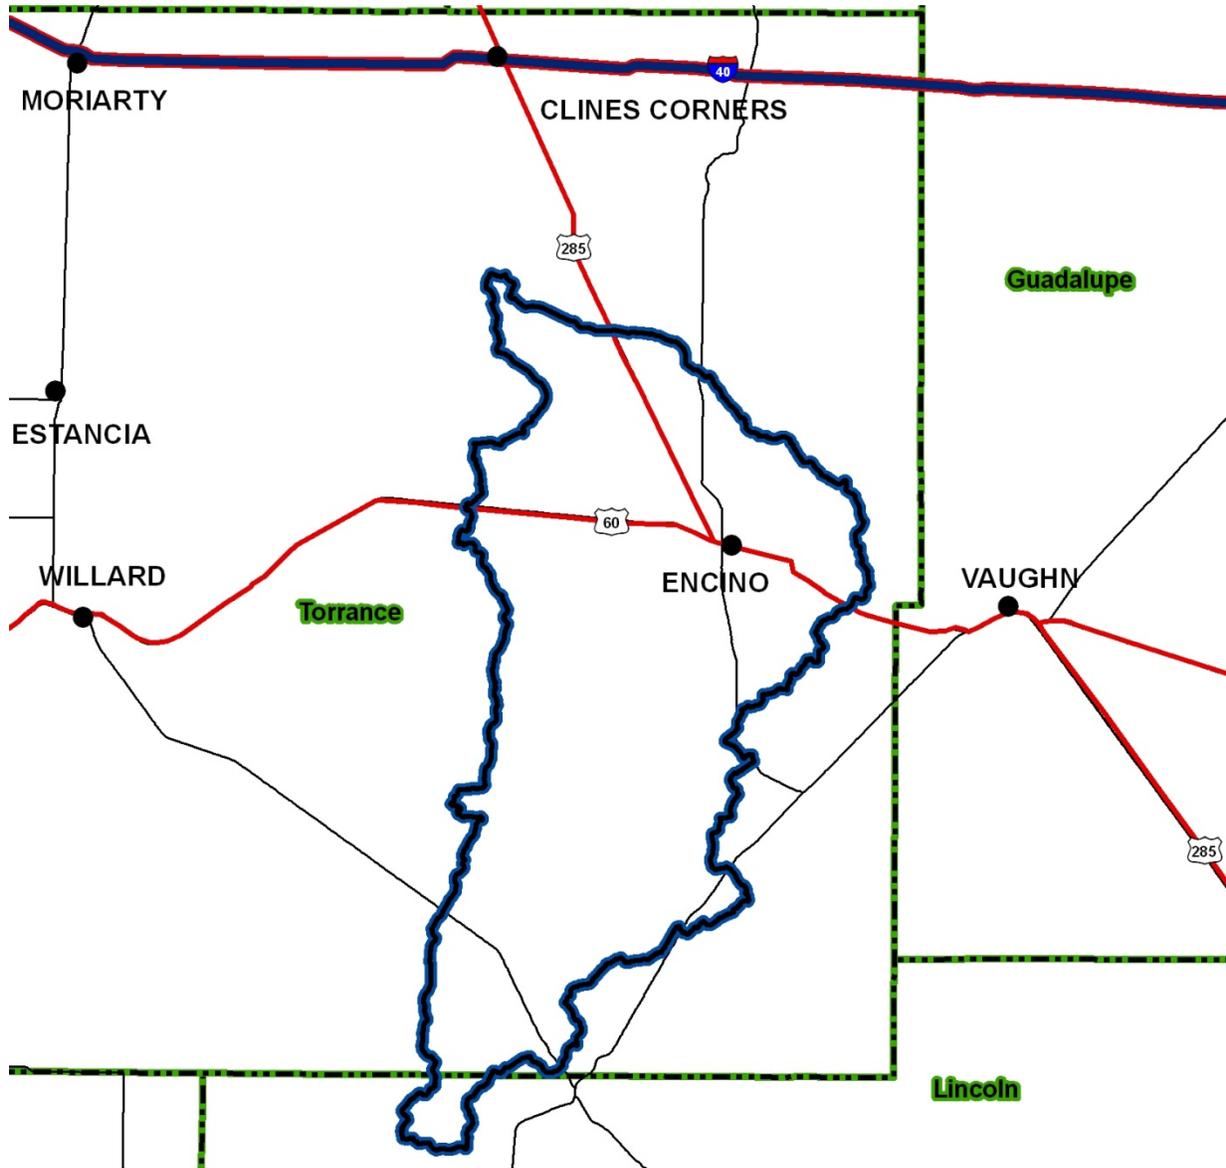
Figure 1. Eastern Estancia Watershed Overview

The Eastern Estancia Watershed is located in east central New Mexico. It covers 329,176 total acres (2,690 sq. km). Portions of the Eastern Estancia watershed extend into Lincoln and Torrance counties. Table 1 summarizes the distribution of the Eastern Estancia watershed.

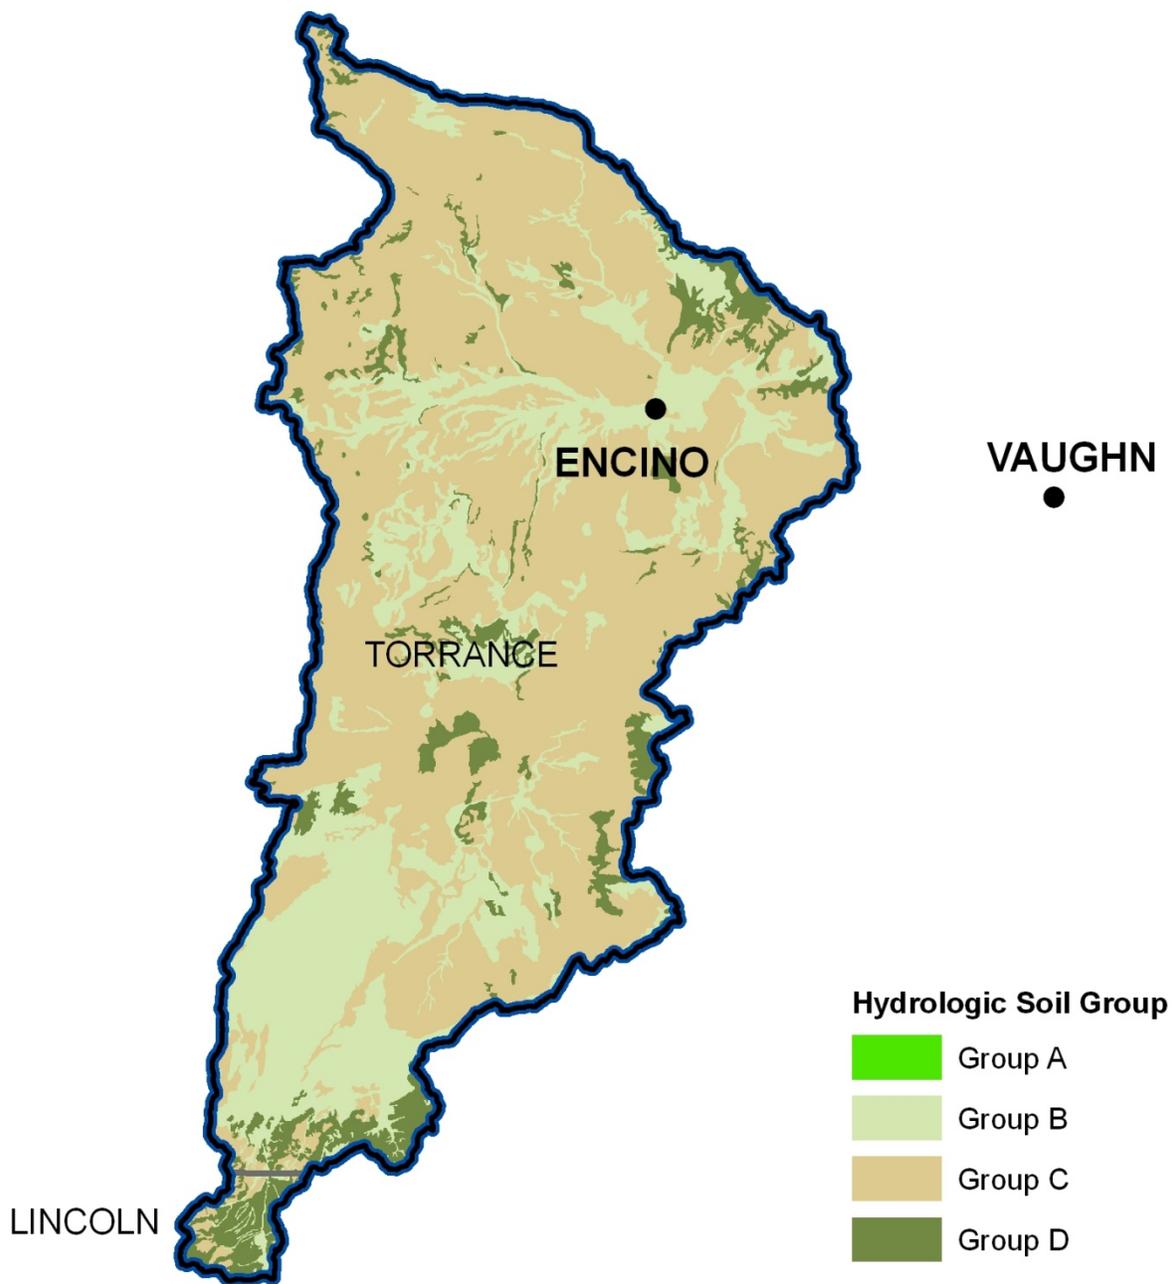
Figure 2. Hydrologic Soil Group

Hydrologic soil groups are based on estimates of runoff potential. Soils are assigned to one of four groups according to the rate of water infiltration when the soils are not protected by vegetation, are thoroughly wet, and receive precipitation from long-duration storms. The soils in the Eastern Estancia watershed are assigned to four groups (A, B, C, and D).

Group A. Soils having a high infiltration rate (low runoff potential) when thoroughly wet. These consist mainly of deep, well drained to excessively drained sands or gravelly sands. These soils have a high rate of water transmission.

Group B. Soils having a moderate infiltration rate when thoroughly wet. These consist chiefly of moderately deep or deep, moderately well drained or well drained soils that have moderately fine texture to moderately coarse texture. These soils have a moderate rate of water transmission.

Group C. Soils having a slow infiltration rate when thoroughly wet. These consist chiefly of soils having a layer that impedes the downward movement of water or soils of moderately fine texture or fine texture. These soils have a slow rate of water transmission.

Group D. Soils having a very slow infiltration rate (high runoff potential) when thoroughly wet. These consist chiefly of clays that have a high shrink-swell potential, soils that have a high water table, soils that have a claypan or clay layer at or near the surface, and soils that are shallow over nearly impervious material. These soils have a very slow rate of water transmission.

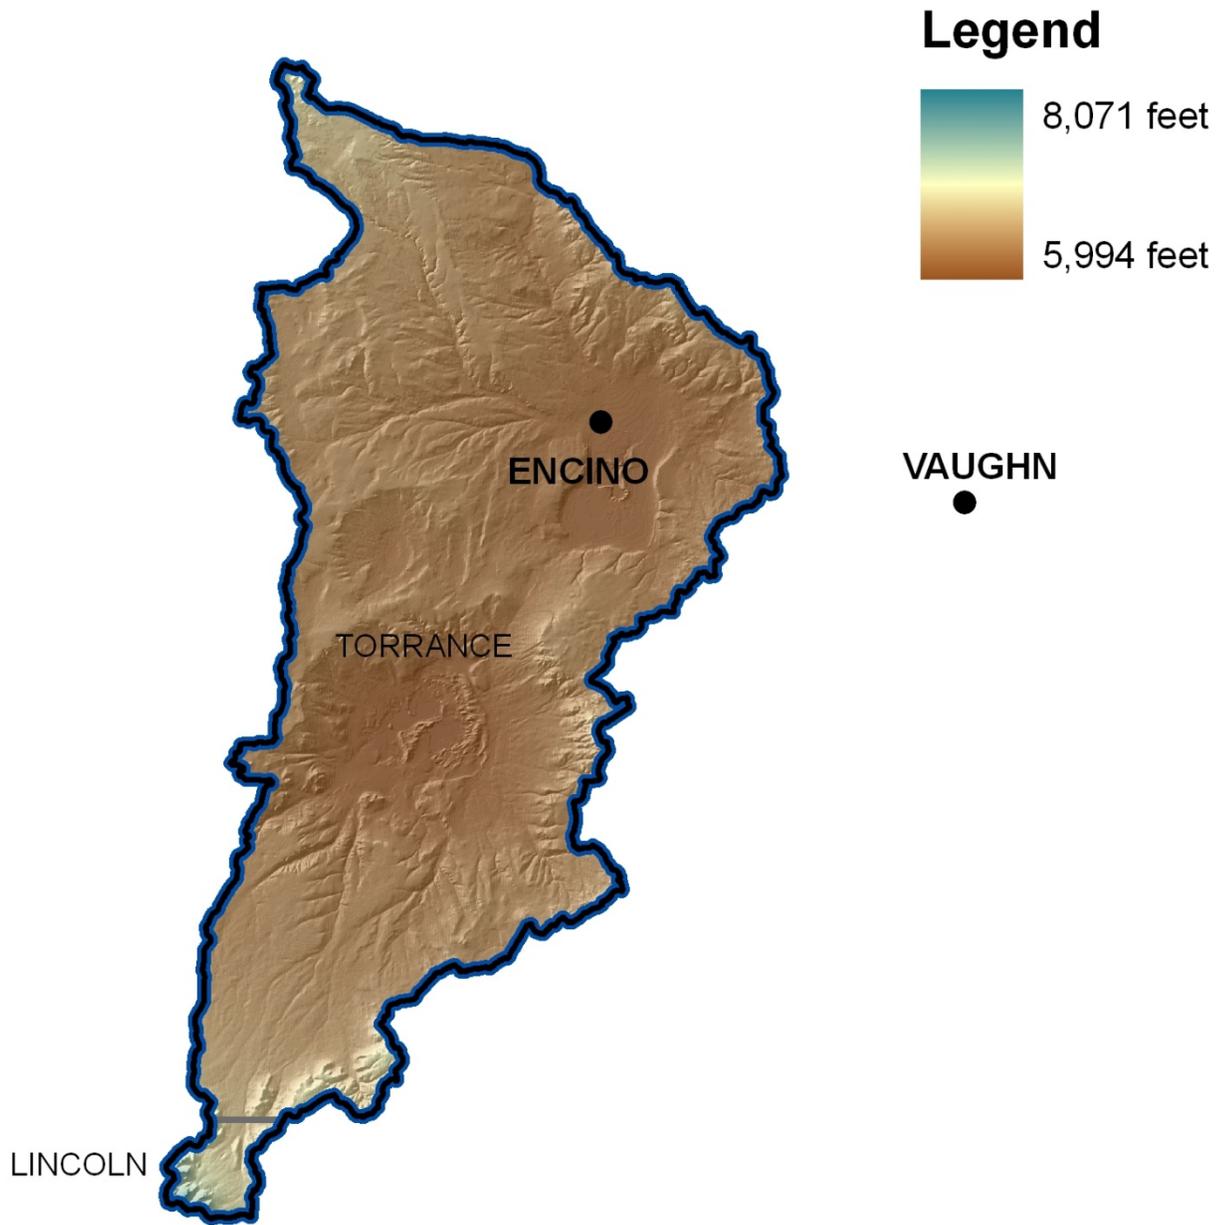
Figure 3. Eastern Estancia Watershed Shaded Relief

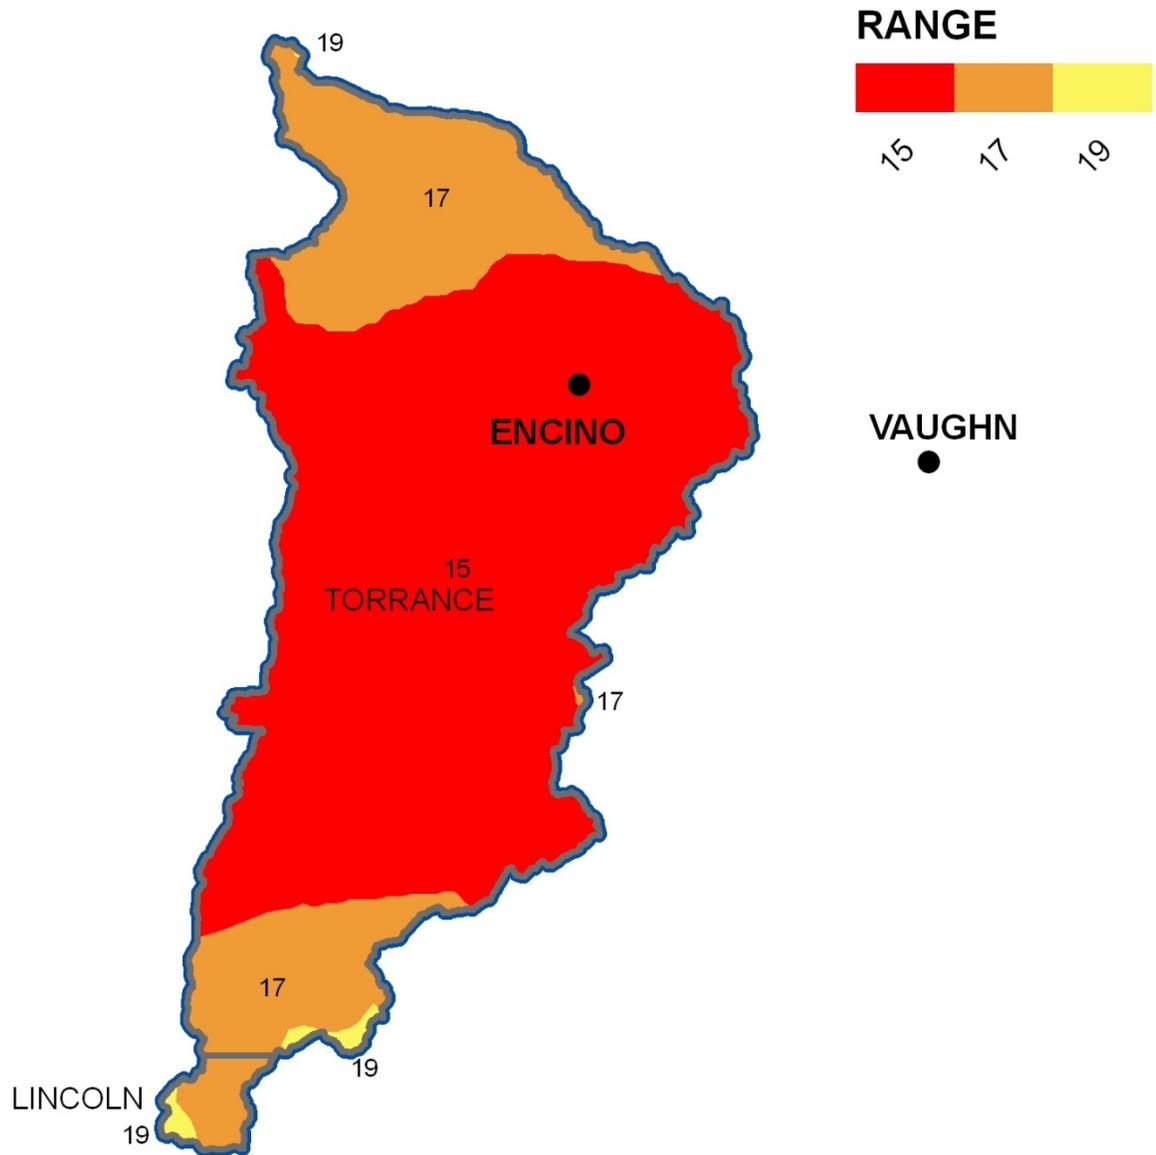
Figure 4. Eastern Estancia Watershed Annual Precipitation.

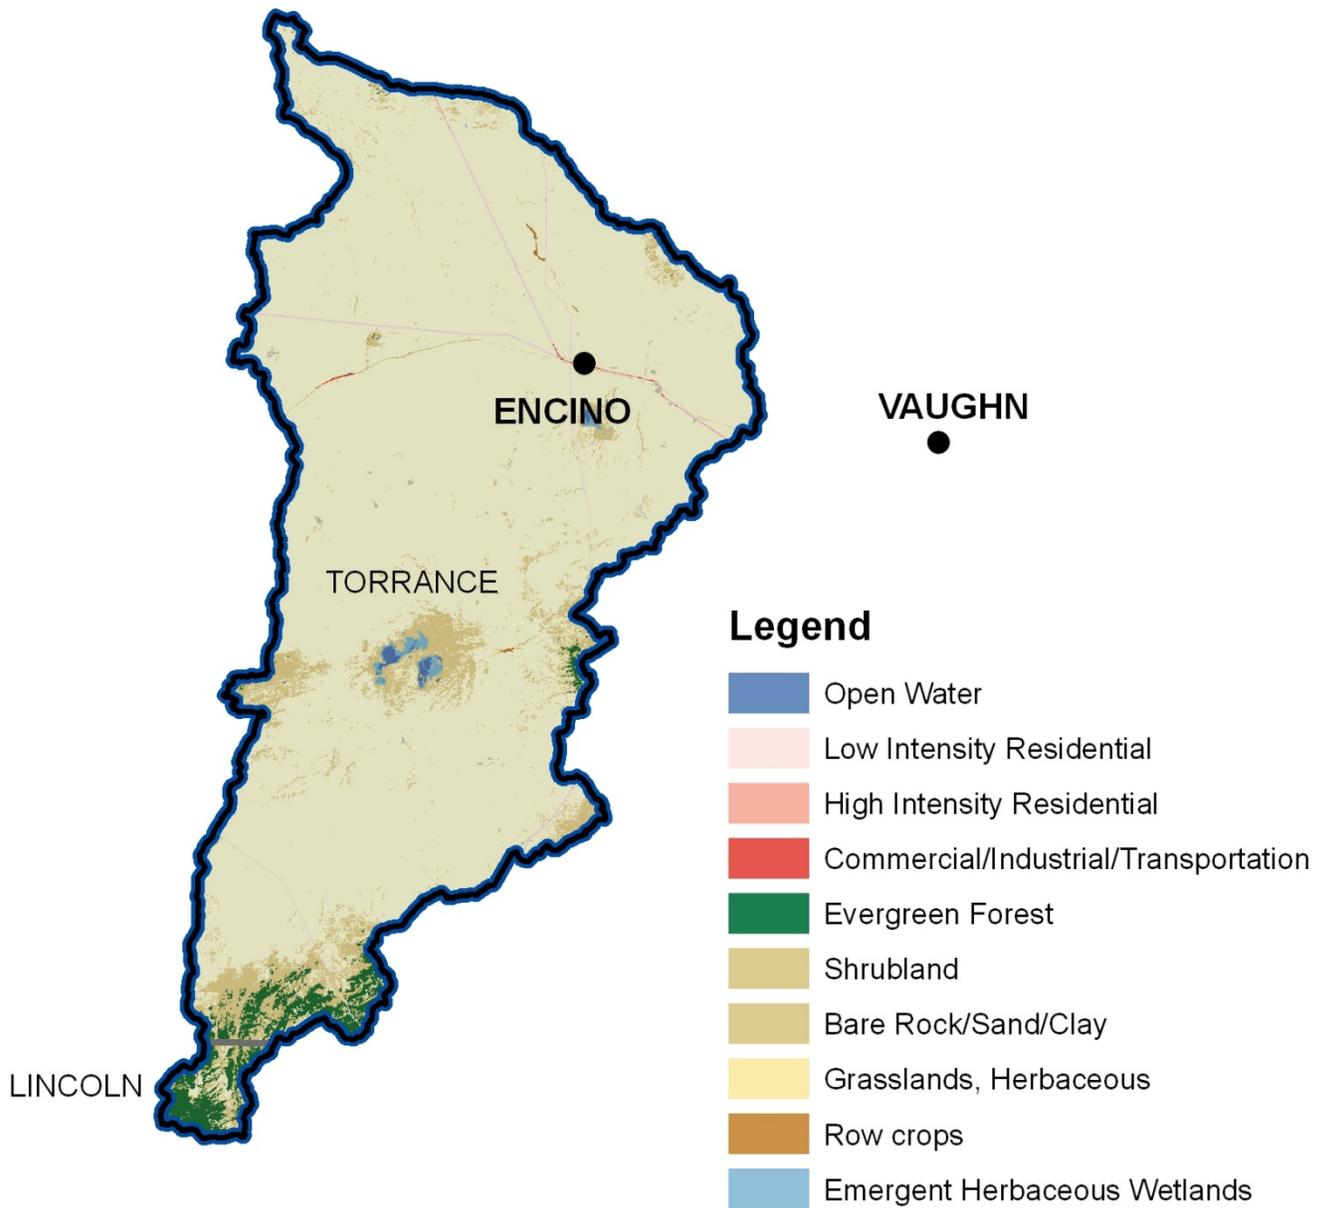
Figure 6: Subset of the National Land Cover Dataset over the Eastern Estancia Watershed.

The U.S. Geological Survey (USGS) produced the National Land Cover Dataset (NLCD) as part of a cooperative project between the USGS and the U.S. Environmental Protection Agency (USEPA). The goal of this project was to produce a consistent land cover data layer for the conterminous United States. The Multi Resolution Land Characterization (MRLC) Consortium collected the data used to compile the NLCD. The MRLC Consortium is a partnership of Federal agencies that produce or use land cover data; partners include the UNITED STATES GEOLOGICAL SURVEY (National Mapping, Biological Resources, and Water Resources Divisions), USEPA, the U.S. Forest Service, and the National Oceanic and Atmospheric Administration.

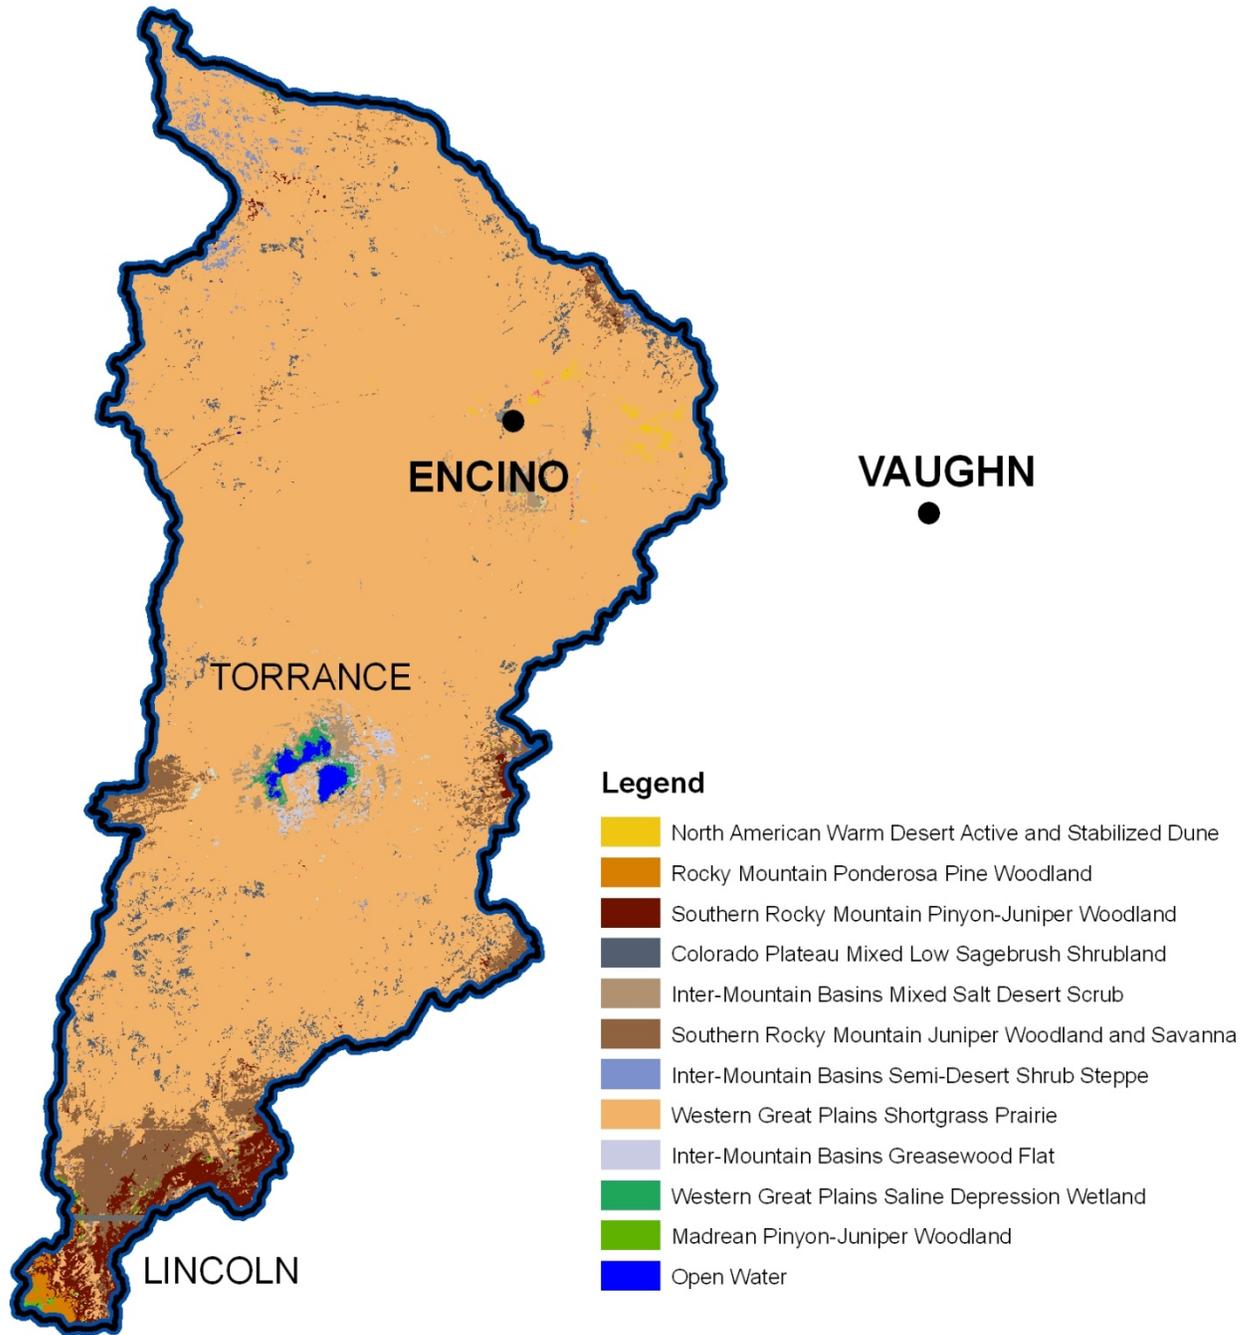
Figure 7. Subset of the SWREGAP over the Eastern Estancia Watershed. The 12 dominant ecosystems are displayed in the legend.

The landcover mapping effort for the Southwest Region Gap Analysis Project was a coordinated multi-institution endeavor. This dataset was created for regional terrestrial biodiversity assessment. Additional objectives were to establish a coordinated mapping approach to create detailed, seamless maps of land cover, all native terrestrial vertebrate species, land stewardship, and management status, and to analyze this information to identify those biotic elements that are underrepresented on lands managed for their long term conservation.

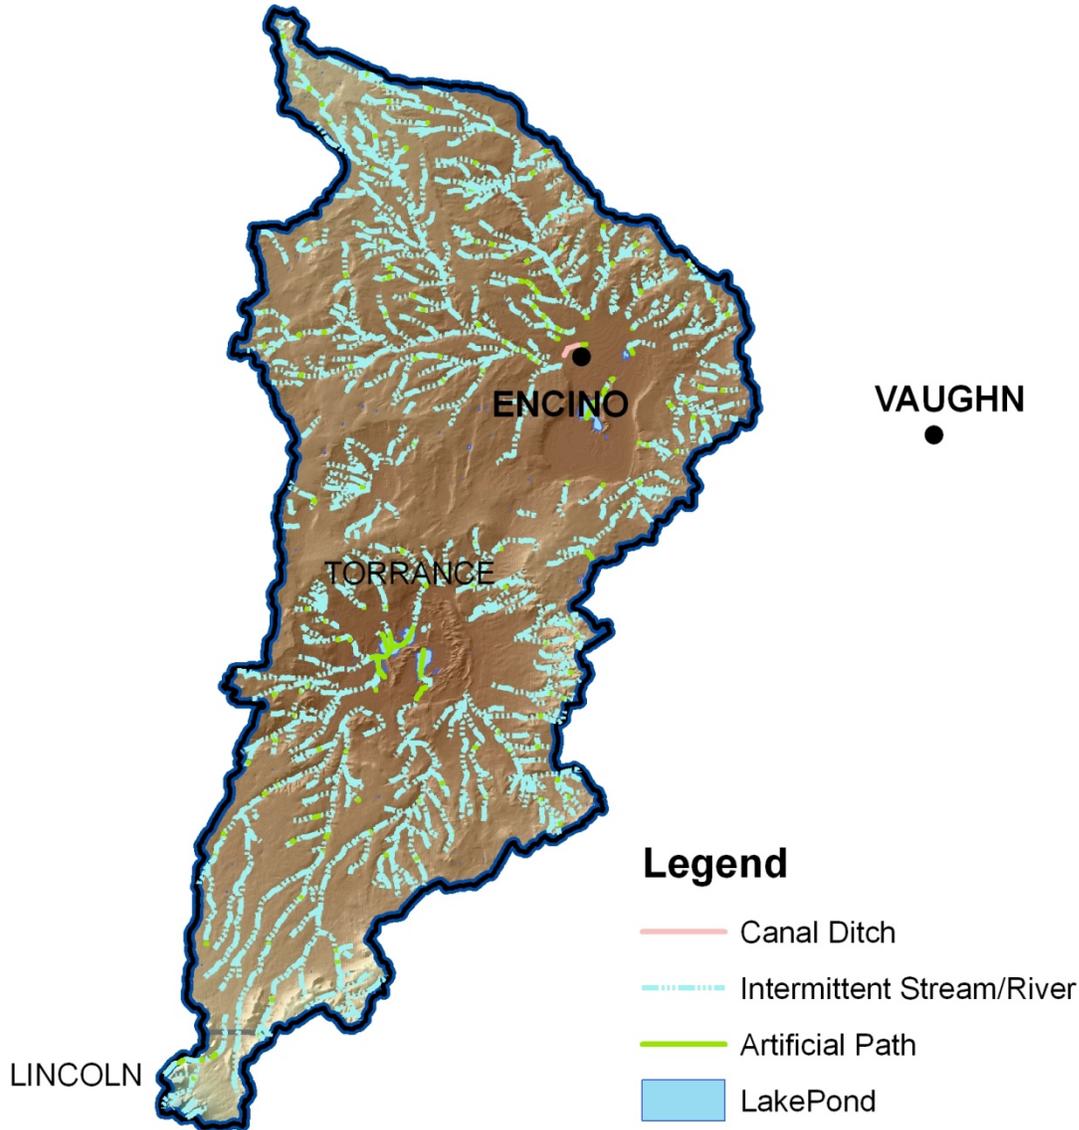
Figure 8. National Hydrologic Dataset (NHD) of the Eastern Estancia.

The National Hydrography Dataset (NHD) is a comprehensive set of data that encodes information about naturally occurring and constructed bodies of water, paths through which water flows, and related entities. The NHD identifies 657 miles (1,041 km) of water courses in the Eastern Estancia River Watershed. The majority of these courses typically flow intermittently in summer months during periods associated with high intensity convective thunderstorms.

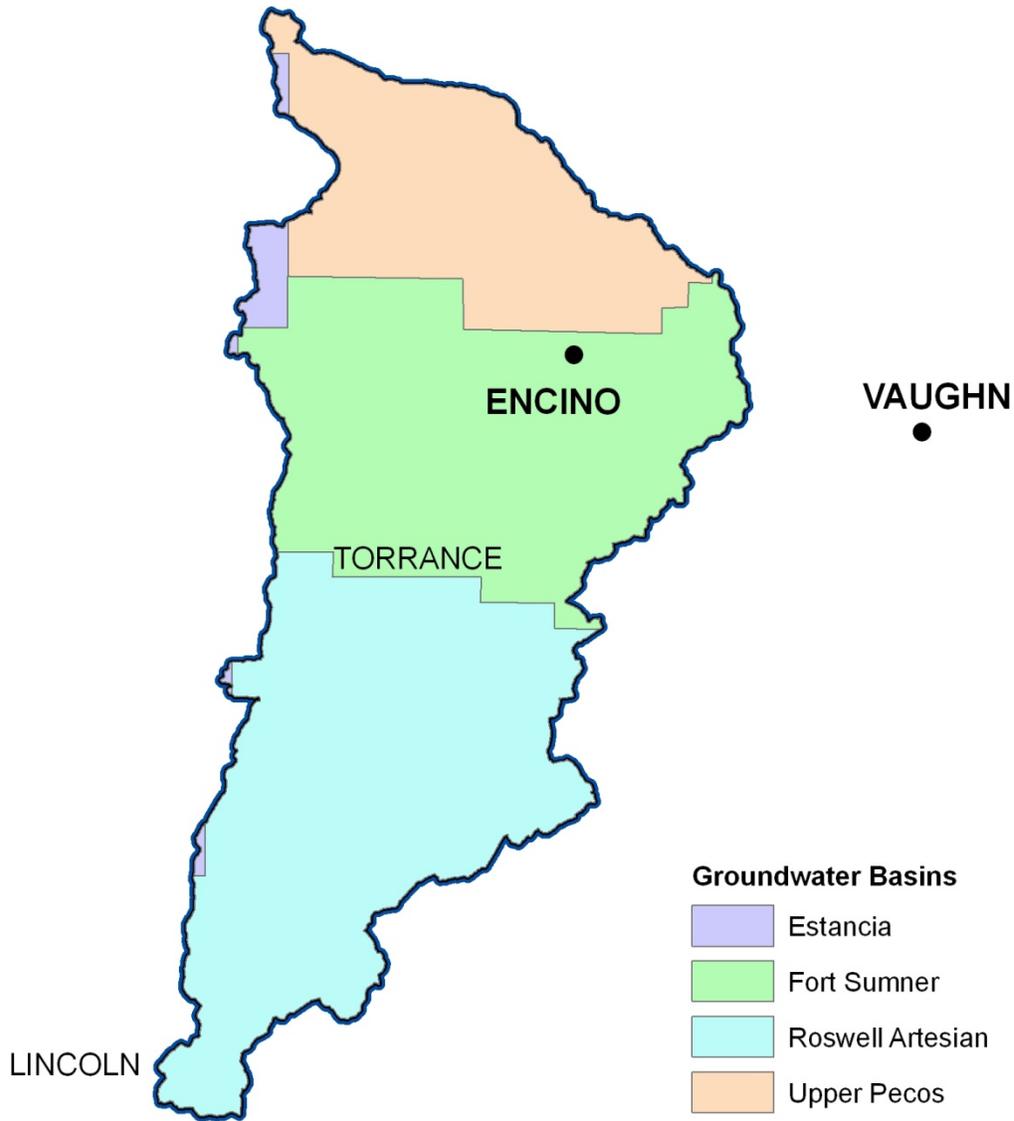
Figure 9. Declared Groundwater Basins of the Eastern Estancia.

A declared groundwater basin is an area of the state proclaimed by the State Engineer to be underlain by a groundwater source having reasonably ascertainable boundaries. By such proclamation the State Engineer assumes jurisdiction over the appropriation and use of groundwater from the source. The Eastern Estancia watershed is within the Estancia, Fort Sumner, Roswell Artesian, and Upper Pecos Underground Water Basins.

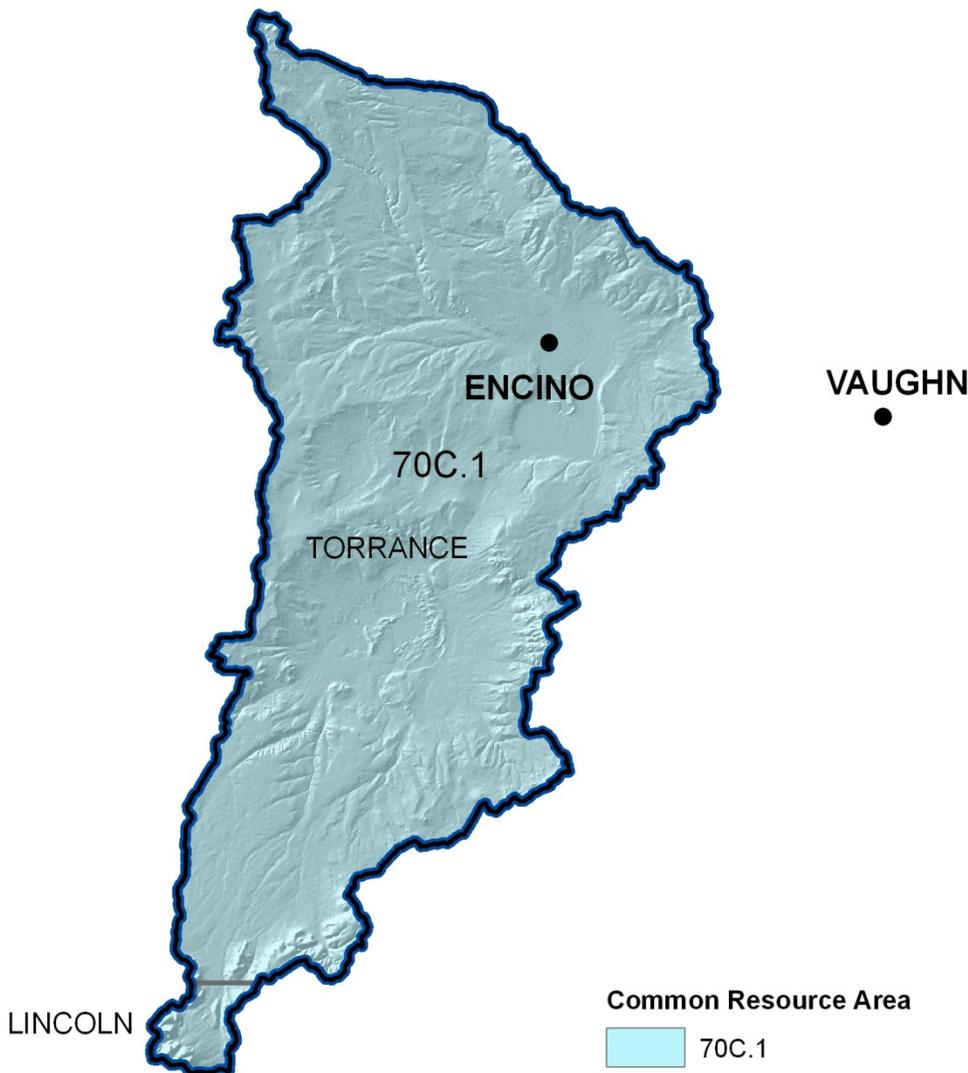
Figure 10. Common Resource Areas of the Eastern Estancia

35.1 – Central New Mexico Highlands

Tablelands and mesas separated by broad plains and small terraces characterize this area. Elevation is 5,000 to 7,200 feet and precipitation is 12 to 17 inches. The soil moisture regime is aridic to ustic and the soil temperature regime is mesic. Pinyon-juniper savannah and pinyon juniper woodlands at higher elevations, and broad mid- to short-grass prairies and basins at lower elevations dominate the area. Current land use is livestock grazing. The soils formed in Quaternary alluvium, eolian sands, and sedimentary rocks of Permian age. (Old CP-3)

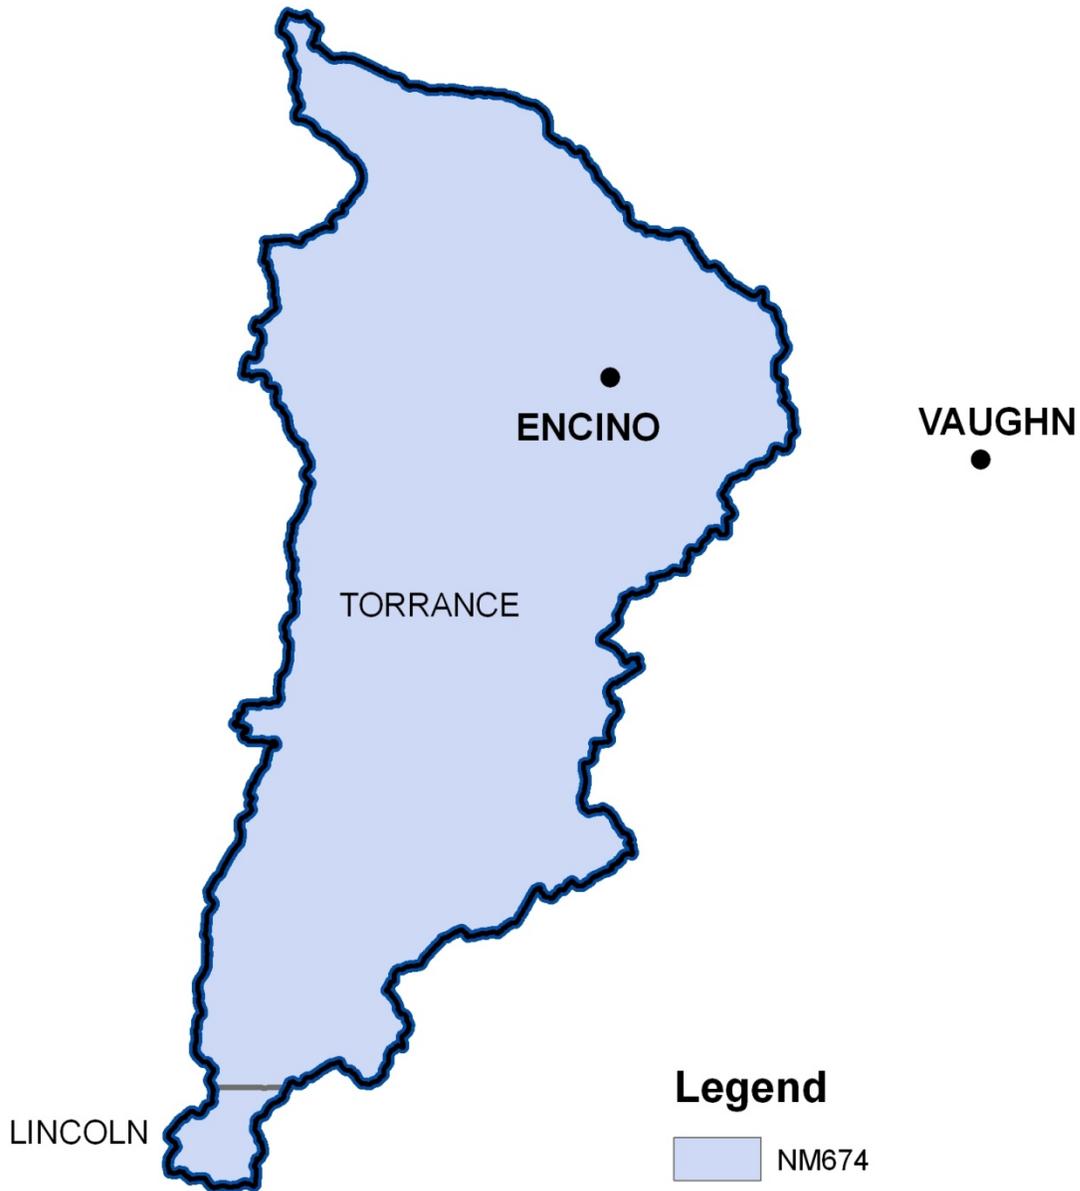
Figure 11. National Cooperative Soil Survey coverage of the Eastern Estancia Watershed

The Eastern Estancia Watershed has one certified National Cooperative Soil Survey (NCSS) inventory covering it, NM 674.

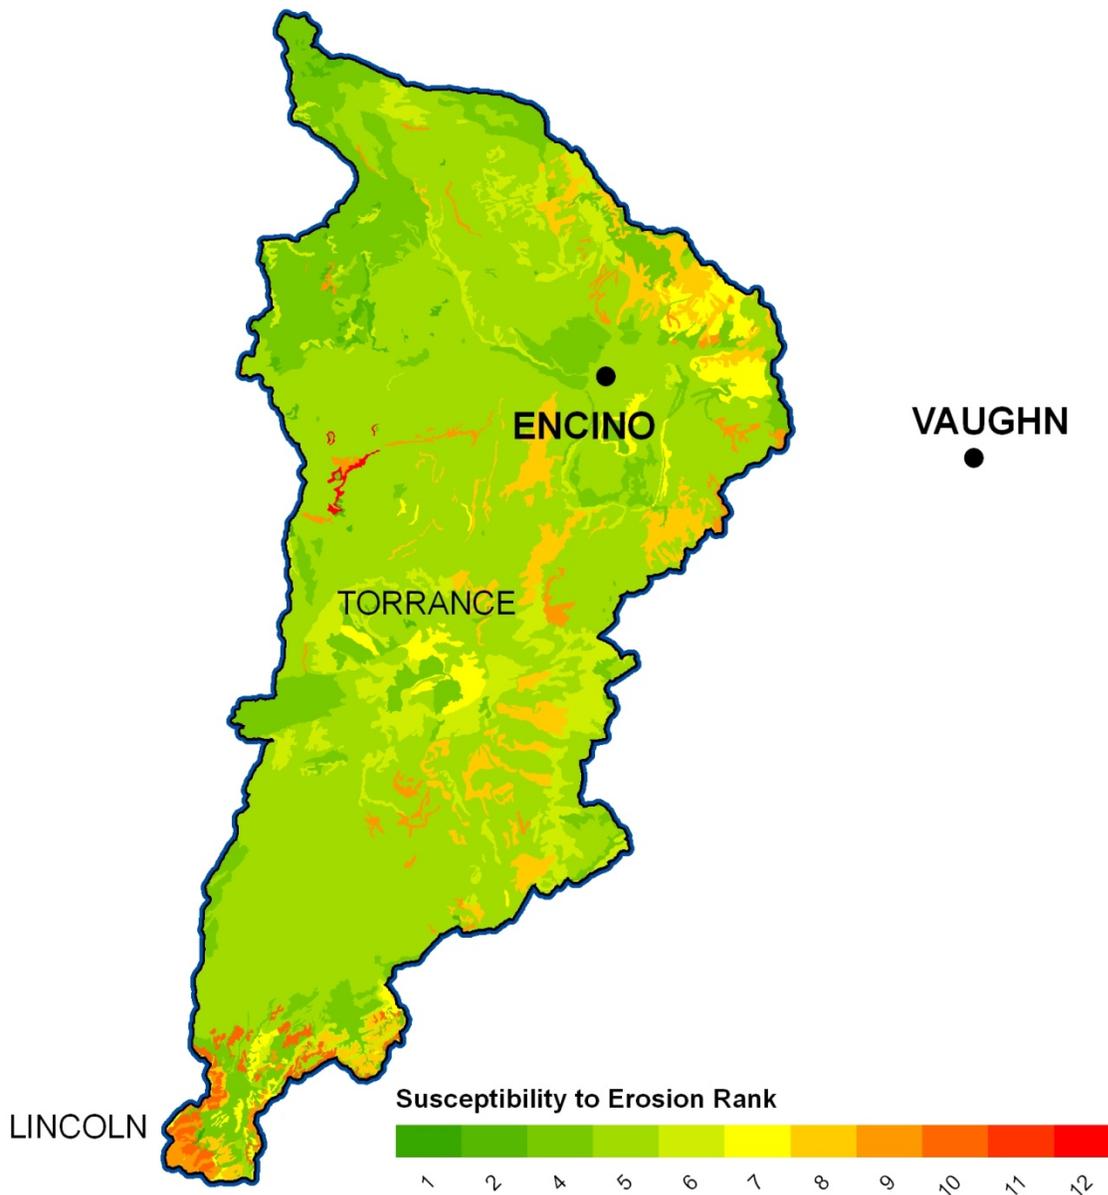
Figure 12. Eastern Estancia Watershed Erosion Potential

In order to evaluate the susceptibility of erosion within the Eastern Estancia watershed, a model was developed using Soil Survey Geographic Database (SSURGO) information. The soil properties saturated hydraulic conductivity, soil loss tolerance, and wind erodibility group were used in conjunction with slope to assess soil mapunit potential for erosion. Saturated hydraulic conductivity and slope are reported in SSURGO databases as interval/ratio data whereas wind erodibility and soil loss tolerance are ordinal data. Data transformations for the model are listed -

For each soil map unit (discrete delineation), the soil properties (named above) of the dominant soil type was used as the condition to be evaluated in the susceptibility to erosion model. Miscellaneous areas such as gravel pits, water, riverwash, etc. were excluded from evaluation. Possible range of values for each map unit are 0 – 16. Increasing values represent a higher susceptibility to soil erosion.

Table 10. Soil Erosion Potential Model Results. A greater rank indicates greater potential for erosion.
