WORK PLAN

- For Watershed Protection, Flood Prevention,
- and Agricultural Water Management

BIG CREEK WATERSHED

BRAZOS COUNTY, TEXAS

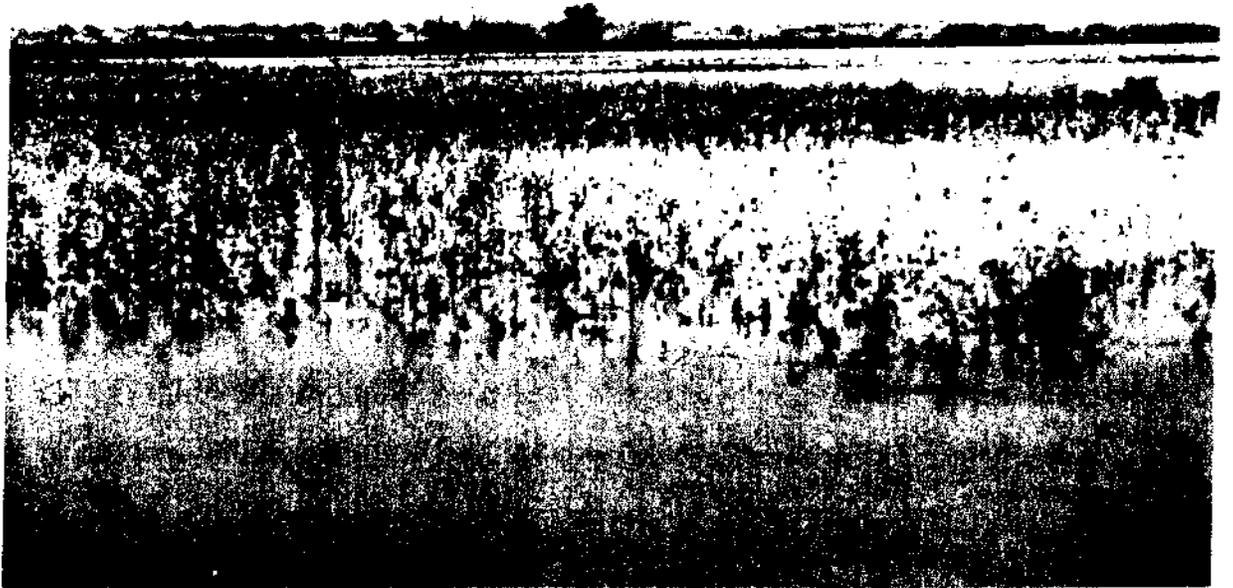
Typical flooding of rich bottomlands resulting in extensive damage to cotton crop.

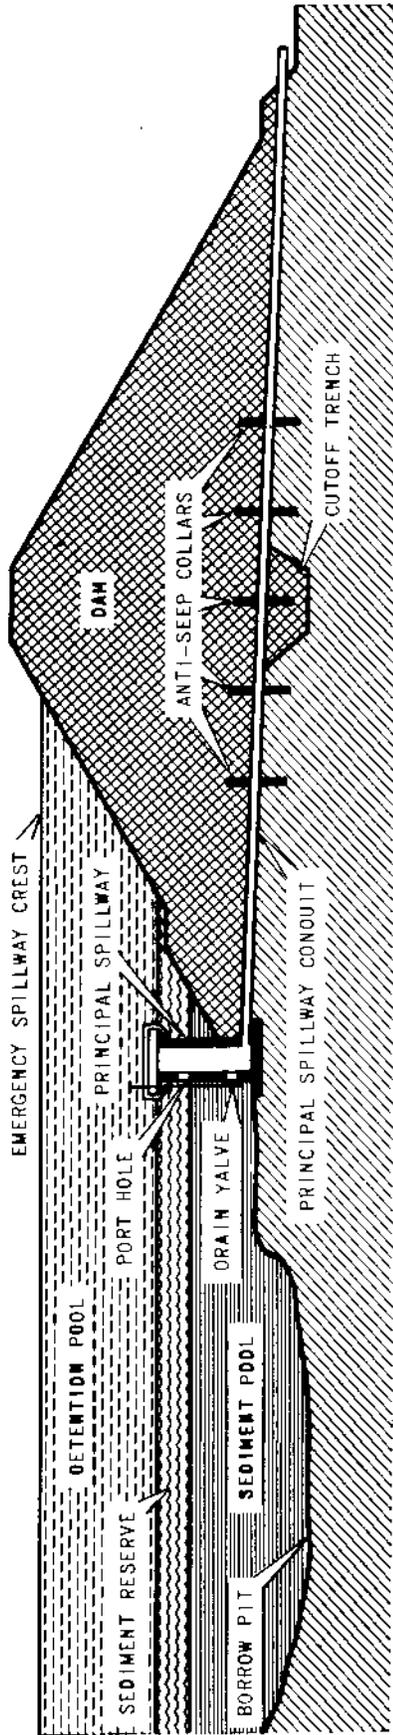
Figure 1
SECTION OF A TYPICAL FLOODWATER RETARDING STRUCTURE

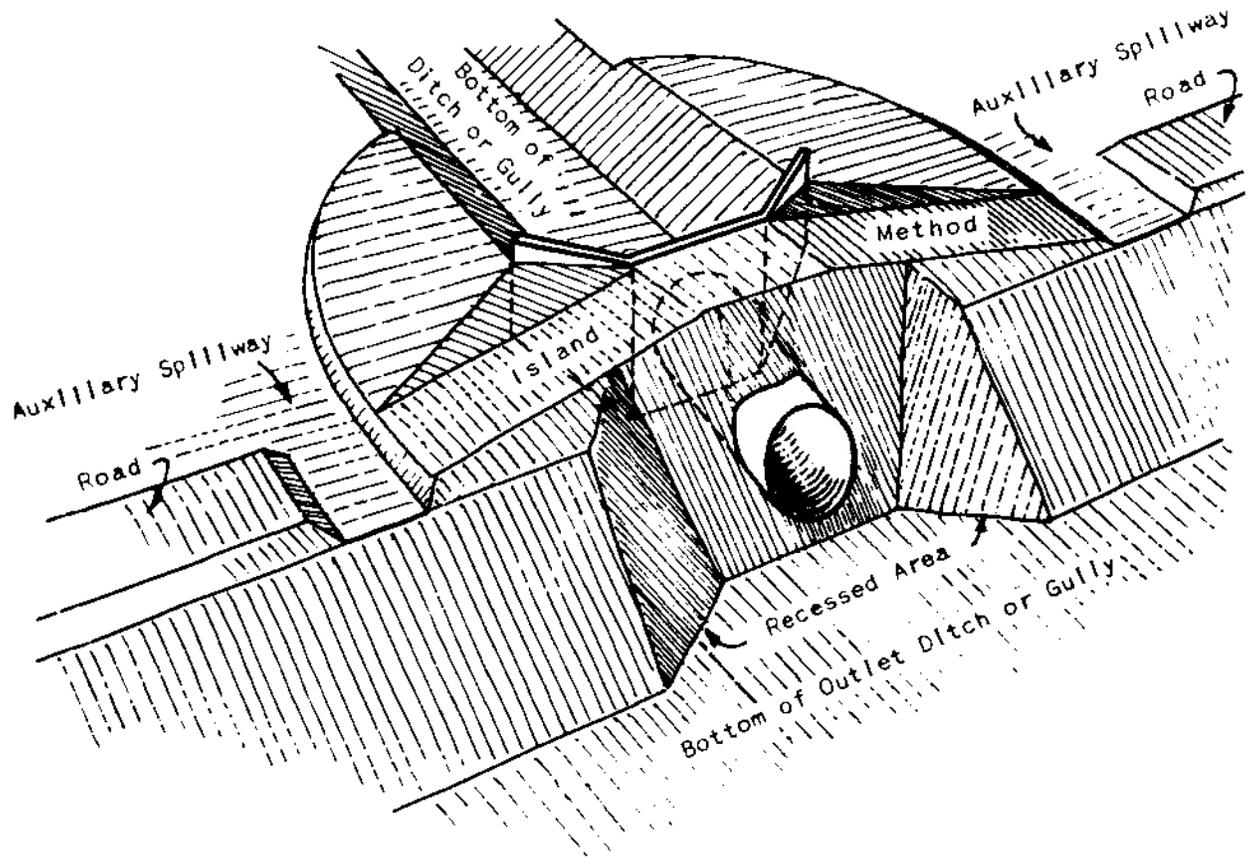
Figure 2
PIPE OVERFALL STRUCTURE

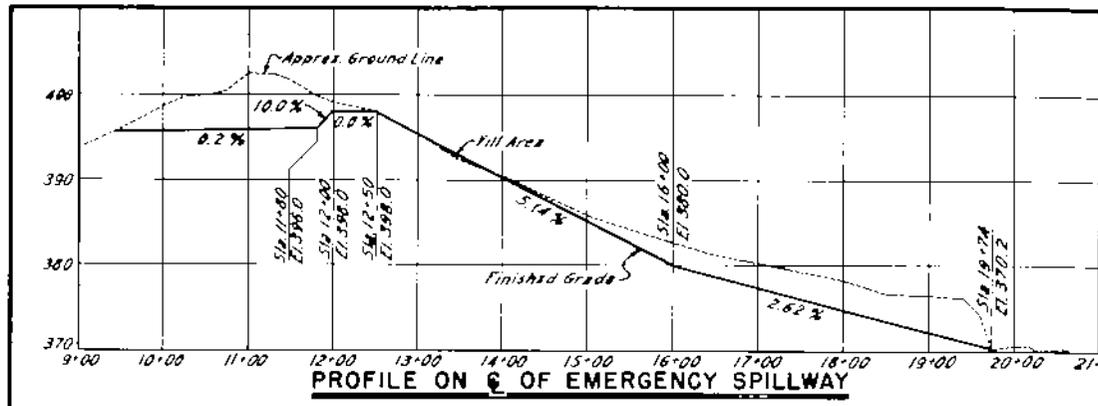
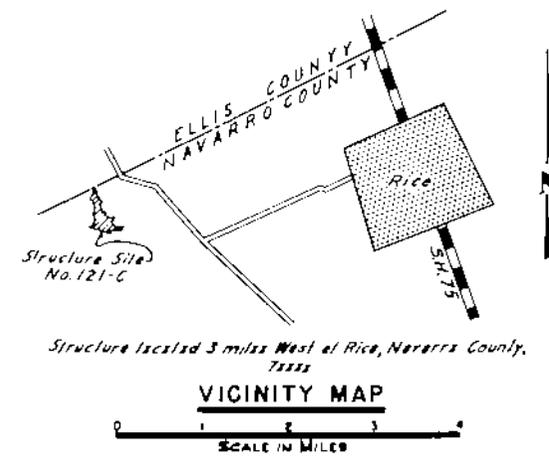
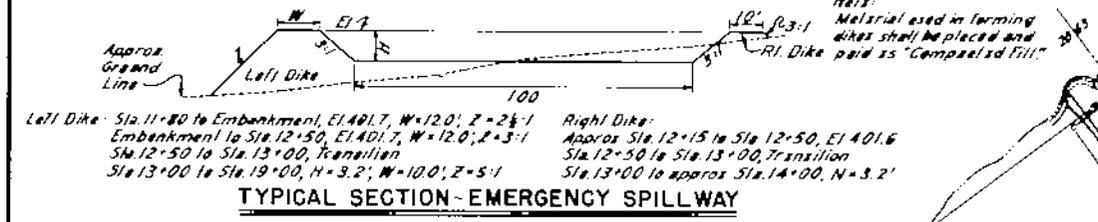
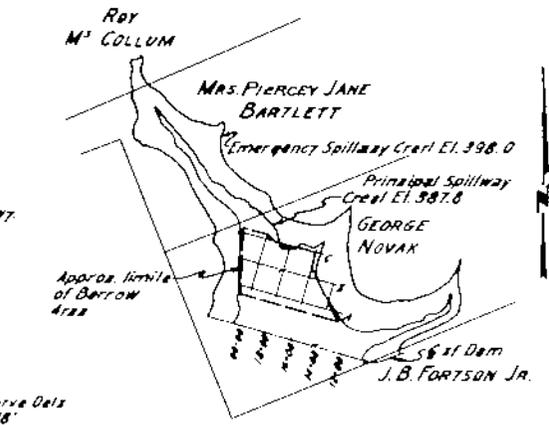
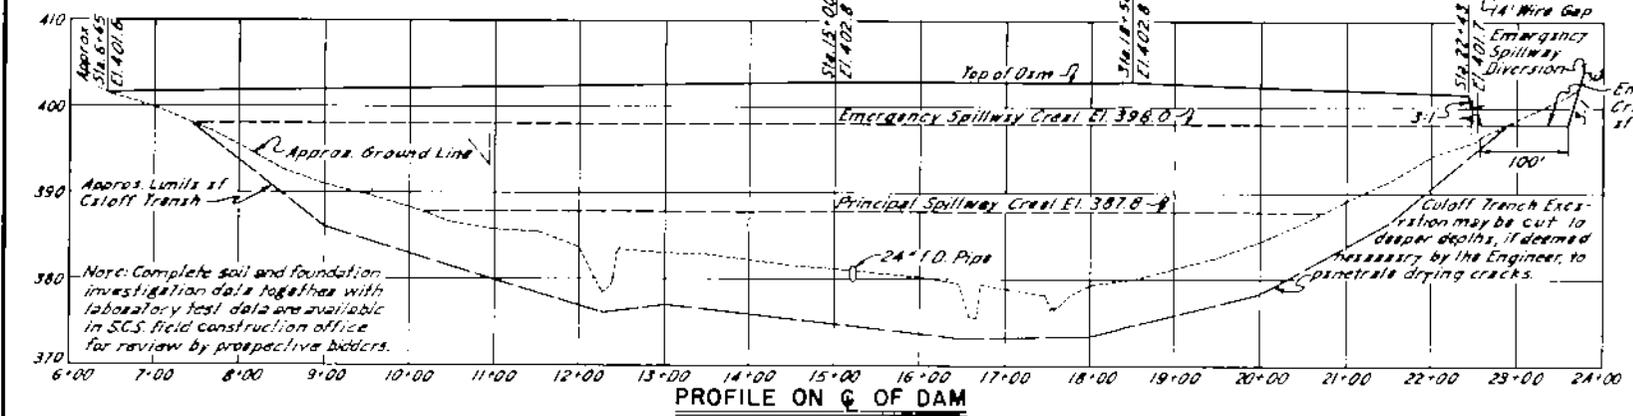
Top of Dam (Effective) Elev. 401.4
 Emergency Spillway Crest Elev. 398.0
 Principal Spillway Crest Elev. 387.8
 Sediment Pool Elev. 387.8
 Drainage Area, Acres 608
 Sediment Storage, Acre Feet 92
 Floodwater Storage, Acre Feet 287
 Max. Emergency Spillway Cap., cfs. 1,664

Left Dike: Sta. 11+80 to Embankment, E1.401.7, W=12.0', Z=2:1
 Embankment to Sta. 12+50, E1.401.7, W=12.0', Z=3:1
 Sta. 12+50 to Sta. 13+00, Transition
 Sta. 13+00 to Sta. 19+00, H=3.2', W=10.0', Z=5:1

Right Dike: Approx. Sta. 12+15 to Sta. 12+50, E1.401.6
 Sta. 12+50 to Sta. 13+00, Transition
 Sta. 13+00 to approx. Sta. 14+00, H=3.2'

Emergency Spillway Division: 18' effective height, 3:1 side slopes, minimum base 13 ft. Crest of Division to be subsidiary to other items of work.
 Stream Channel within embankment area to be cleared of objectionable material in accordance with "Stream Channel Cleanup" of the specifications.
 A minimum of 6" of Topsoil to be placed in Emergency Spillway and on all "Compacted Fill Areas". See the specifications.

Figure 5
 TYPICAL
 FLOODWATER RETARDING STRUCTURE
 GENERAL PLAN AND PROFILE
 U. S. DEPARTMENT OF AGRICULTURE
 SOIL CONSERVATION SERVICE

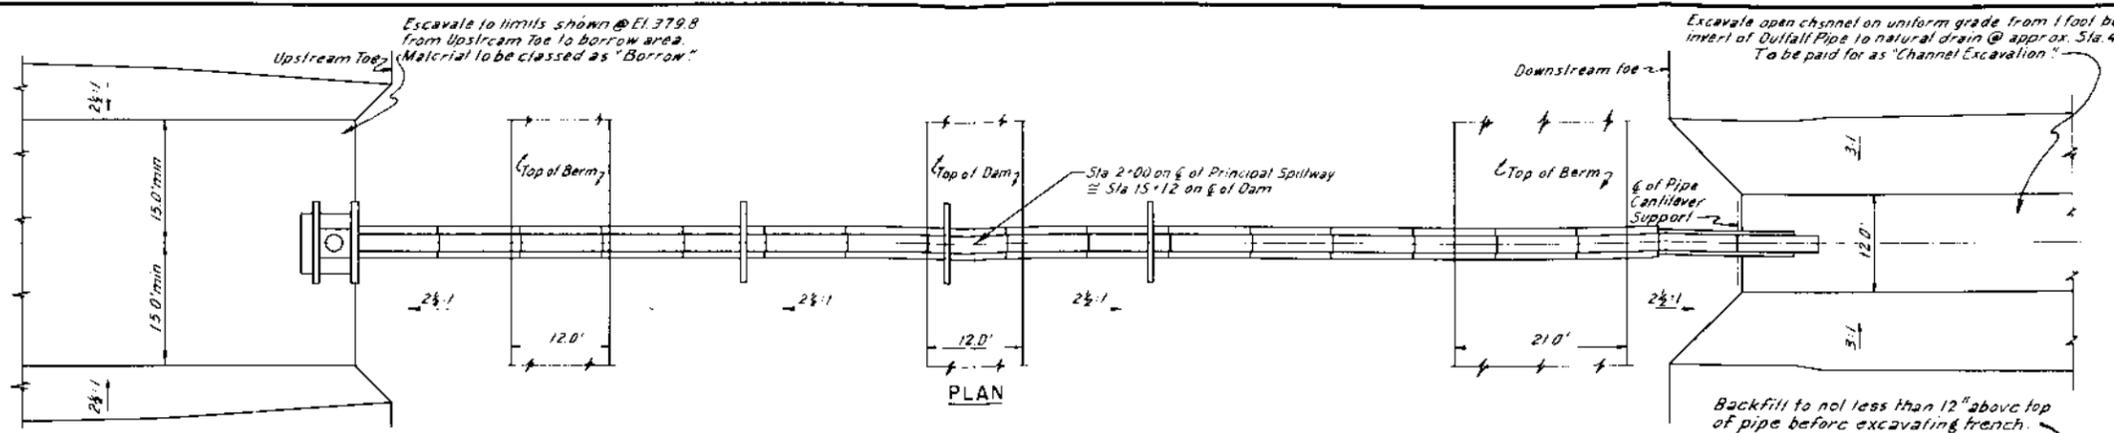
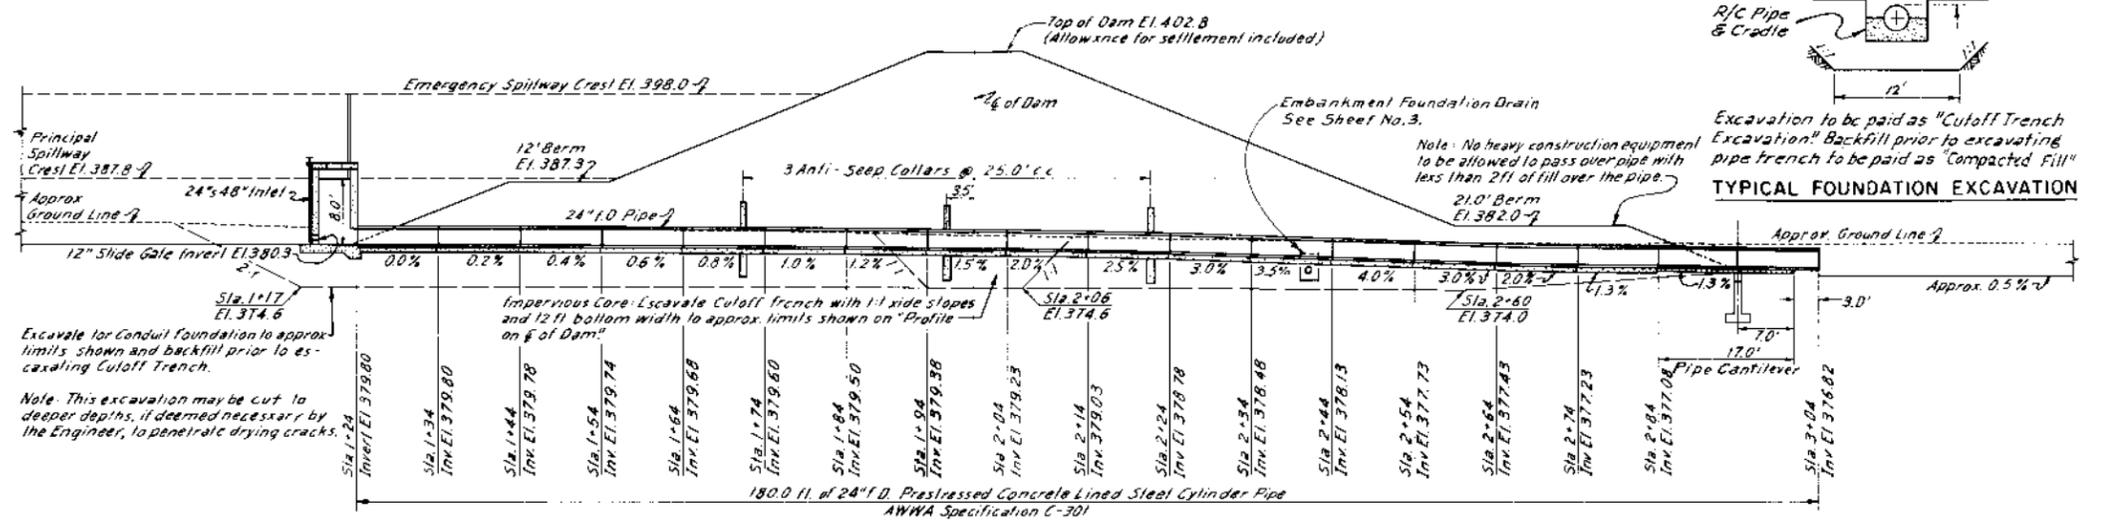
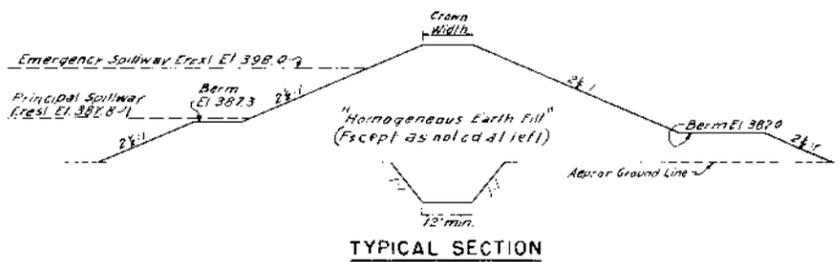
**SECTION
PRINCIPAL SPILLWAY**

2. Clay materials from Cutoff Trench and Conduit Foundation Trench Excavations shall be placed in the upstream portion of the Embankment with the compaction requirements of the laboratory curve No. 2.

3. The small volume of silty sand excavated from the Cutoff Trench, right abutment, shall be placed immediately above the Graded Filter Drain (Embankment Foundation Drain) as directed by the Engineer.

4. Maximum dry density, optimum moisture, minimum acceptable dry density and moisture range shown in the table are for material particles passing the no. 4 sieve. If the material being placed contains 1/4" or larger rock particles, the minimum acceptable dry density & moisture range will be corrected for the presence of rock.

Figure 34
**TYPICAL FLOODWATER RETARDING STRUCTURE
PLAN AND SECTION**
