WORK PLAN

WATERSHED PROTECTION AND FLOOD PREVENTION

NORTH CUERO WATERSHED

DeWITT COUNTY, TEXAS

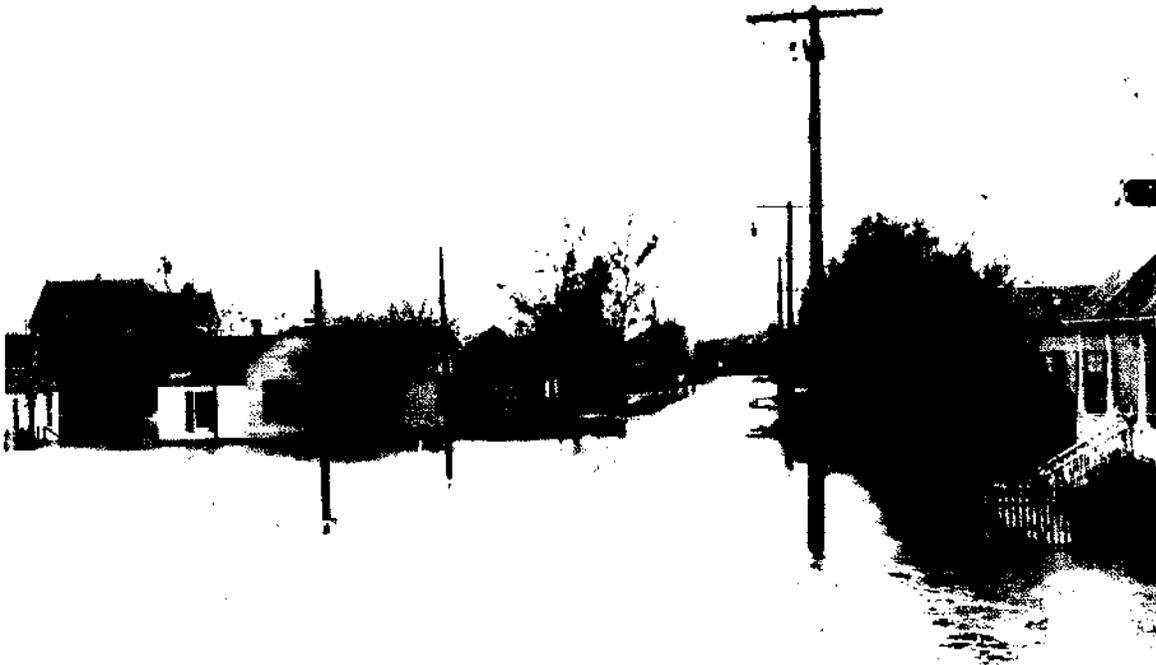
Typical flood scene in Cuero from an estimated 5-year frequency flood.

Urban damages in Reach 2 result from overflow of Gohlke Creek into the northwest part of Cuero in the vicinity of valley cross sections G-11a through G-14 (figure 1). Flooding to a maximum depth of about 4.7 feet has occurred. Floodwaters cause damage to residential properties, business establishments, streets, and utilities. There are some other areas of the city that are flooded; however, most of this flooding, except that which has resulted from an occasional overflow of the Guadalupe River, is caused by accumulation of rainfall occurring in and near the urban area.

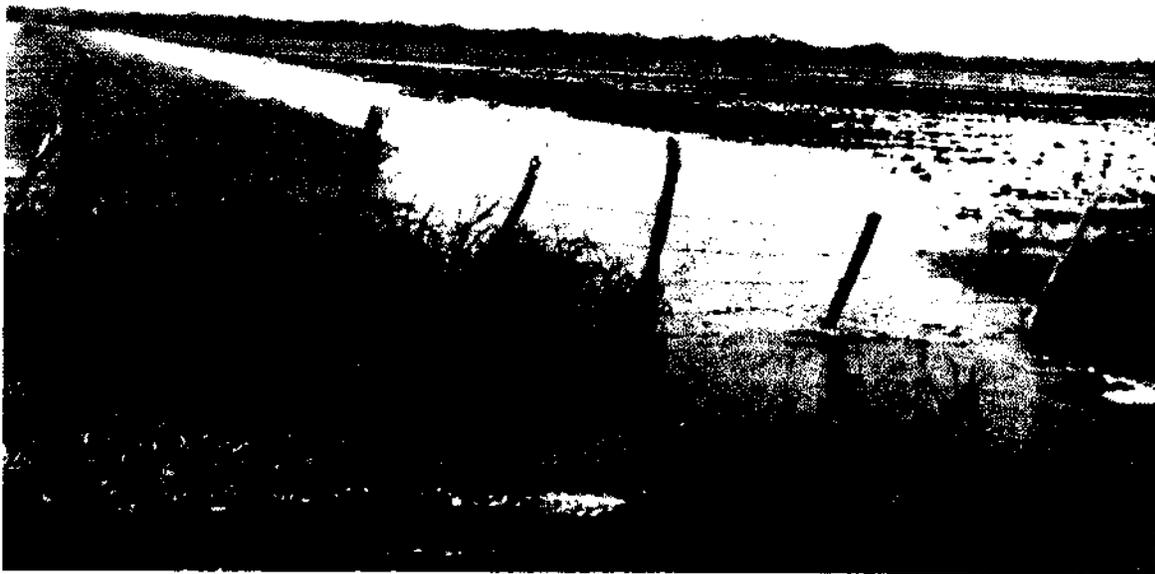
Floodwater beginning to spread over large cropland field from accumulation of rainfall in the area.

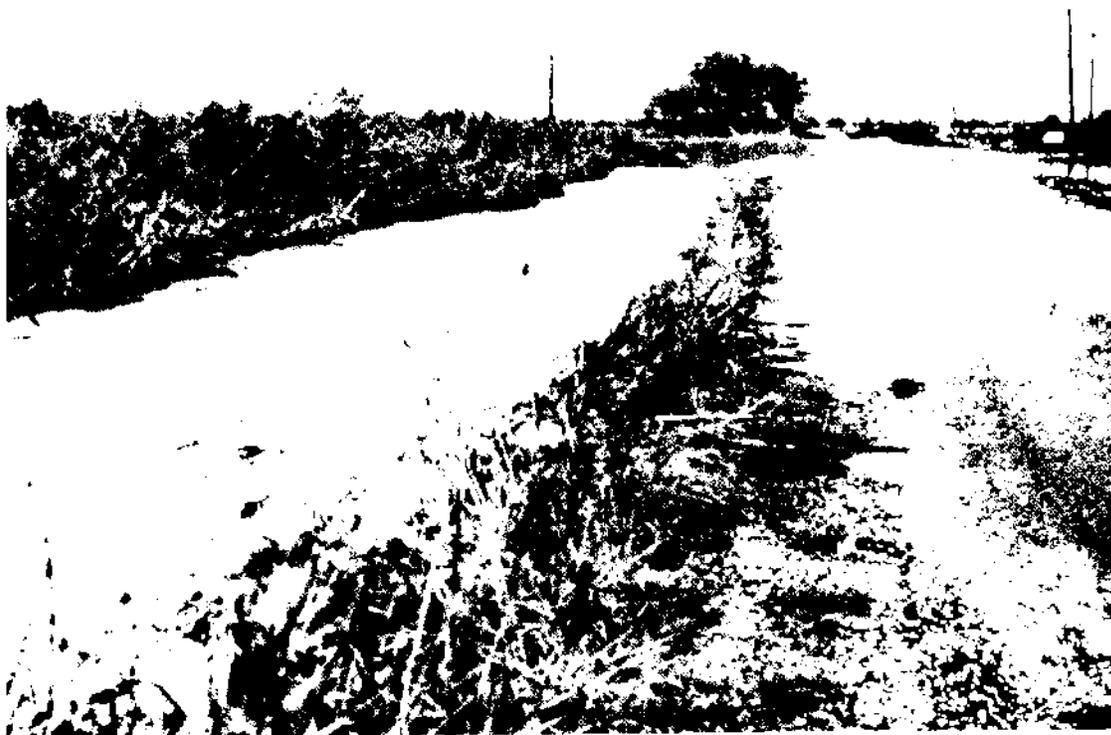
Inundation of County Road from accumulation of floodwater.

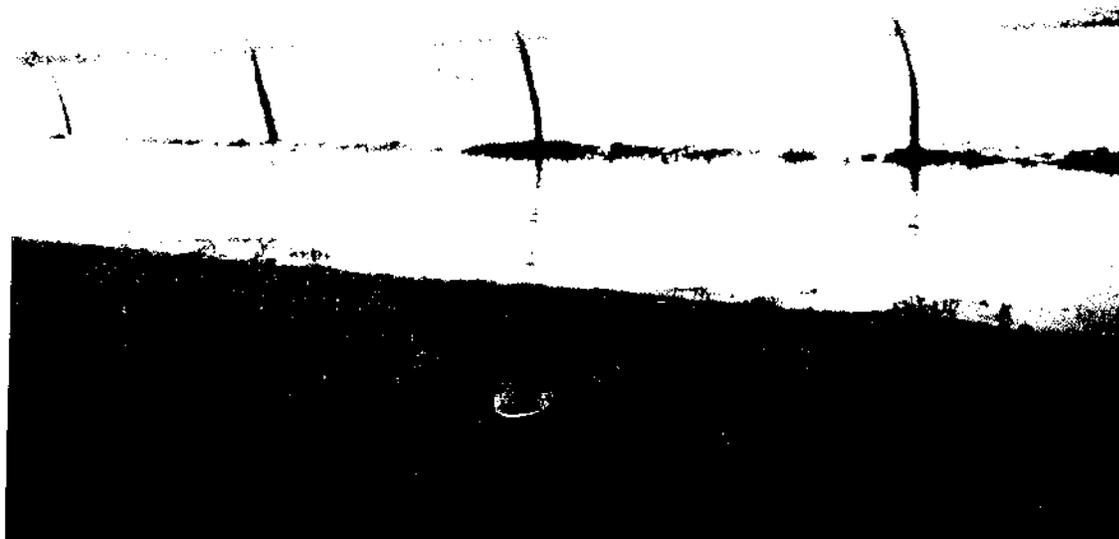
Typical flooding of the nearly level flood plain.
