SUPPLEMENT TO WORK PLAN

FOR WATERSHED PROTECTION AND FLOOD PREVENTION

**SULPHUR CREEK
WATERSHED**

BURNET AND LAMPASAS COUNTIES, TEXAS

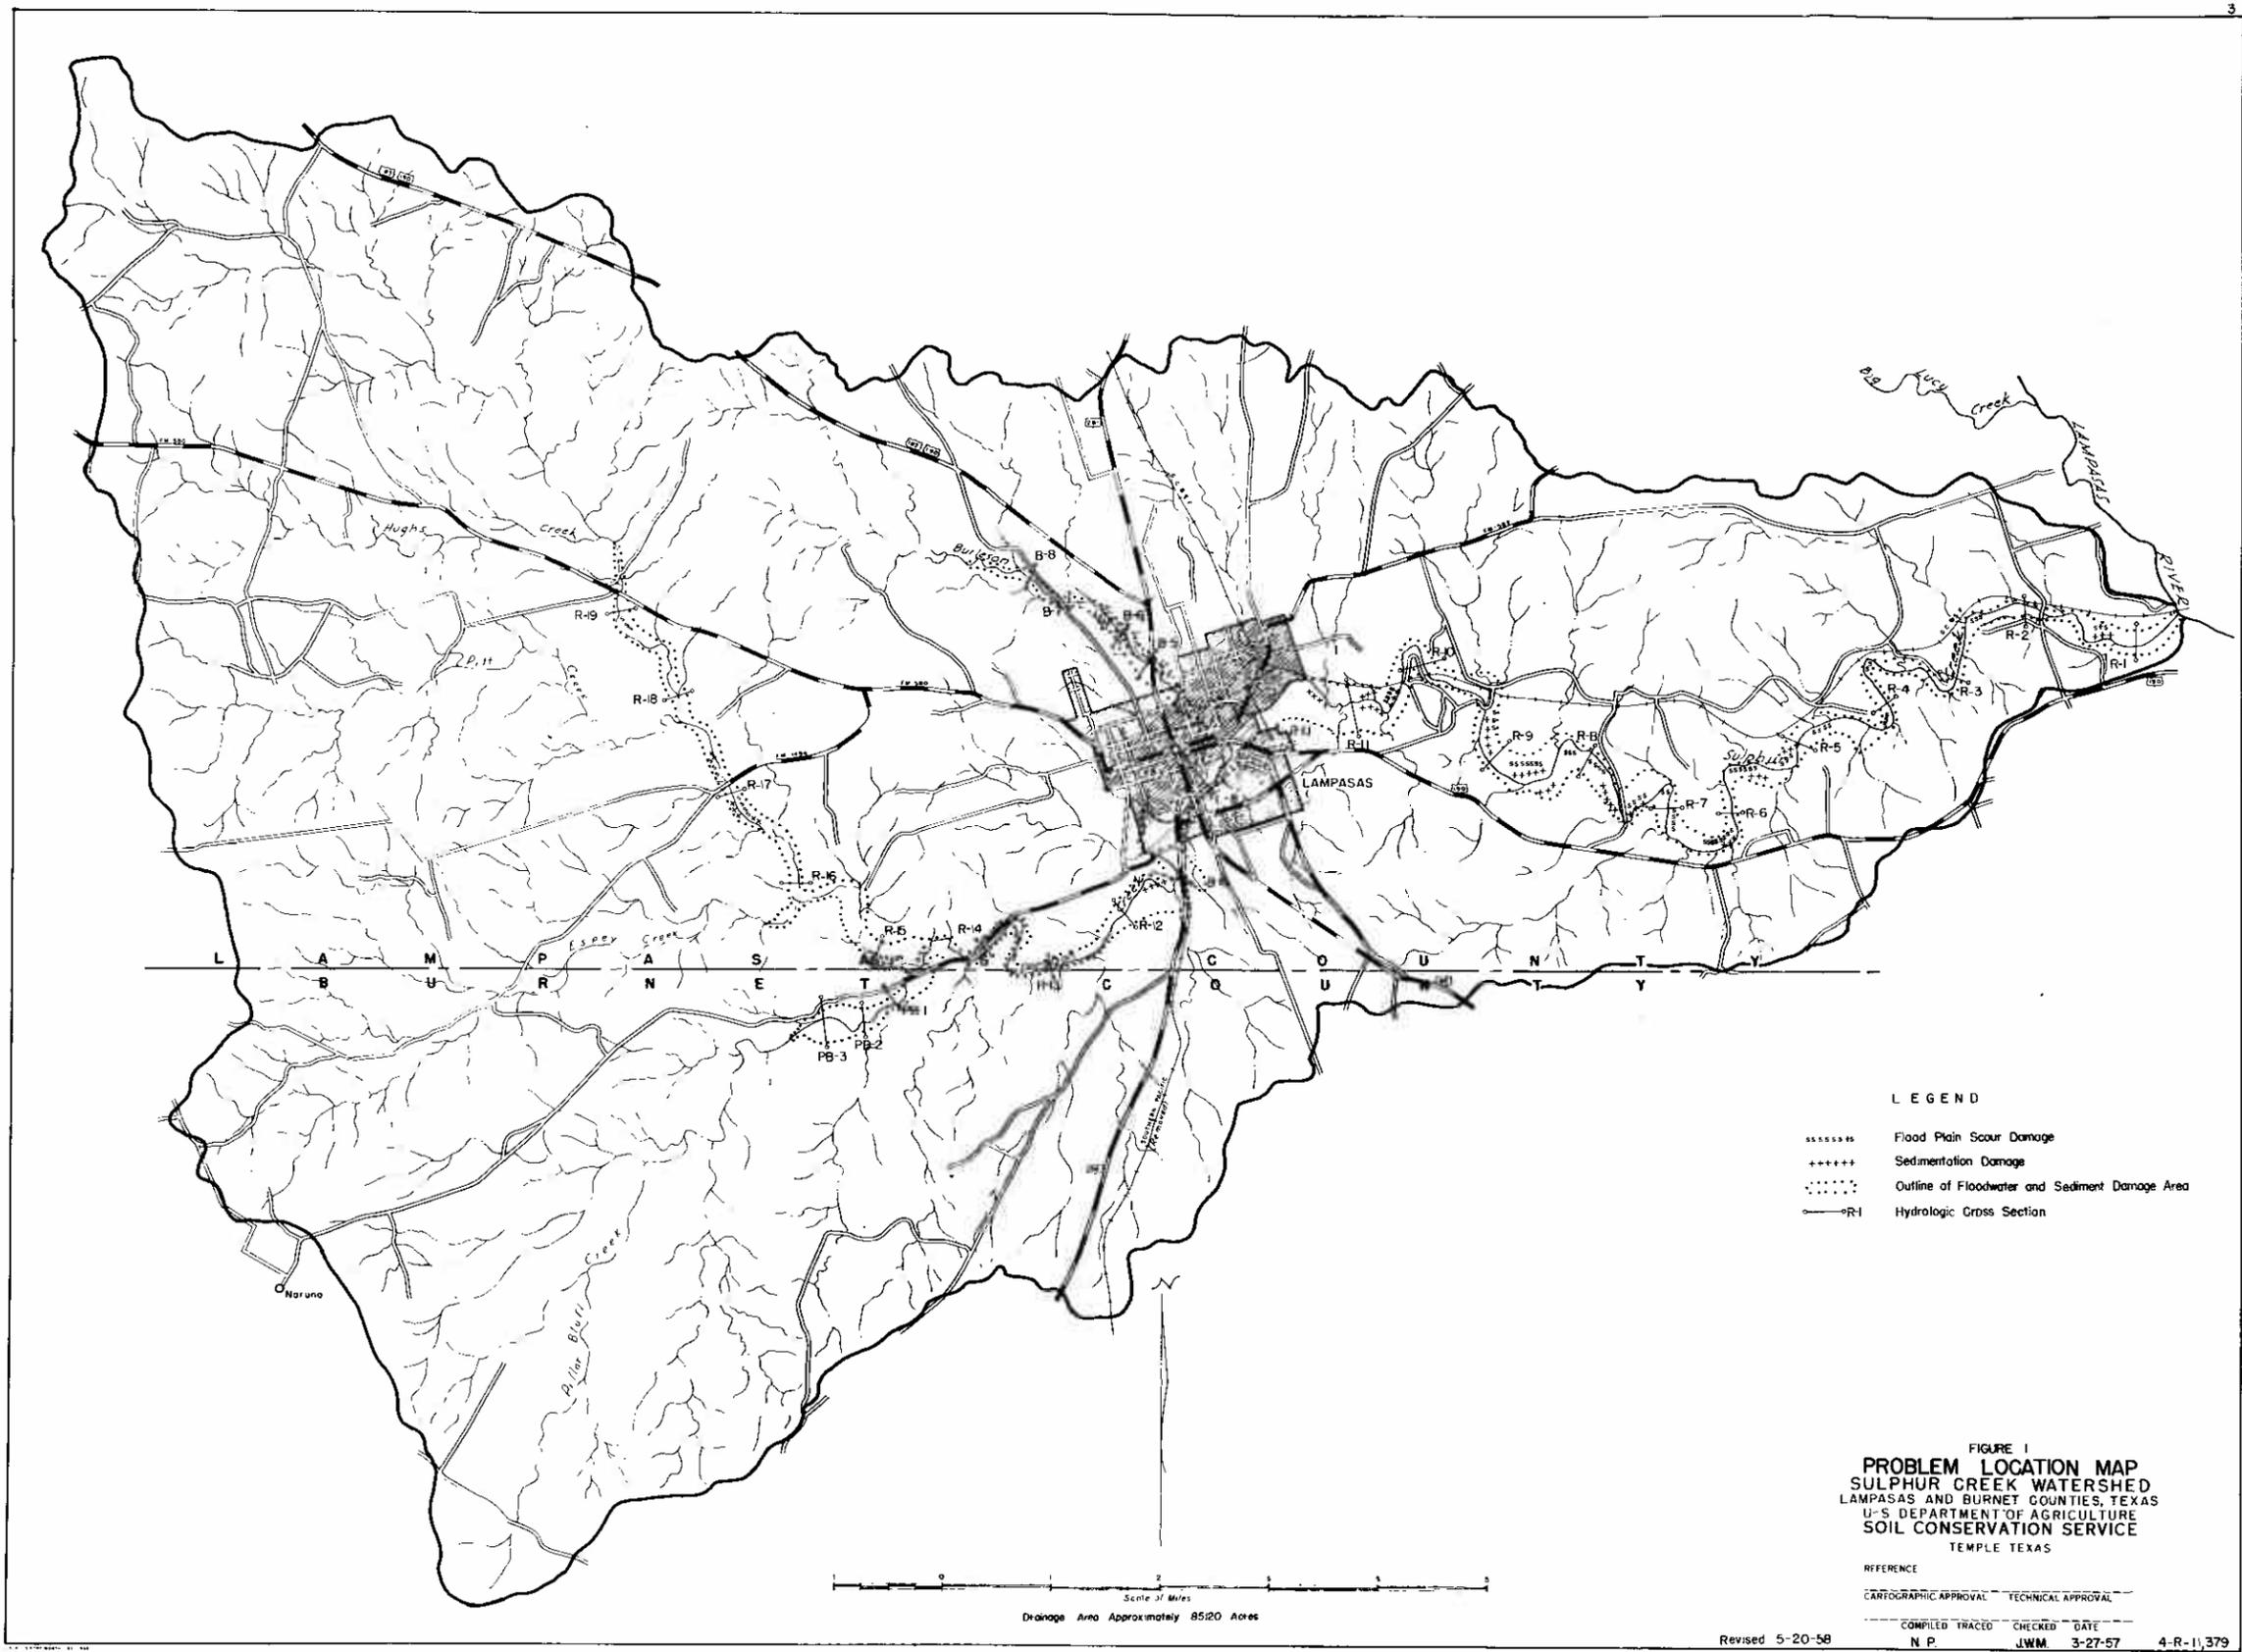
FIGURE 1
PROBLEM LOCATION MAP
SULPHUR CREEK WATERSHED
LAMPASAS AND BURNET COUNTIES, TEXAS
 U.S. DEPARTMENT OF AGRICULTURE
 SOIL CONSERVATION SERVICE
 TEMPLE TEXAS

The approximately 400 acres of the town which is in the flood plain (figure 1) were inundated by the May 12, 1957 storm.

<u>Cross Section</u> (Figure 1)	<u>Storm of May 12, 1957</u> <u>Peak Discharges in C.F.S.</u>	
	<u>Without</u> <u>Project</u>	<u>With</u> <u>Project</u>
No.		
B-5	16,800	10,670
L-8	69,000	15,177
R-111	72,000	19,965

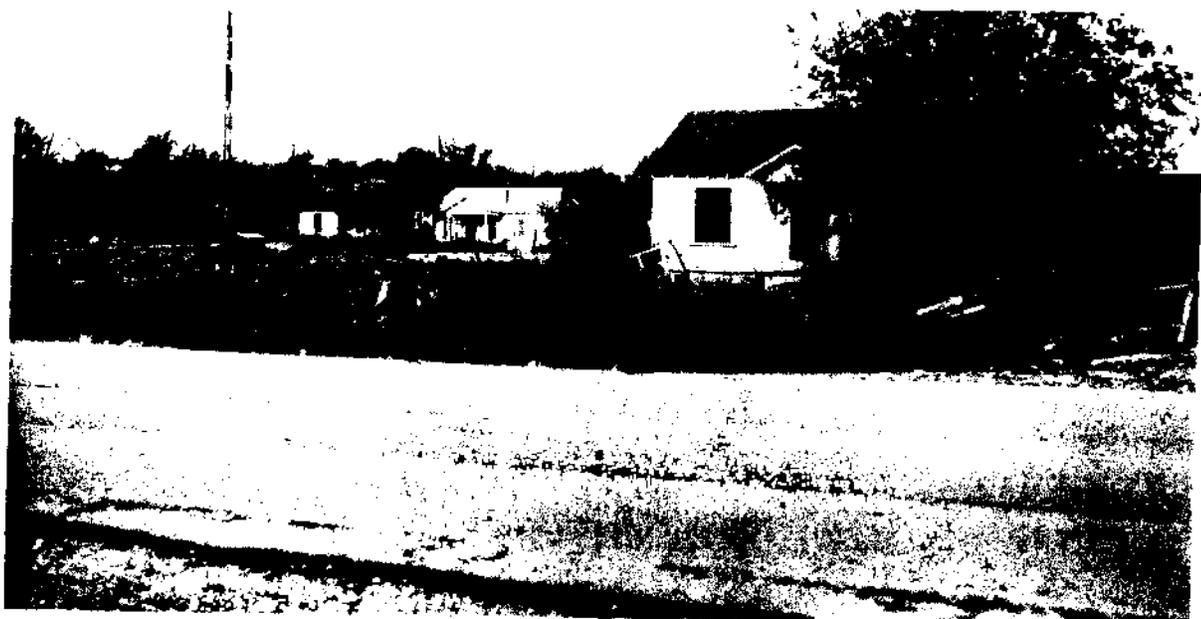
During the Lampasas flood these homes were window-deep in water

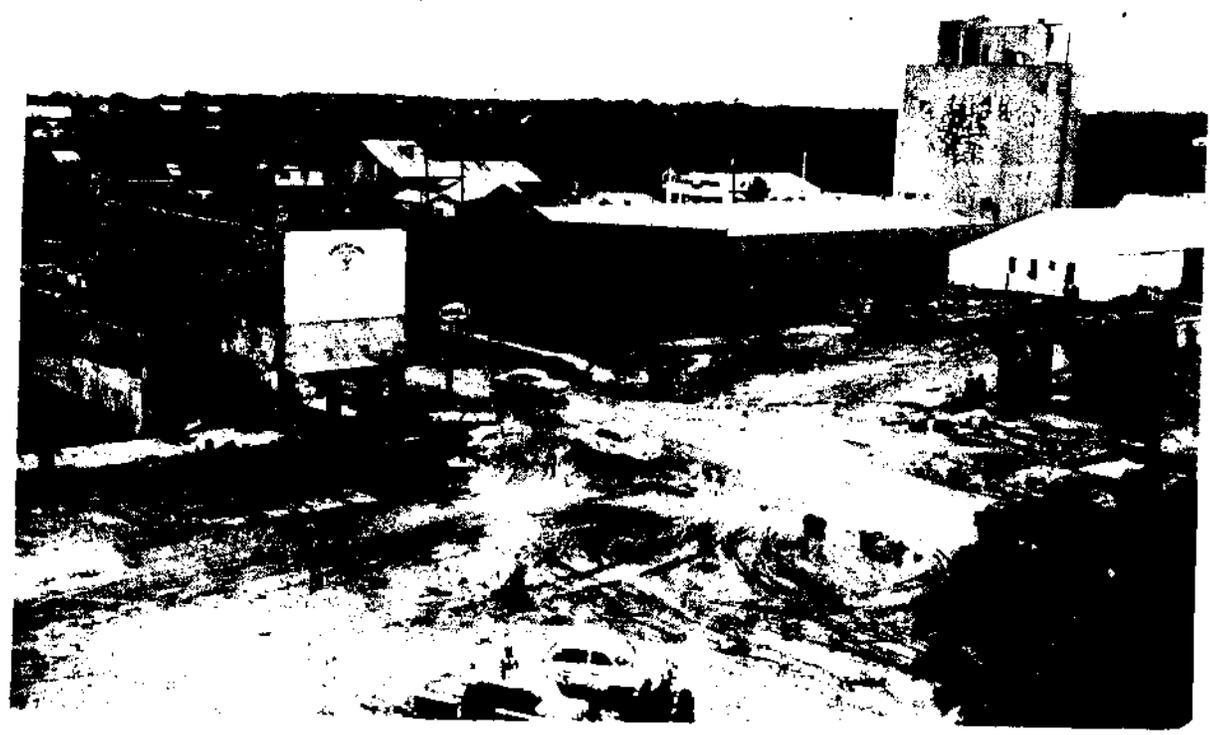
. . . the wool warehouse was moved from its foundation . . .

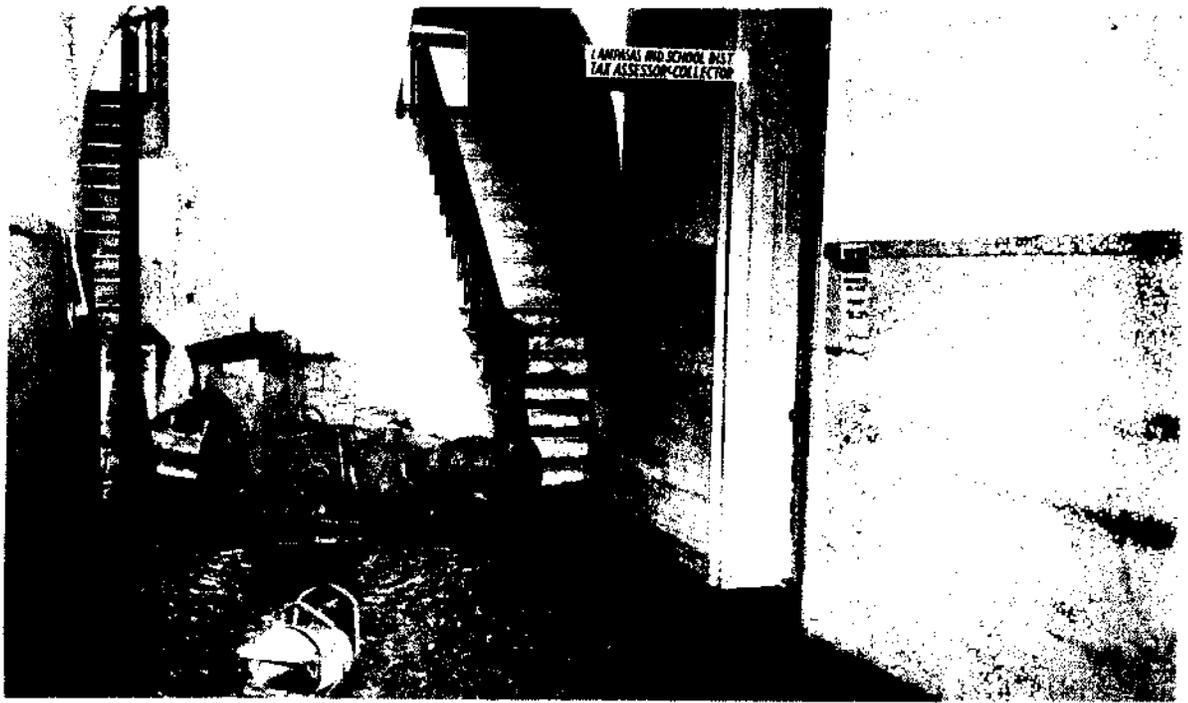
Sediment deposited in the Lampasas County Courthouse by the flood of May 12.

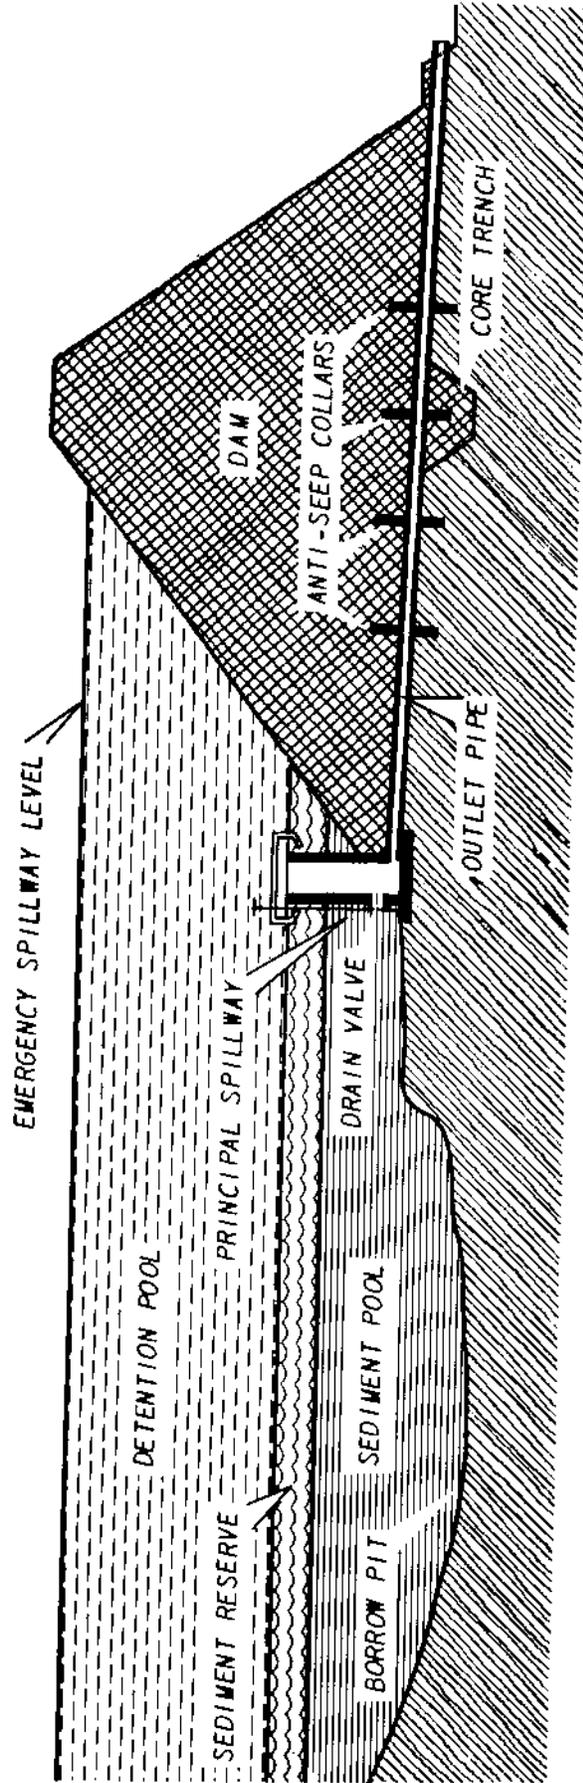
Figure 2
SECTION OF A TYPICAL FLOODWATER RETARDING STRUCTURE

A system of 10 floodwater retarding structures will be installed in the Sulphur Creek watershed to afford the needed protection to flood plain lands which cannot be provided by land treatment measures alone. The system of floodwater retarding structures will temporarily detain runoff from 59 percent of the watershed. Above valley cross section L-8 (figure 1) which represents the area in Lampasas where 86 percent of the urban damage occurs, 86 percent of the drainage area will be behind floodwater retarding structures. The design provides for emptying the minimum required detention pool within a period of 10 days or less. Figure 2 shows a section of a typical floodwater retarding structure.

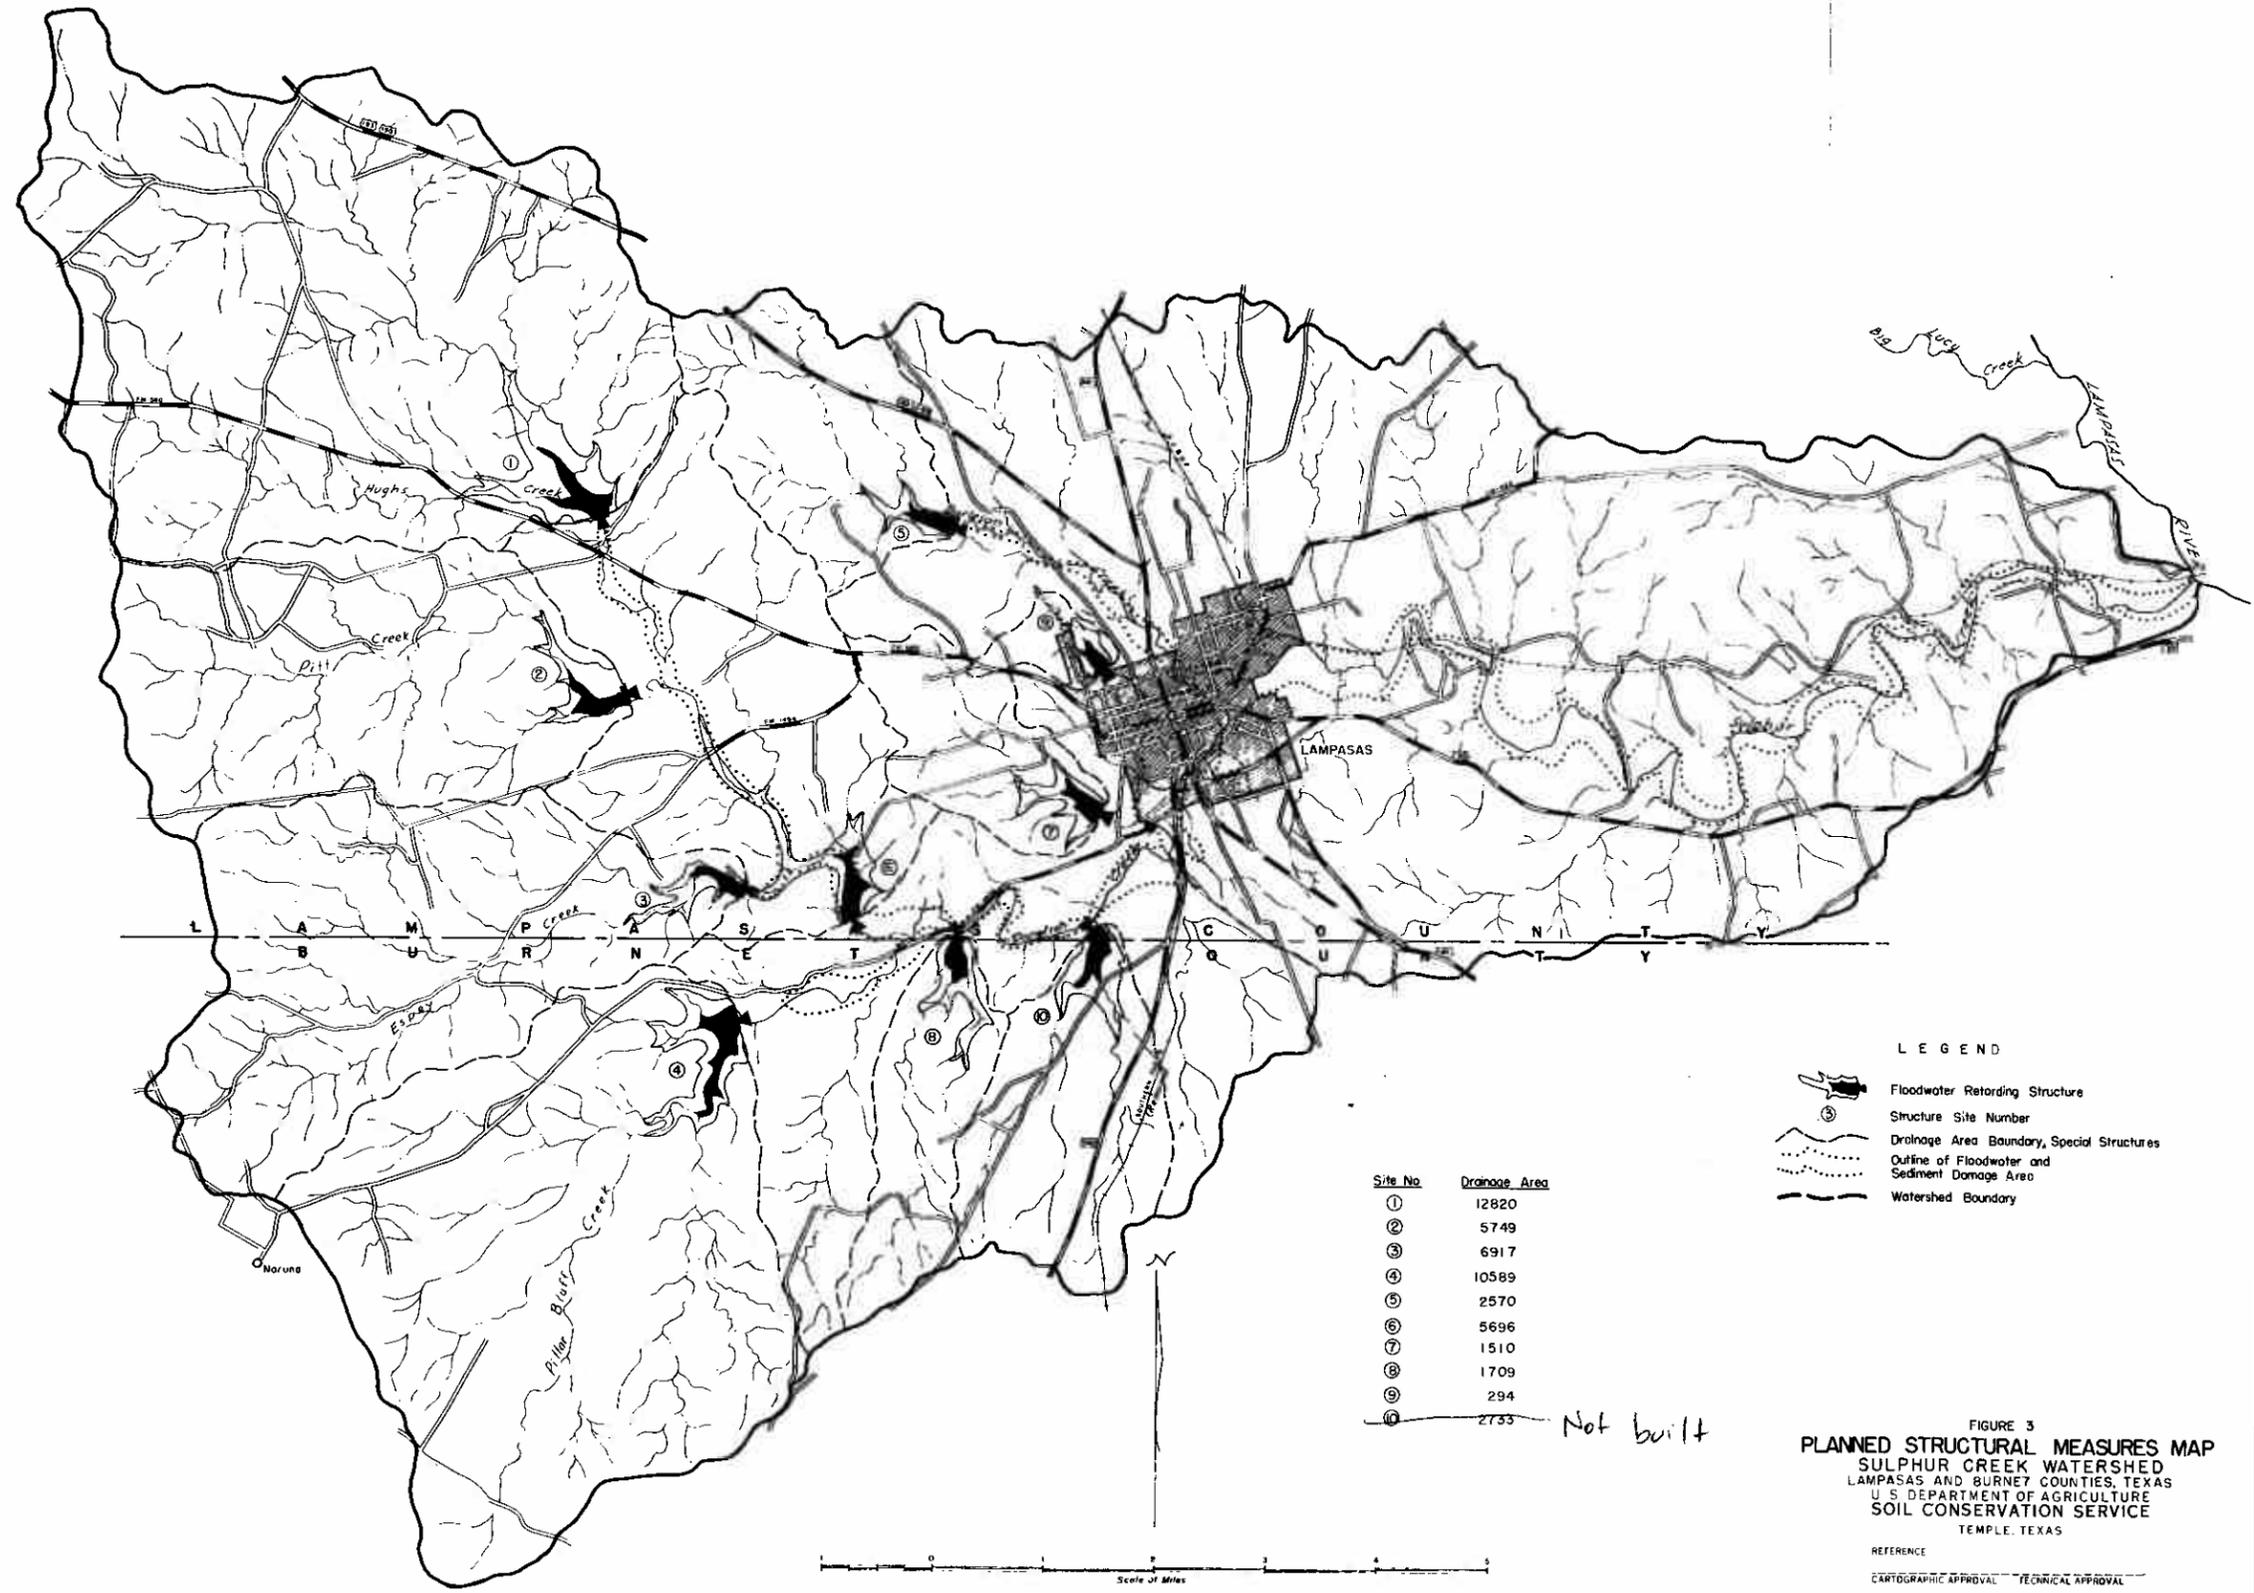
FIGURE 3
PLANNED STRUCTURAL MEASURES MAP
 SULPHUR CREEK WATERSHED
 LAMPASAS AND BURNEZ COUNTIES, TEXAS
 U. S. DEPARTMENT OF AGRICULTURE
 SOIL CONSERVATION SERVICE
 TEMPLE, TEXAS

The location of the floodwater retarding structures is shown on the Planned Structural Measures map, figure 3. The total estimated cost of establishing these works of improvement is \$1,905,366, of which \$1,784 will be borne by Public Law 566 funds and \$120,522 by other interests (tablea 1 and 2).

Site No.	Drainage Area
①	12820
②	5749
③	6917
④	10589
⑤	2570
⑥	5696
⑦	1510
⑧	1709
⑨	294
⑩	2735

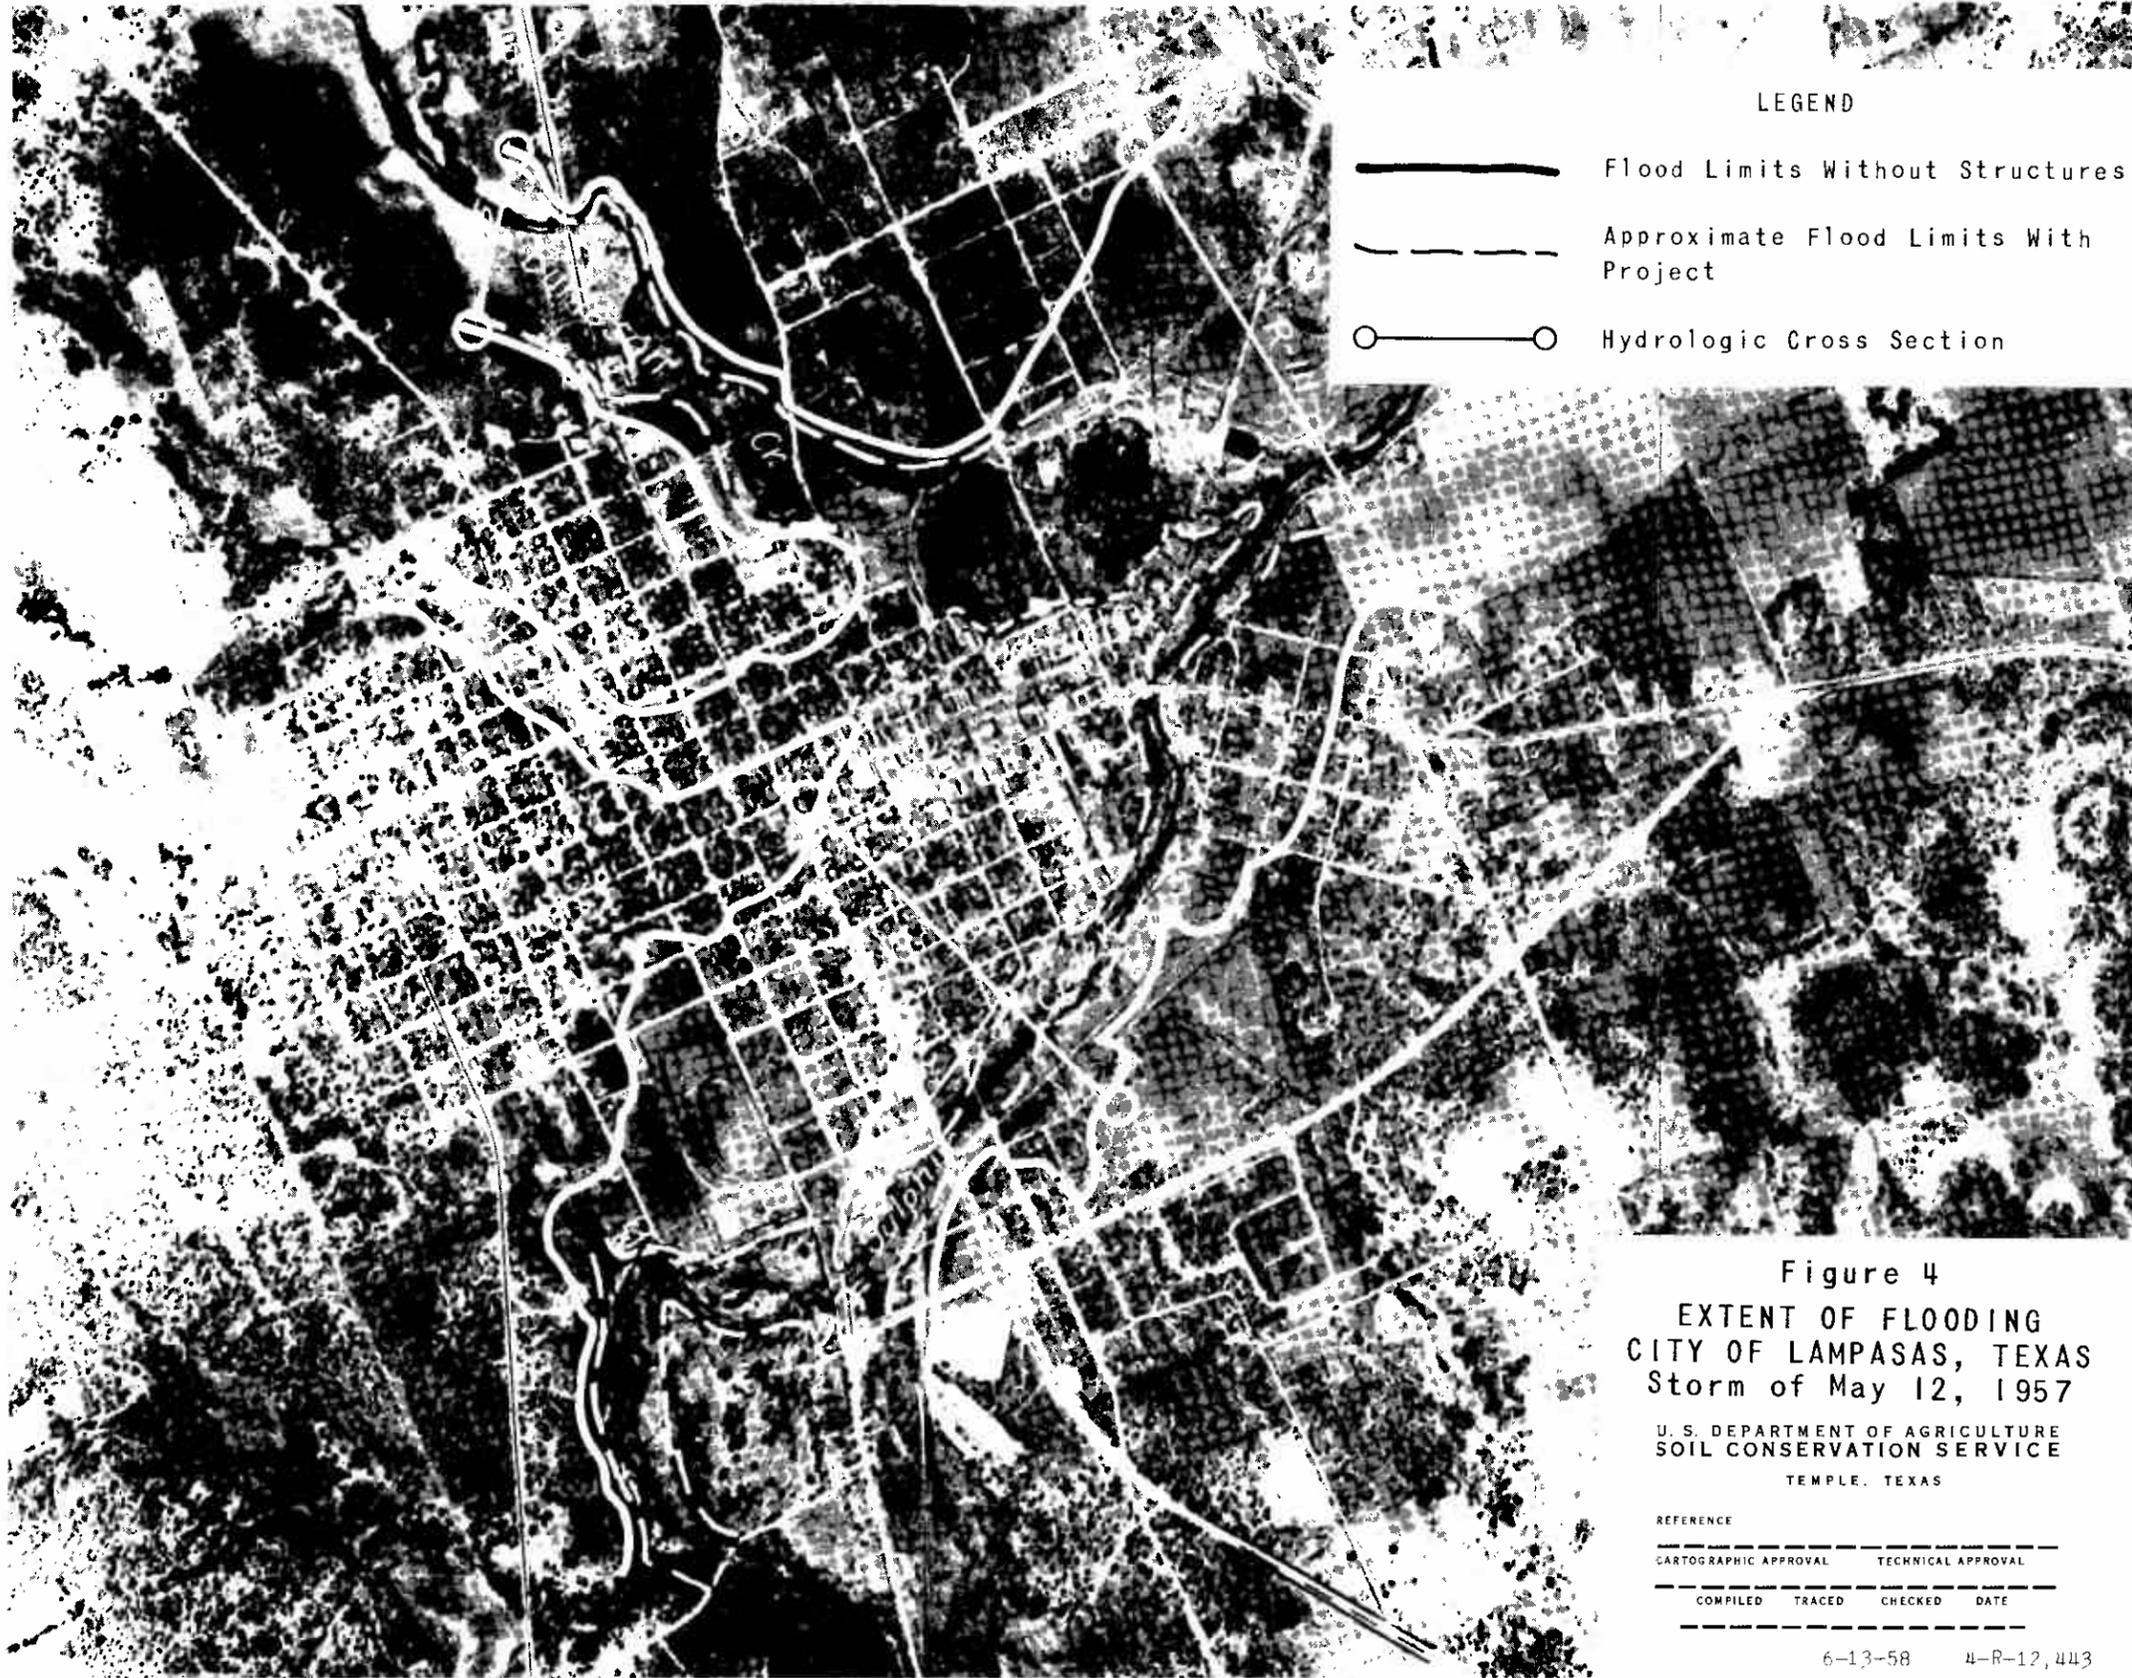
Figure 4
 EXTENT OF FLOODING
 CITY OF LAMPASAS, TEXAS
 Storm of May 12, 1957

Figure 4 shows the extent of flooding in Lampasas as a result of the May 12, 1957 storm. The estimated reduction in width of flooding to be brought about by structures was determined at valley cross sections R-111, L-8, and B-5, by the time conversion method of routing and adjustments, as explained in Section II under Hydraulic and Hydrologic Investigations. Basic determinations of peak discharges with and without the project are as follows:

Interpolated values of discharge were used at 19 additional urban area valley cross sections on Sulphur Creek and 5 on Burleson Creek to determine the extent of flooding with the project installed, figure 4.

It is estimated that a considerable portion of the Burleson Creek flood plain would still be inundated by a storm like the May 12, 1957 storm; however, the area which would be inundated is undeveloped and additional measures can not be justified at this time.

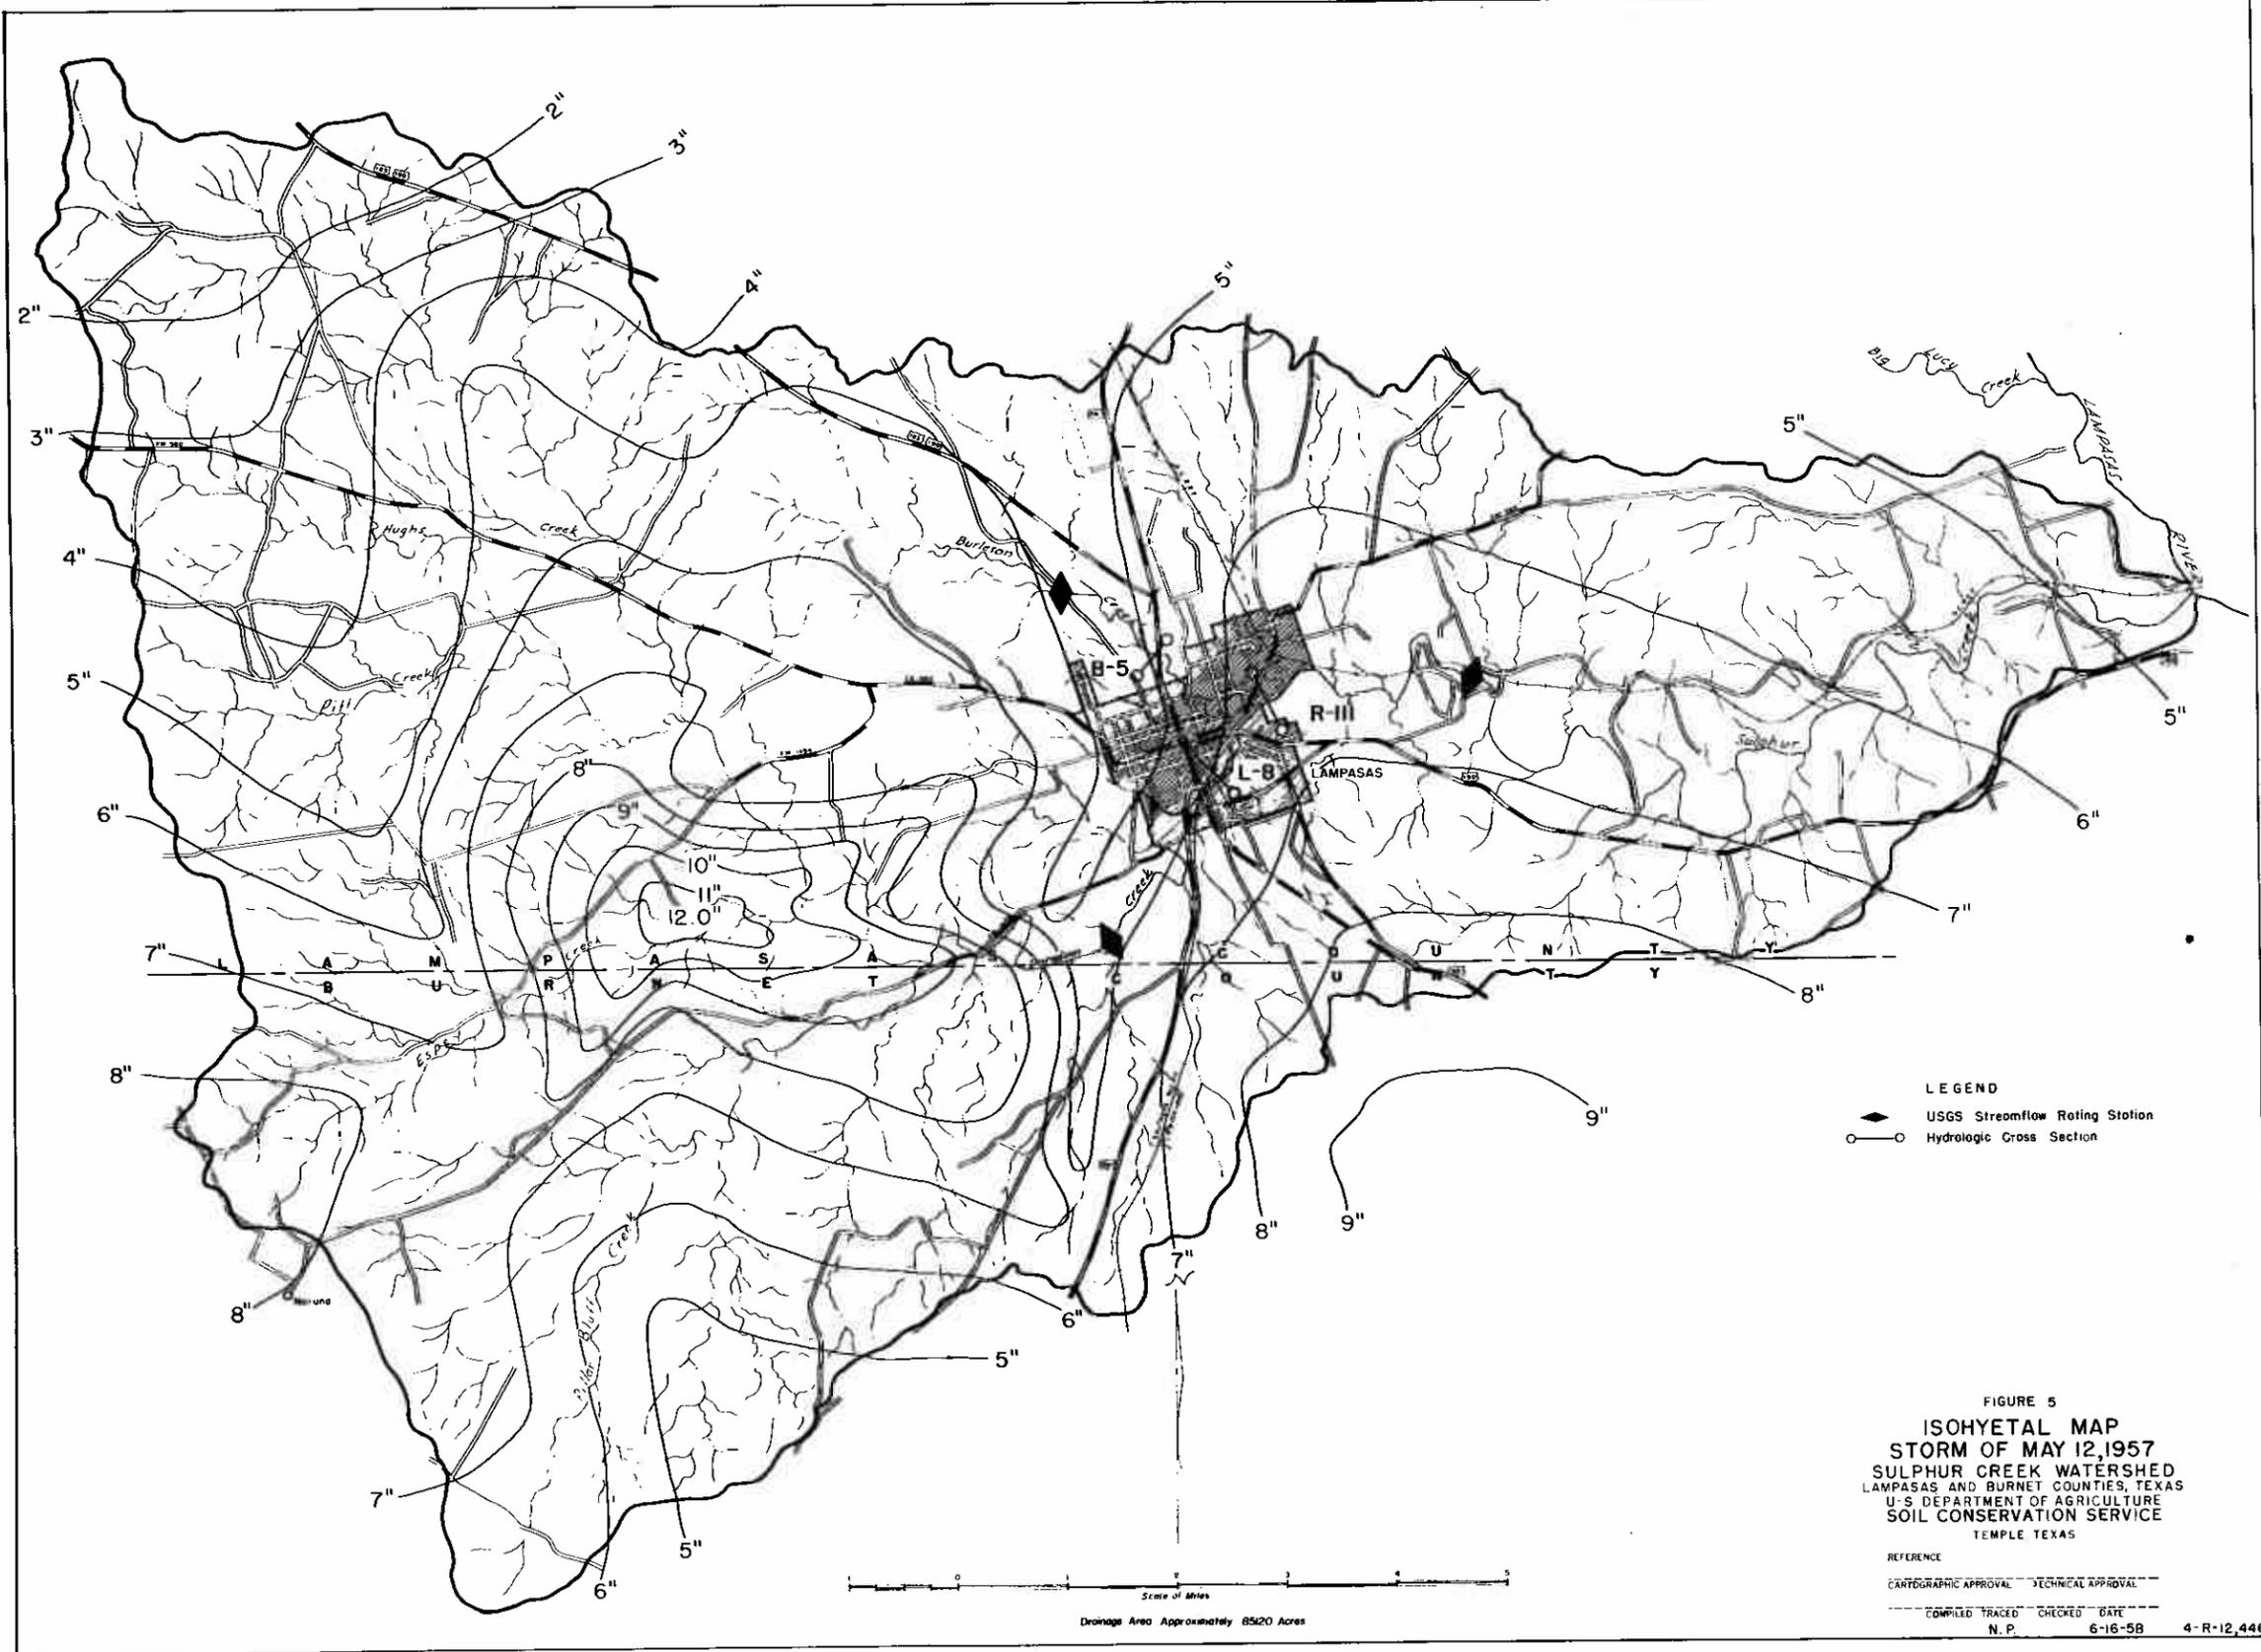
FIGURE 5
ISOHYETAL MAP
STORM OF MAY 12, 1957
SULPHUR CREEK WATERSHED
LAMPASAS AND BURNET COUNTIES, TEXAS
 U.S. DEPARTMENT OF AGRICULTURE
 SOIL CONSERVATION SERVICE
 TEMPLE, TEXAS

The U. S. Weather Bureau and the Soil Conservation Service co-operated in obtaining thirty-three additional bucket survey reports of point rainfall for the same period, ranging from 1.3 to 12 inches. These data were the source of the Isohyetal map shown as figure 5. Weighted rainfall for 29 individual subwatersheds upstream from valley cross section R-111, near Lampasas, ranged from 3.24 to 8.90 inches and averaged 5.89 inches for the total of these areas. If soil moisture condition III is assumed, the computed runoff from the individual subwatersheds ranges from 1.87 to 6.86 inches and for the total area of the 29 subwatersheds it is 4.14 inches. The weighted runoff for the Sulphur and Burleson Creek portions is 4.22 and 3.49 inches, respectively. The weighted runoff from the drainage areas above the proposed floodwater retarding structure sites is given in the following table.
