WORK PLAN

- For Watershed Protection and Flood Prevention

UPPER BOSQUE RIVER WATERSHED

ERATH, HAMILTON, AND BOSQUE COUNTIES, TEXAS

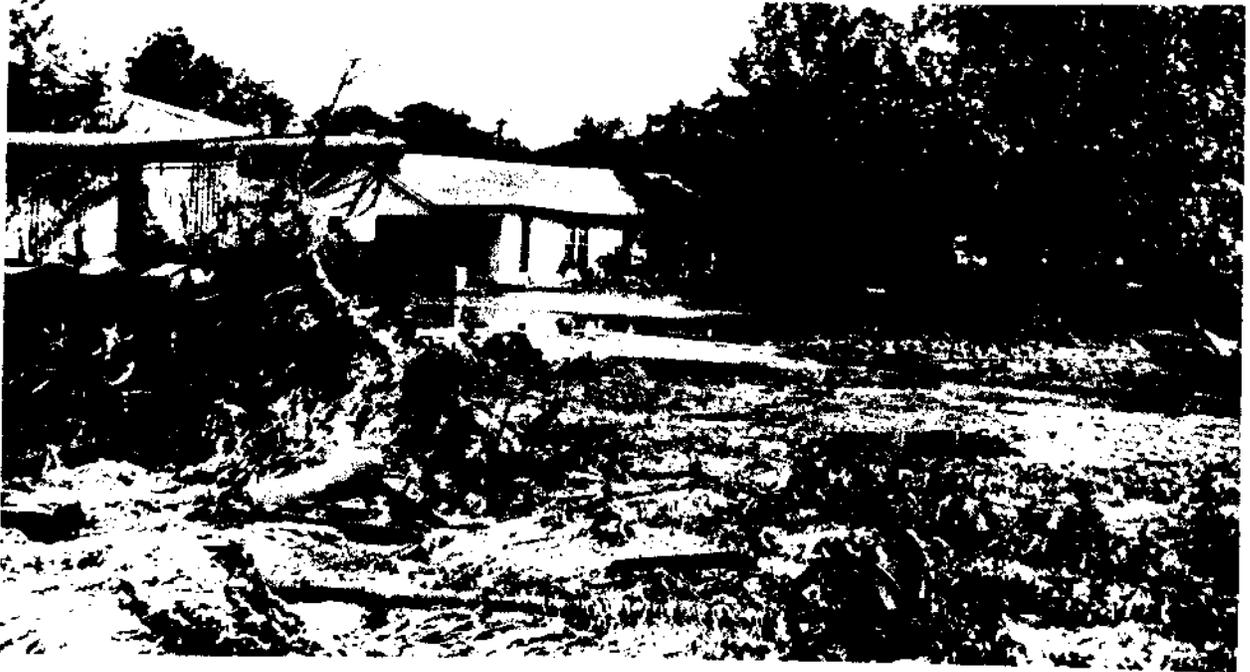
Flood damage in Stephenville as a result of flood of May 18-19, 1955. Water had been two feet deep in house during the night.

In Stephenville the flood of 1955 caused damage to about 45 homes, 10 business establishments, utilities, streets, and parks. Most of the homes and businesses were flooded to depths ranging from a few inches to 4 feet. Damages were estimated to be \$103,842.

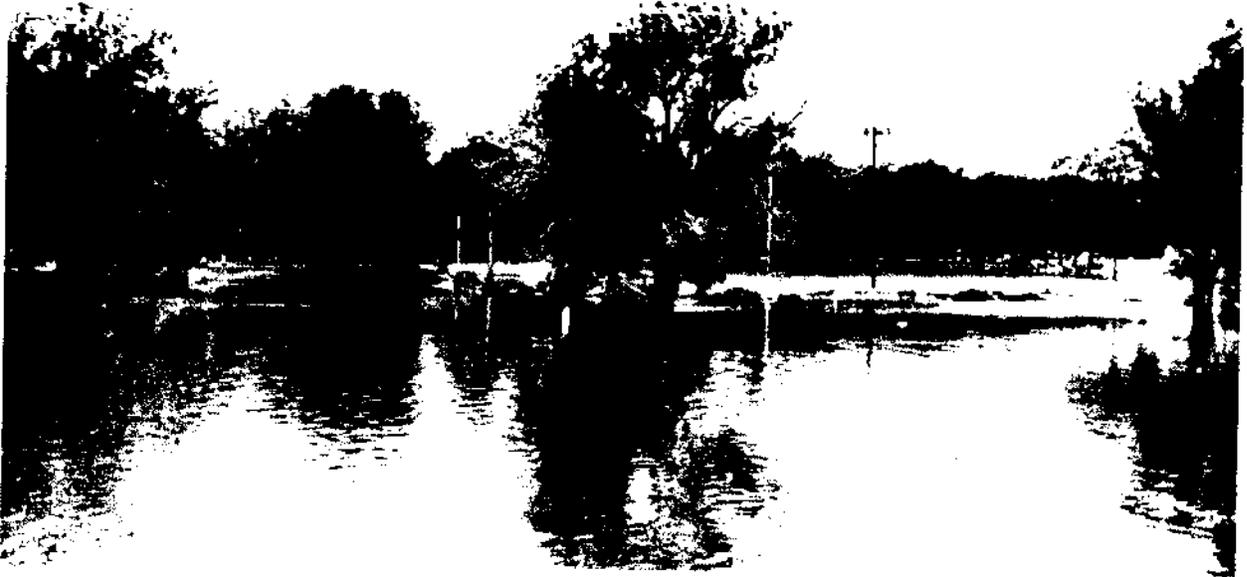
Floodwater in Stephenville Park on morning after flood of May 18-19, 1955. Water had been 3.5 feet higher during the night.

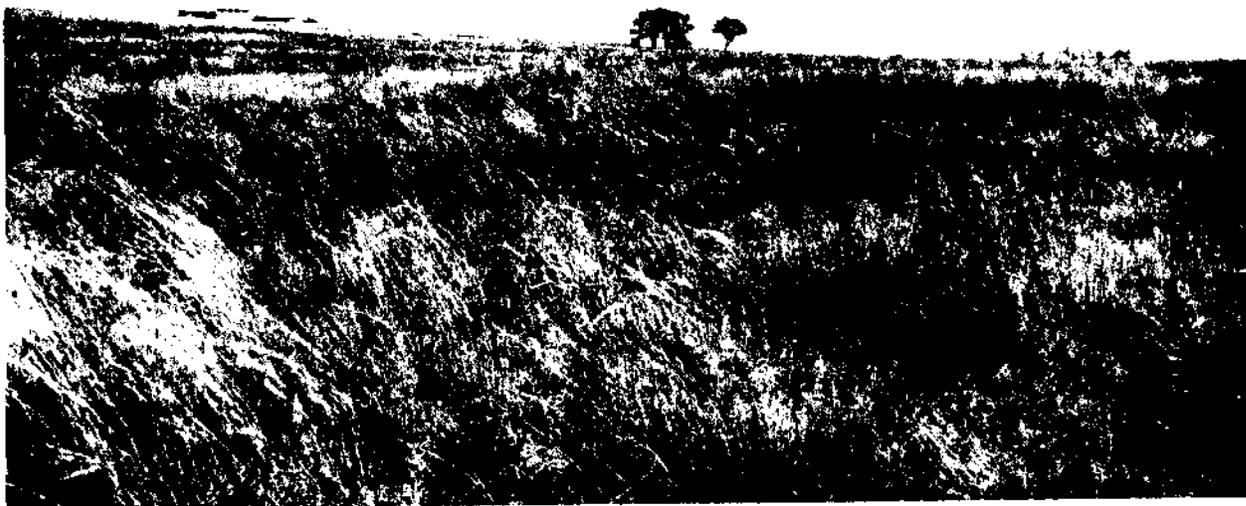
Deferred grazing of rangeland improves grass stands and is effective in slowing runoff and reducing soil erosion.
