Subject: SOI -- Ground-Penetrating Radar Assistance

Date: May 27, 2005

PURPOSE:

Two geophysical tools, ground-penetrating radar (GPR) and electromagnetic induction (EMI), were used to support soil, archaeological, environmental and engineering site assessments in New Hampshire.

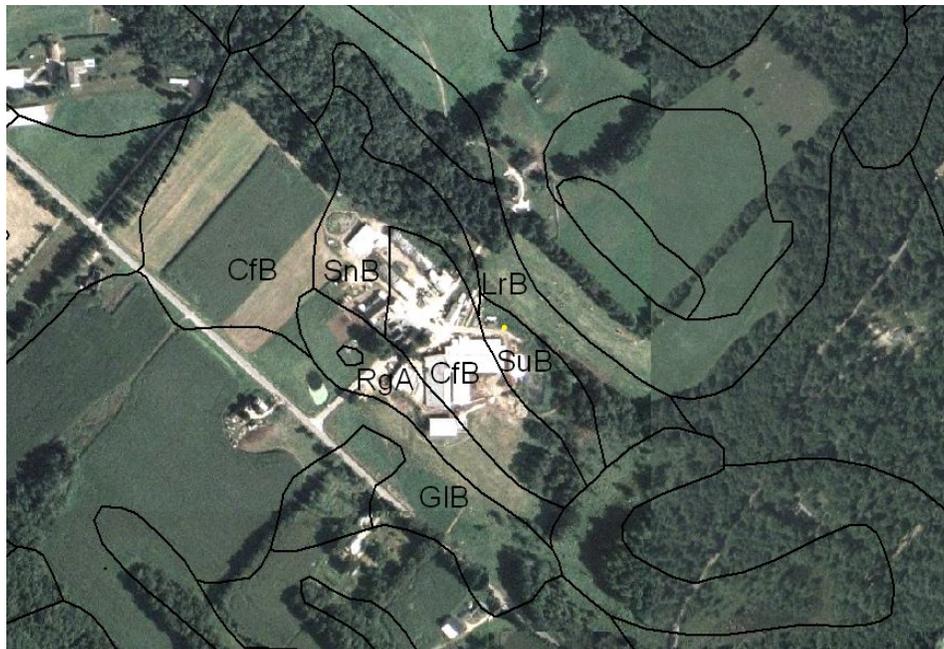
Figure 4. Aerial photograph of the Farm complex showing the soil map unit boundary lines and symbols.

The study site is located about 0.5 miles southeast of Merrill Corner in Rochester County. Two precast concrete structures handle the wastes from 130 milking cows and 100 heifers. Figure 4 is an aerial photograph of the farm complex showing soil boundary lines and pertinent soil map unit symbols. The

first waste storage structure that was surveyed (Site 1) is located on the extreme right (east) of the farm complex (in Figure 4, the building located under the “u” in SuB). The second waste storage structure that was surveyed (Site 2) is located on the extreme bottom (south) of the farm complex (in Figure 4, the southern-most structure located in map unit RgA). Soil map units delineated in the survey area include Charlton fine sandy loam, 3 to 8 percent slopes (M.U. CfB), Gloucester fine sandy loam, 3 to 8 percent slopes (M.U. GIB), Ridgebury fine sandy loam, 0 to 3 percent slopes (M.U. RgA), and Sutton very stony fine sandy loam, 0 to 8 percent slopes (M.U. SuB). These soils formed in till. Ridgebury soil is shallow to densic materials. The taxonomic classifications of these soils are listed in Table 1.

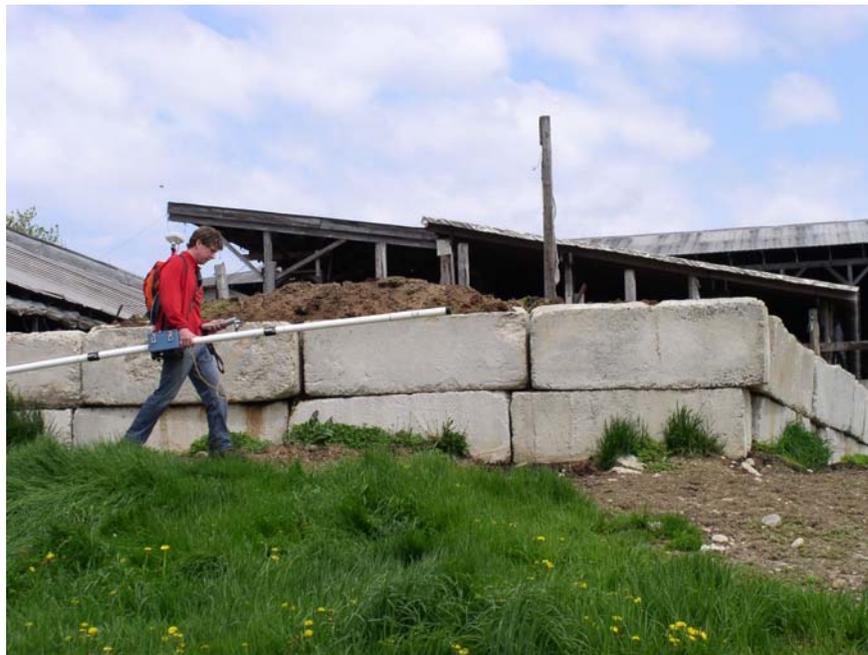
Figure 5. Conducting an EMI agricultural waste survey with an EM31 meter, an Allegro field computer, and a Garmin Global Positioning System Map 76 receiver.

Figure 5 shows the operation of the EM31 meter with the DAS70 system. The EM31 meter was operated in the vertical dipole orientation with geo-referenced, EC_a measurements automatically recorded at 1-sec intervals. The EM31 meter was held at hip-height with its long axis parallel to the direction of traverse. Walking at a fairly brisk pace, in a random back and forth pattern across each survey area completed an EMI survey. Cultural features were avoided where possible. However, interference and anomalous EMI responses from these features are evident near farm structures in the datasets.
