United States Department of Agriculture
Soil Conservation Service

Subject: GEO - Saluda Lake Project

Date: 11 May 1994

To use ground-penetrating radar (GPR) to assist with a bathymetric and sedimentation survey of Lake Saluda in Greenville and Pickens County, South Carolina.

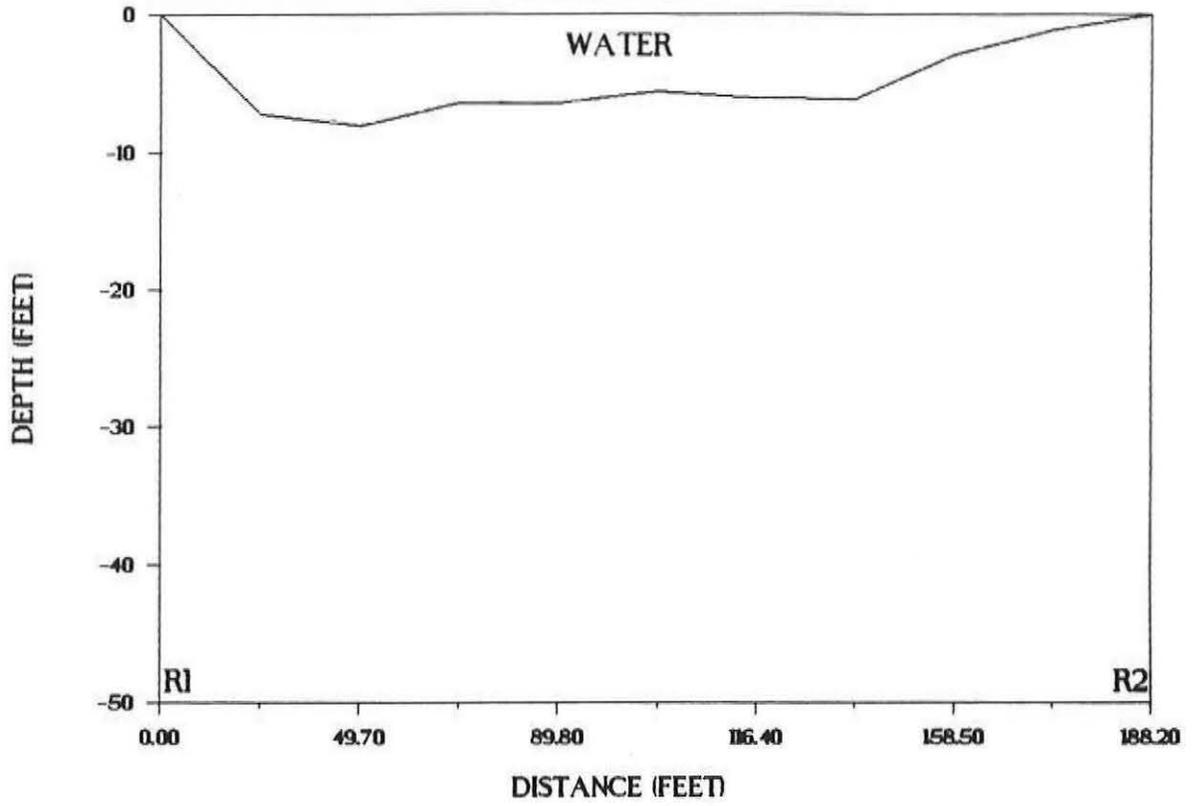
RANGE LINE #18

BATHYMETRIC SURVEY OF SALUDA LAKE

Cross-sectional profiles of each range line are shown in Figures 3 through 11. These profiles show the depths of water along each range line. These profiles have been prepared from radar interpretations. For each profile, the end points shown in Figure 1 have been indicated.

The major sub-bottom interface was not detected on range lines 10 through 18. For range lines 10 through 18, it is conceivable that the bottom sediments became either too thick to be profiled with GPR or became too electrically similar with the underlying deposits and were therefore not detectable.
