Subject: ENG -- Electromagnetic Induction (EMI) Assistance

Date: 1 August 2006

Electromagnetic induction (EMI) was used to assess the structural integrity and potential seepage from an animal waste lagoon in Otsego County, New York.

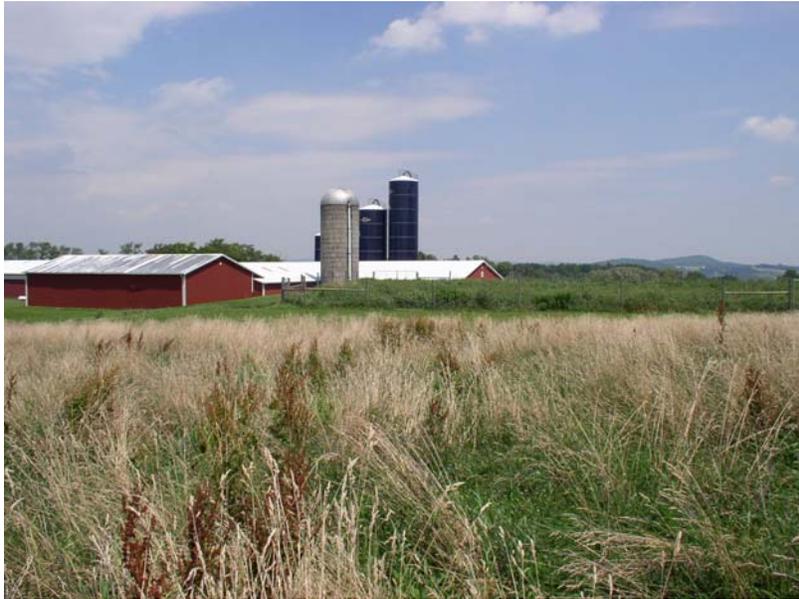
Figure 1. View from the west of the manure storage lagoon (higher ground enclosed by fence) and farm structures in the background (northeast).

Separate surveys were conducted with each meter. Each meter was operated in vertical dipole orientation and continuous mode with measurements recorded at 1-sec intervals. The EM31 meter was held at hip-height with its long axis parallel to the direction of traverse. The EM38 meter was held about 5 cm (2 inches) above the ground surface and orientated with its long axis parallel to the direction of traverse. Each survey was completed by walking at a rather slow and uneven pace, in a random back and forth pattern across the more accessible portions of survey area. Cultural features, such as buildings, farm implements, and fence lines, were avoided where possible. Areas accessible to EMI were restricted at this site. The survey was hindered by multiple fence lines, dense undergrowth and uneven ground surfaces. Farm buildings, machinery and other artifacts were present within the survey area and produced unwanted background noise if approached too closely (see Figures 1 & 2).

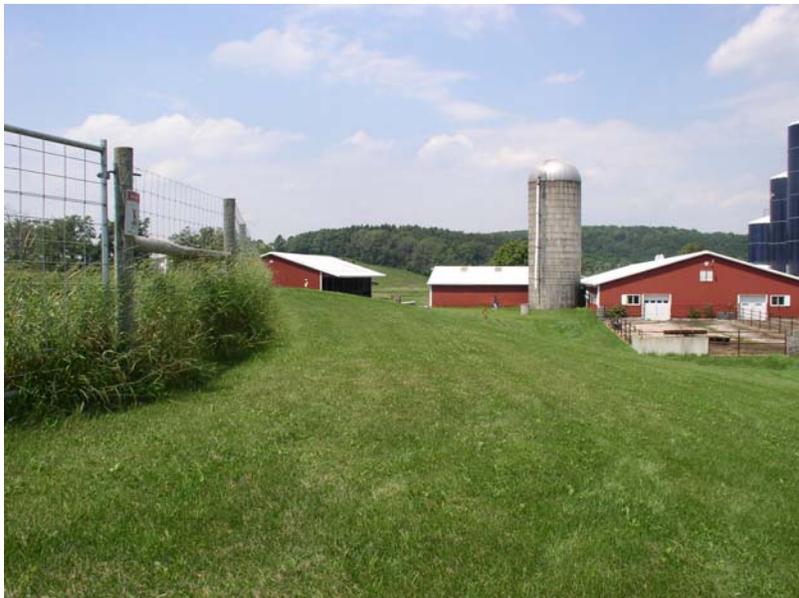
Figure 2. View from the south of the manure storage lagoon (higher ground enclosed by fence) with farm structures in the background (north).

Elevated EC_a was evident in the EM38 data along the higher-lying portions of the manure storage lagoon’s embankment. Two areas on the down slope side of the lagoon (right-hand side in Figure 6) suggest possible routes of discharge from the lagoon. In Figure 2, these areas have been highlighted with directional arrows.

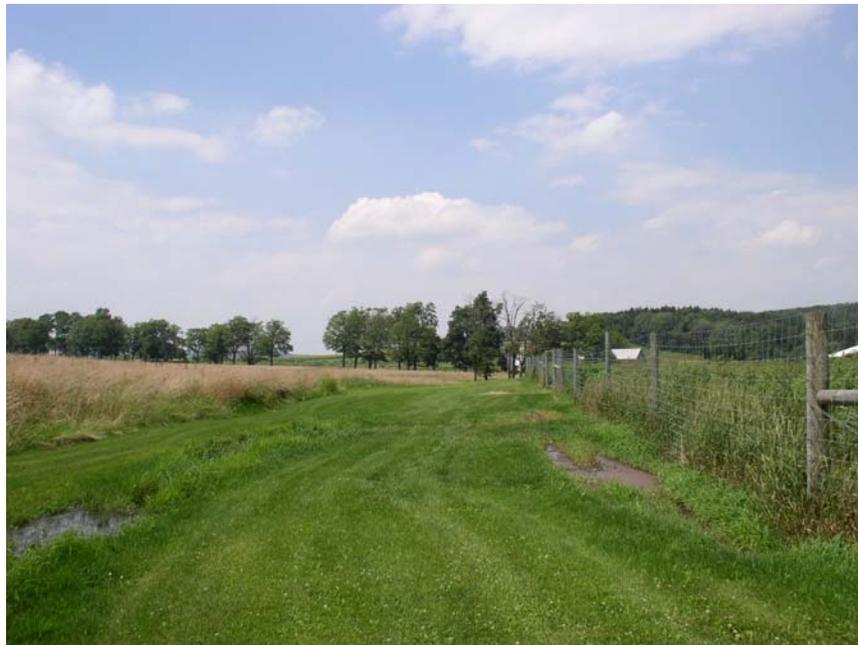
Figure 3. View from the south of the manure storage lagoon (area on right that is enclosed by a fence) showing areas with standing water.

A larger area was surveyed with the deeper-sensing (0 to 6 m) EM31 meter than with the shallower-sensing (0 to 1.5 m) EM38 meter. The EM31 meter was used to locate potential areas of seepage; the EM38 meter was used to assess overland flow from the manure storage lagoon. Recent catastrophic rains have caused the manure storage lagoon to overflow in some areas. Standing waters were observed adjacent to the structure and along drainage lines (see Figure 3).

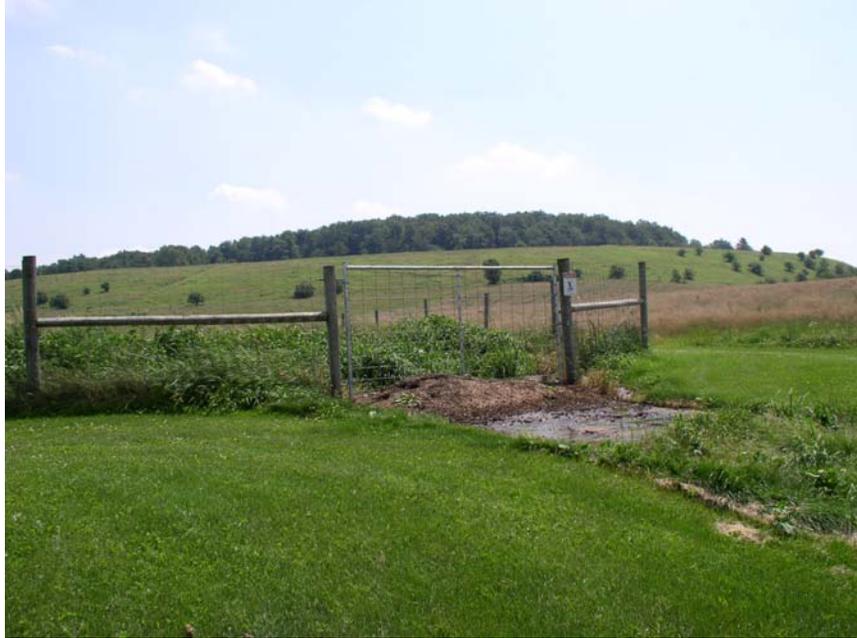
Figure 5 shows the concrete pad that is located on the northwest corner of the manure storage lagoon. Here, EMI traverses approached the fence (with gate) too closely and crossed the concrete pad (with standing water and manure). These factors were responsible for the anomalous EC_a that was observed at “A” in Figure 4.

Figure 5. Anomalously high EC_a were observed in this corner of the manure lagoon. The metal fence and concrete pad produced unwanted interference and caused the elevated EMI responses.

high EC_a readings were attributed to passing too close to the encompassing fence or crossing a concrete pad, which was located in the northwest corner of the lagoon (see Figure 5).
