**Subject:** Soils-Geophysical Field Assistance

**Date:** 22 July 2008

Approximately 12 acres of land at the southern end of Lake George is being purchased by Warren County, the town of Lake George, and three environmental groups (Lake George Association, Lake George Land Conservancy, and the Land Conservancy Fund). The goals of the *West Brook Project* are to restore much of the purchased area to a wetland with walking paths and gardens (*north parcel*), and to construct a storm water treatment facility (*south parcel*). During Colonial times, much of the site was a marsh. Historically, the project area was repeatedly used by military forces during the French and Indian (1754-1763), American Revolution (1775-1783), and the War of 1812 (1812-1815). After this period of military use, the area was subjected to multiple episodes of filling, grading, and different land use. The Lake George Association and the State Historic Preservation Officer's Office want to confirm that the depths to the buried marsh sediments and associated archeological artifacts that may be disrupted by this project. Additionally, the environmental assessment of the site seeks to identify the nature and extent

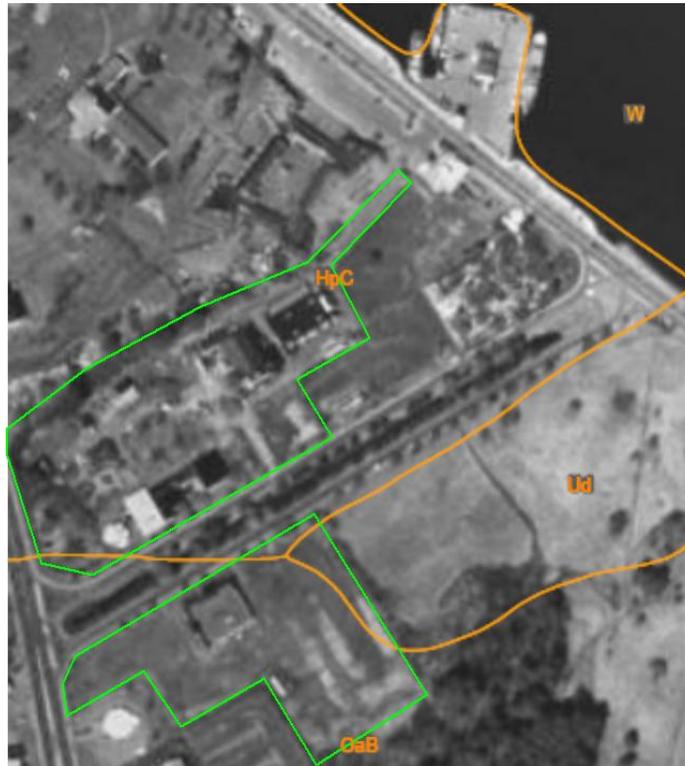
Figure 1 is a soil map of the *West Brook Project* area. Soils polygons identified within the site include: Hinckley-Plainfield complex, sloping (HpC), Oakville loamy fine sand, 3 to 8 percent slopes (OaB,) and Udorthents, smoothed (Ud). The very deep, excessively drained Hinckley and Plainfield soils formed in water-sorted sandy materials. Oakfield soils formed in sandy aeolian deposits. Hinckley soils contain large amounts of coarse fragments. Within the solum, rock fragments range from 5 to 50 percent gravel, 0 to 30 percent cobbles, and 0 to 3 percent stones. Plainfield soils contain less than 15 percent gravel. Oakville soils lack coarse fragments and

Figure 1. Soil map of the *West Brook Project* area from the Web Soil Survey. Areas in green represent the *north* and *south* parcels.

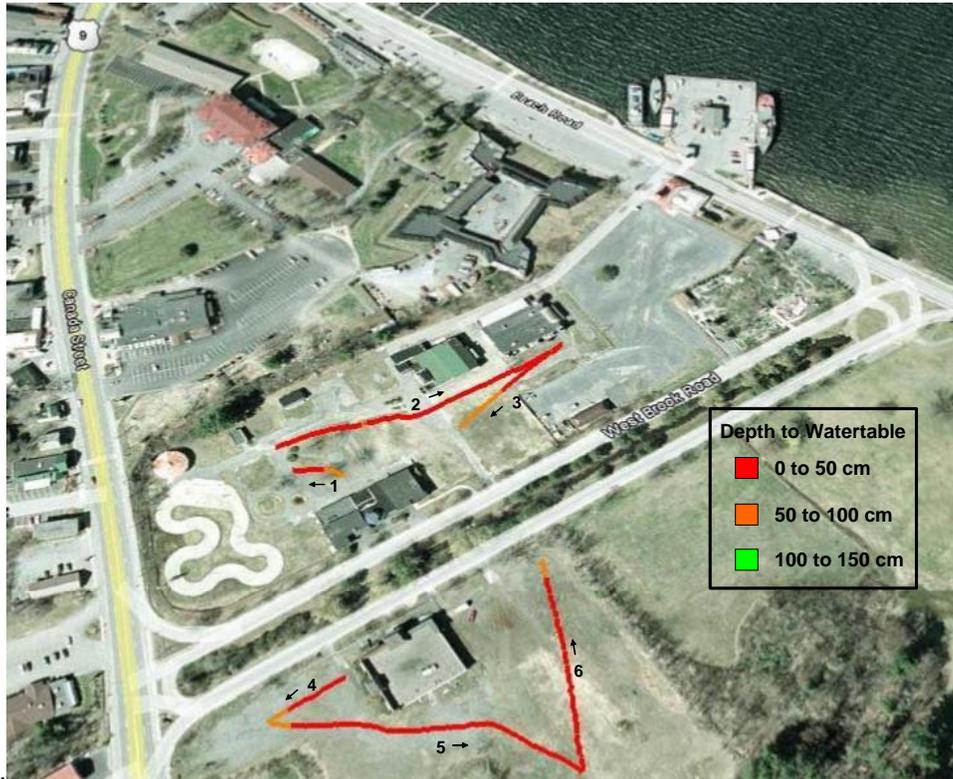
The locations of the six GPR traverse are shown in Figure 2. In Figure 2, each radar traverse is labeled and the direction of advance indicated by an arrow. Different colors show the relative depths to the water table along these lines. These depths were confirmed at five monitoring wells, which were the end points for five of the six GPR traverses. Reflections from the water table provided an identifiable interface that could be traced across each radar record with relative confidence. In Figure 2, the depths to water table are grouped into three depth classes: shallow (less than 50 cm (20 inches), red), moderately deep (50 to 100 cm (20 to 40 inches), orange) and deep (100 to 150 cm (40 to 60 inches), green).

Figure 2. Locations of GPR Traverse lines and depth to water table interpretations.

Figures 3 to 7 represent 3D images of the radar records collected in this study. In each images the depth and distance scales are in meters. The identities and locations of the traverse lines are shown in Figure 2. In addition, at the bottom of each 3D image, locations are identified by Universal Traverse Mercator (UTM) coordinates. Traverse lines 1 to 3 were conducted within a polygon of Hinckley-Plainfield complex, sloping (HpC), in the *north parcel*. Traverse lines 4 to 6 were conducted within a polygon of Oakville loamy fine sand, 3 to 8 percent slopes (OaB), in the *south parcel*.

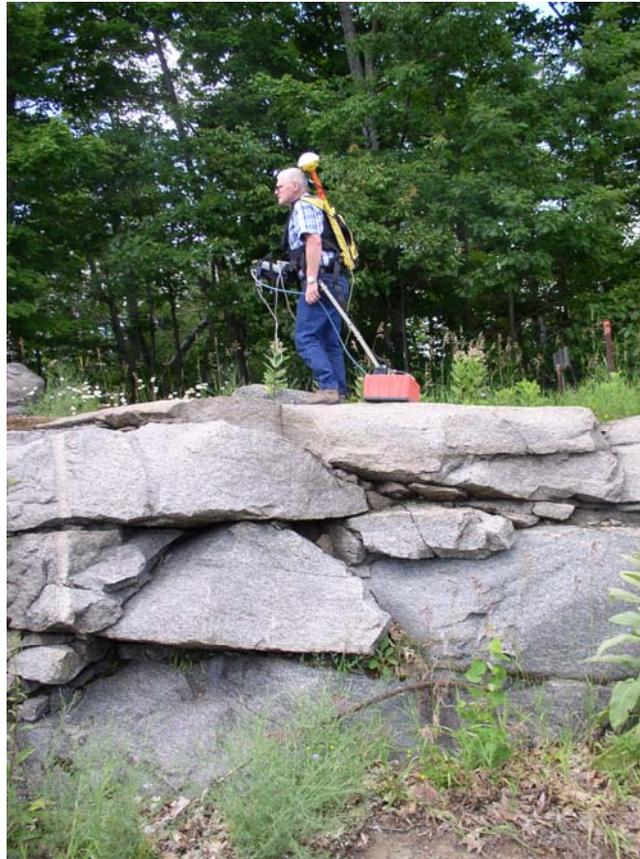
The photograph in Figure 8 shows a radar traverse being conducted with a 400 MHz antenna near the face of the exposed granitic-gneiss outcrop. Horizontal cracks are evident in this photograph. Narrow, vertically inclined fractures were noticeable on the face of this exposure. In general, vertical fractures are markedly narrower and less obvious than the horizontal joints or cracks.

Figure 9. Conducting a radar traverse with the 400 MHz antenna across an exposure of granitic gneiss on Prospect Mountain.
