**Subject:** Soils – Geophysical Field Assistance

**Purpose:**

The purpose of this visit was to work with Don Keirstead and conduct electromagnetic induction (EMI) surveys of two agricultural waste sites in Grafton County. During this visit setup, calibration, and survey procedures for the newly acquired EM38MK2-1 meter were reviewed with Don Keirstead.

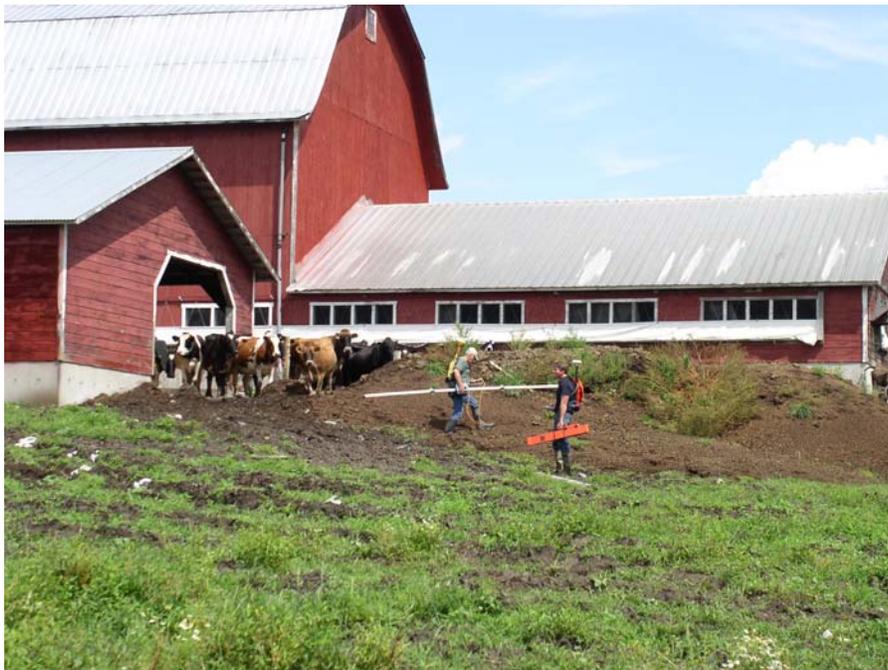
*Figure 1. Jim Doolittle operates EM31 meter as Don Keirstead pauses momentarily in his survey with an EM38MK2-1 meter.*

The EM31, EM38MK2-1, and Profiler EMP-400 meters were used in this study. The EM31 and EM38MK2-1 meters (see Figure 1) are manufactured by Geonics Limited (Mississauga, Ontario).<sup>1</sup> Both meters require only one person to operate. No ground contact is required with either meter. Lateral resolution is approximately equal to the meter's intercoil spacing. Apparent conductivity is typically expressed in milliSiemens/meter (mS/m).

McNeill (1980b) has described the principles of operation for the EM31 meter. The EM31 meter has a 3.66-m (12-ft) intercoil spacing and operates at a frequency of 9,810 Hz. The meter weighs 12.4 kg (27 lbs). When placed on the soil surface, the EM31 meter provides theoretical penetration depths of about 6-m (19-ft) in the vertical dipole orientation (McNeill, 1980b).

The EM38-MK2-1 meter operates at a frequency of 14,500 Hz and weighs about 5.4 kg (11.9 lbs). The meter has one transmitter and receiver coil that are separated at a distance of 1.0 m. This configuration provides nominal penetration depths of about 1.5 and 0.75 m in the vertical and horizontal dipole orientations, respectively. The EM38-MK2-1 meter, in either dipole orientation, provides measurements of both the quadrature-phase ( $EC_a$ ) and the in-phase (susceptibility) components. Operating procedures for the EM38-MK2-1 meter are described by Geonics Limited (2007).

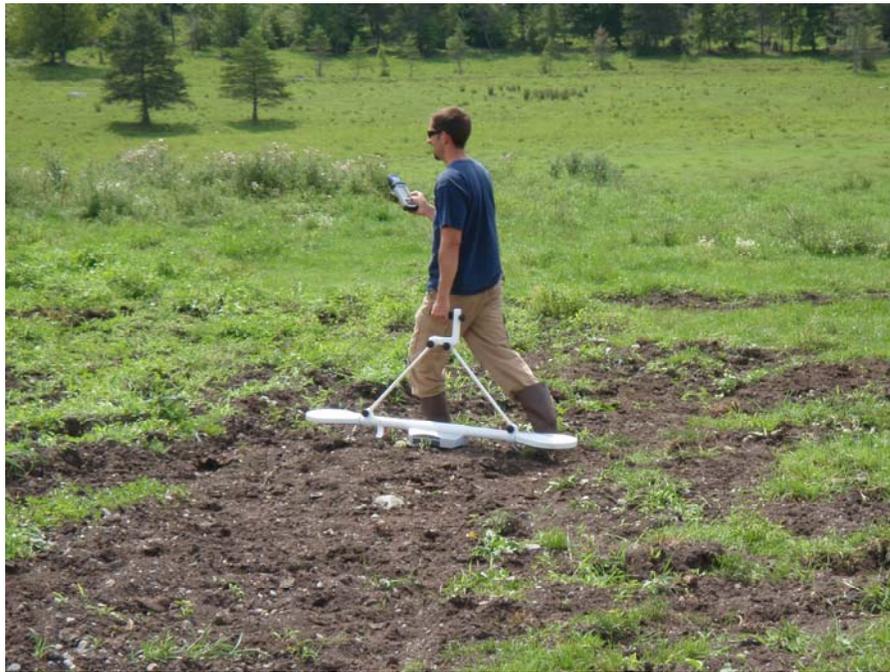
Figure 2. Brian Jones of GSSI operates a Profiler EMP-400 multi-frequency sensor.

The Profiler EMP-400 multi-frequency conductivity meter is manufactured by Geophysical Survey Systems Inc (Salem, NH). This system is comprised of a transmitter, receiver, electronics enclosure, and PDA. The meter weighs 5.5 kg (9.9 lbs), has a 1.21 m (4 ft) intercoil spacing. It is charged by a re-chargeable Lithium Ion battery or 8 (eight) AA batteries. The Profiler EMP-400 multi-frequency conductivity meter (see Figure 2) can be configured to simultaneously measure up to 3 frequencies between 1000 Hz and 16,000 Hz, in either the vertical or horizontal dipole mode. All survey acquisition parameters, GPS coordinates and EMI data are stored in an internal memory. Files are structured in Excel spreadsheet format (ASCII text file) for simple downloading to a PC for presentation in GIS.

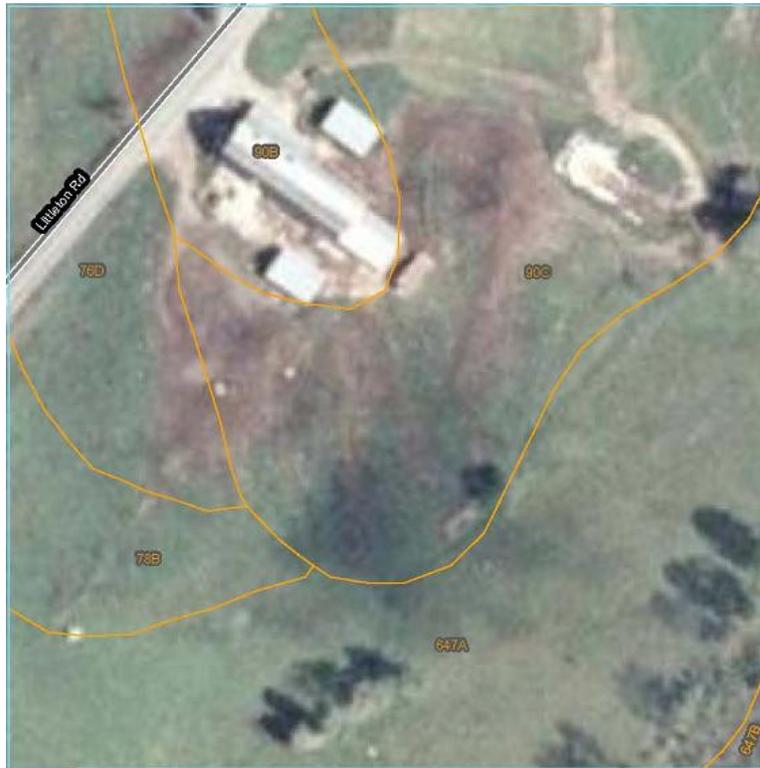
Figure 3. This soil map from the Web Soil Survey shows the area that was surveyed at the Morrison Farm.

The second site is at the farm of Mark Morrison, which is located on Littleton Road in Monroe, New Hampshire (see Figure 3). Mark Morrison operates a certified organic dairy with approximately 50 heads of mixed breed Jersey-Holstein. The present manure storage is inadequate and long-term barnyard issues of traffic and roof-runoff have contributed to nutrient runoff into an adjacent wetland/ wet meadow. In addition, milk-house waste-water discharges into this wetland/ wet meadow. Mark will be applying for assistance to install a manure storage facility and other barnyard improvements.

The area surveyed at the Mark Morrison farm is in pasture. The survey area was principally located in a delineation of Tunbridge-Lyman complex, 8-15 % slopes (90C), but included areas of Marlow fine sandy loam, 15-25% slopes (76D), and Tunbridge-Lyman complex, 3-8 % slopes (90B). A large wetland area of Pillsbury fine sandy loam, 0-3 % slopes, very stony (647A), is located to the east and south of the survey area. The shallow, somewhat excessively drained Lyman and the moderately deep, well drained Tunbridge soils formed in a thin mantle of till overlying frost fractured schist, phyllite, granite or gneiss bedrock on glaciated uplands. The well drained Marlow soils formed in loamy till on glaciated uplands. Marlow soils are moderately deep to a densic contact and very deep to bedrock. The very deep, poorly and somewhat poorly drained Pillsbury soils formed in compact, loamy till on glaciated uplands. Pillsbury soils are shallow or moderately deep to a densic contact and very deep to bedrock. Because of low clay and soluble salt contents, and the relatively shallow depths to electrically resistive bedrock, these soils have low apparent conductivity. Because of wetness caused by a perched, fluctuating water table that is at or near the soil surface, Pillsbury soils should have a slightly higher conductivity. The taxonomic classifications of the soils named at each site are listed in Table 1.

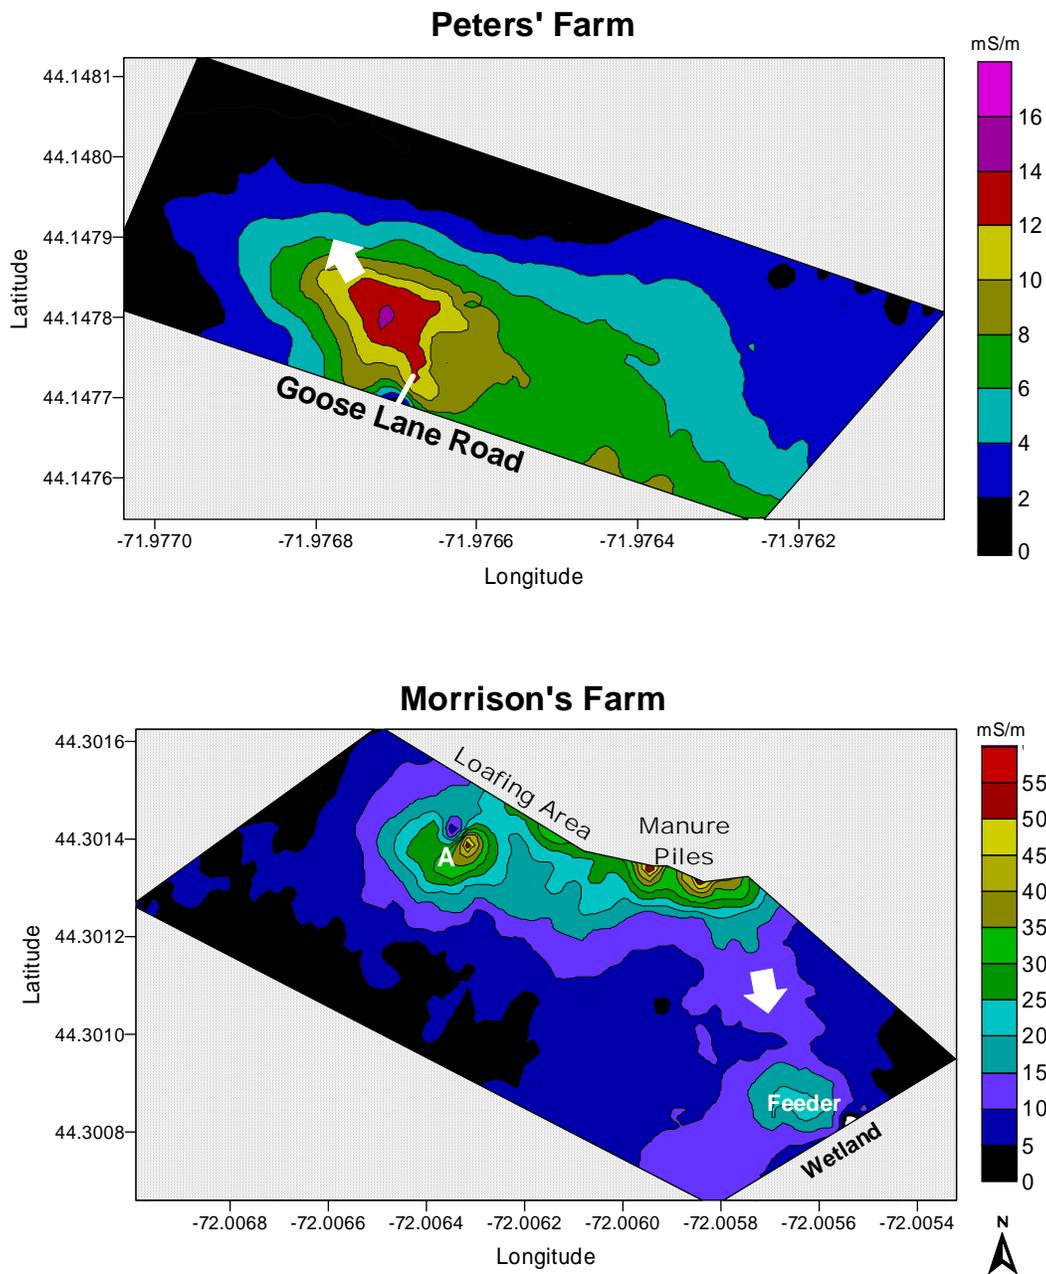
Figures 4 show two plots of EC<sub>a</sub> data collected with the EM31 meter in the deeper-sensing (0 to 5 m), vertical dipole orientation at the two sites. The same color ramp, but different scales have been used in these plots. In each plot, the black-colored and possibly the dark blue-colored polygons are assumed to represent natural background levels of EC<sub>a</sub>.

At the Peters' Farm site (upper plot in Figure 4), the EMI survey was restricted on the south by Goose Lane Road. In Figure 4 (upper plot), the white-colored line extending into the field from Goose Lane Road represents the location of the offending culvert. This culvert is indicated by a black arrow in Figure 5. Also evident in Figure 5 is the portion of the corn field that is most noticeably affected by the animal wastes.

In Figure 4 (upper plot), a white arrow indicates the direction (northwest) of observed surface runoff across the field. Spatial patterns in this plot do confirm that a zone of higher EC<sub>a</sub> (> 10 mS/m) does extend outwards in a west north-westerly direction from the culvert. A larger zone of moderate EC<sub>a</sub> (6 to 10 mS/m) appears to extend outwards from the culvert, but more noticeably along the road in an east south-easterly direction. While the reasons for this zone are unclear, the pattern may be attributed to deeper seepage, the affects of road salts, or variations in soil properties. While the area most affected by animal wastes is evident in this plot, the concentrations of wastes mapped by EMI must be determined by ground-truth measurements.

At the Morrison's Farm site (lower plot in Figure 4), the EMI survey revealed comparatively high (>25 mS/m) values of EC<sub>a</sub> adjacent to the loafing area for the herd and the manure piles. In addition two areas of livestock gathering are evident: 1) along the crest of the ridge near the loafing area (see "A" in Figure 4), and 2) at a feeder located midway down a side slope (see "Feeder" in Figure 4). These areas have conspicuous accumulations of animal-wastes on the soil surface, which contribute to these higher EC<sub>a</sub>. A noticeable plume-like pattern extends in a south south-westerly, down slope direction from the area of the manure piles, past the feeders, and into the adjoining wetland area (see arrow in lower plot of Figure 4). Values of apparent conductivity within this plume-like strip are only between 10 and 15 mS/m, but are higher than the more unaffected (by waste products) background areas in this plot, which are less than 10 mS/m. As this strip of higher EC<sub>a</sub> contains several wetter, seepage areas, the cause of the increased conductivity can be attributed to greater moisture and/or nutrient contents. Once again, EMI has provided evidence of the spatial distribution of contaminants, but conclusions as to the significance of these patterns must await ground-truth sampling and verification.

Figure 4. Plot of  $EC_a$  data collected with the EM31 meter operated in the vertical dipole orientation at the Peters' (upper plot) and Morrison's (lower plot) Farms.

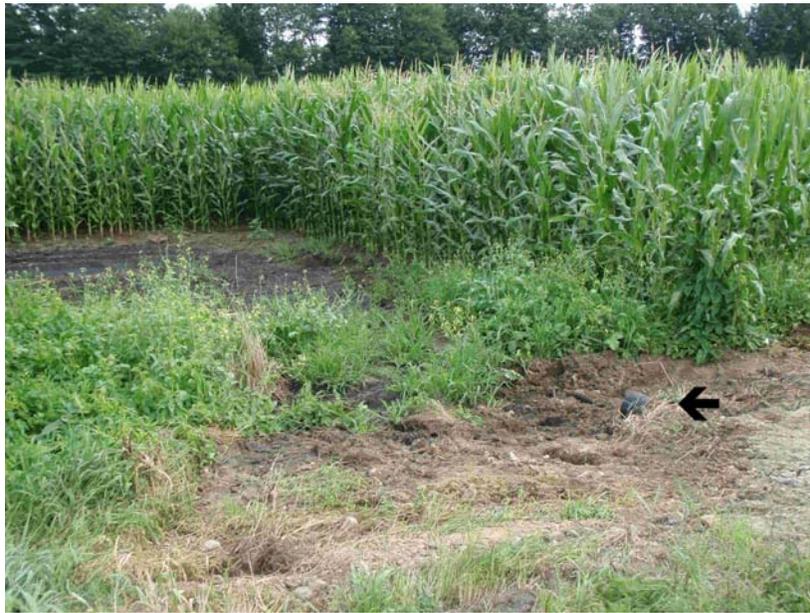
*Figure 5. This image shows the portion of the Peters' corn field that is most affected from discharge of animal wastes from a culvert (see arrow).*
