# *A Guide for Planning Riparian Treatments in New Mexico*

New Mexico Natural  
Resources Conservation  
Service

September 2007

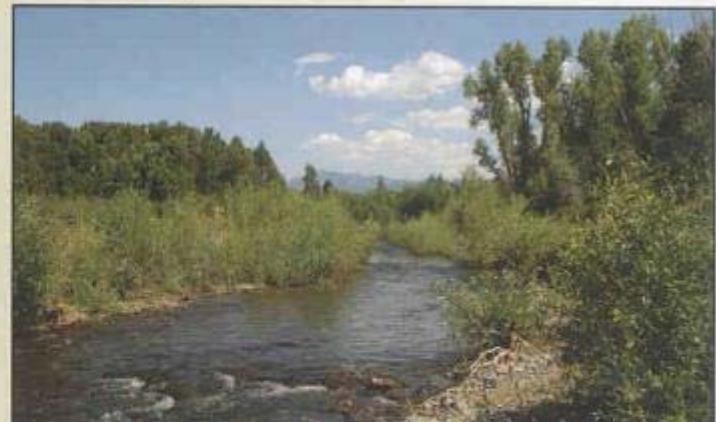
Photo 3 – No hydrologic alterations, Rio Chama, Rio Arriba County

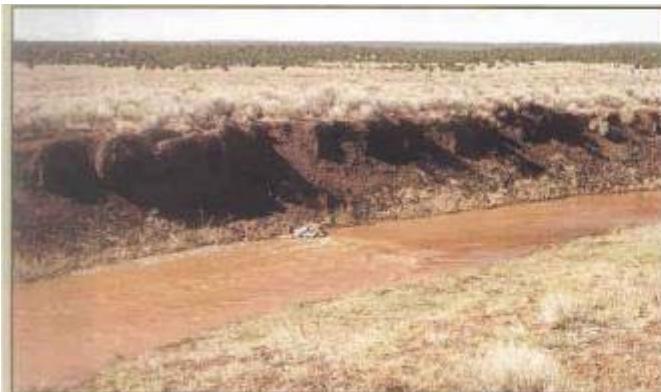
Photo 4 – Incised channel with unstable banks, Cottonwood Creek, McKinley County

**Channel Condition** – Channels that are stable are in balance with their landscape position. Channel form is dependent on gradient, substrate size, and watershed discharge. Depending on stream type, a healthy channel has a characteristic width depth ratio, access to its floodplain, and incisionment ratio.

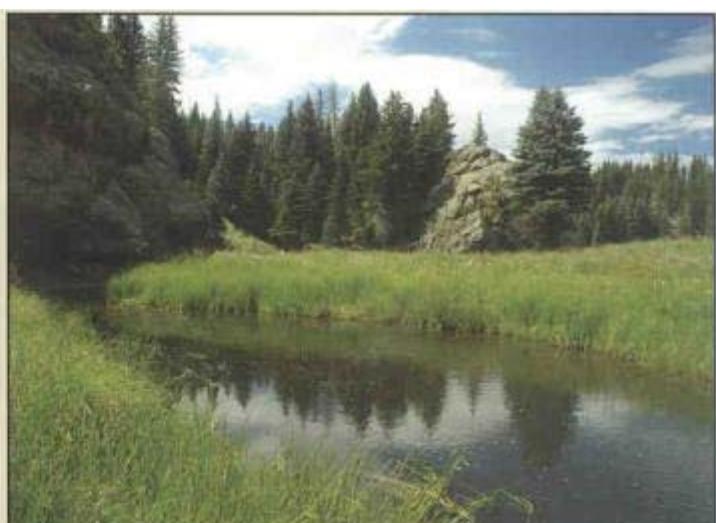
Photo 8 – Stable bank, East Fork of Jemez River, Sandoval County

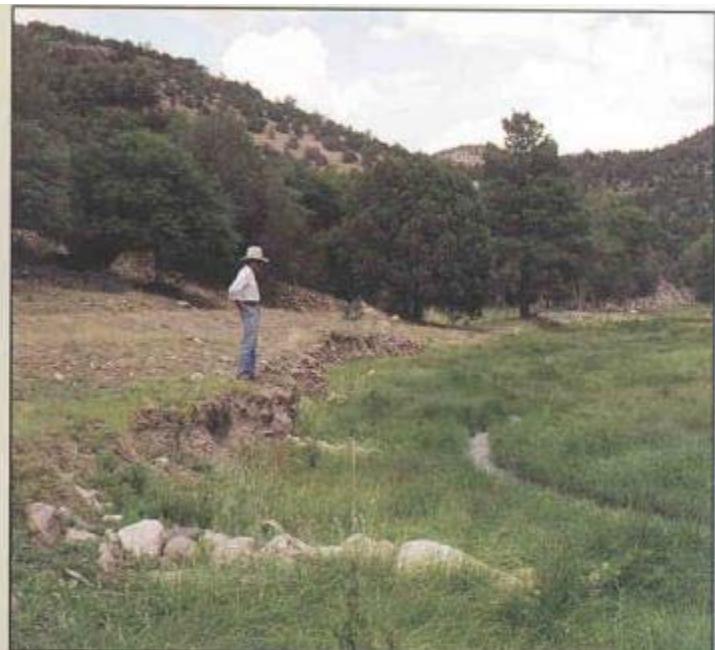
Photo 10 – Riparian area widening inward, channel narrowing, Taylor Creek, Catron County

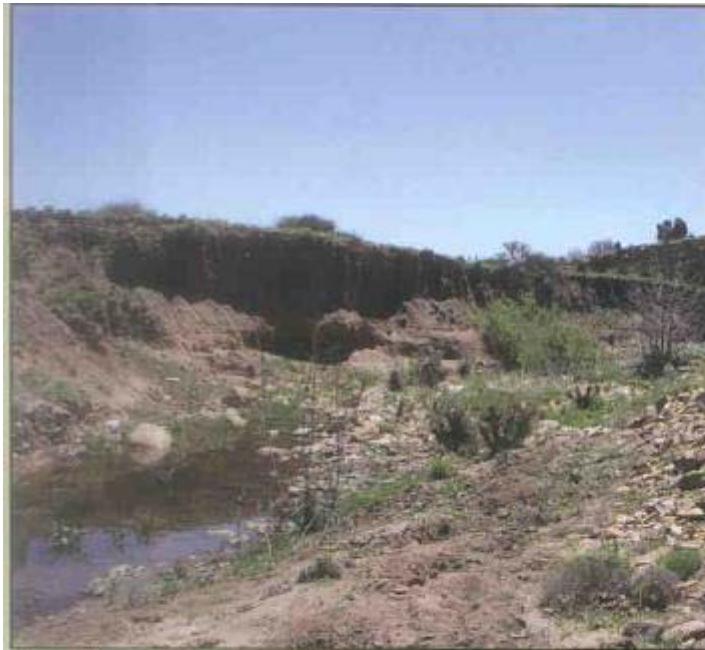
Photo 13 – Poor rooting medium due to erosion of channel and flood plain materials, Harding County

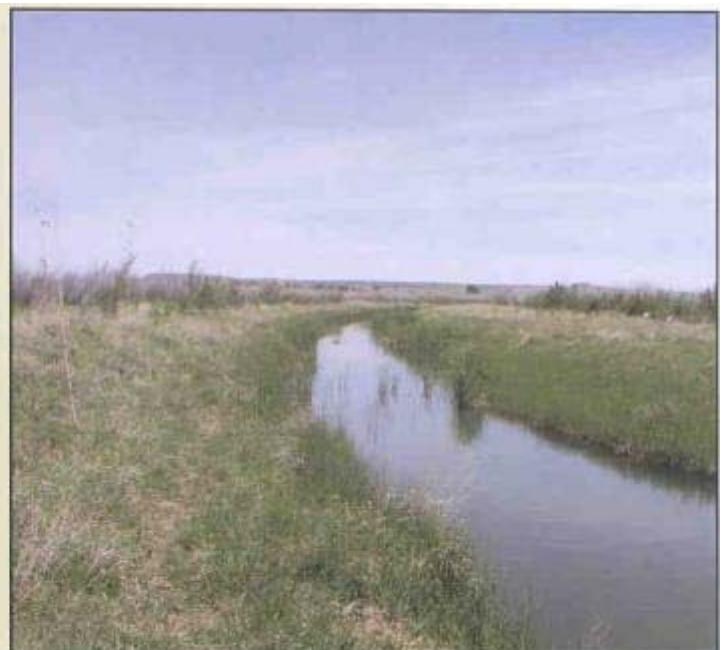
Photo 14 – Adequate rooting medium, Ute Creek, Harding County

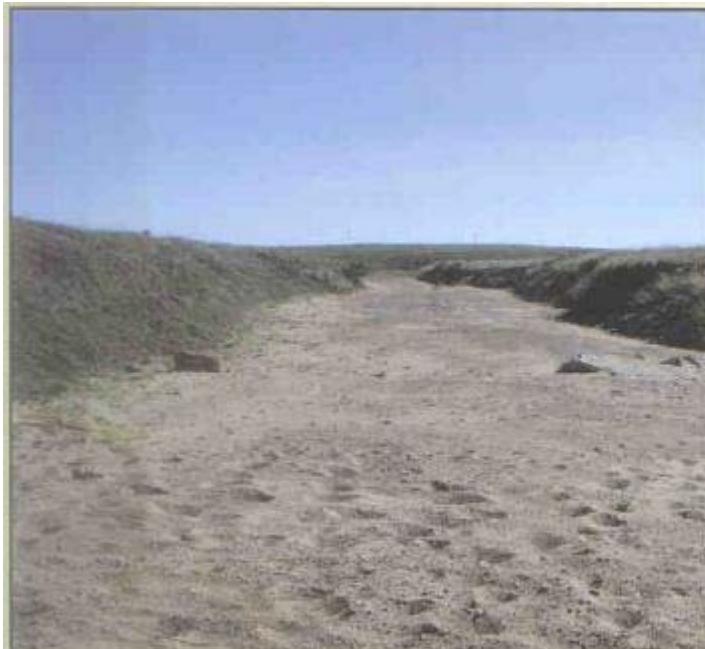
Photo 15 – Greater than 50% bare ground, Union County

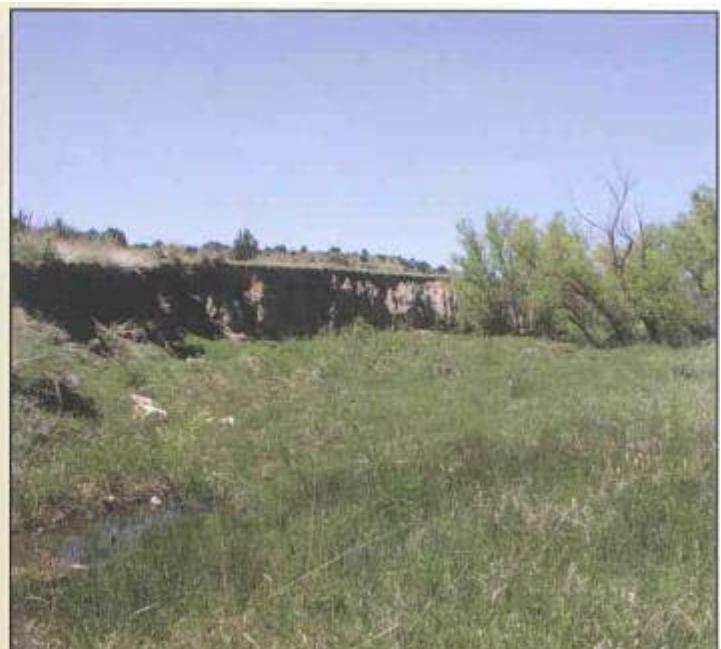
Photo 16 – 10% to 20% bare ground, Harding County

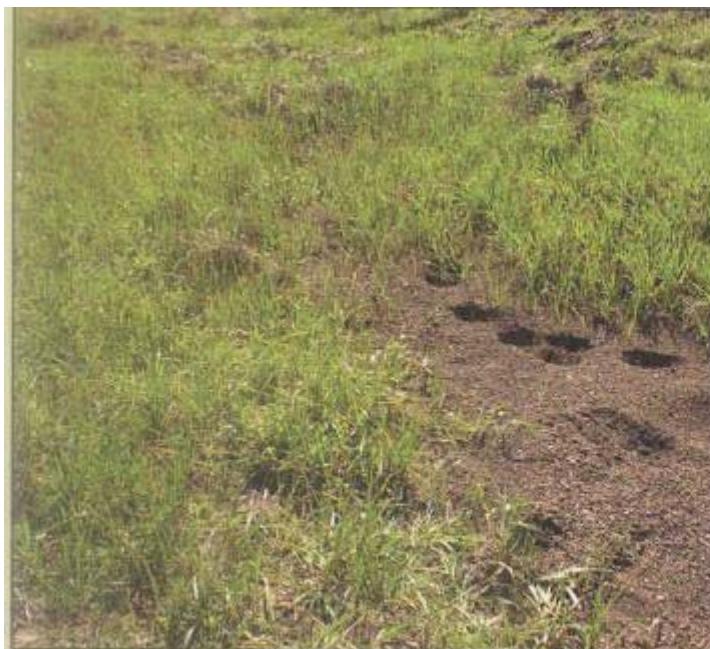
Photo 19 – No rock armor increases the opportunity for channel and bank erosion, Cottonwood Creek, McKinley County

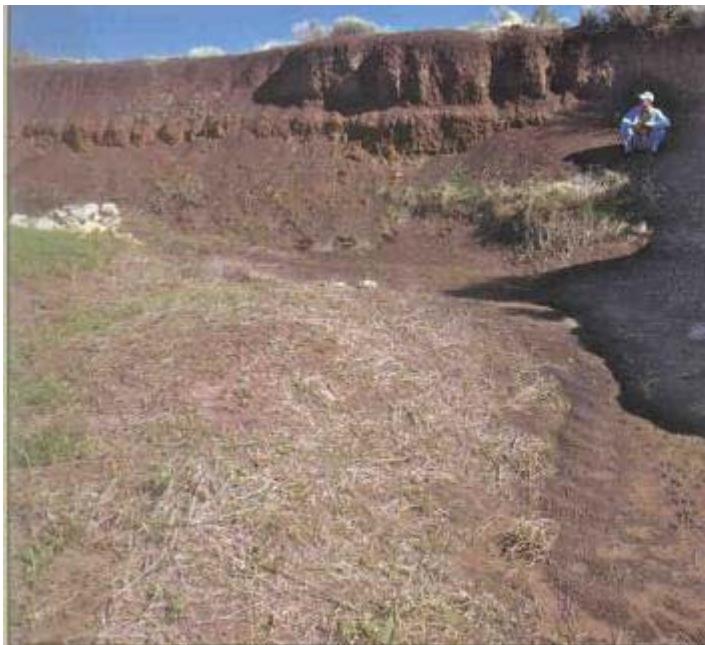
Photo 21 - Unstable point bars lead to unstable channels, Cottonwood Creek, McKinley County

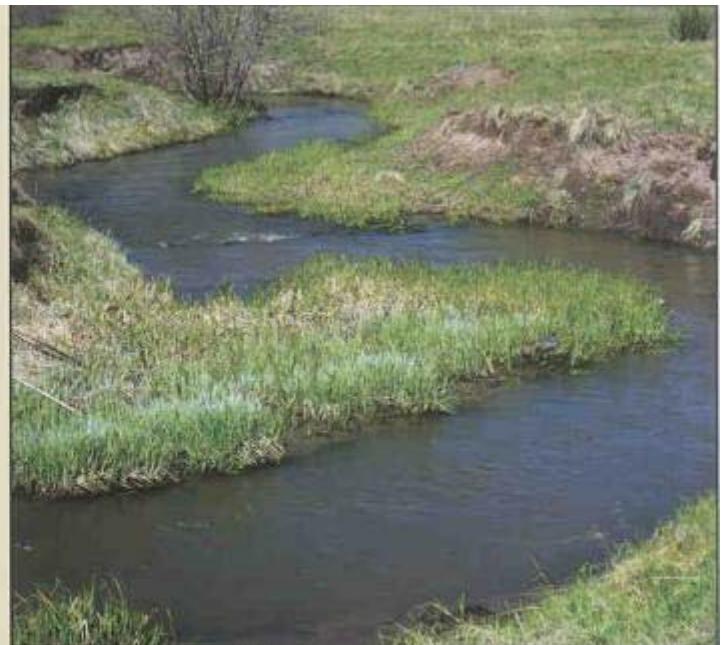
Photo 22 - Stable point bars are indicative of healthy channel width and function, Rio Guadalupe, Sandoval County

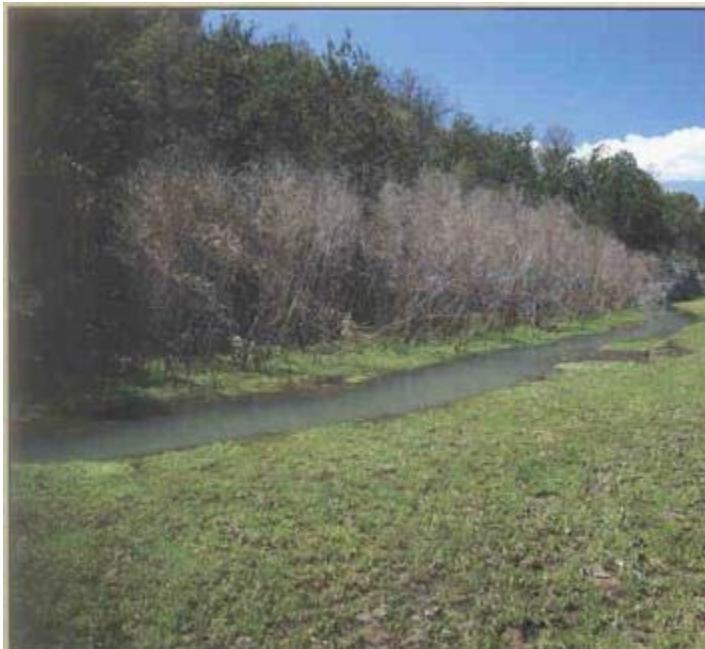
Photo 23 - Even aged riparian trees lacking saplings and seedlings indicating a lack of reproduction, Penasco River, Otero County

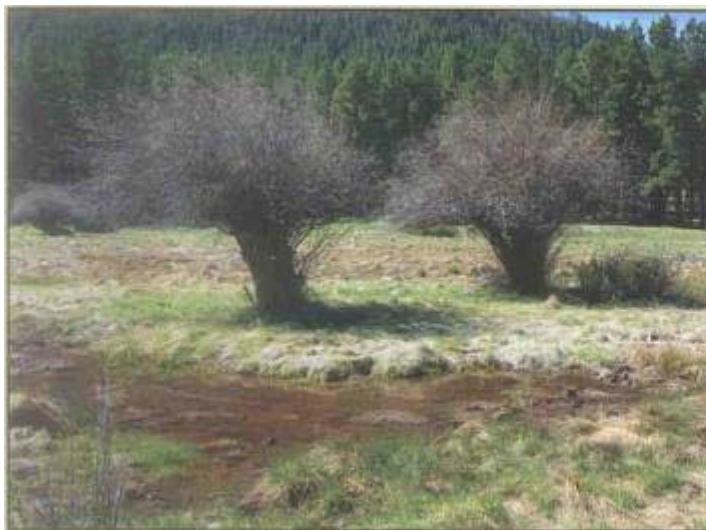
Photo 25 – Decadent willows, no seedlings or saplings, Rio Guadalupe, Sandoval County

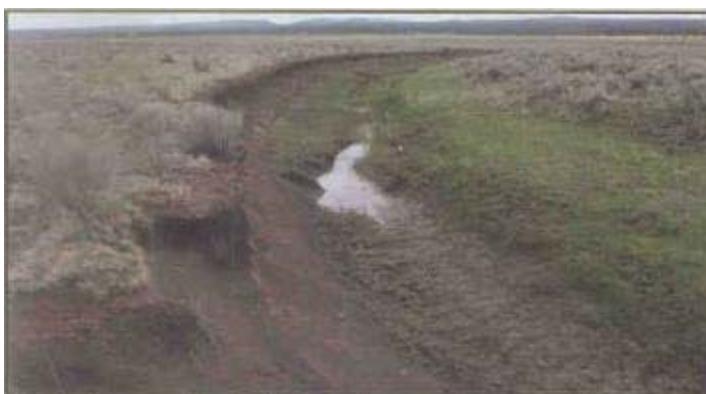
Photo 27 – Less than 50% groundcover, Cottonwood Creek, McKinley County

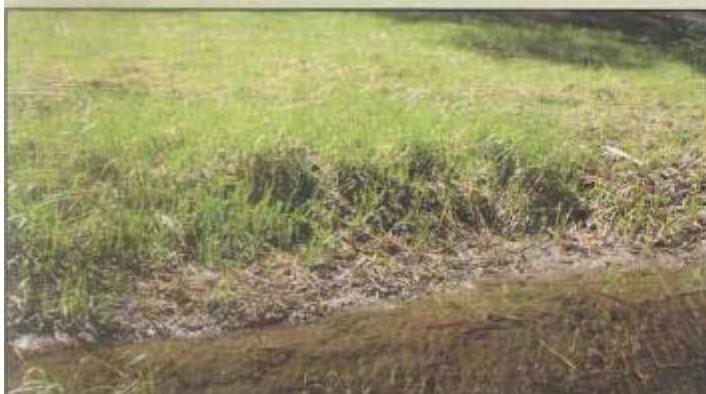
Photo 28 – 75% to 95% groundcover Bluewater Creek, Cibola County

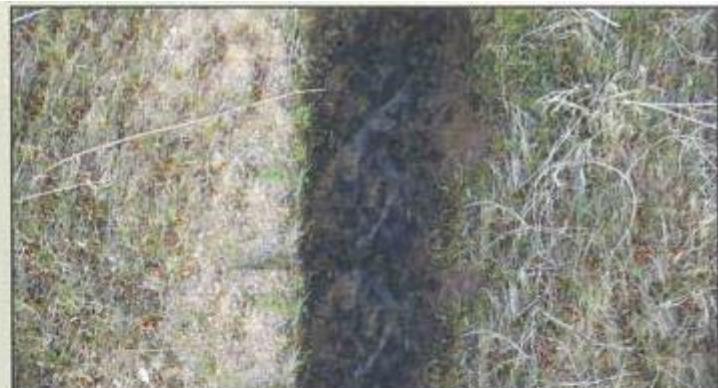
Photo 31 – 50% to 75% coverage, Burro Cienega, Grant County

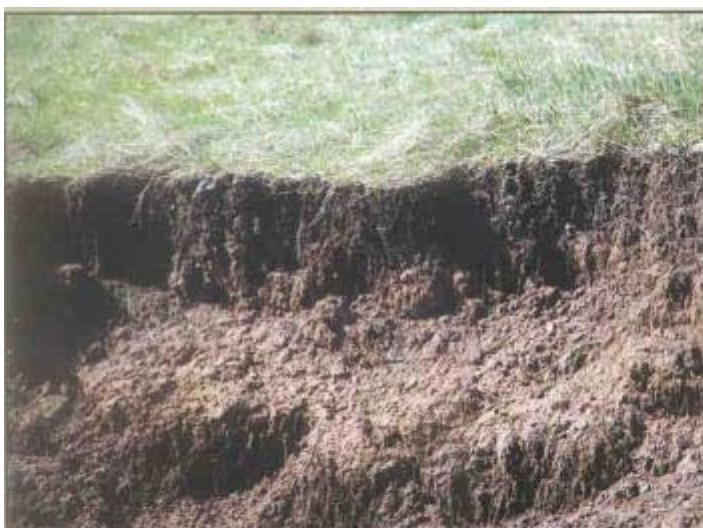
Photo 33 – Less than 25% of the bank with deep binding root mass (pasture grasses), Rio Guadalupe, Sandoval County

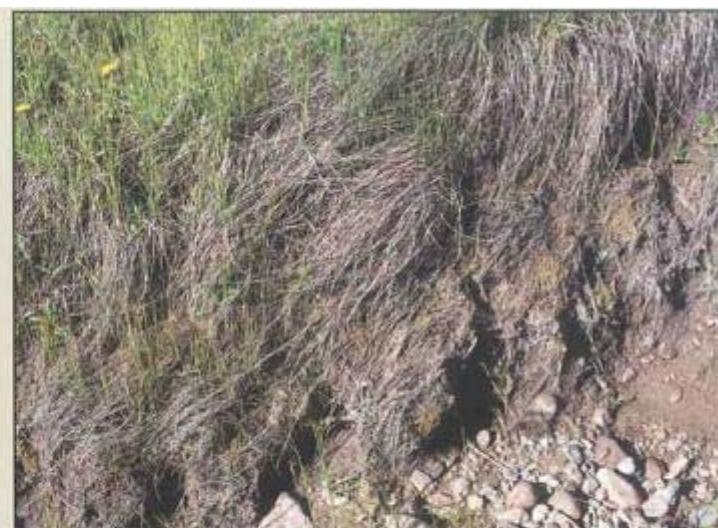
Photo 34 – Greater than 75% of the bank with a deep binding root mass (sedges), Cottonwood Creek, McKinley County

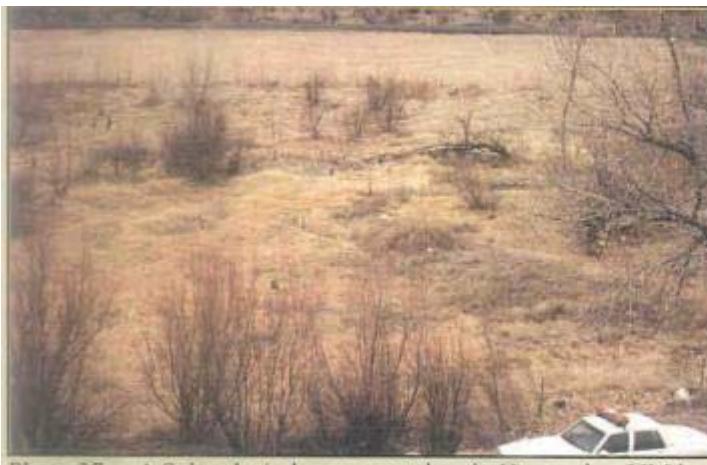
Photo 37 – A Saltcedar/salt grass meadow in Hernandez, NM before a pond is excavated where the annual precipitation is about 11 inches.

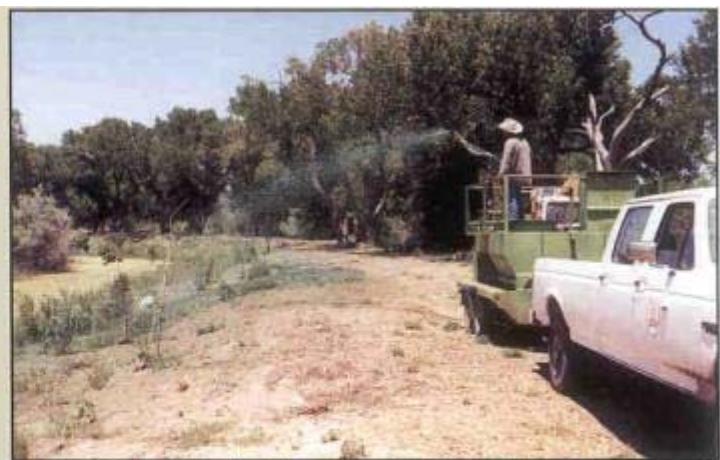
Photo 42 – In July, the site was seeded by hand broadcasting and raking. A wood fiber hydro-mulch was sprayed over the planting after seeding. Plants were temporarily covered during the hydro-mulching activity to prevent them from being coated with the sticky mulch.

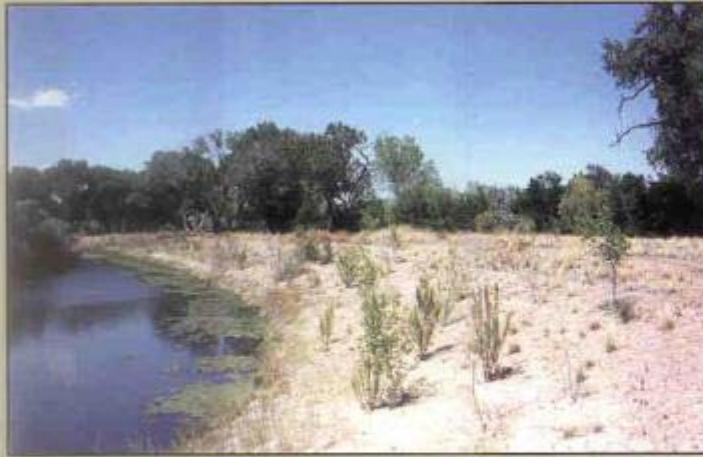
Photo 43 – By the end of the second growing season, transplants, pole cuttings, and grasses seem to be well established. The shrub and pole cuttings had a better than 80% survival with only one initial irrigation.

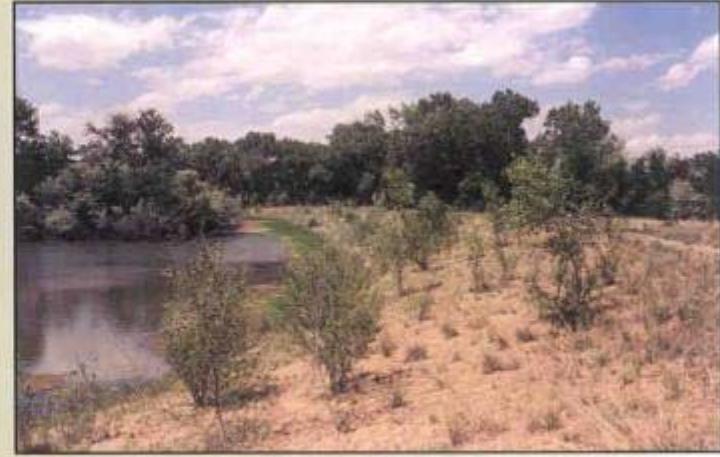
Photo 44 – By the fourth growing season, the vegetation seemed to be at a maturity stage where surface erosion may be controlled.

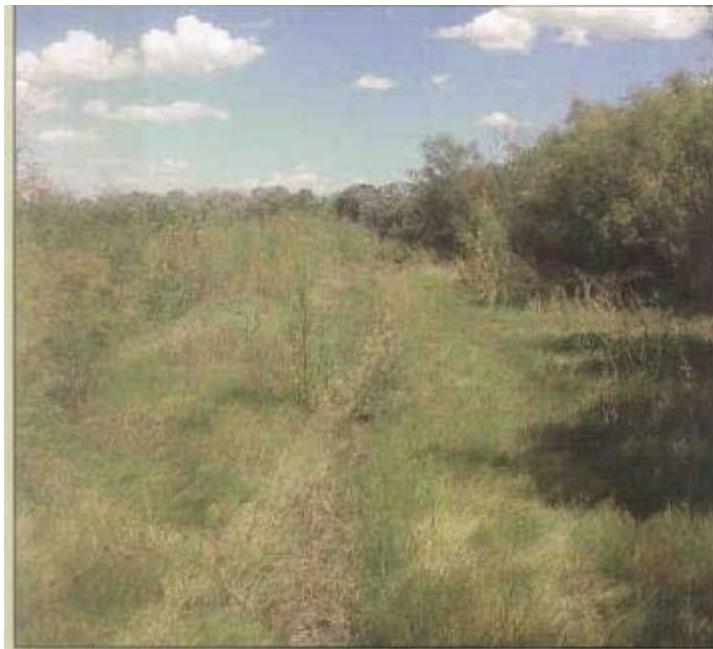
Photo 45 – Saltcedar and Russian olive were treated using the cut stump method with the chemical Triclopyr to control resprouting of the stumps on the San Juan River near Farmington, New Mexico. The annual precipitation averages less than 10 inches at this location.

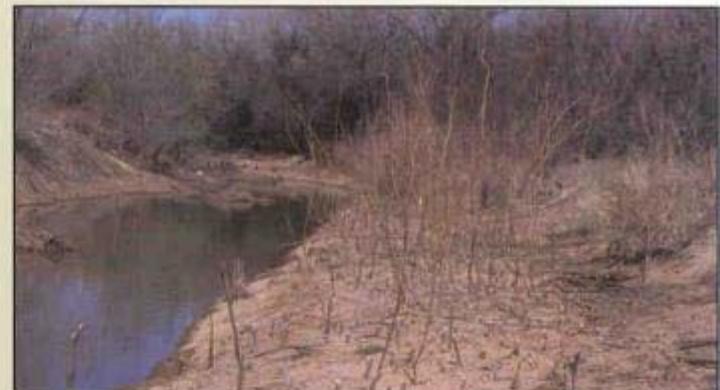
Photo 49 – Beaver predation of planted willow is common. However, because a 30 inches stem is planted, there is plenty of stem carbohydrate reserves available for re-sprouting.

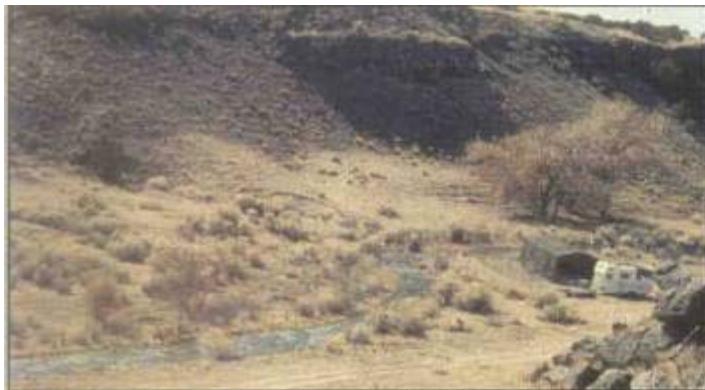
Photo 50 – A fence was built around this 7 acre planting site to protect it from cattle grazing on the Rio Santa Fe near Pena Blanca, New Mexico, where the annual precipitation is less than 12 inches.

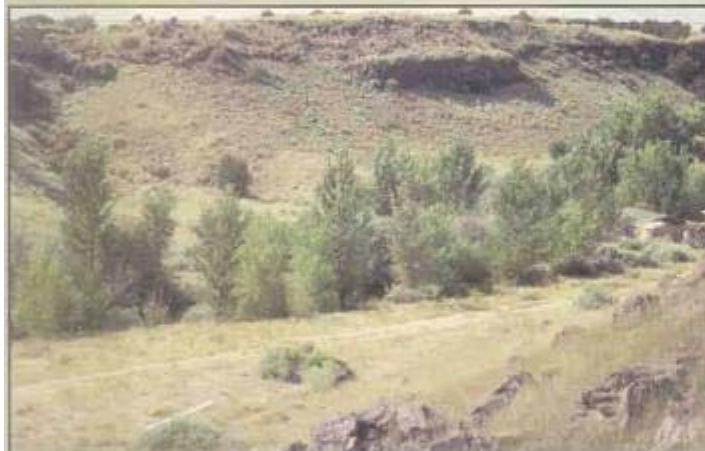
Photo 51 – A total of 350 cottonwood and black willow pole cuttings, 1,000 coyote willow whips, and 200 transplants were planted.

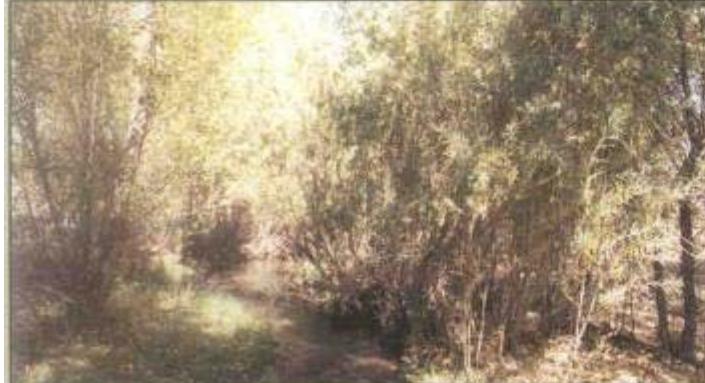
Photo 52 – By the tenth year, survival of all plants averaged about 75% and provided a closed canopy, shading the stream and enhancing fish habitat. Three supplemental irrigated treatments were provided only to the transplants: two treatments the first year and a third treatment the second year.

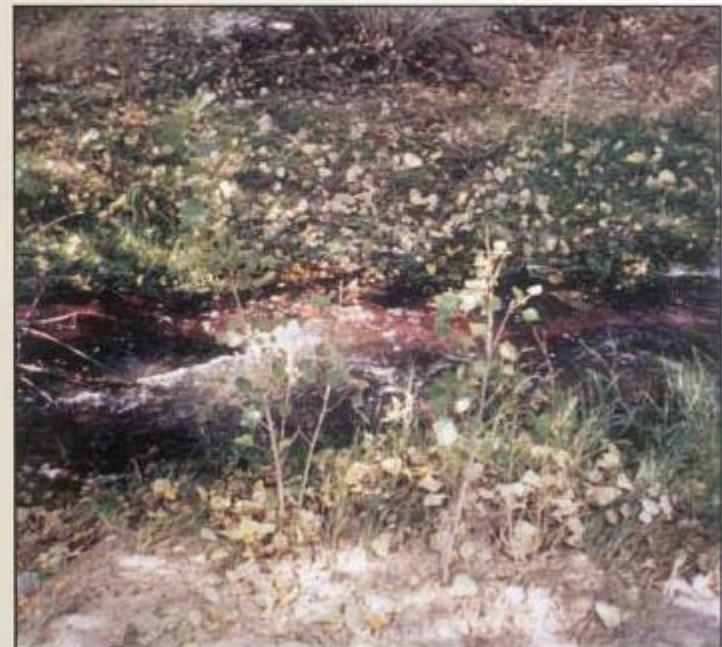
Photo 54 – Step-pooling resulted in some overbank flooding, providing the environment for natural recruitment of cottonwood seedlings.

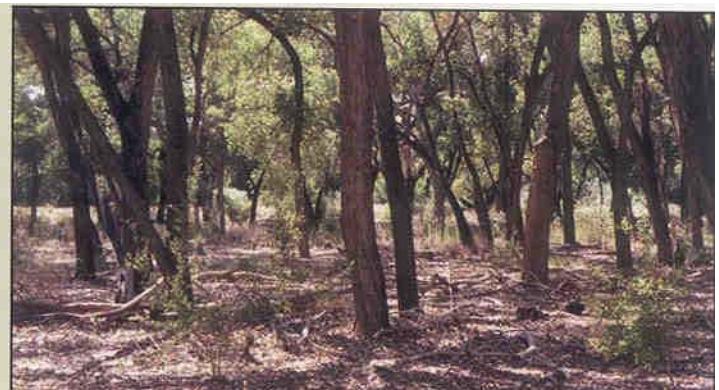
Photo 56 – New Mexico olive was planted in areas of dense shade.

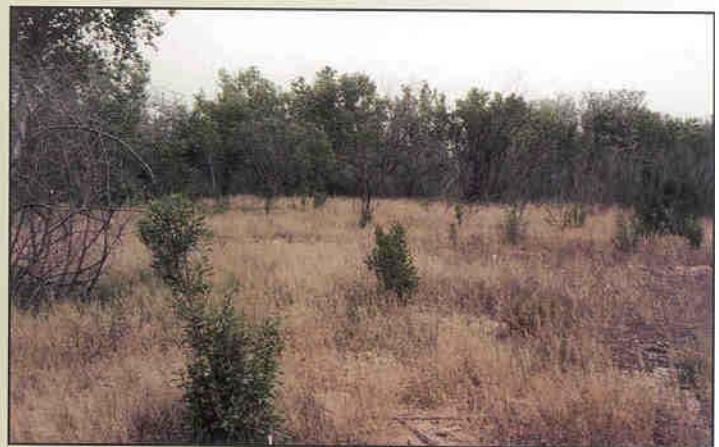
Photo 57 – False willow was planted in open areas.

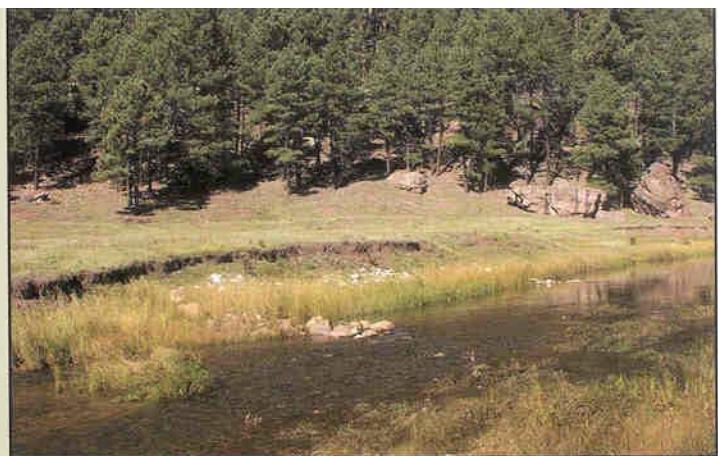
Treated site in 2006, Rio de las Vacas, Sandoval County

The project has been in place for over ten years. It has performed during spring runoff events with minimal damage. The only repairs have consisted of restacking some of the rocks from the nose of several of the barbs. These rocks had been rolled off of the barbs during high and extended flows, but overall the damage has been minimal. Woody riparian vegetation has not recovered due to continued grazing. The herbaceous species, including sedges and rushes, have increased in frequency and density. Some trampling and trails behind the barbs have continued to have detrimental effects on the treated streambanks.

This project has functioned as designed for ten years. The treated streambank has remained relatively stable although there has been minor recession as the bank reaches a stable angle of repose. The fence remains in place and has not been moved as was required before the treatment. The bank has more vegetation and more desirable riparian species than before the treatment. The stream barbs have been effective in keeping the lateral movement of the stream in check and also capturing new coarse sediment behind the barbs. The project continues to be monitored and photographed yearly.
