## **Appendix E**

**Concept Design Drawings**  
**(Berm and Channel Improvements Full Riprap Alternative)**

# DRAWINGS FOR CONSTRUCTION OF THE WATERSHED PLAN EA TOOELE COUNTY

TOOELE COUNTY  
WATERSHED PLAN EA  
TOOELE COUNTY

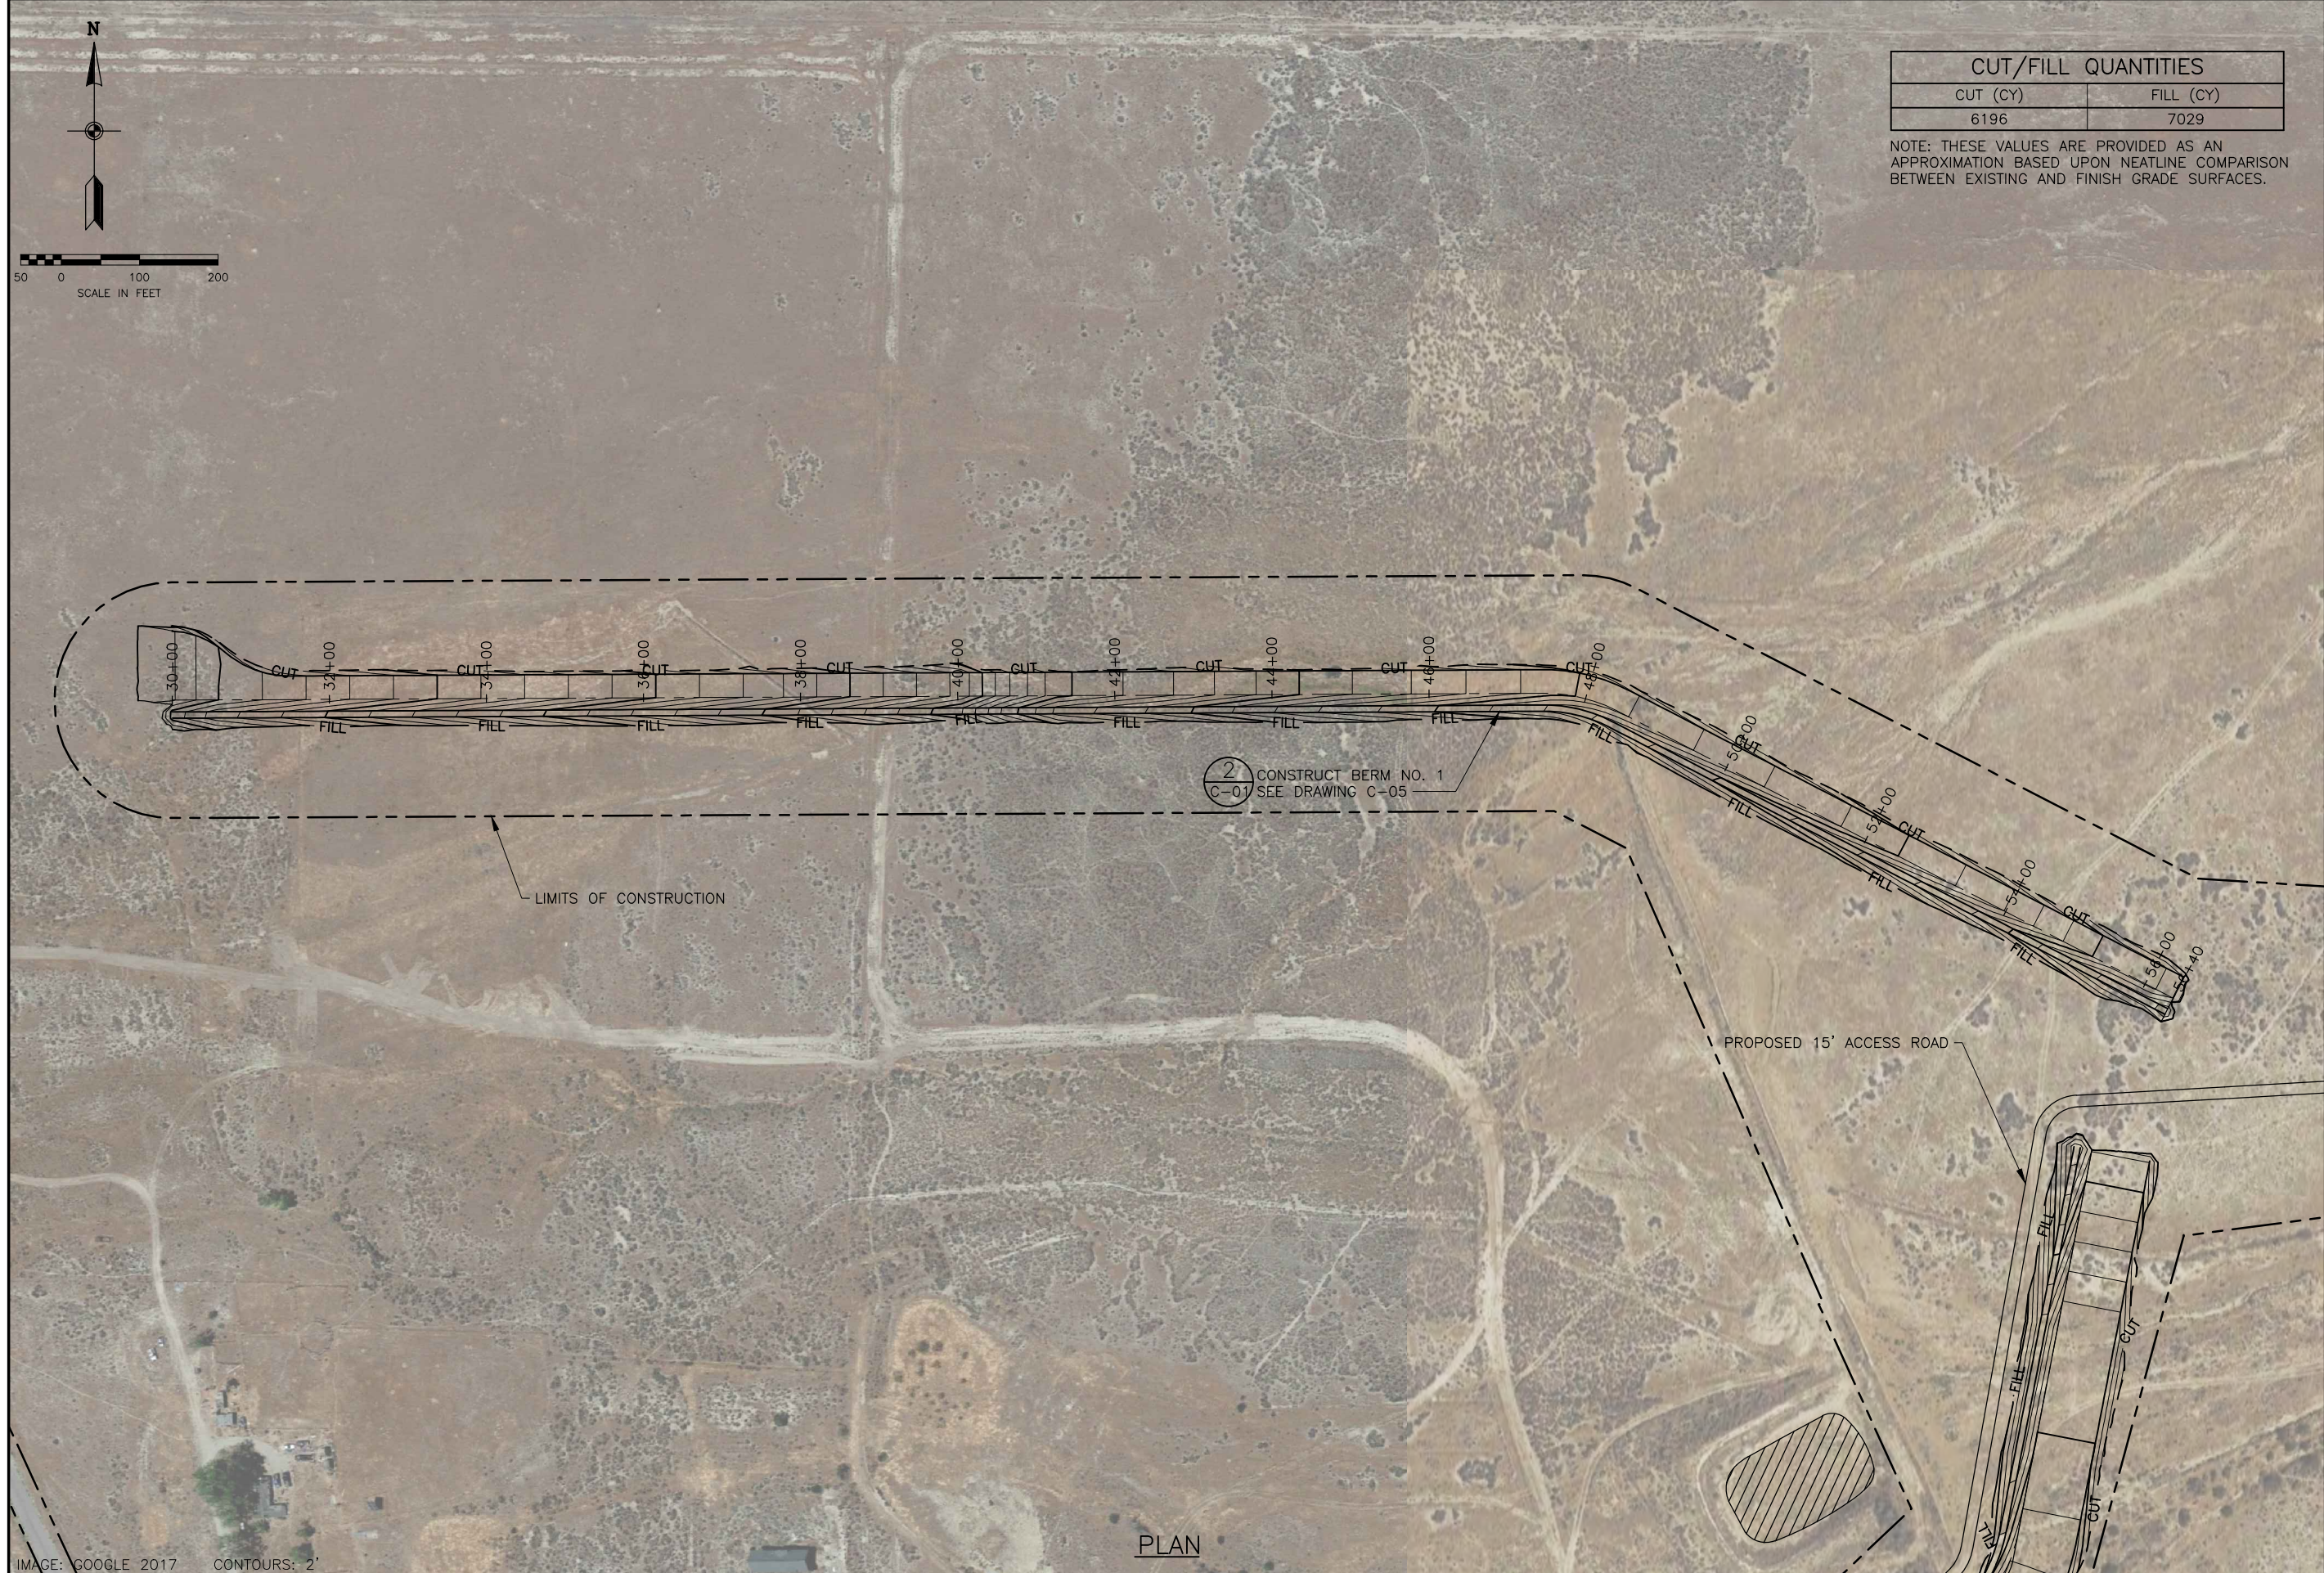
SHEET 4 OF 10

NOTE: THESE VALUES ARE PROVIDED AS AN APPROXIMATION BASED UPON NEATLINE COMPARISON BETWEEN EXISTING AND FINISH GRADE SURFACES.

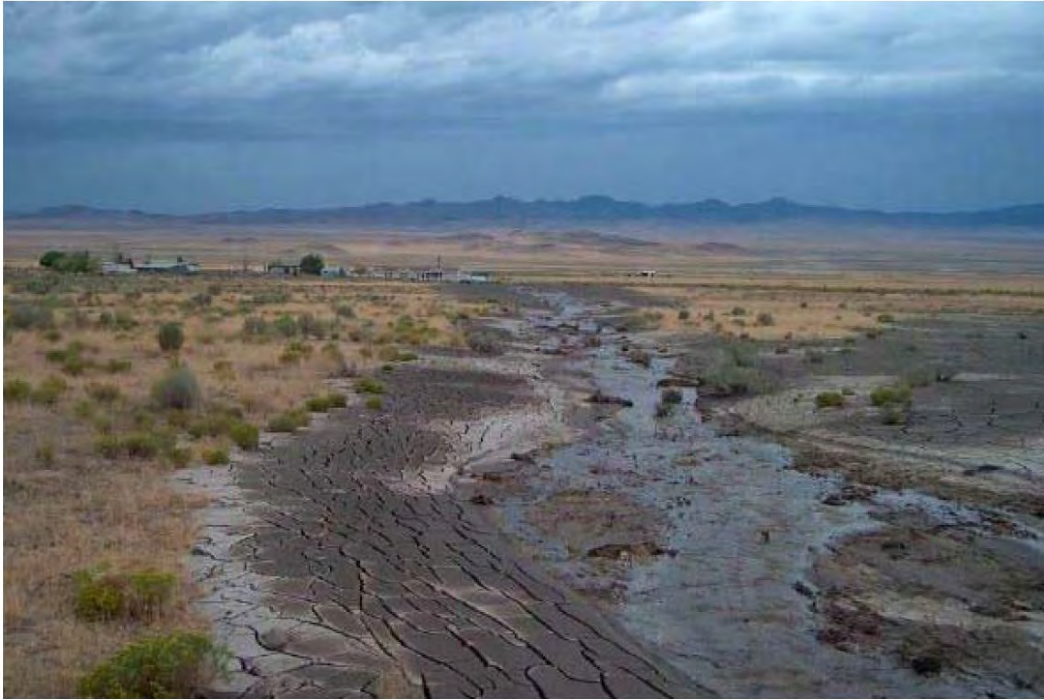
***Photo 1. Mudflow east of the Reservation following the 2013 event. (USACE 2018 Figure 7)***

yards” of debris from the canyon onto the alluvial fan upstream of the Reservation. Photos taken following these two flood events are shown in Photos 1, 2 and 3.

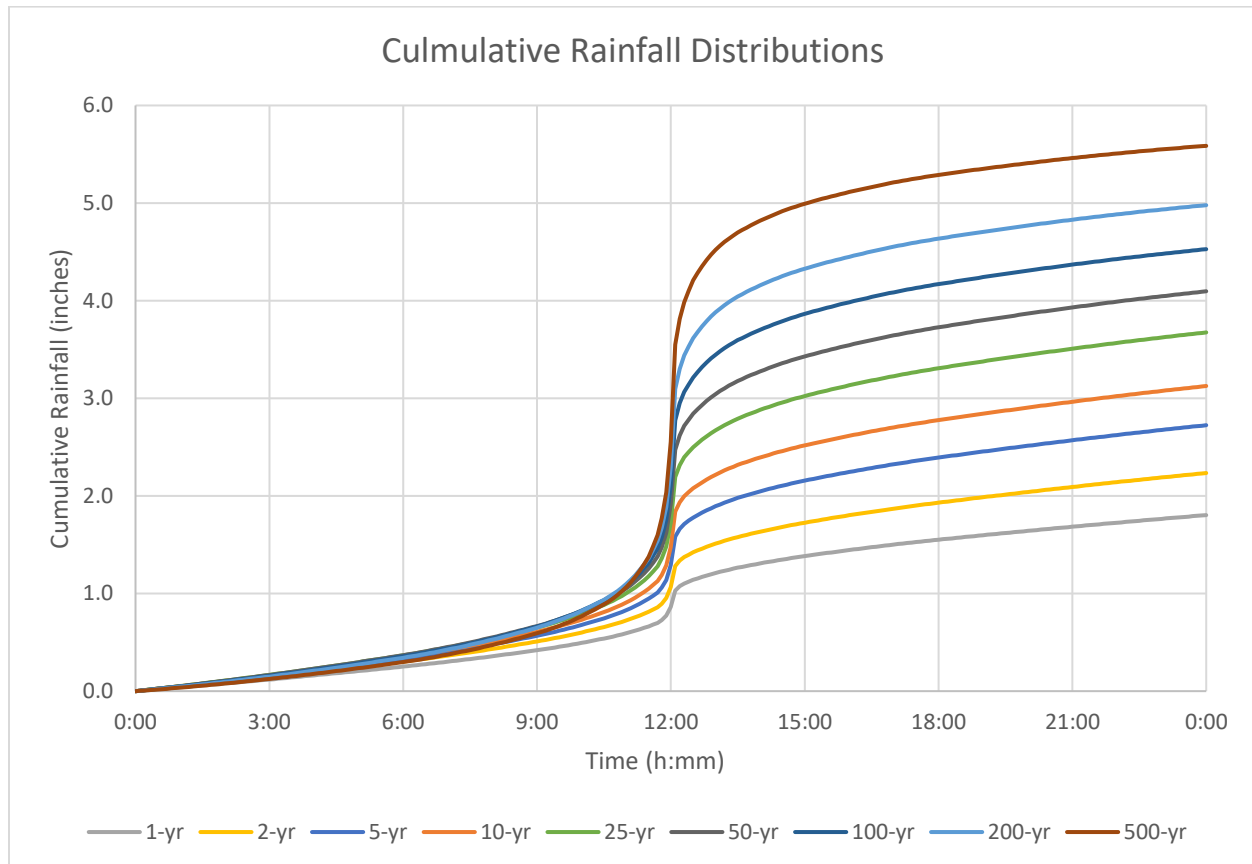
**Figure 6. Design Storm Distributions**

The selected design storm distributions were determined using NRCS WinTR-20 software. Using the procedures described in NEH 630.04, WinTR-20 software takes the rainfall depth-duration-frequency data obtained from the NOAA PFDS and generates site specific unit rainfall distributions for various recurrence intervals from 1- to 500-years. Using these unit rainfall distributions and the storm depths adjusted for area and seasonality as described above, the final design storm distributions shown in Figure 6 below were developed. Tabulated values for the design storms used are provided in Appendix B.

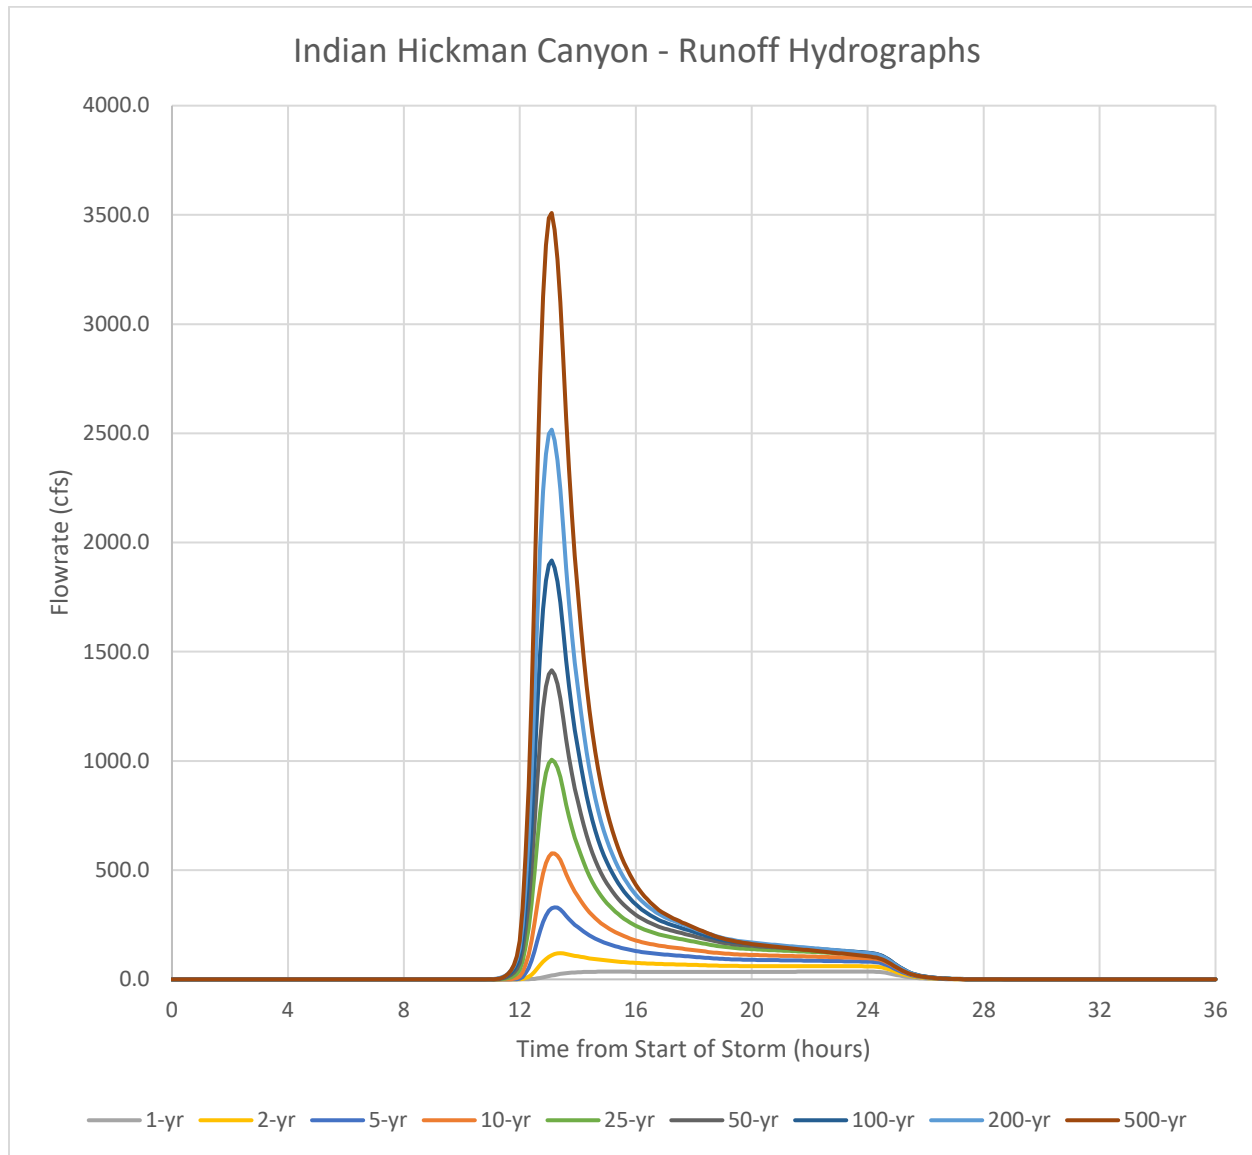
**Figure 7. Runoff hydrographs for Indian Hickman drainage basin.**

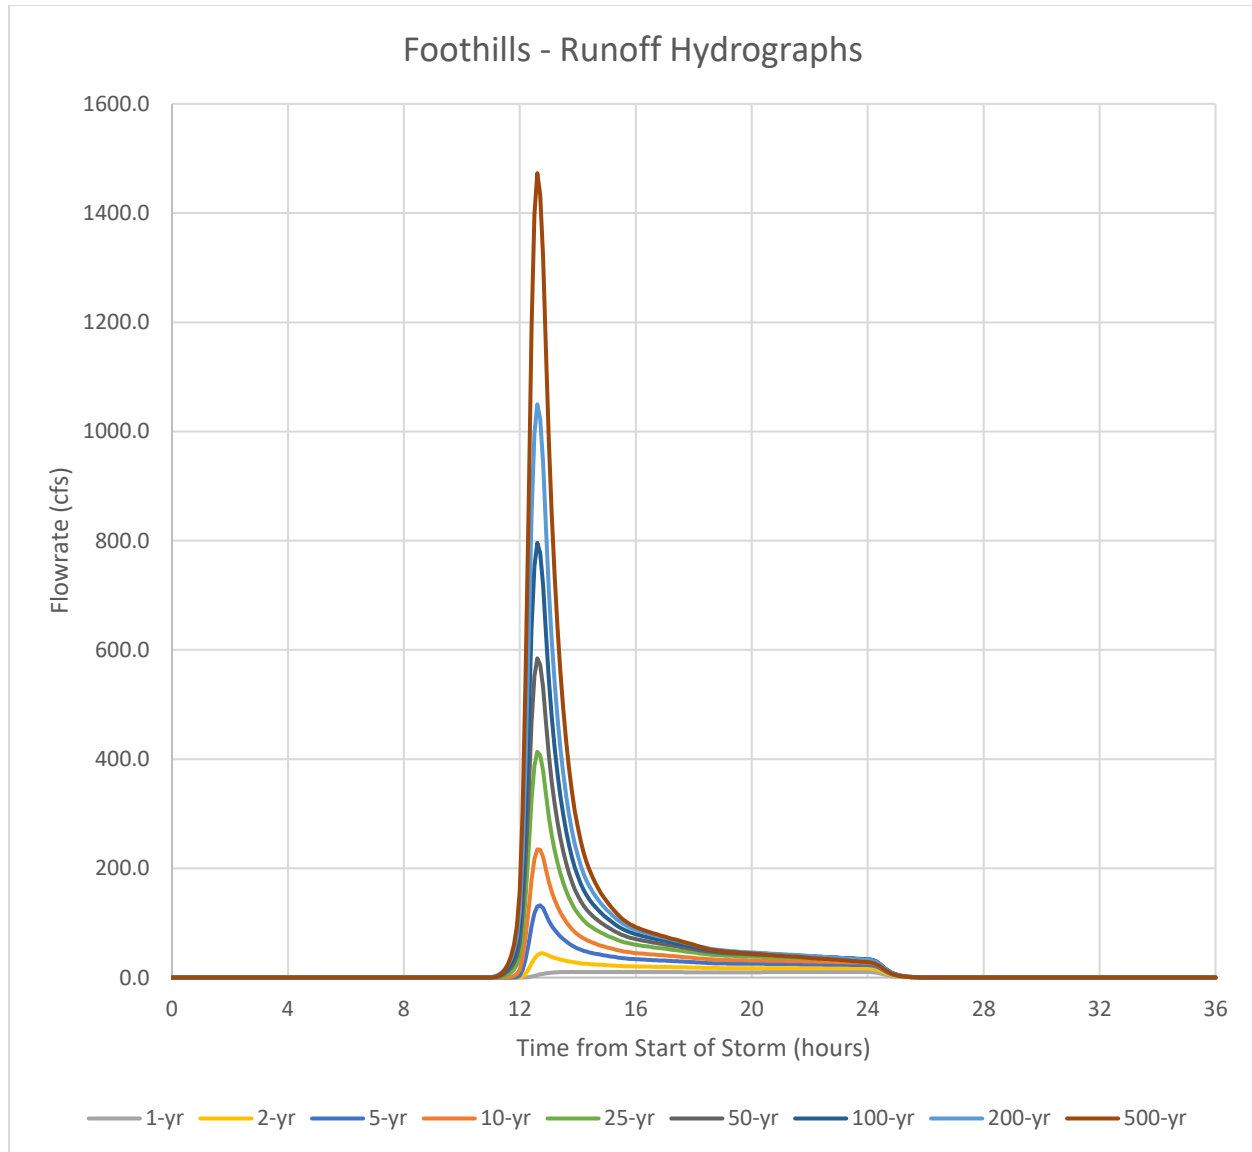
**Figure 8. Runoff hydrographs for Foothills drainage basin.**

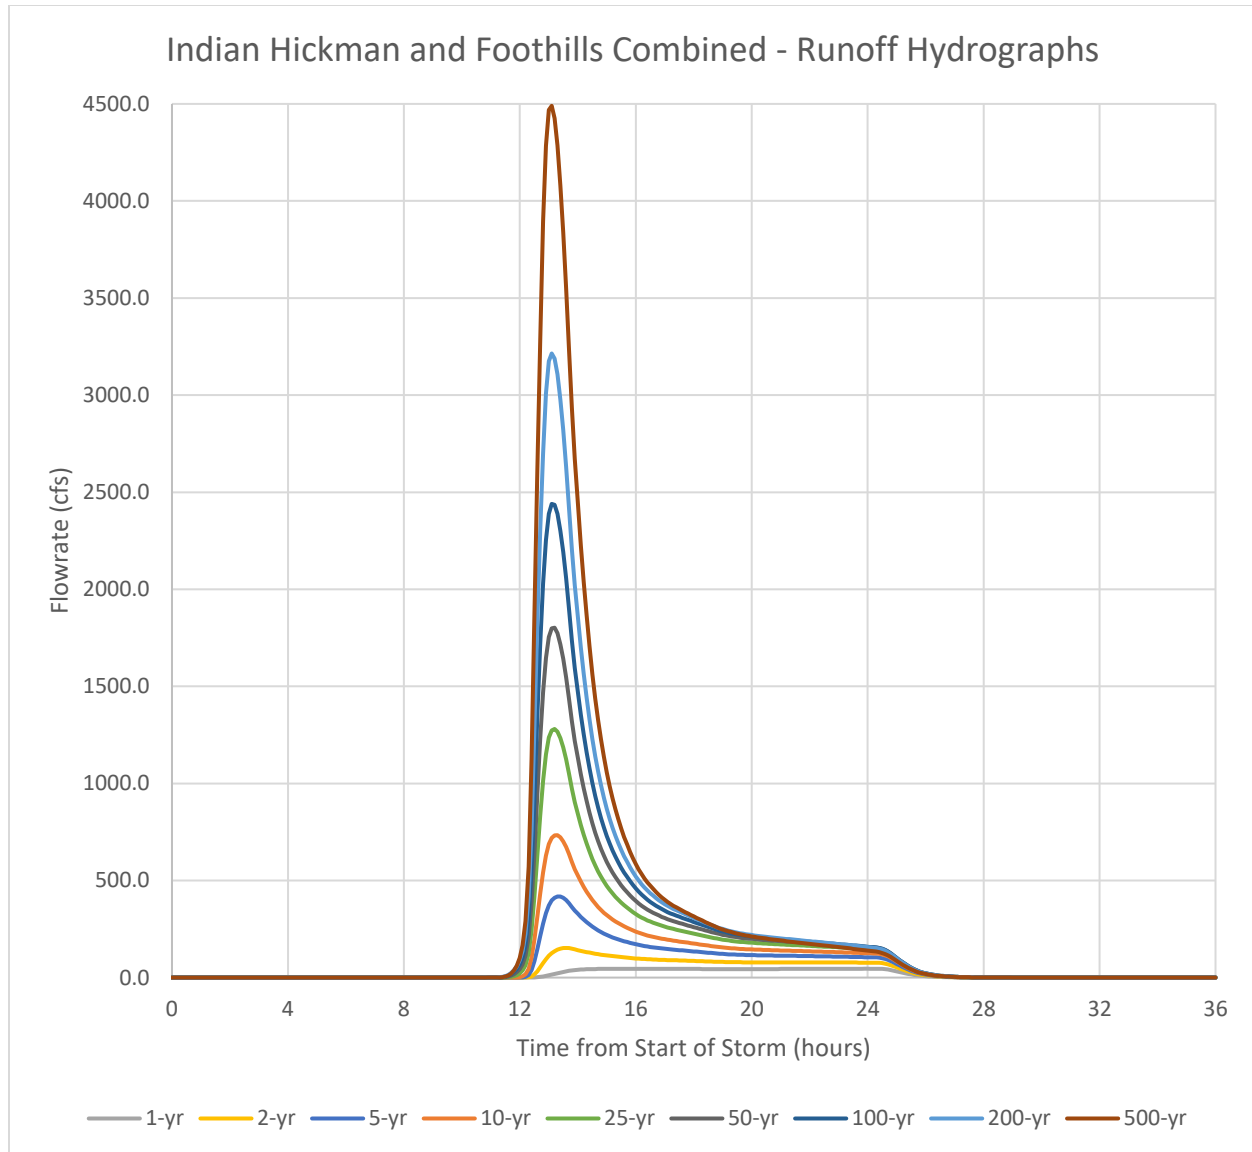
**Figure 9. Combined Indian Hickman and Foothills Hydrographs.**

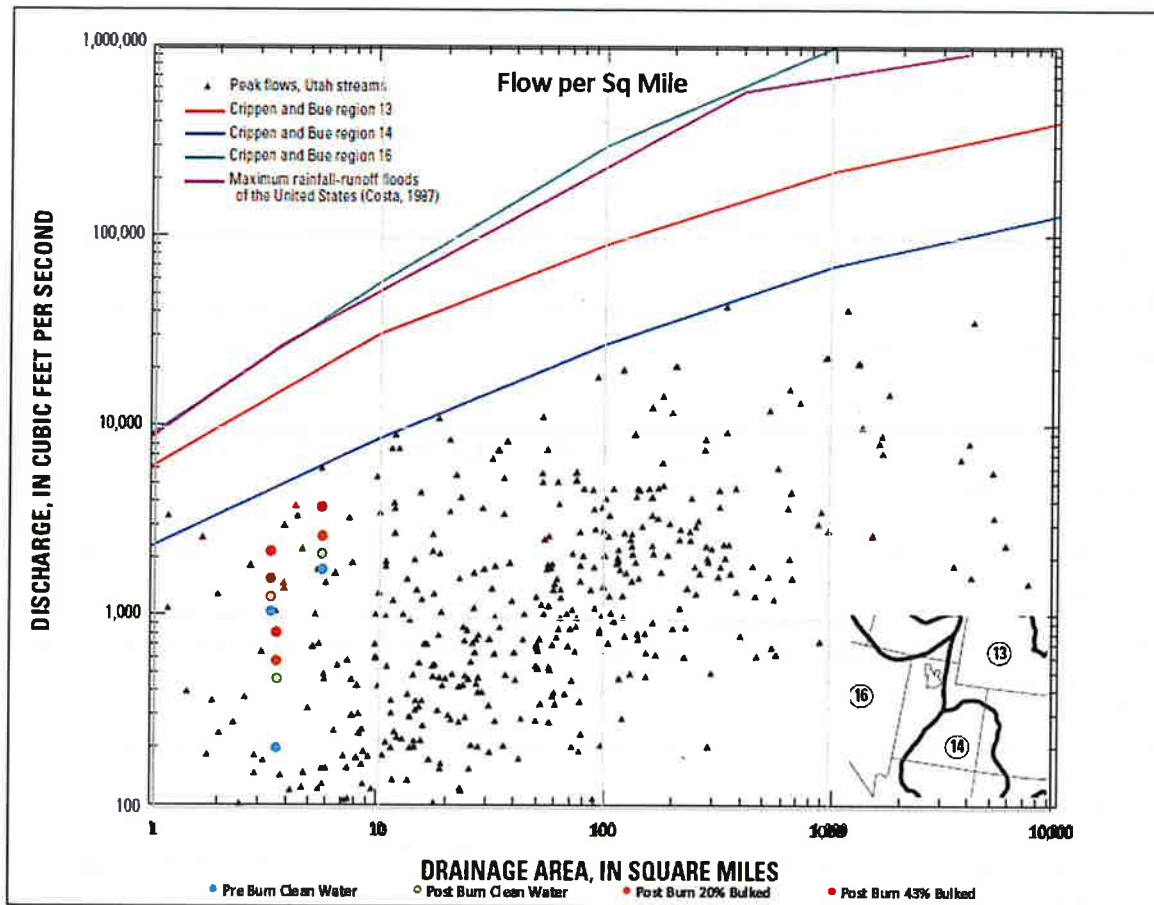
Figure 4 maximum instantaneous (peak) flow for any site in Utah plotted with Crippen and Bue (1977) envelope curves for regions 13, 14 and 16 along with Costa (1987) envelope curve of maximum rainfall runoff floods of the United States (magenta curve) and the HMS and the HMS model results for the 1% event at Skull Valley Reservation and points upstream. The brown dots represent the discharge from HMS using the initial and constant loss method and the blue dots represent HMS results with the SCS curve number method. Inset shows flood region boundaries from Crippen and Bue (1977).

Because there are no long term flow gauges within Skull Valley, an envelope curve is used to test the validity of the model results. These curves are developed for a given region by plotting the largest peak flows for all gauge sites against the drainage areas of the gauge sites. With a long enough cumulative streamflow, a limiting relation (envelope curve) between peak flows and drainage area can be interpreted. A series of envelope curves for Utah from Kenny et al. 2007, "Methods for Estimating Magnitude and Frequency of Peak flow for Natural Streams in Utah" is presented along with the HMS results in figure 4. Crippen and Bue (1977) defined 17 hydrologic regions for the continental United States with most of Utah being in region 14, western Utah in region 16 and northeastern Utah in region 13 (see inset on figure 3). Because physiographic and atmospheric characteristics are determining factors of maximum flood flow, different regions will have different envelope curves. Figure 4 shows envelope curves for three regions of the western United States and a fourth envelope curve from Costa 1987 for all of the continental United States. The HMS results for the 1% AEP event in Skull Valley fall within the envelopes for Utah.

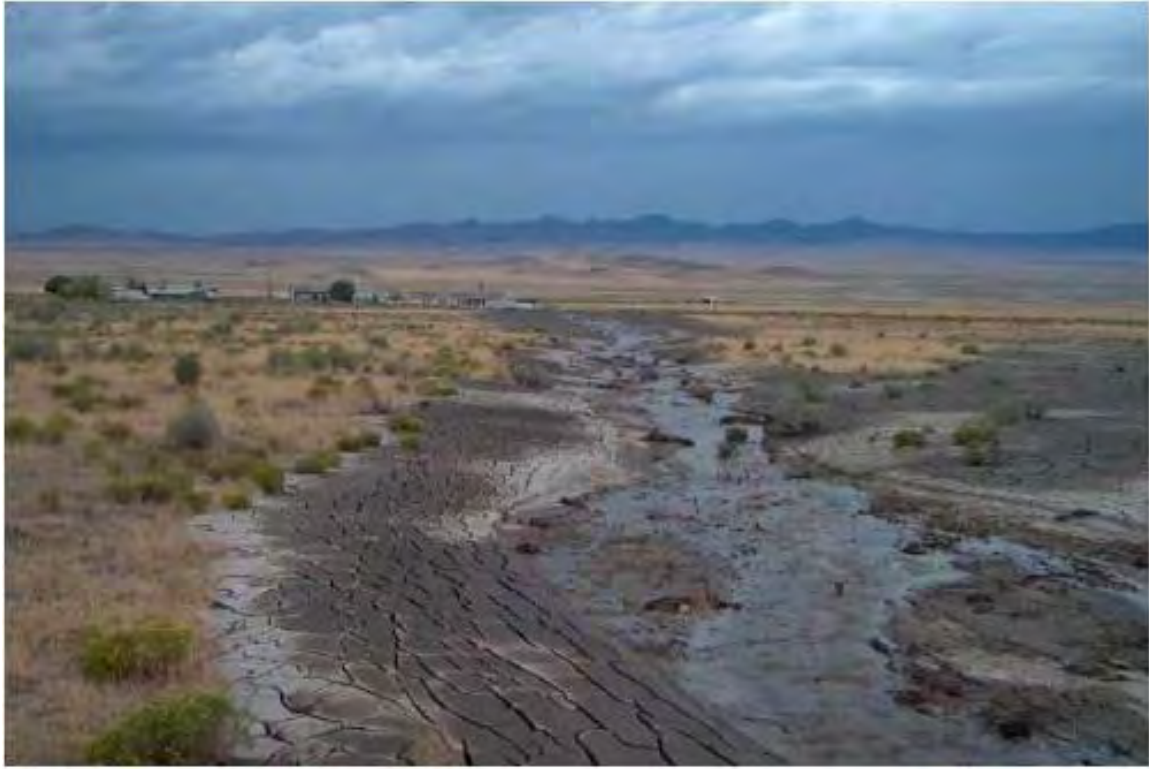
**Figure 5. Mudflow from Indian Hickman Canyon following 2013 flood event.**

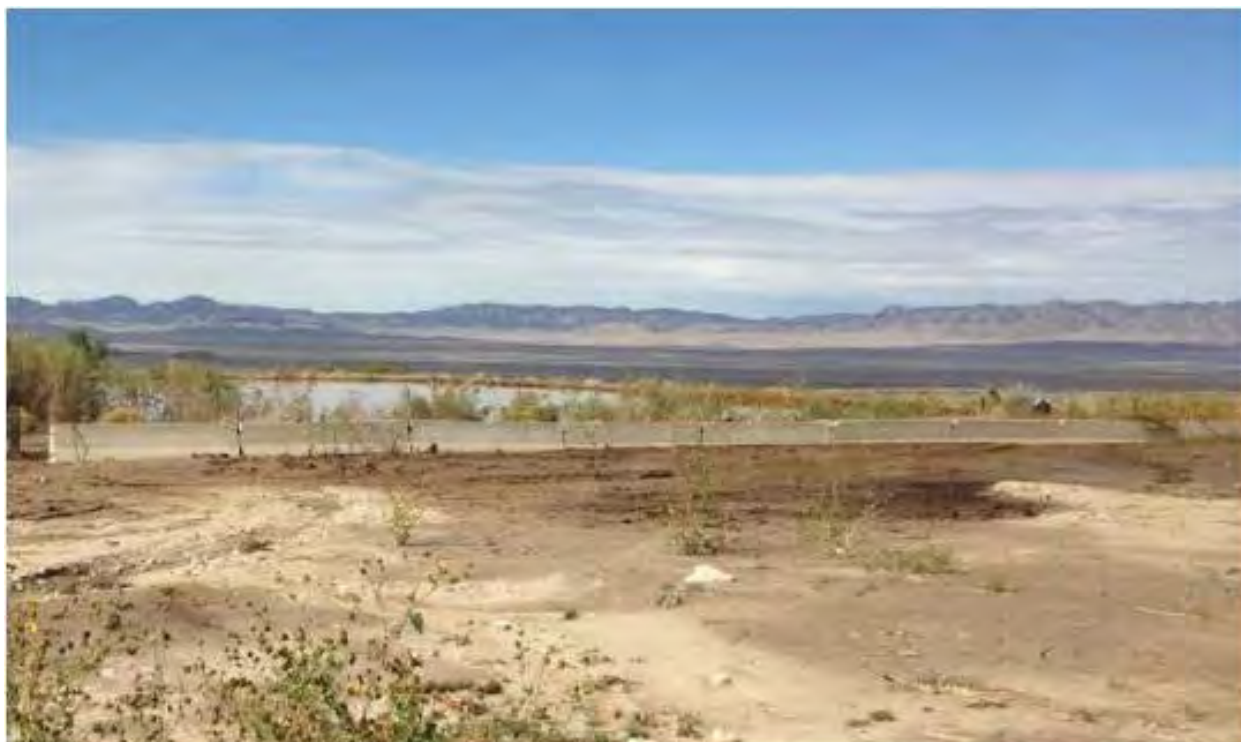
*Figure 7. K-rails installed after 2013 flood event.*

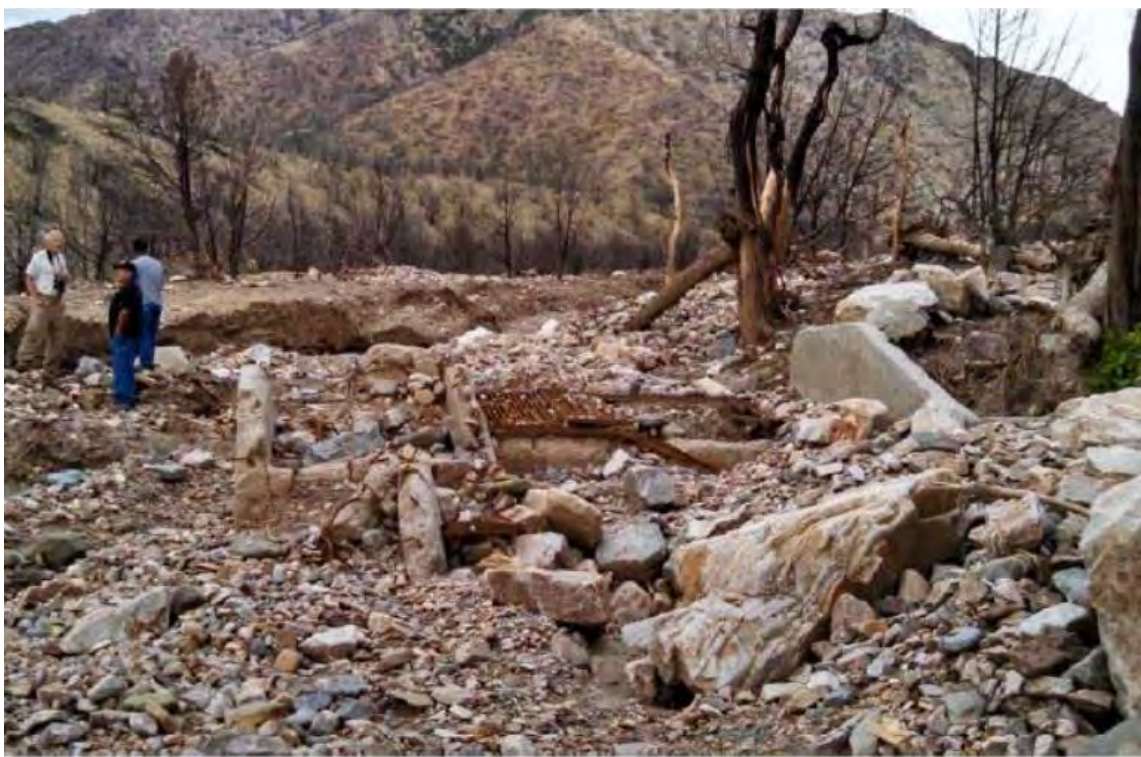
*Figure 8. Water Intake structure destroyed in Indian Hickman Canyon*

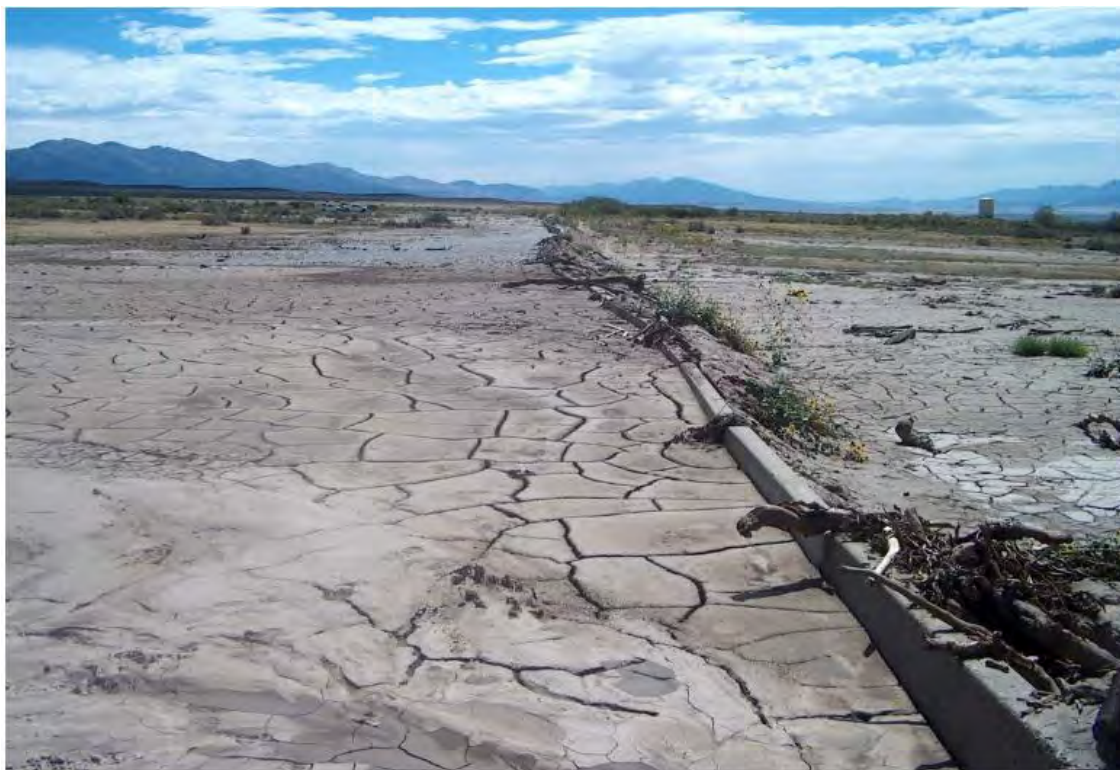
***Figure 9. Sediment and debris accumulation upstream of K-rails installed in 2013***

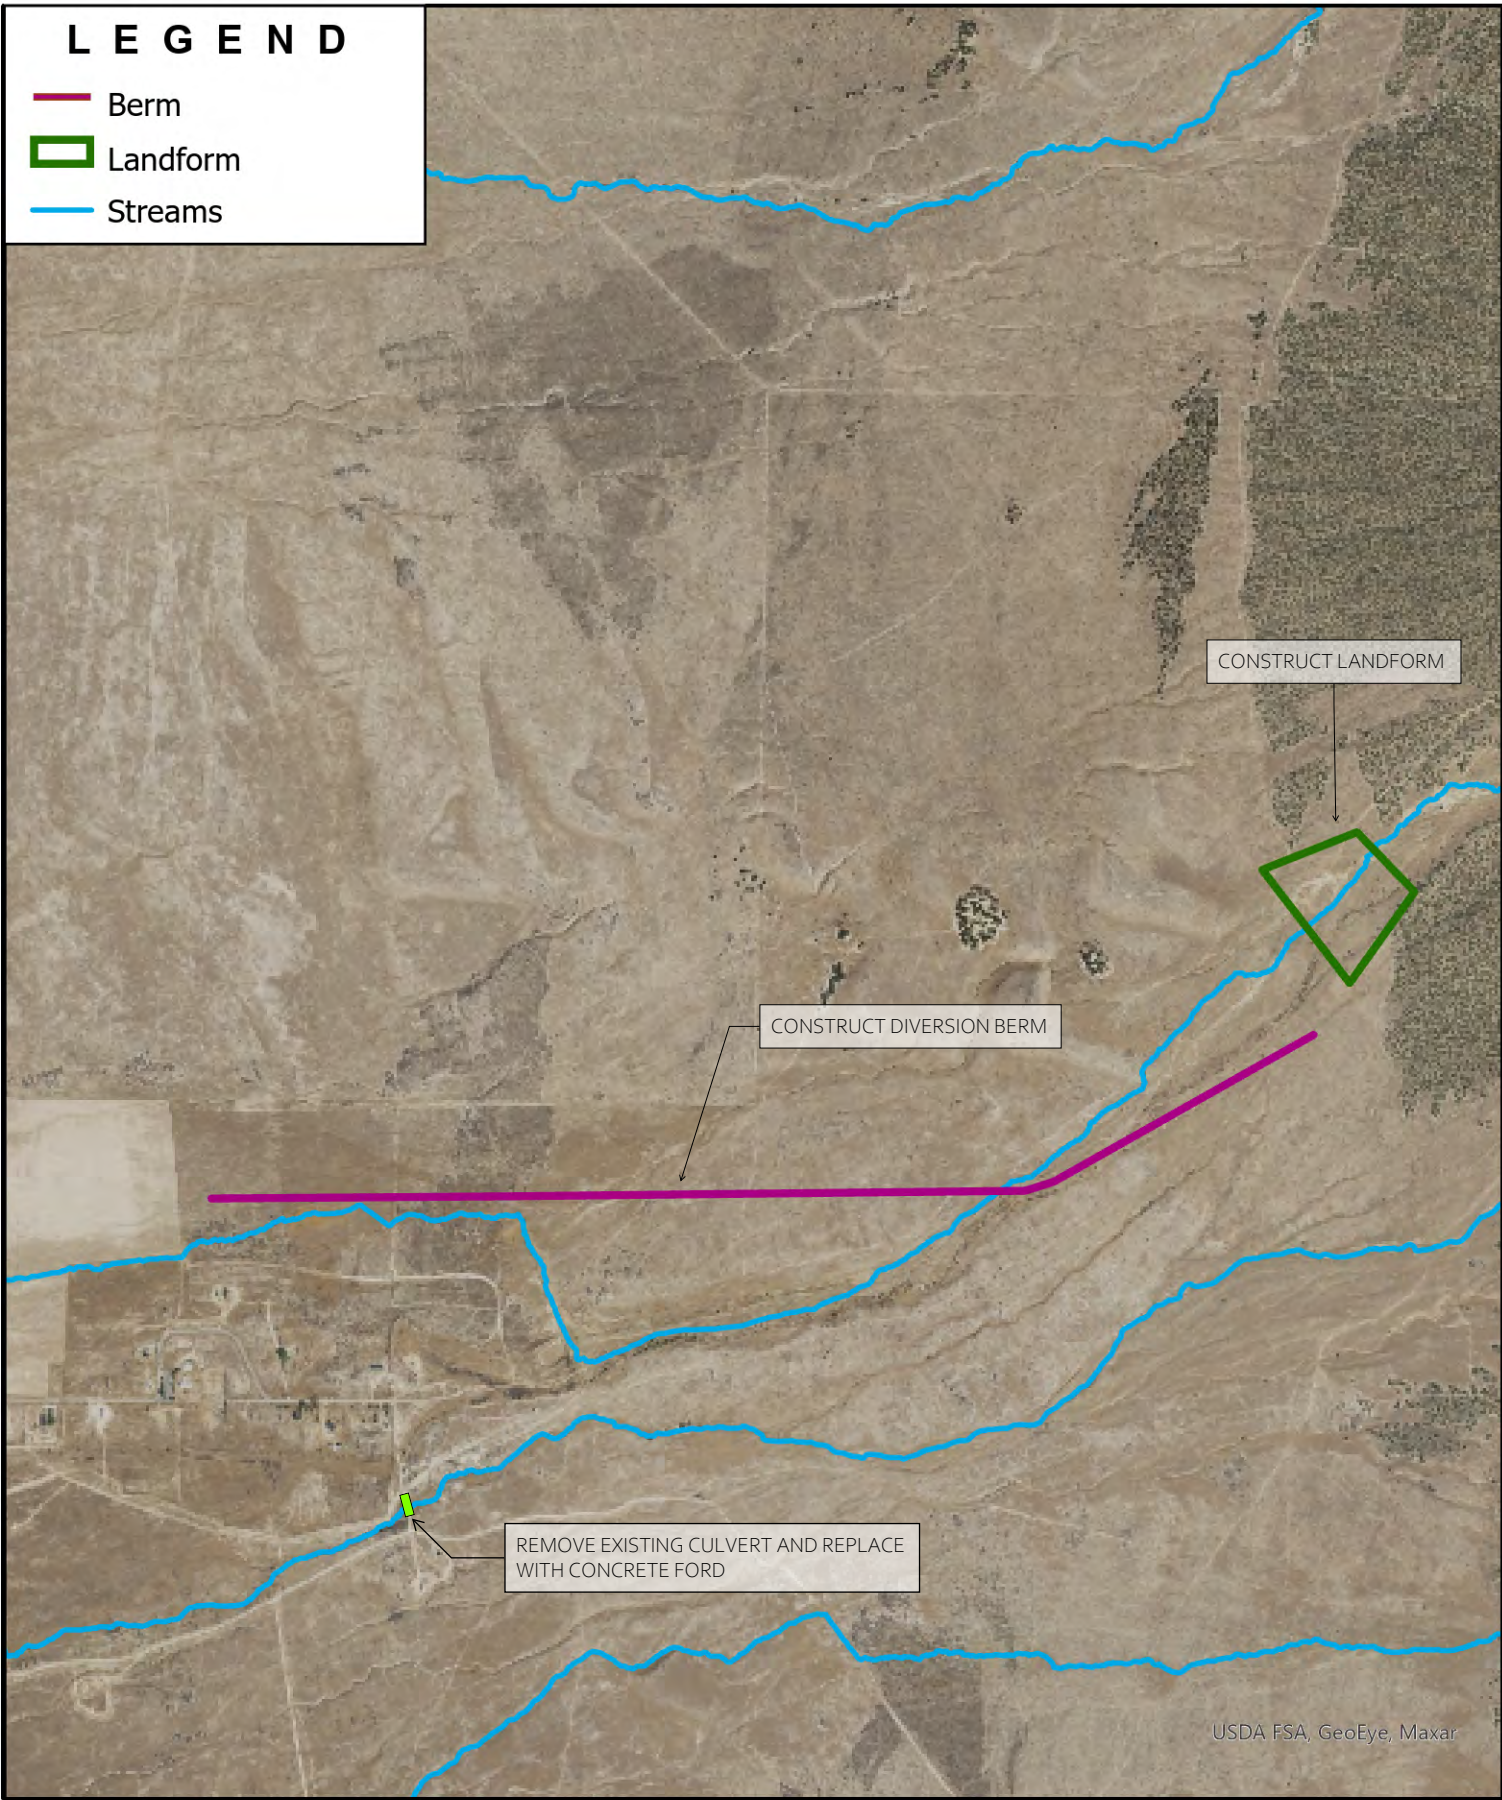
An Excel spreadsheet utilizing the Manning's Equation (solving for normal depth) and the existing conditions 2D HEC-RAS model were used to size the proposed improvements to the flood channel and shown in Appendix B.

POTENTIAL ALTERNATIVE 2  
IMPROVEMENTS

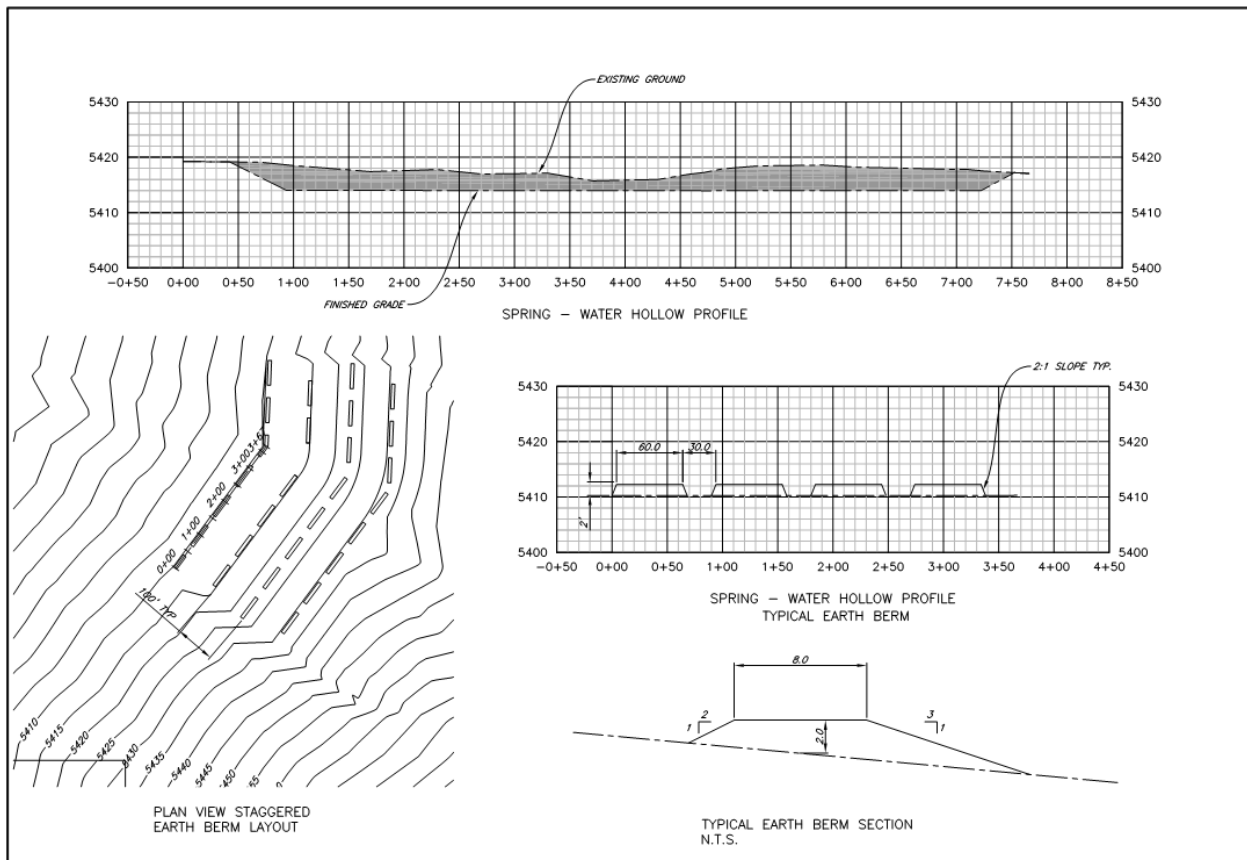
**Figure 15. Typical Landform Concept Detail (Provided by NRCS)**

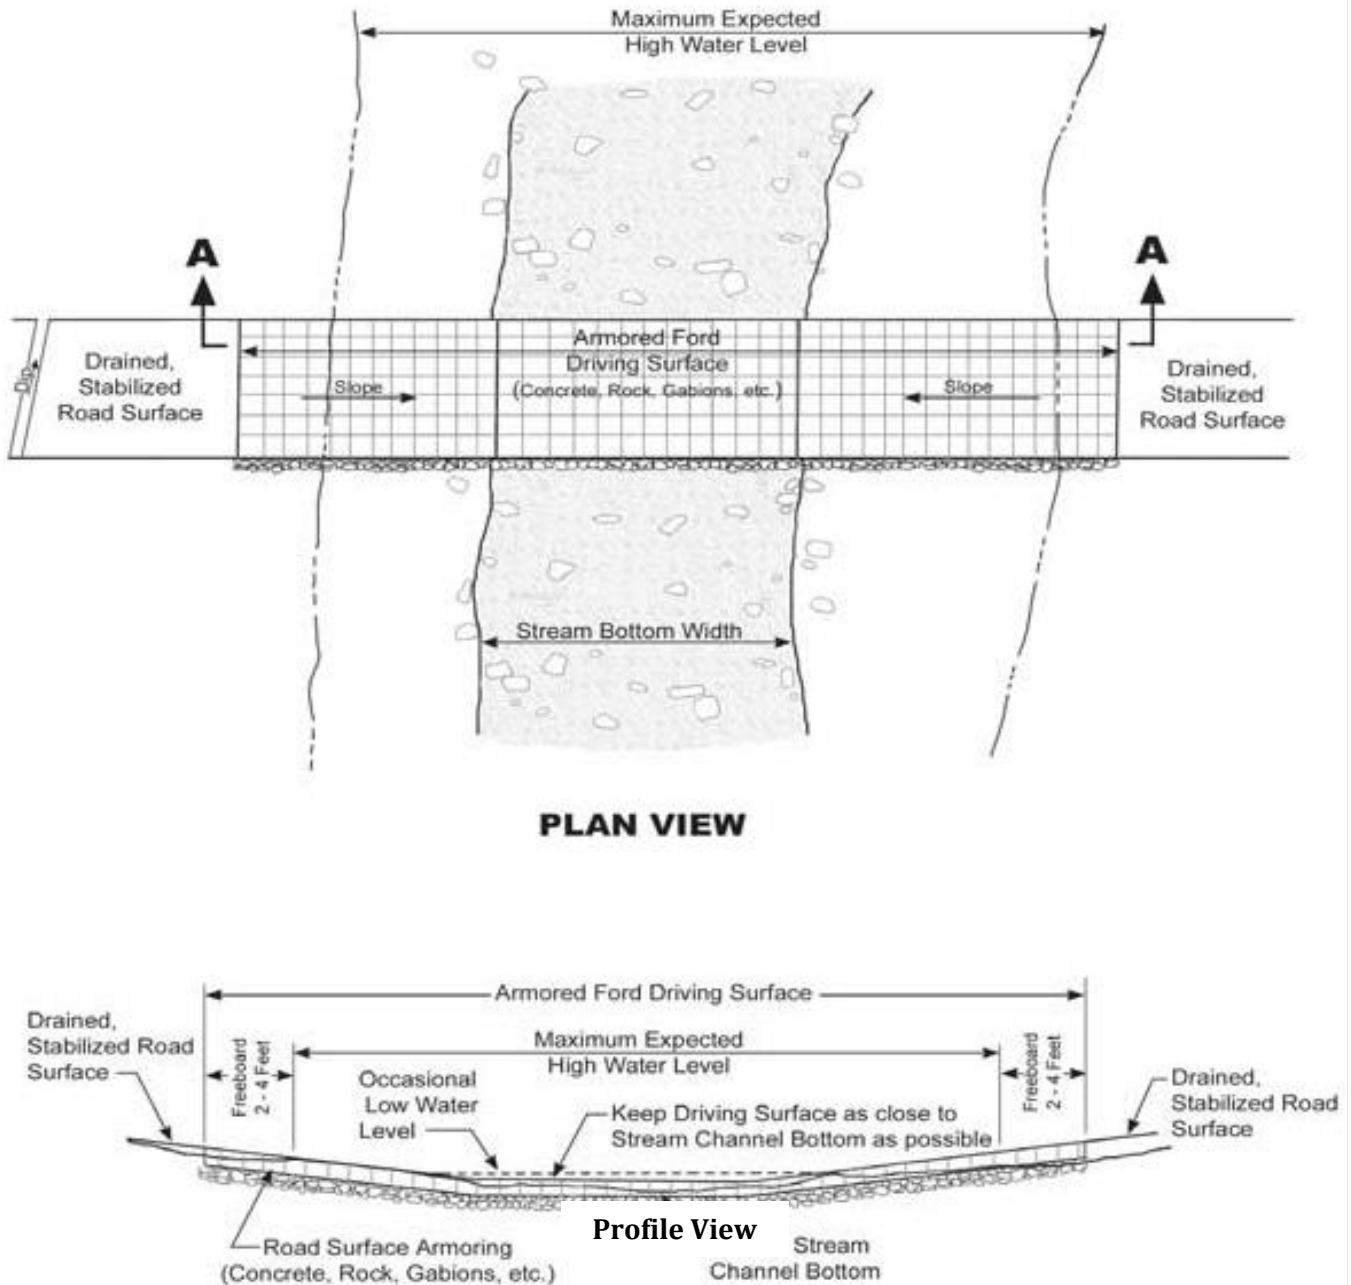
*Figure 16. Typical Ford Concept (Provided by USDA Forest Service)*
