## **Appendix E**

**Concept Design Drawings**  
**(Berm and Channel Improvements Full Riprap Alternative)**

# DRAWINGS FOR CONSTRUCTION OF THE WATERSHED PLAN EA TOOELE COUNTY

TOOELE COUNTY  
WATERSHED PLAN EA  
TOOELE COUNTY

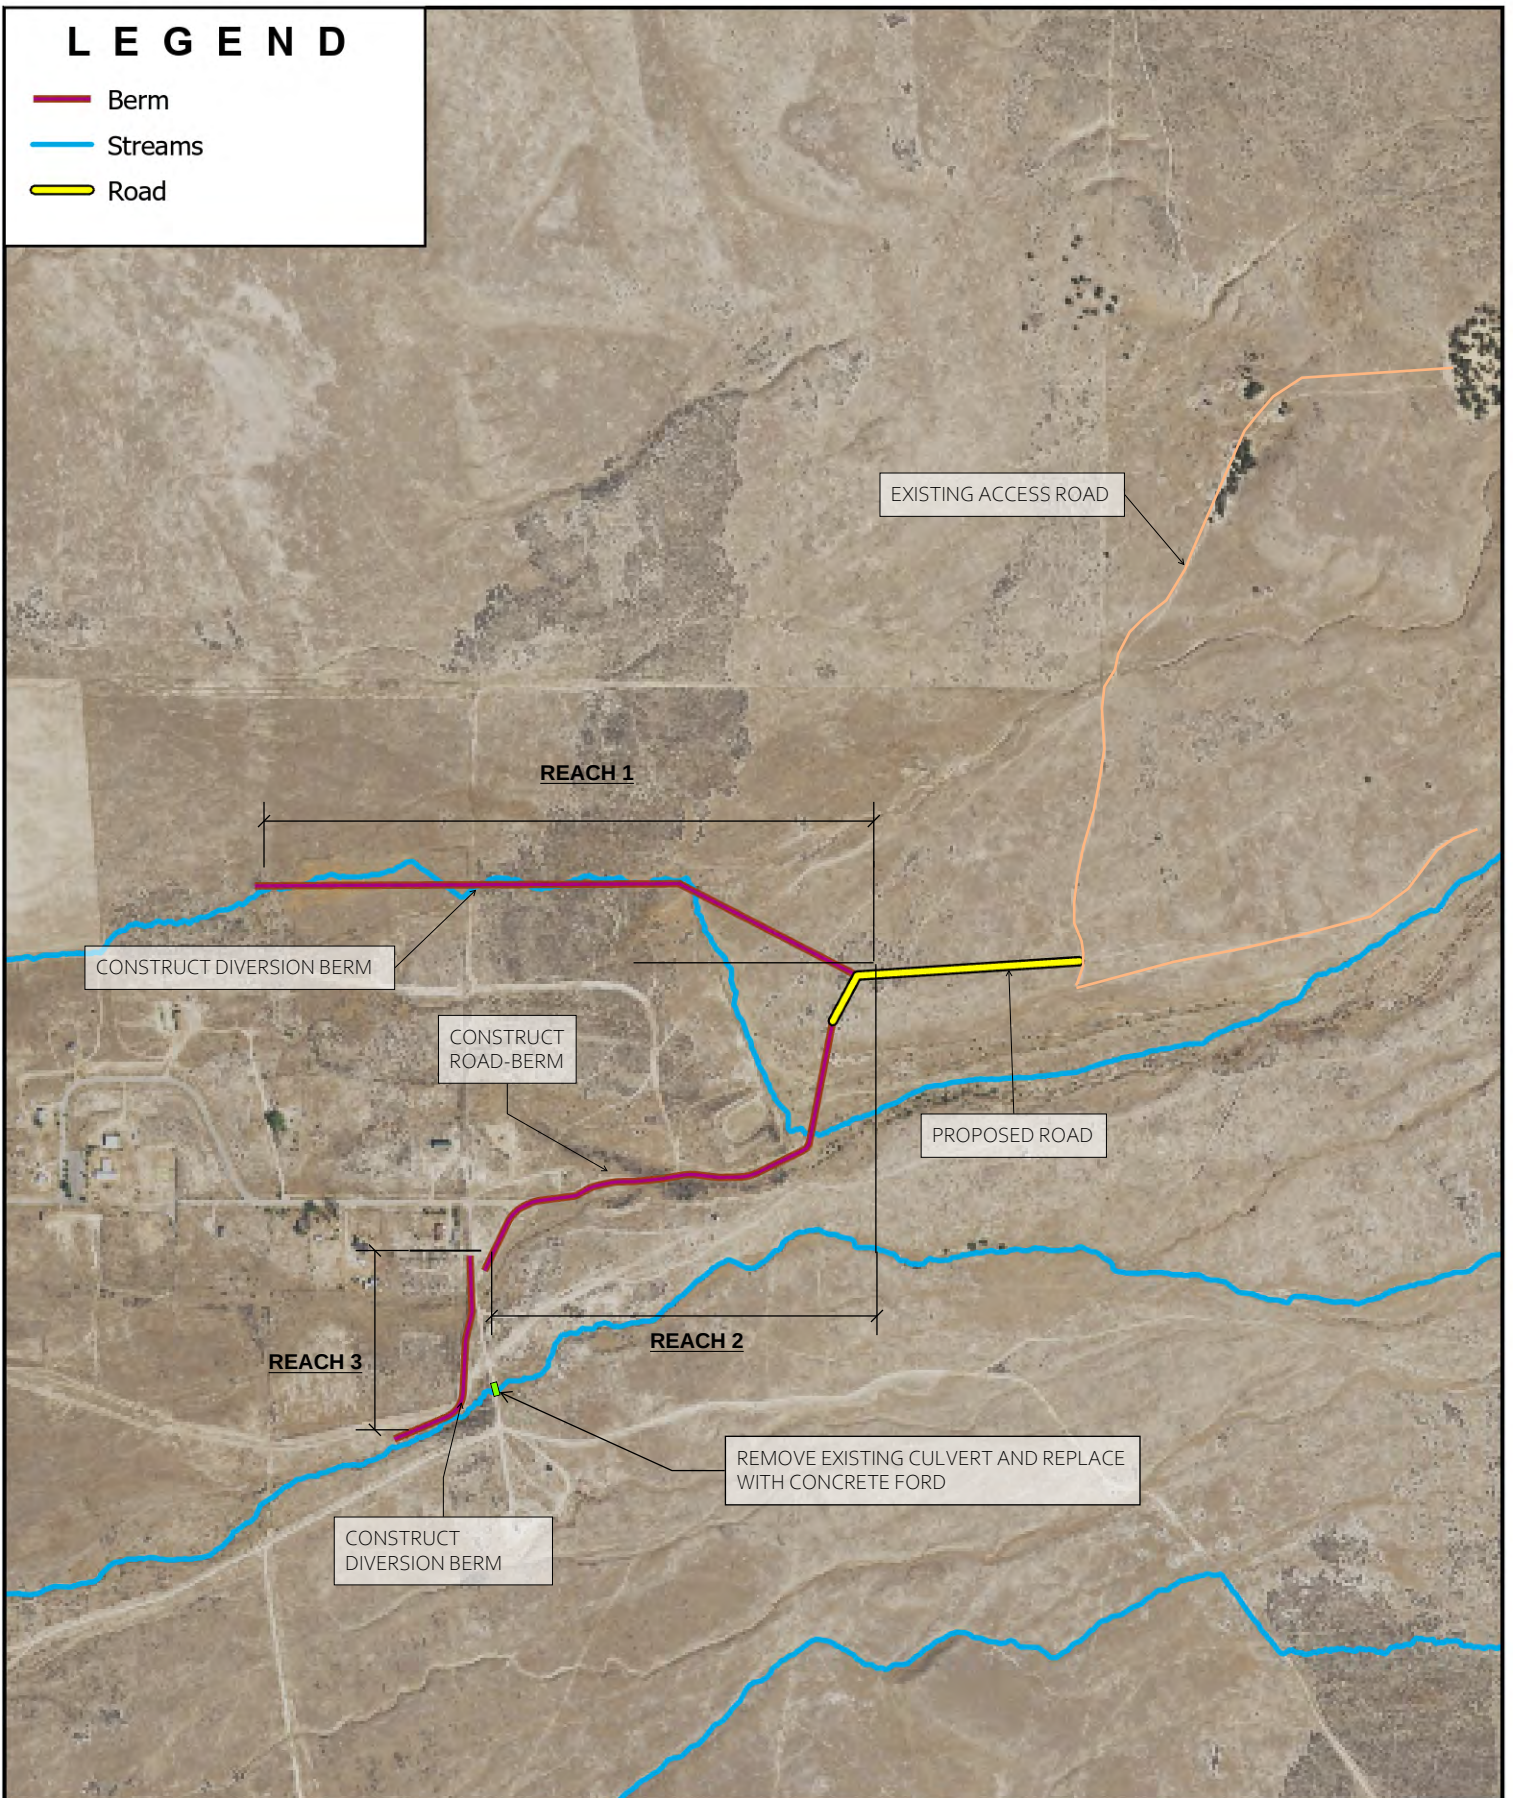
## POTENTIAL ALTERNATIVE 3 IMPROVEMENTS

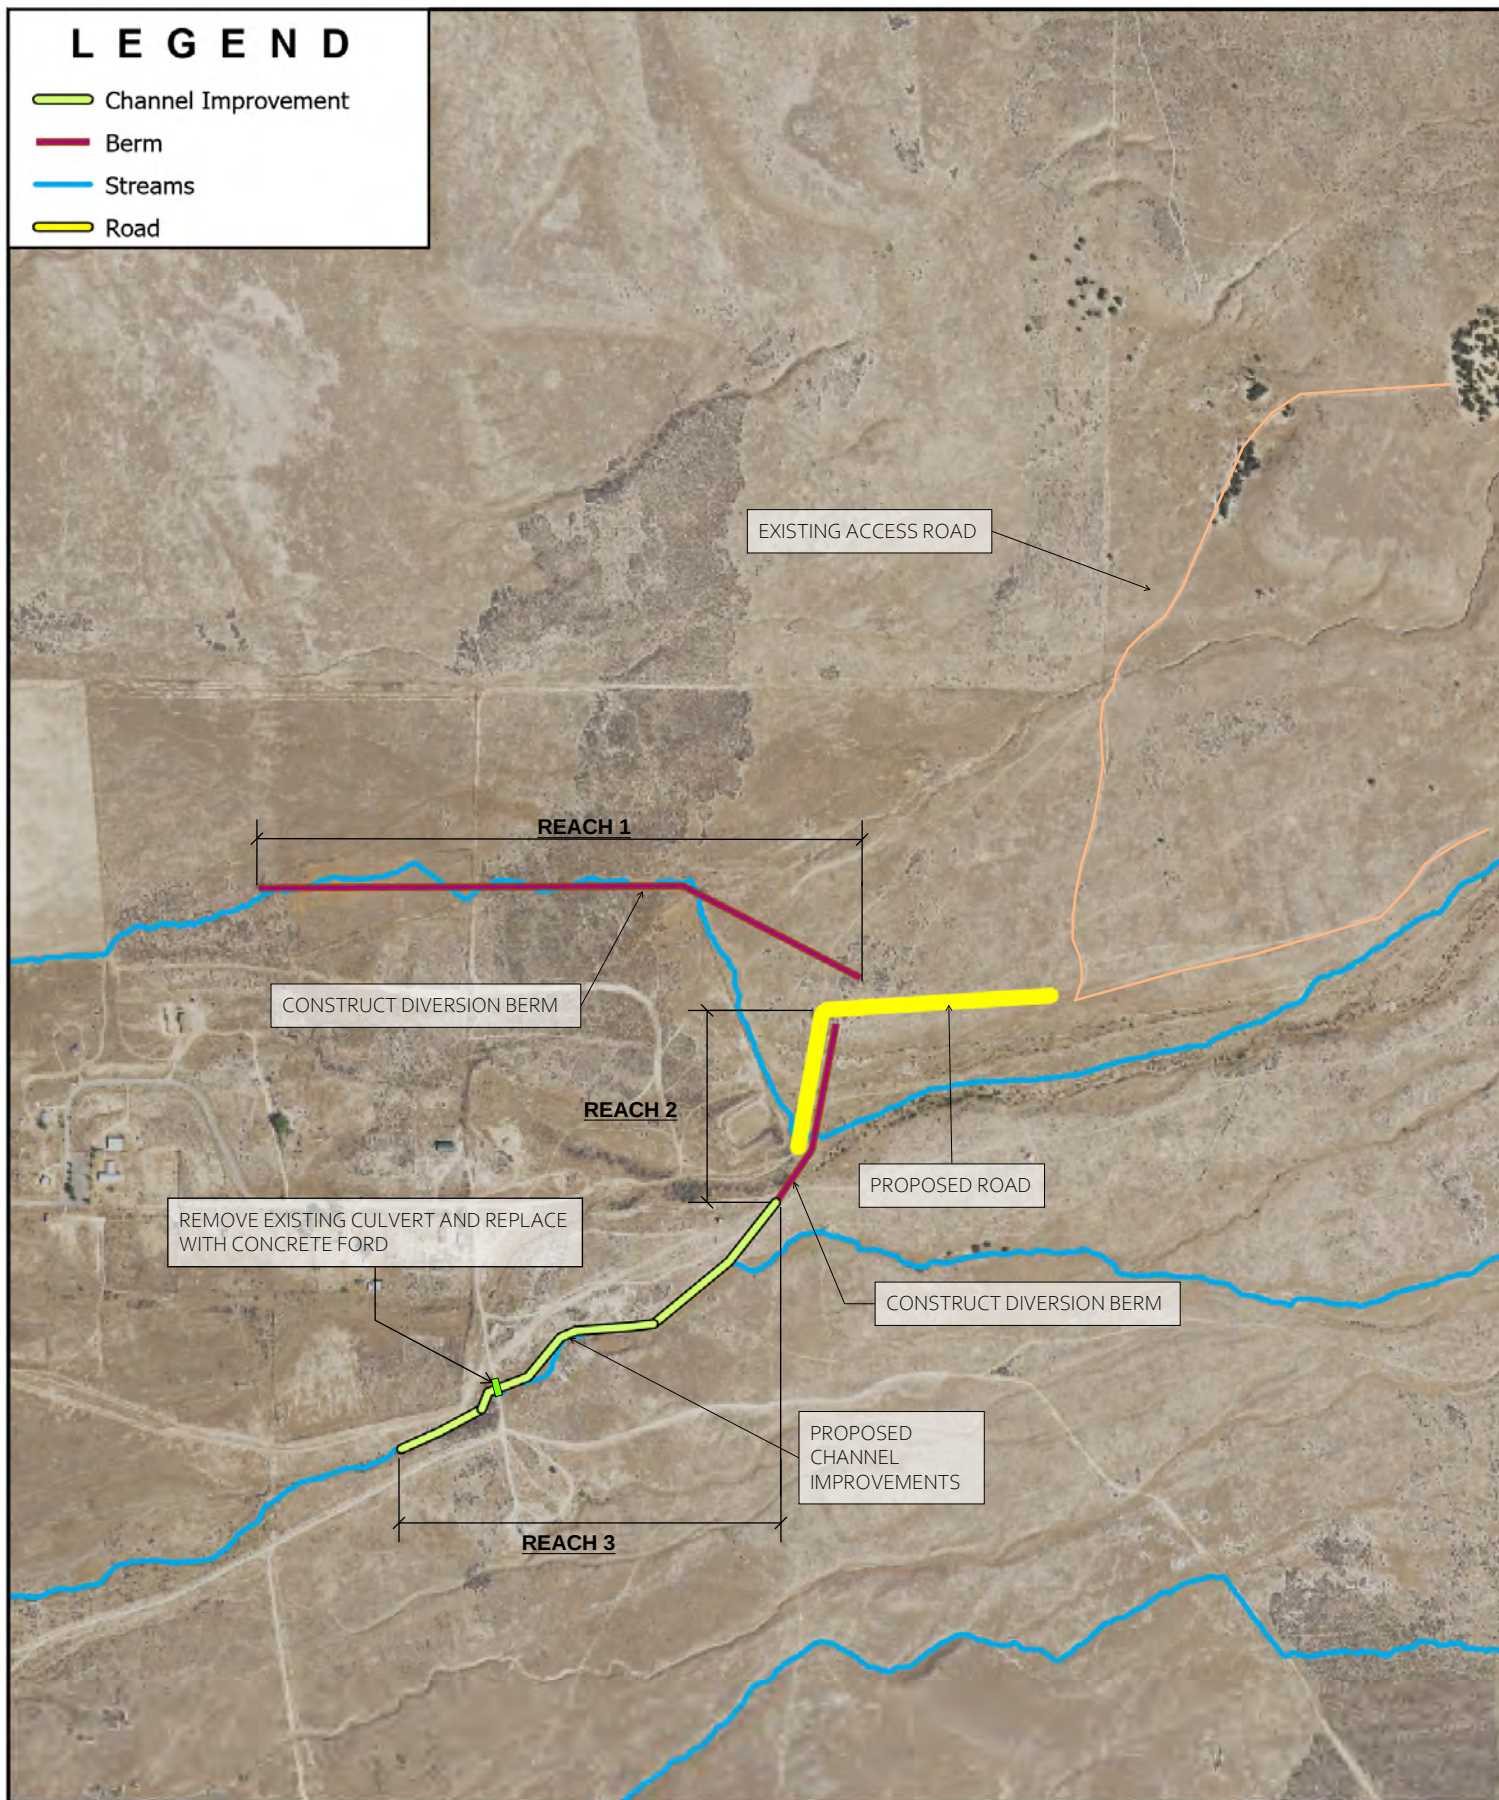
## POTENTIAL ALTERNATIVE 4 IMPROVEMENTS

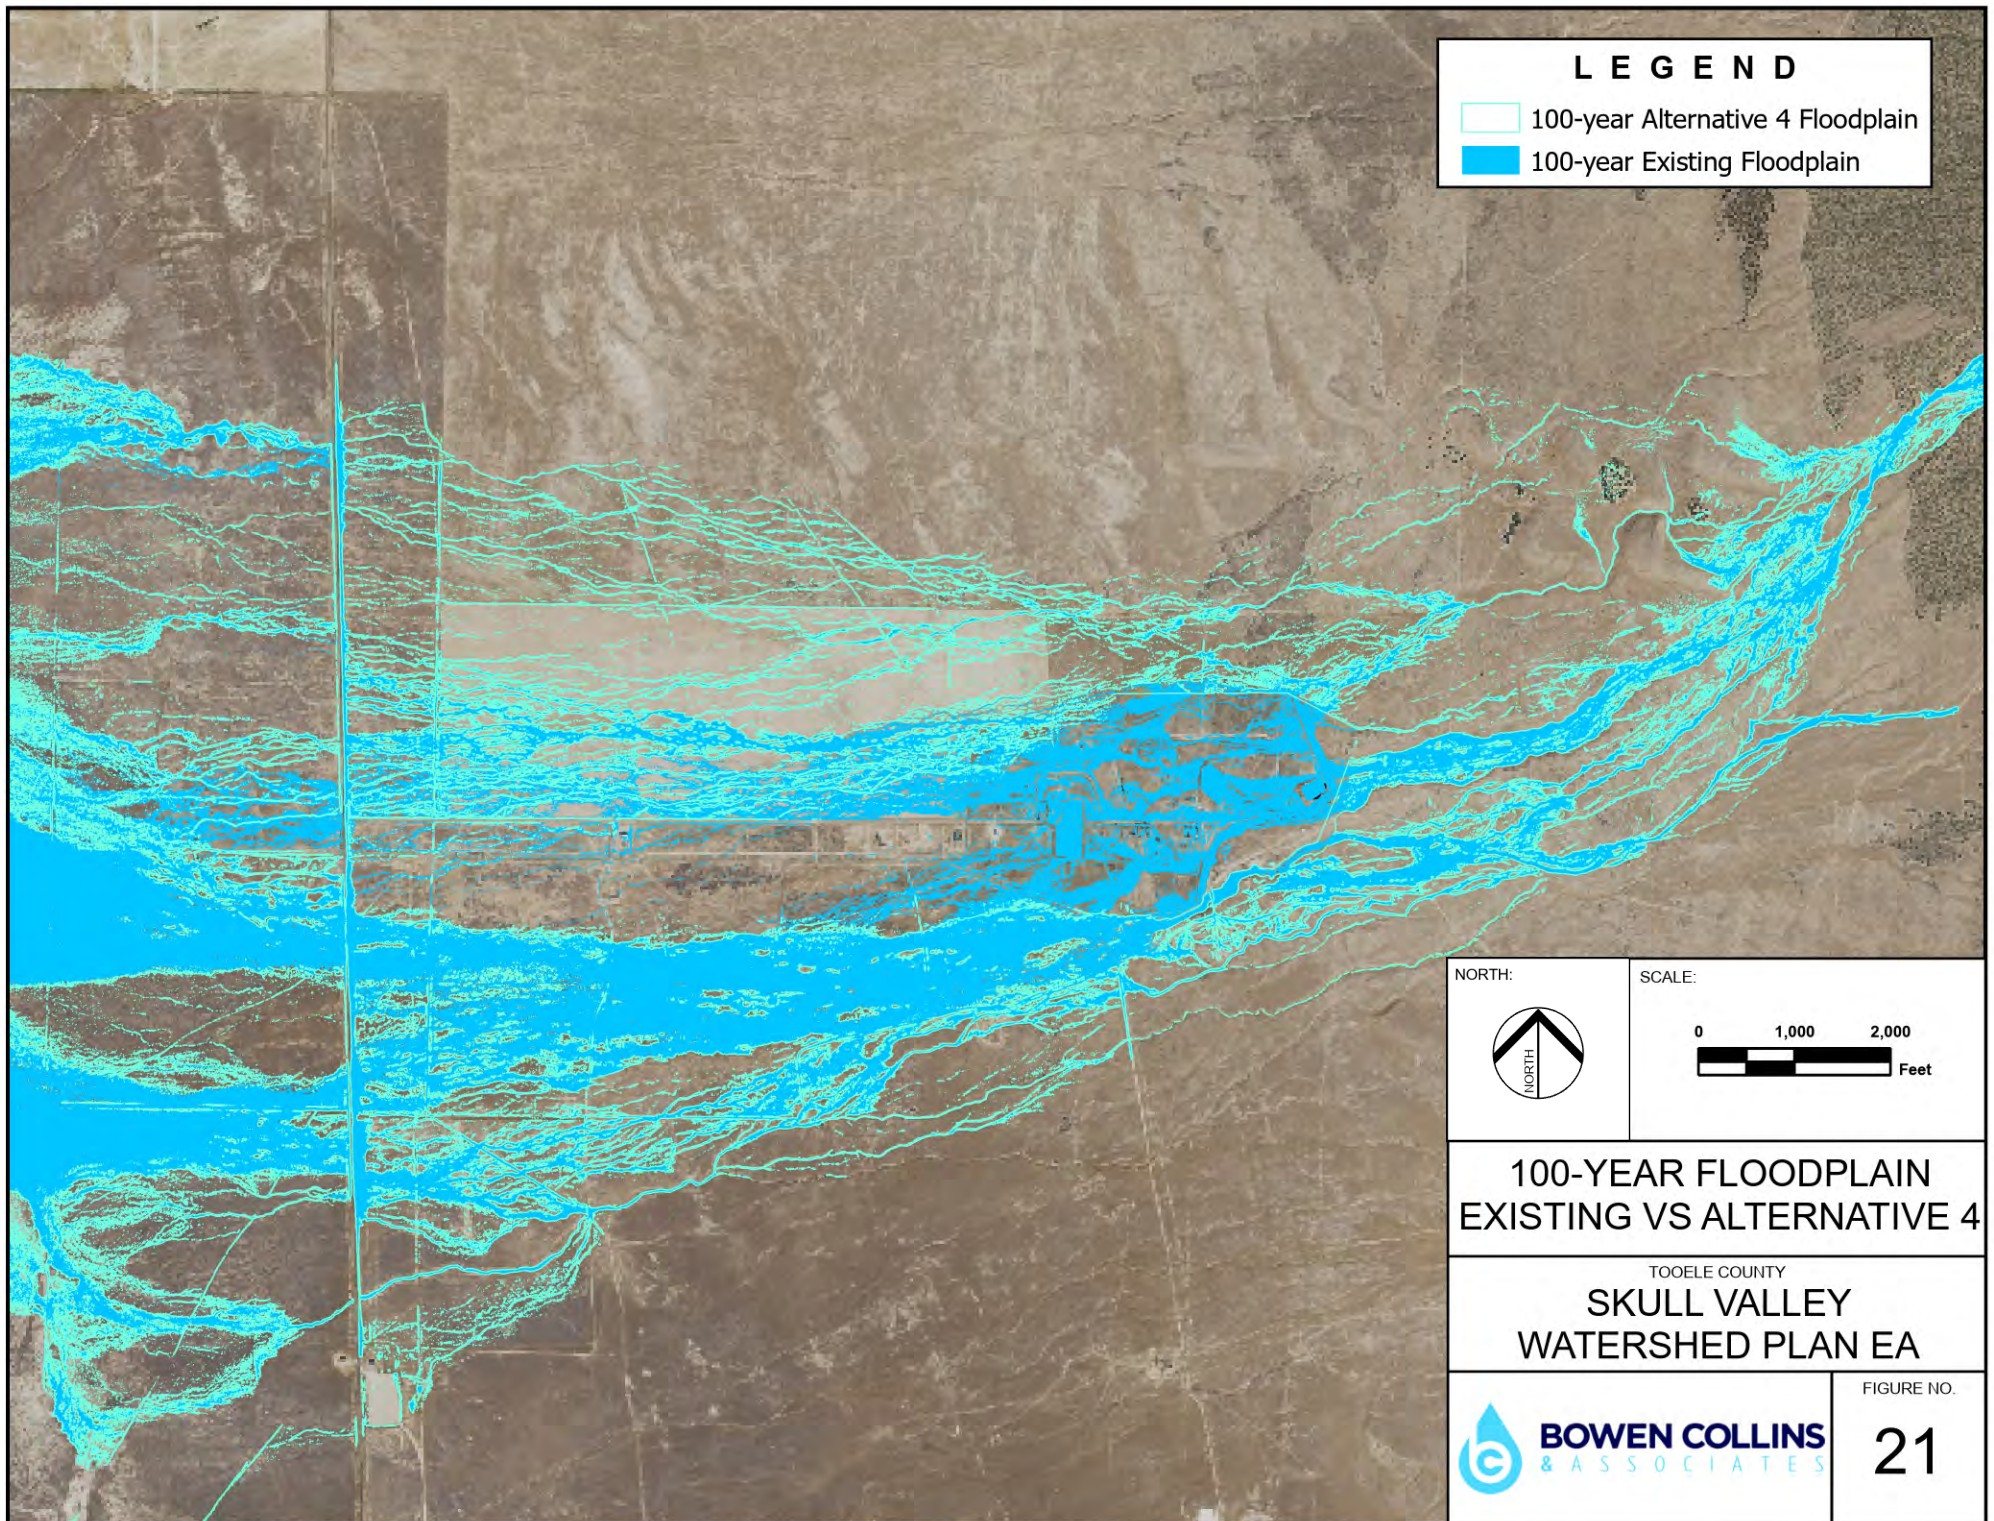
Figure 21 below shows a comparison between the 100-year existing and Alternative 4 floodplains. The results show that the berm diversions and a channel would direct water away from Reservation land and protect existing structures. The results illustrated on Figure 21 also show that the exterior 100-year floodplain limits for existing and is not affected by Alternative 4 improvements and all impacts are on reservation property.

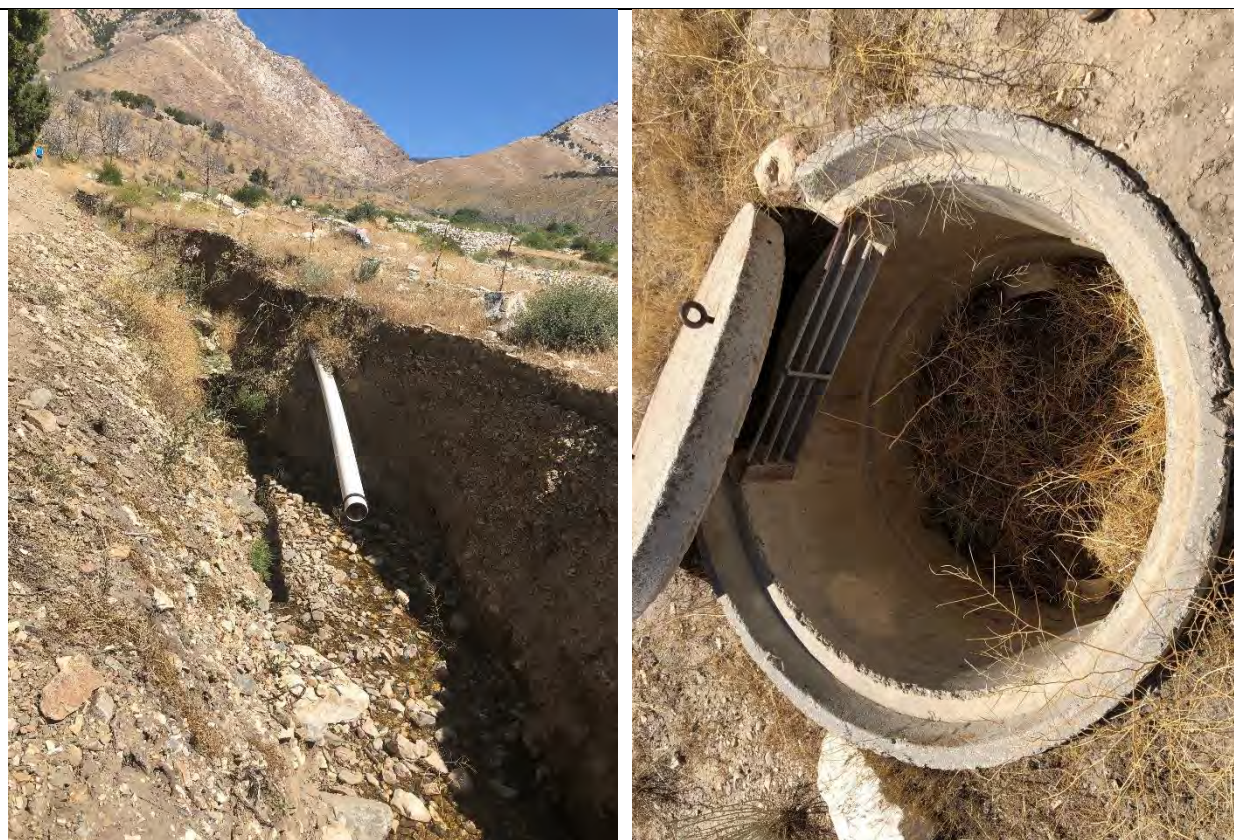
***Figure 24. Destroyed Pipeline and Manhole Example 2***

Several assumptions were made with regard to developing a concept design for improvements to replace the damaged irrigation pipeline and to repair the irrigation pond due to the lack of data and information on the existing facilities. Figure 25 below shows the approximate locations and improvements for the irrigation pond and pipeline.

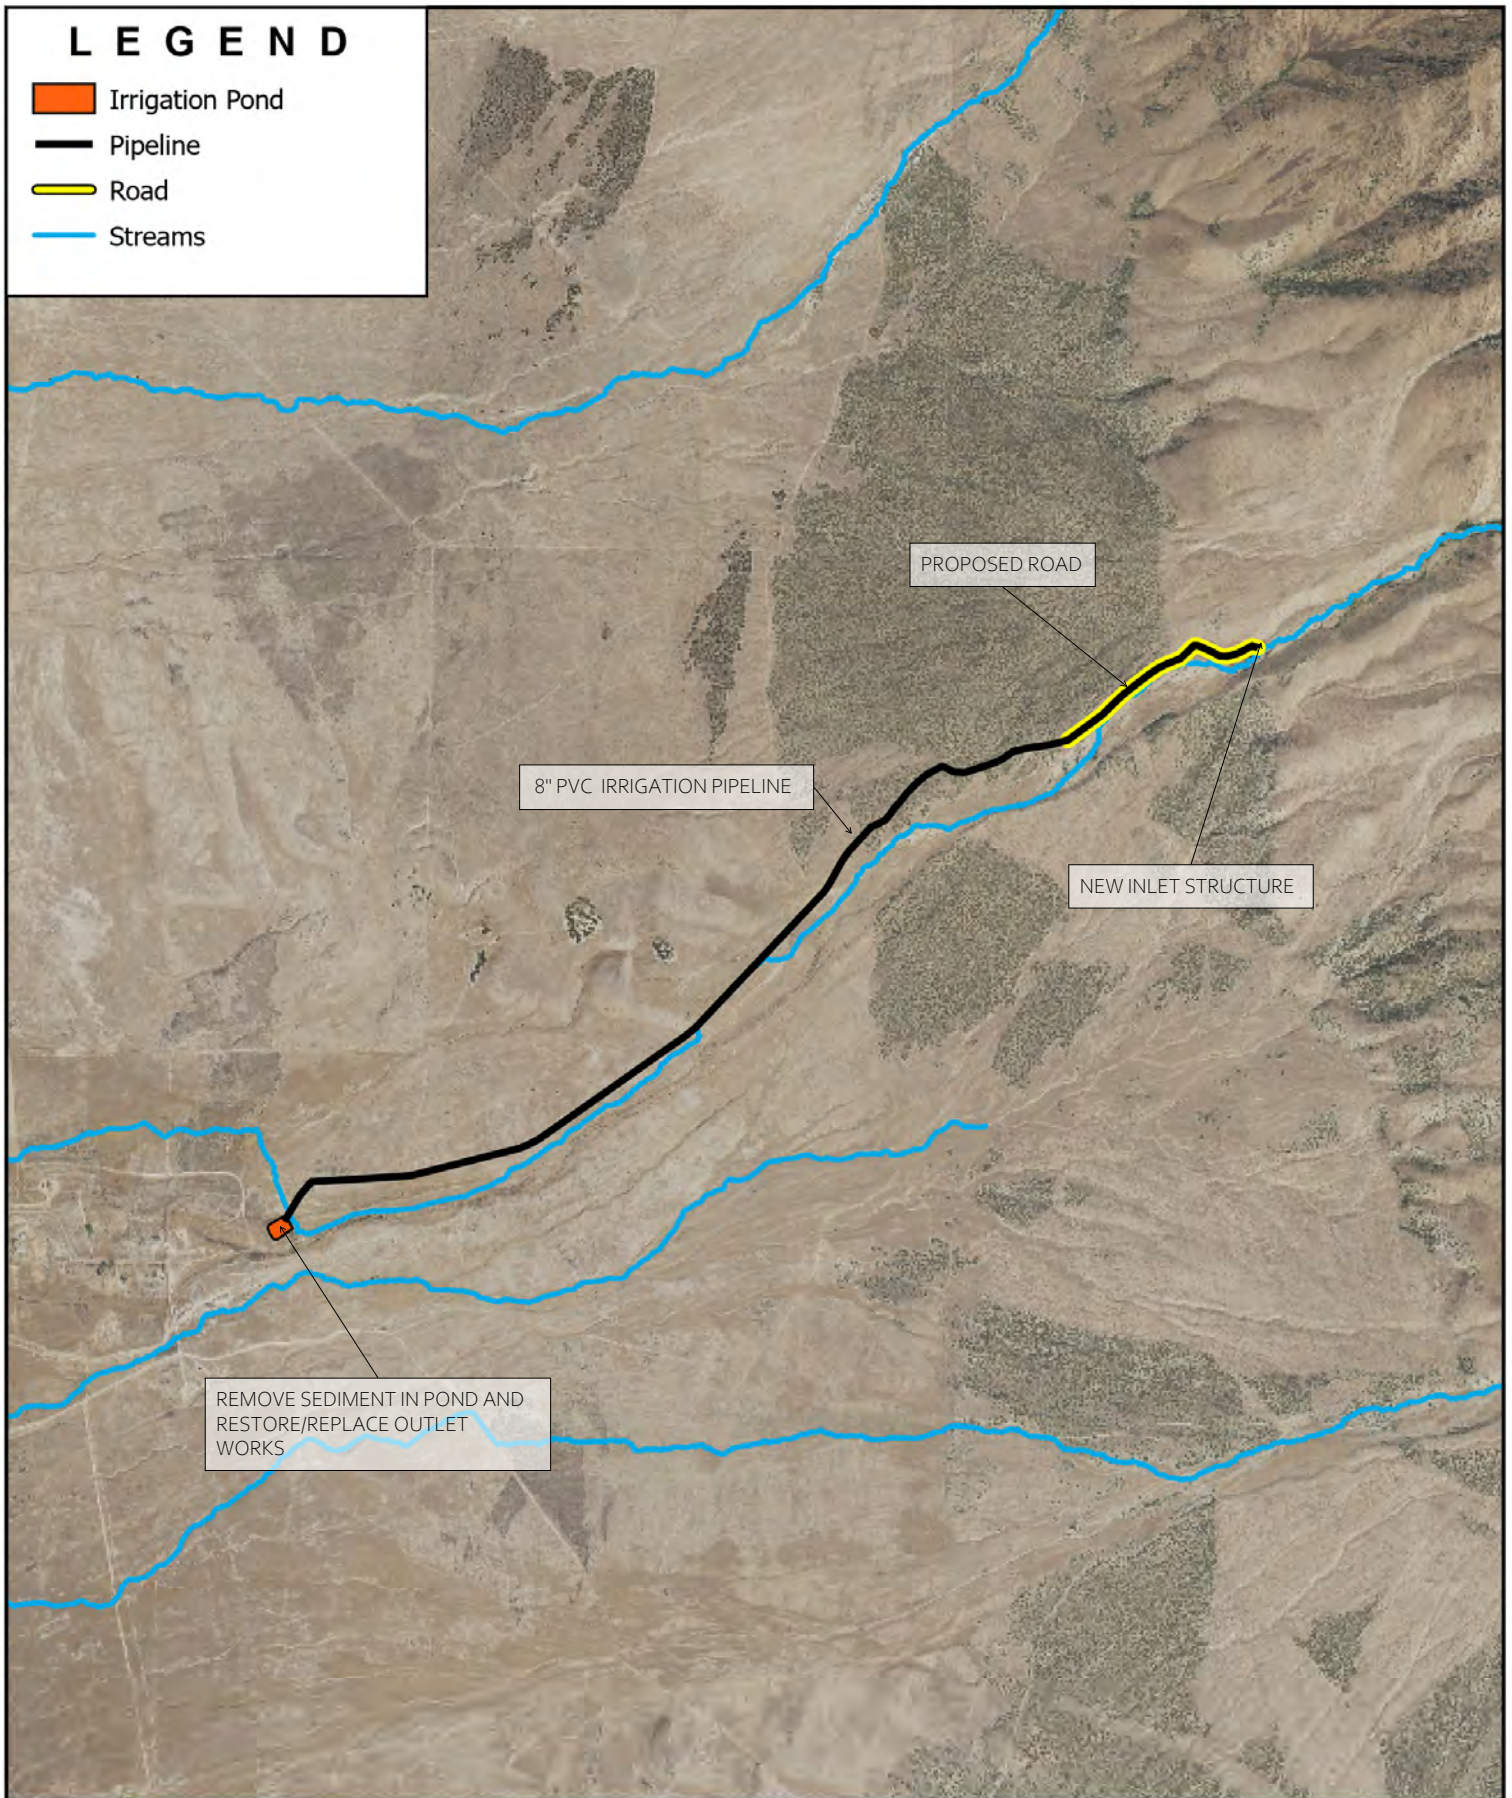
## IRRIGATION POND AND PIPELINE POTENTIAL IMPROVEMENTS

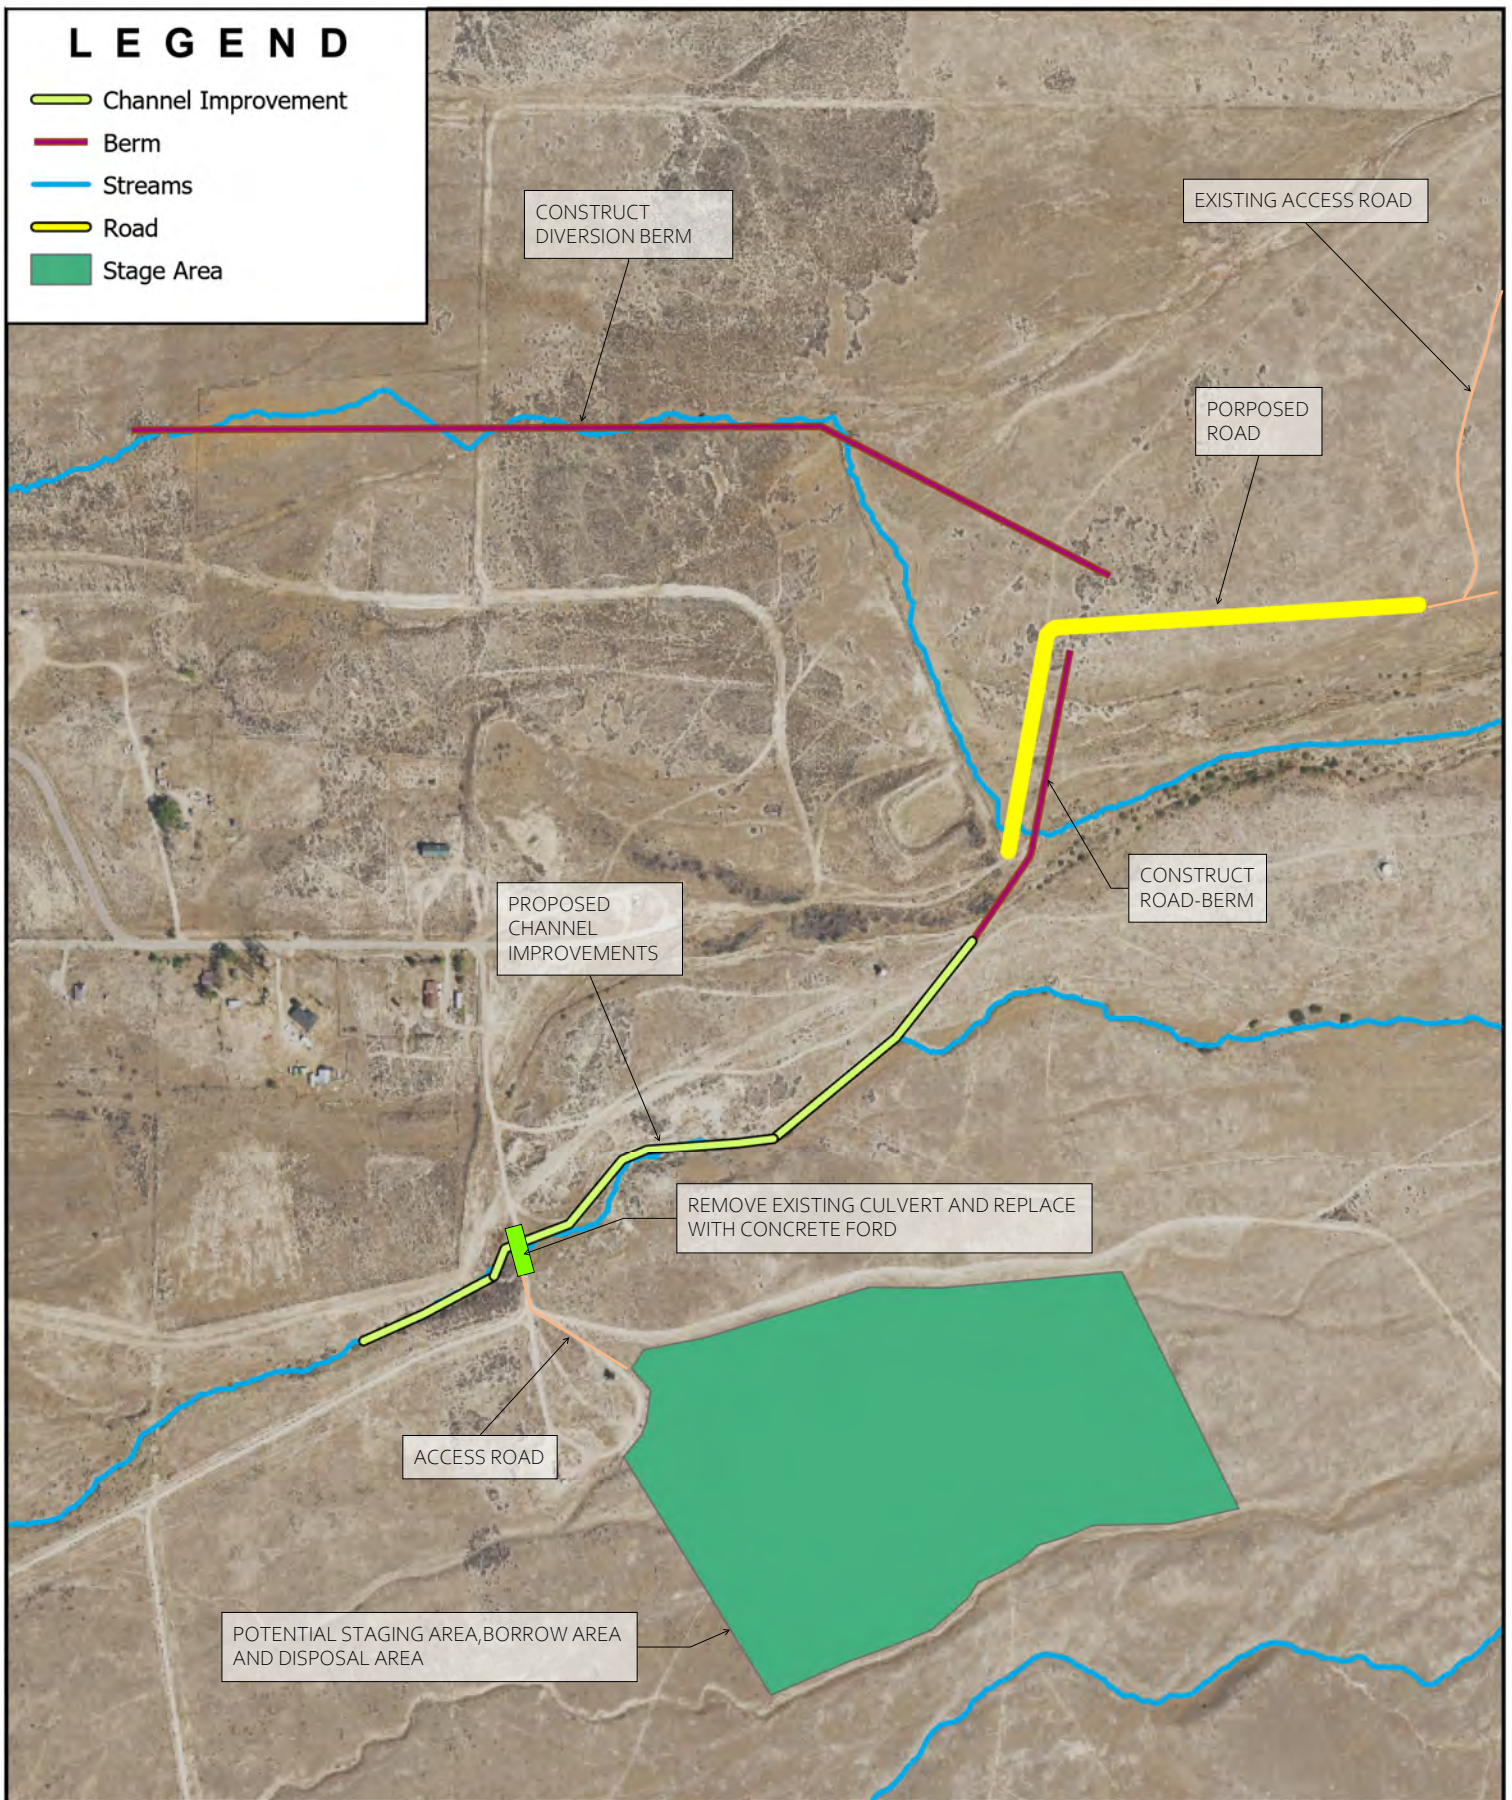
## RECOMMENDED IMPROVEMENTS

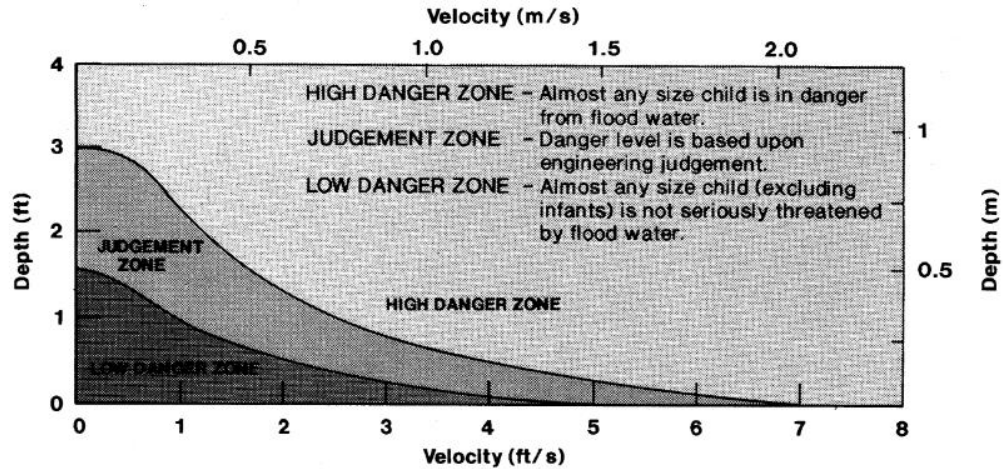
Figure 1 USBR 1988 Hazard Danger for Children

In 1988 the USBR and more recently in 2010/2011 Engineers Australia, developed hazard mapping guidelines for vehicle and pedestrian stability limits during a flood event based on depth x velocity. Figures 1 through 3 show example graphs from the USBR study and Figures 3 and 4 show graphs from the Engineers Australia study which also shows the experimental data used to help develop the graphs and final recommendations. The final recommendation from Engineers Australia for hazard mapping and used for our analysis is presented in Table 4 and Table 5 below. The tables were converted from SI to English units as our study was done in English units. The USBR and Engineers Australia documents are provided as attachments to this memo.

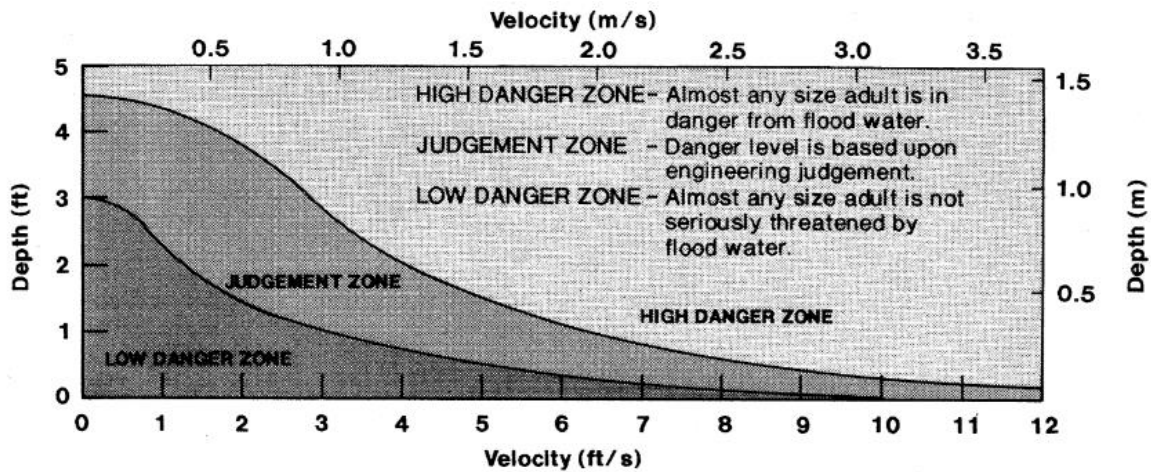
Figure 2 USBR 1988 Hazard Danger for Adults

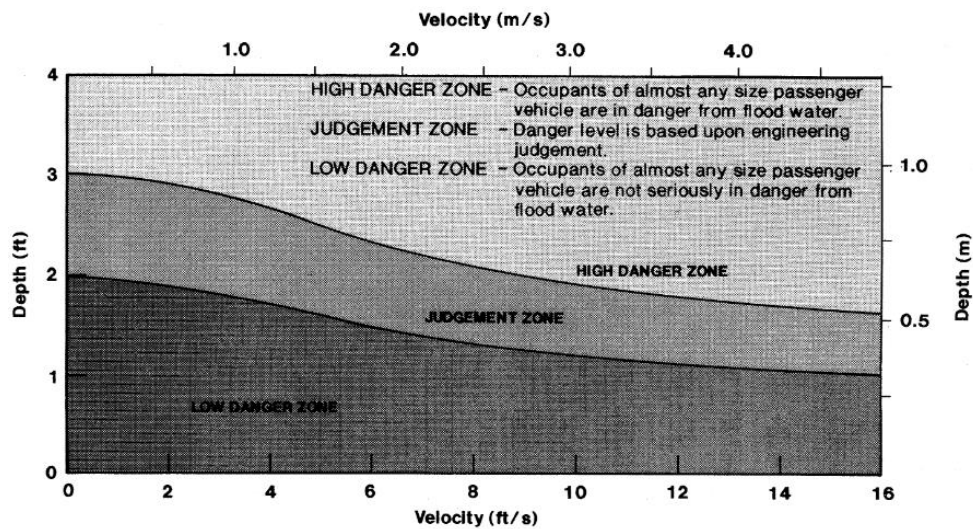
Figure 3 USBR 1988 Hazard Danger for Cars

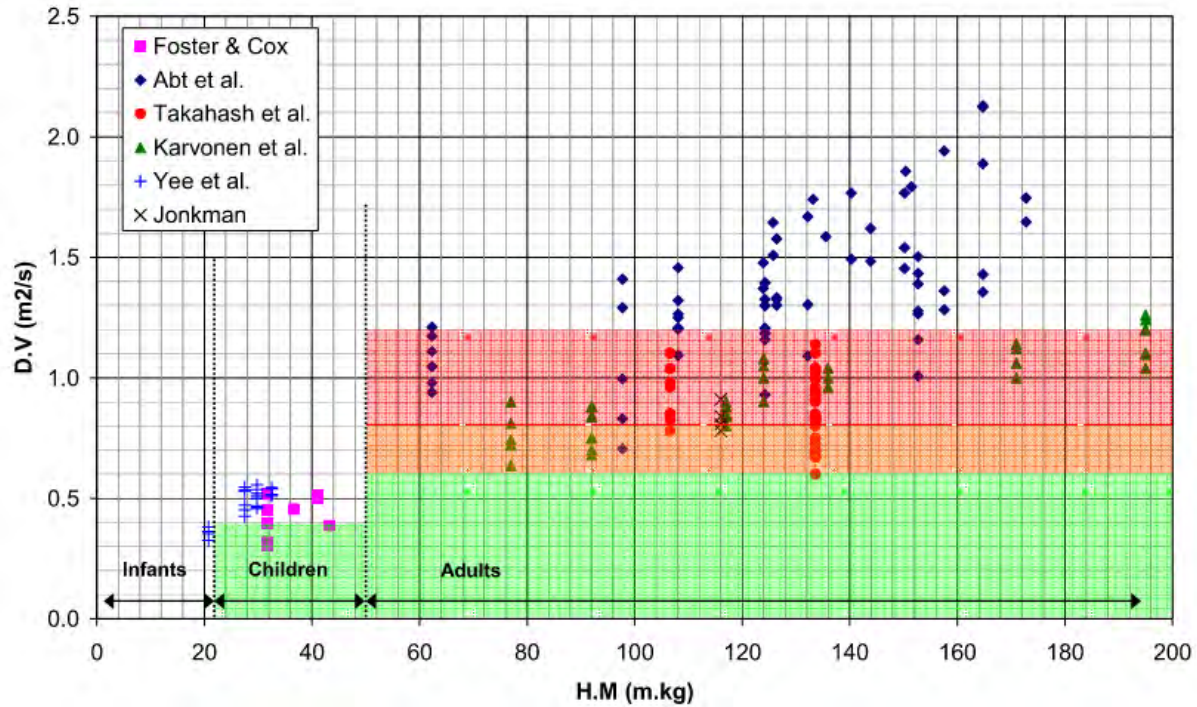
**Figure 4 Engineers Australia 2010 Hazard Danger Zones based on Height and Mass Compared to Available Experimental Data**

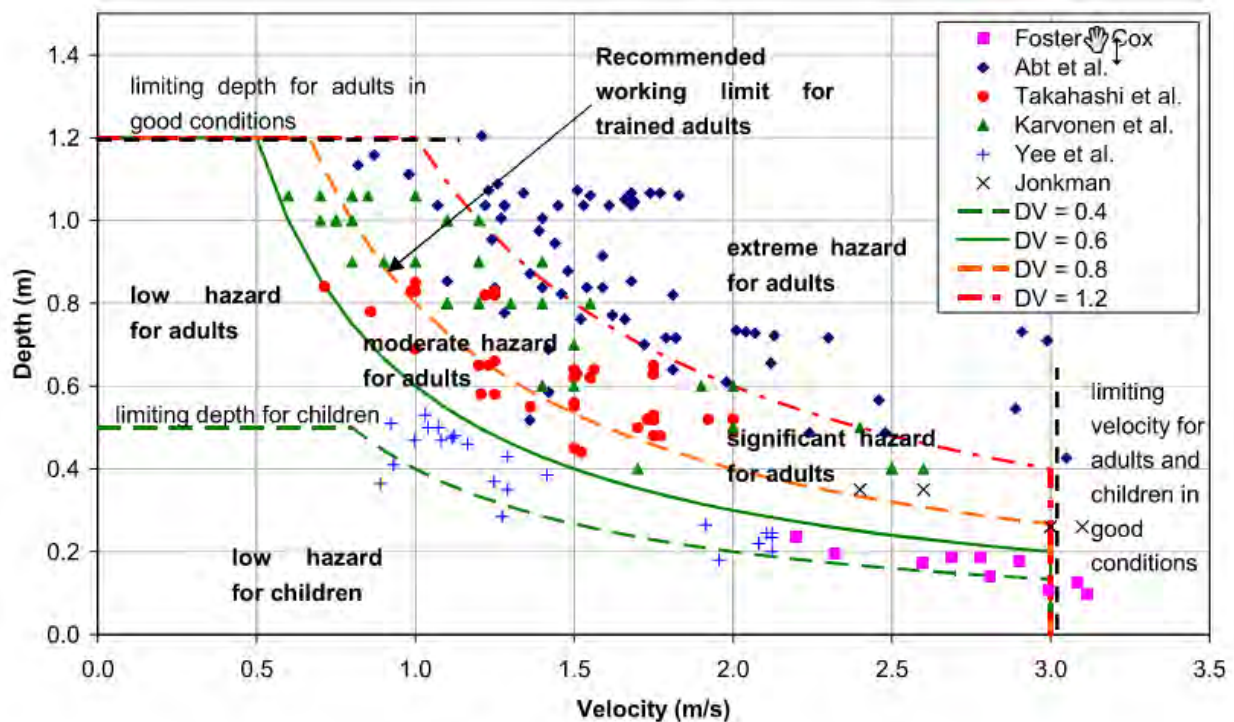
**Figure 5 Engineers Australia 2010 Hazard Danger Zones for People Compared to Available Experimental Data**
