# APPENDIX E

- Technical Memo Draft: Santa Clara Watershed EA Dammeron Valley and Diamond Valley Alternatives
- Hydraulic and Freeboard Report - Preliminary

- Preliminary Hydrology Report - Draft

- Geotechnical Investigation Report for Preliminary Design
  - o Report

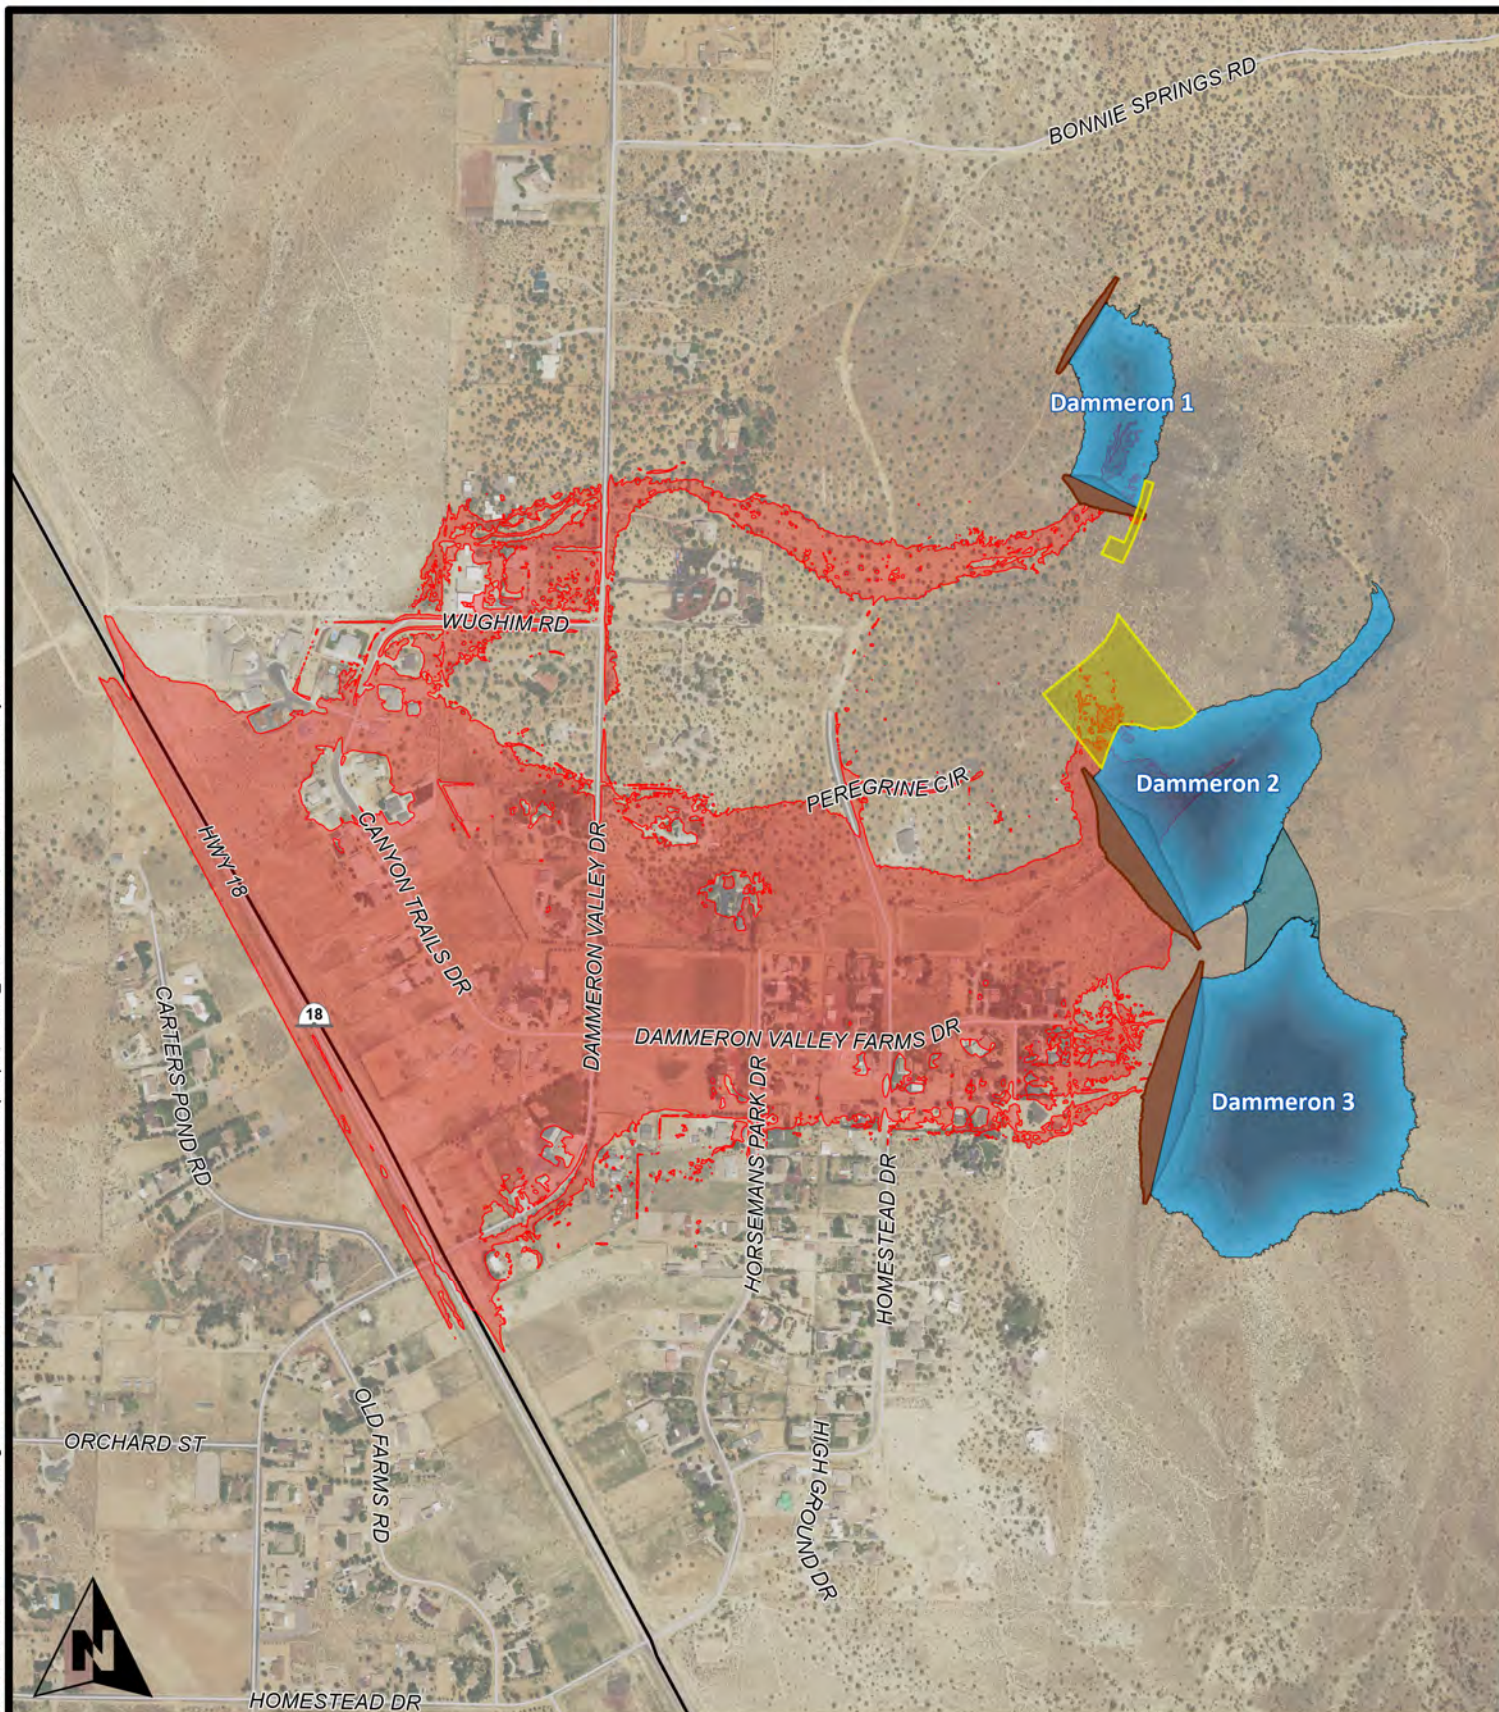
**Fig 6. Damm2 Breach Map**  
Santa Clara EA, Dammeron Valley

- Dam
- Detention Basin High Water
- Excavated Channel
- Spillway
- Dammeron 2 Breach Inundation Boundary
- Diamond 2 Breach Inundation Boundary

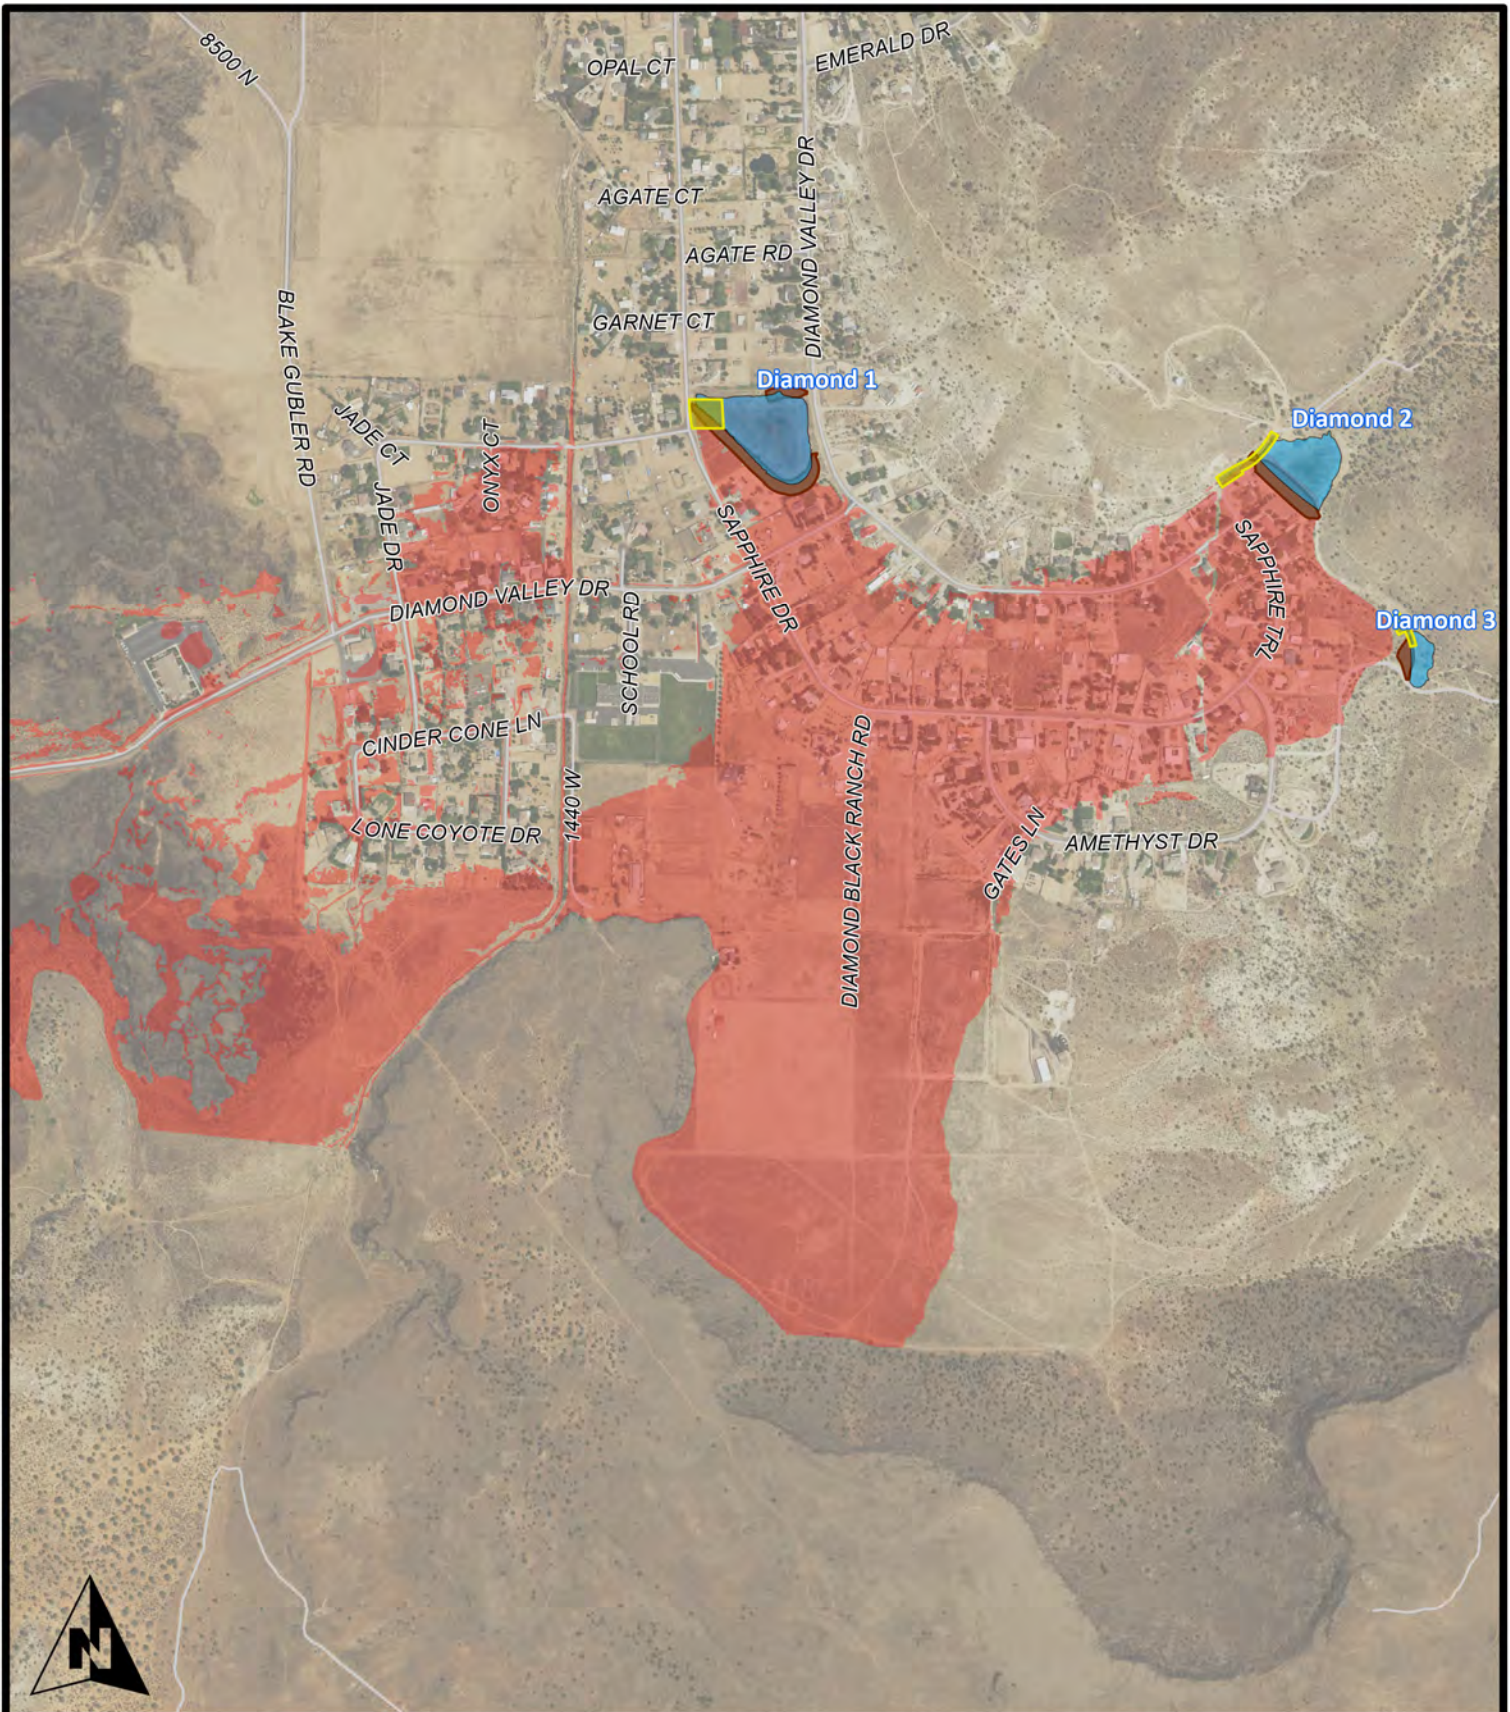
**Fig 9. Diam2 Breach Map**  
Santa Clara EA, Diamond Valley

- Dam
- Detention Basin High Water
- Excavated Channel
- Spillway
- Diamond 2 Breach Inundation Boundary

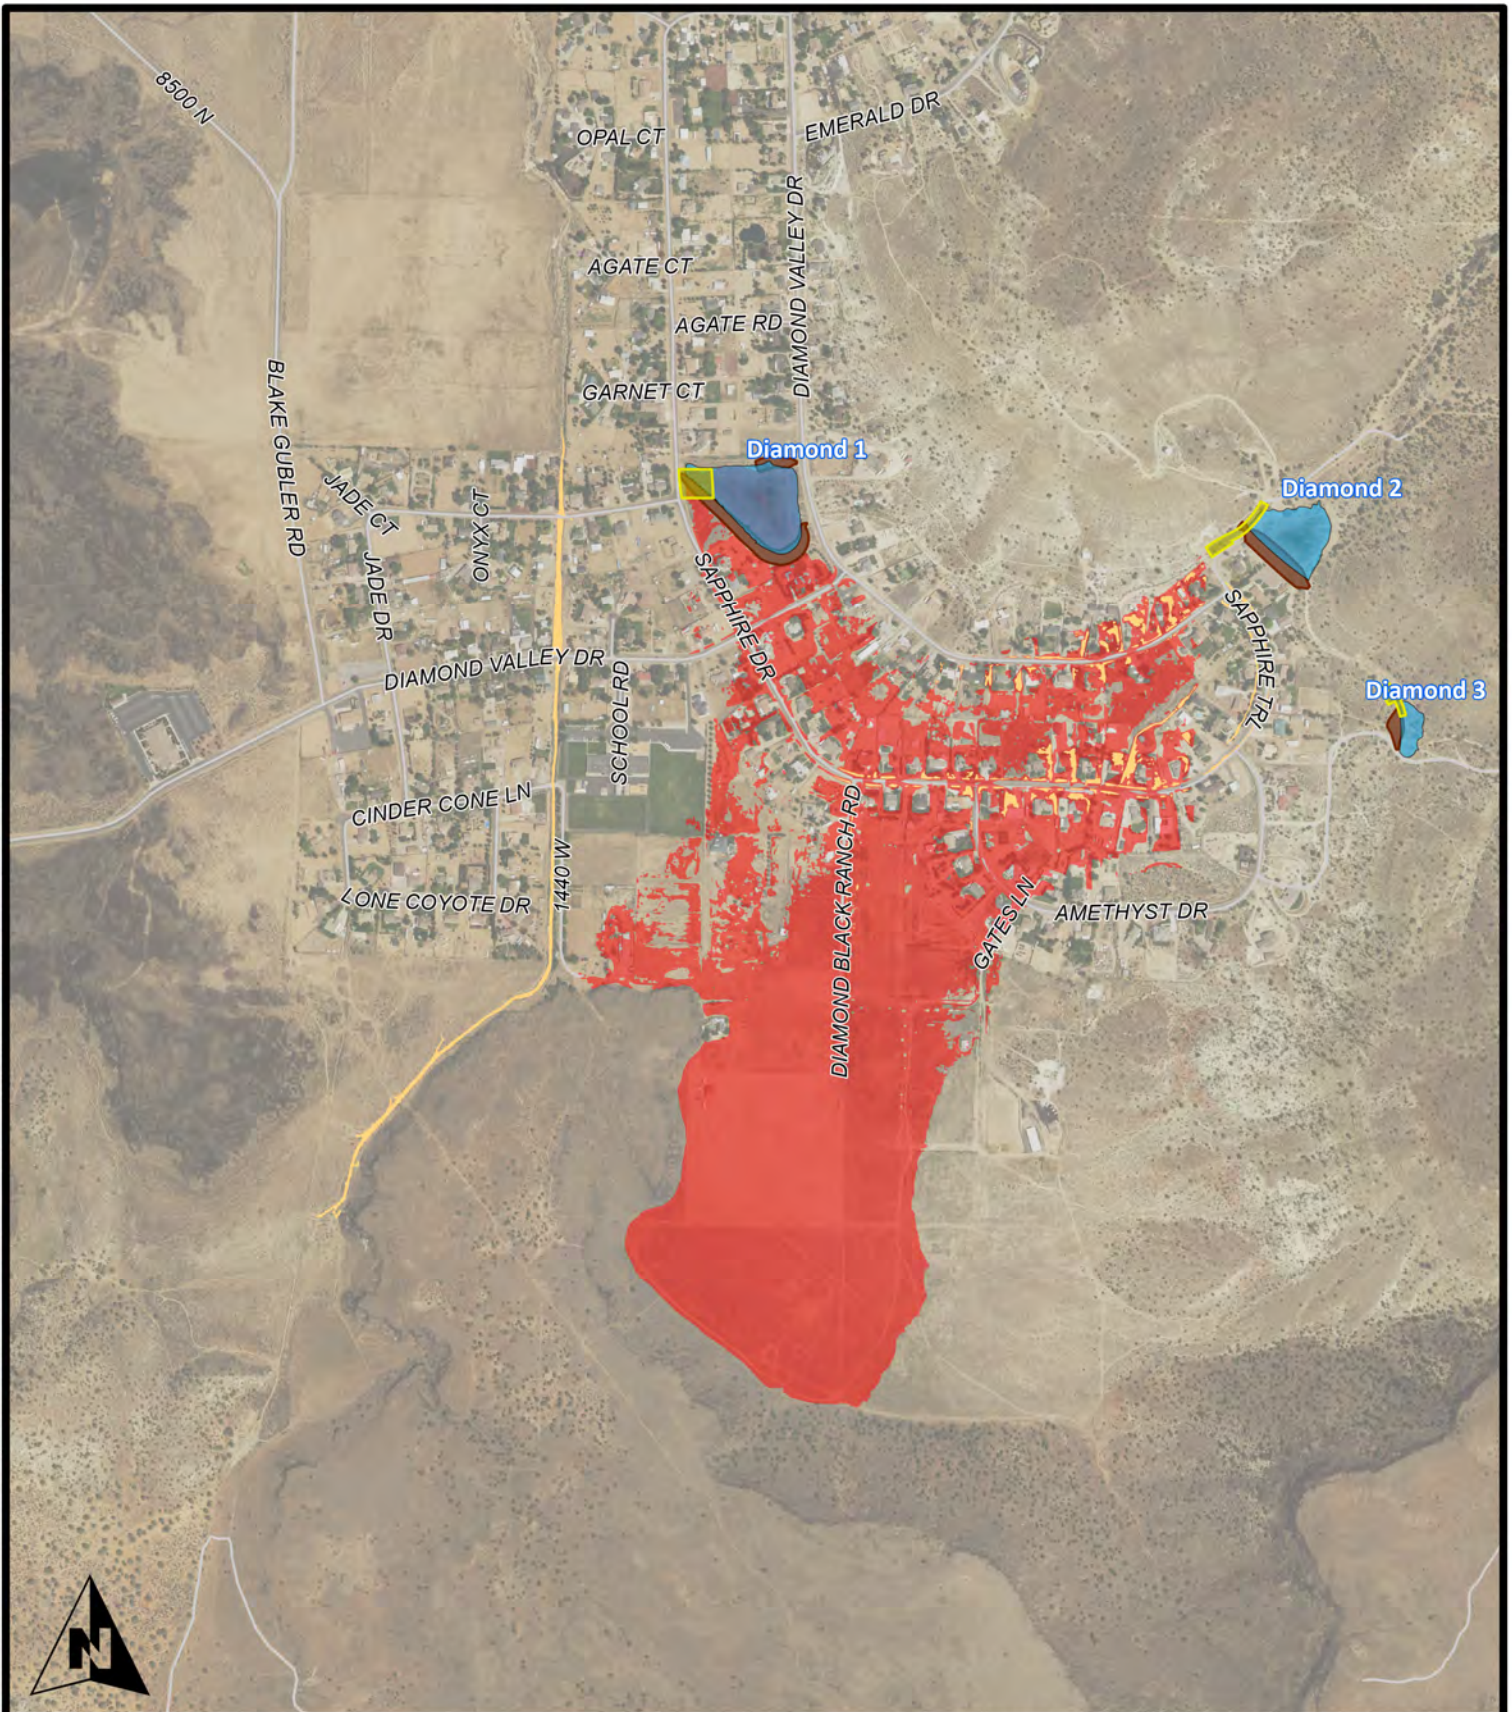
**Fig 23. 50-yr Inundation Map**  
Santa Clara EA, Diamond Valley

- Dam
- Detention Basin High Water
- Excavated Channel
- Spillway
- 50-year Inundation Boundary without Dams
- 50-year Inundation Boundary with Dams

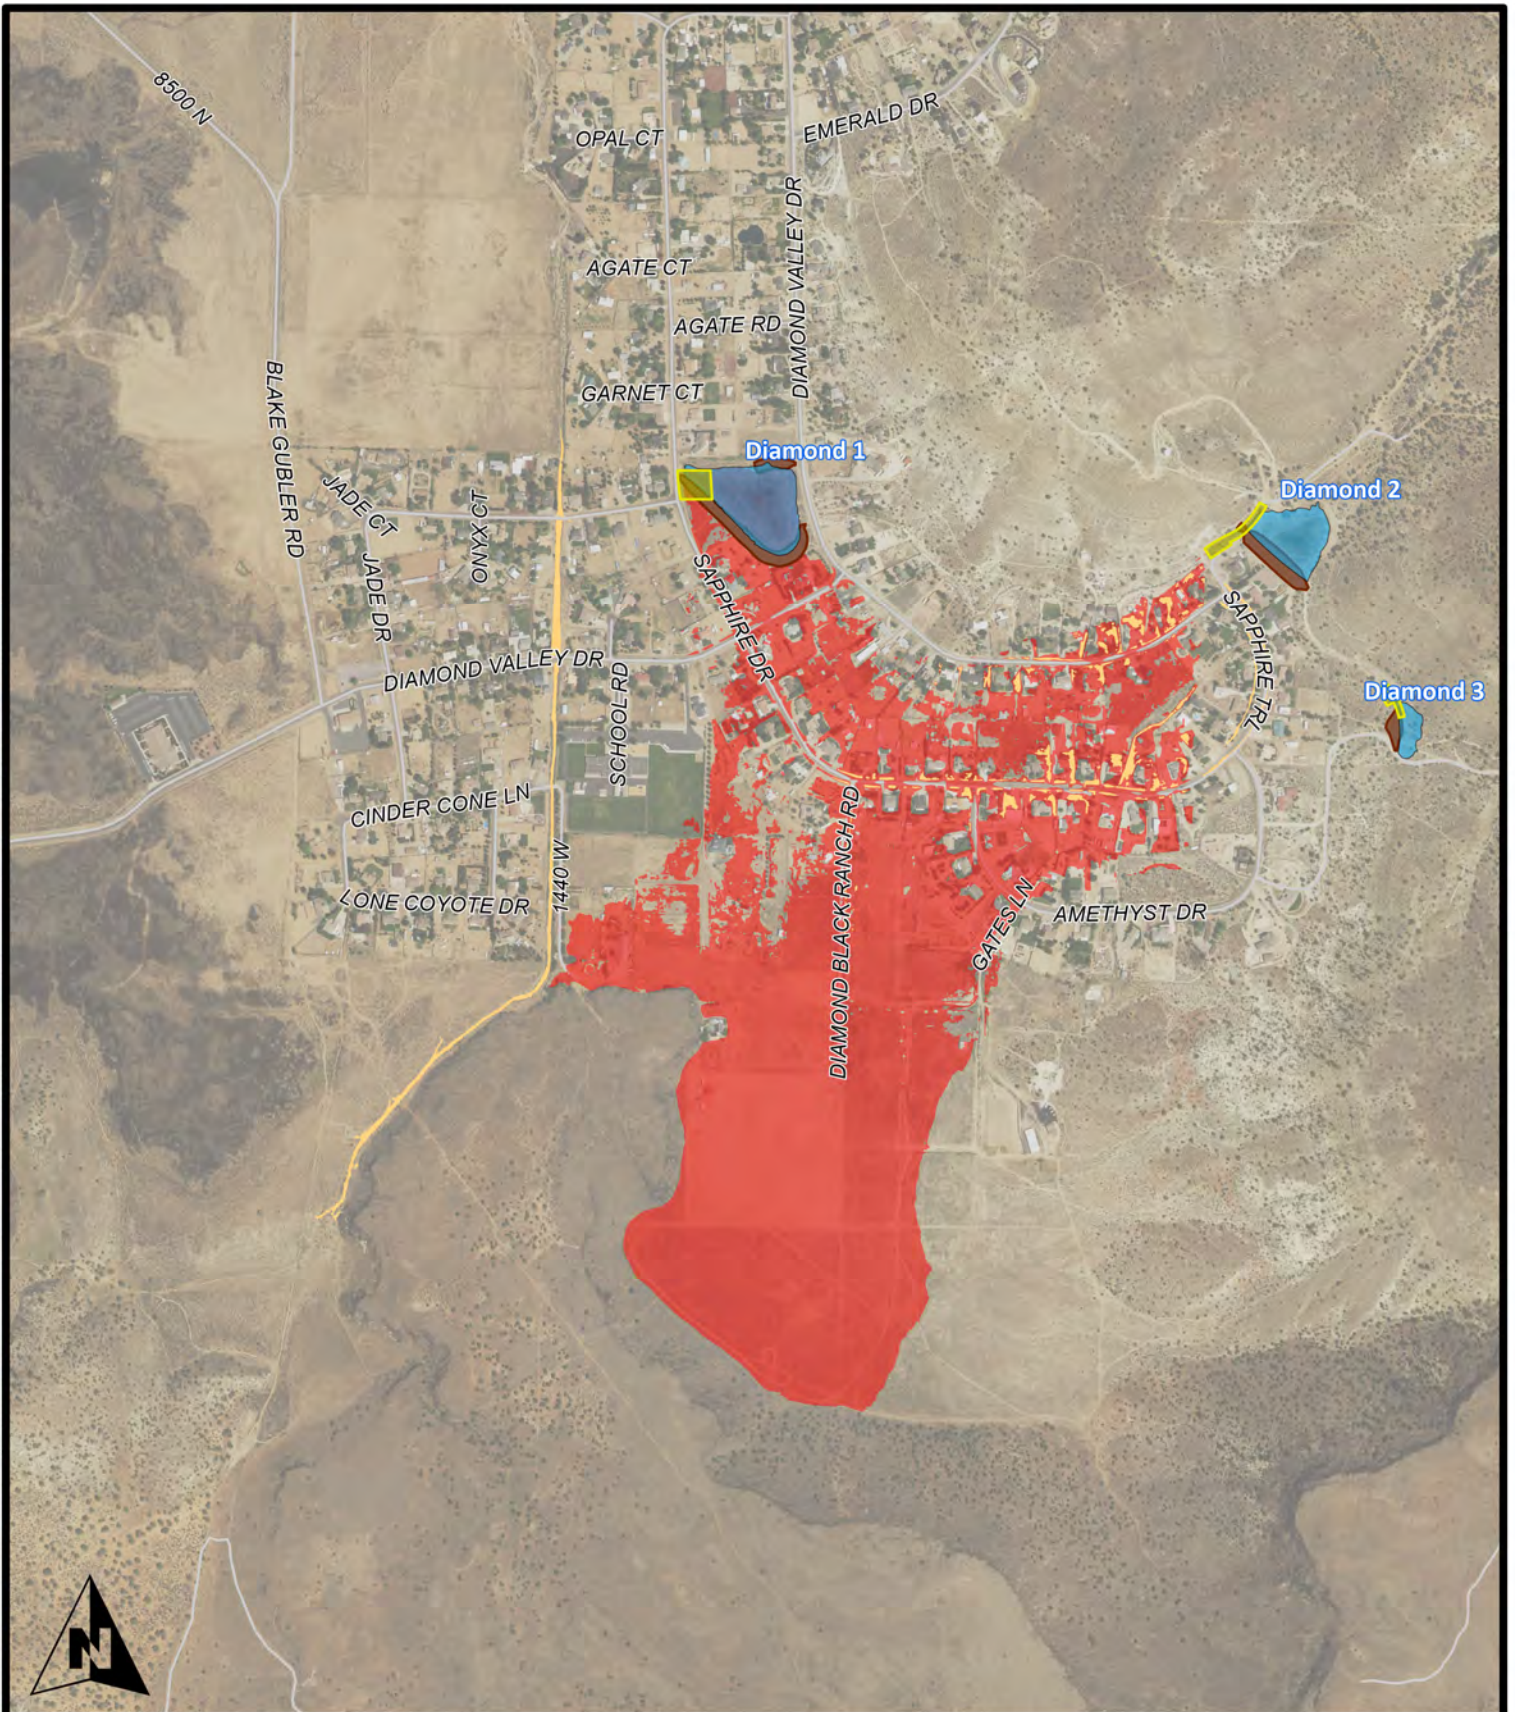
**Fig 24. 100-yr Inundation Map**  
**Santa Clara Watershed Hydraulics**

- Dam
- Detention Basin High Water
- Excavated Channel
- Spillway
- 100-year Inundation Boundary without Dams
- 100-year Inundation Boundary with Dams

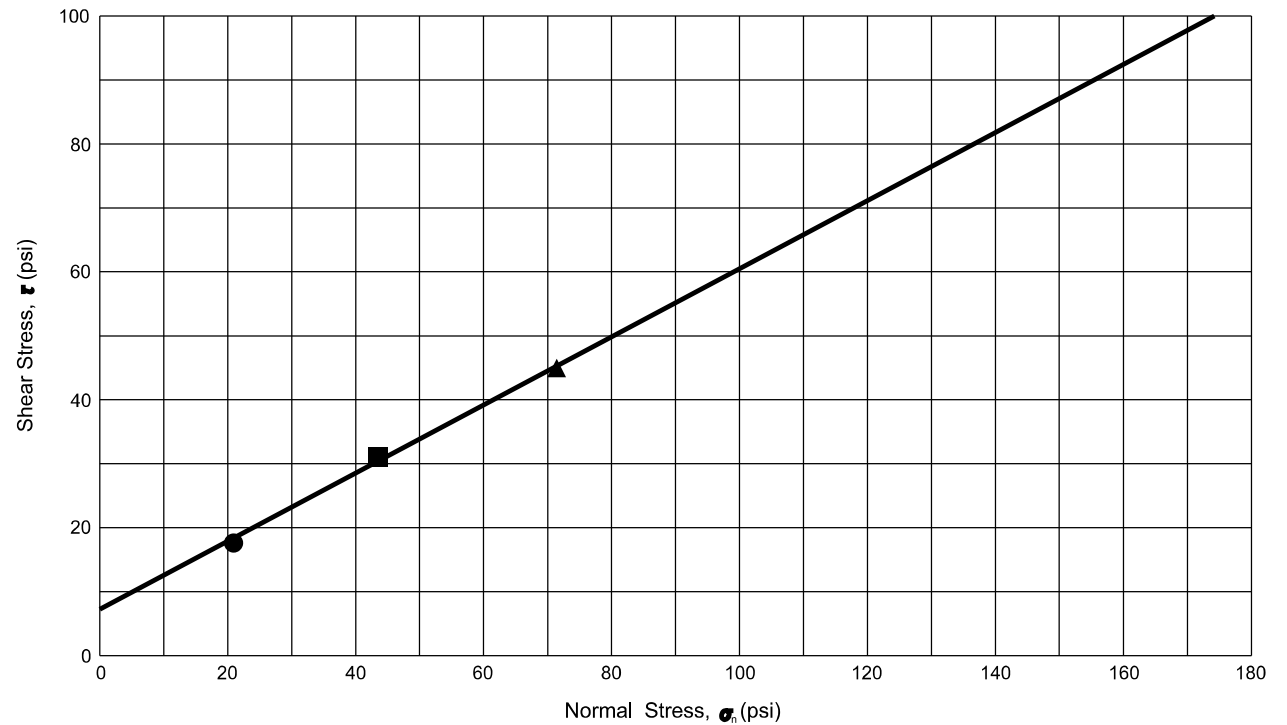
| Test No. or Symbol | Sample Size (inches) | Sample Data | | Degree of Saturation (%) | Normal Stress $\sigma_n$ (psi) | Maximum Shear Stress $\tau$ (psi) | Strain Rate (inches/minute) | Shear Strength Parameters | |

MATERIAL: SILTY CLAYEY SAND W/GRAVEL, SC-SM (TEST PERFORMED ON -3/8" MATERIAL)

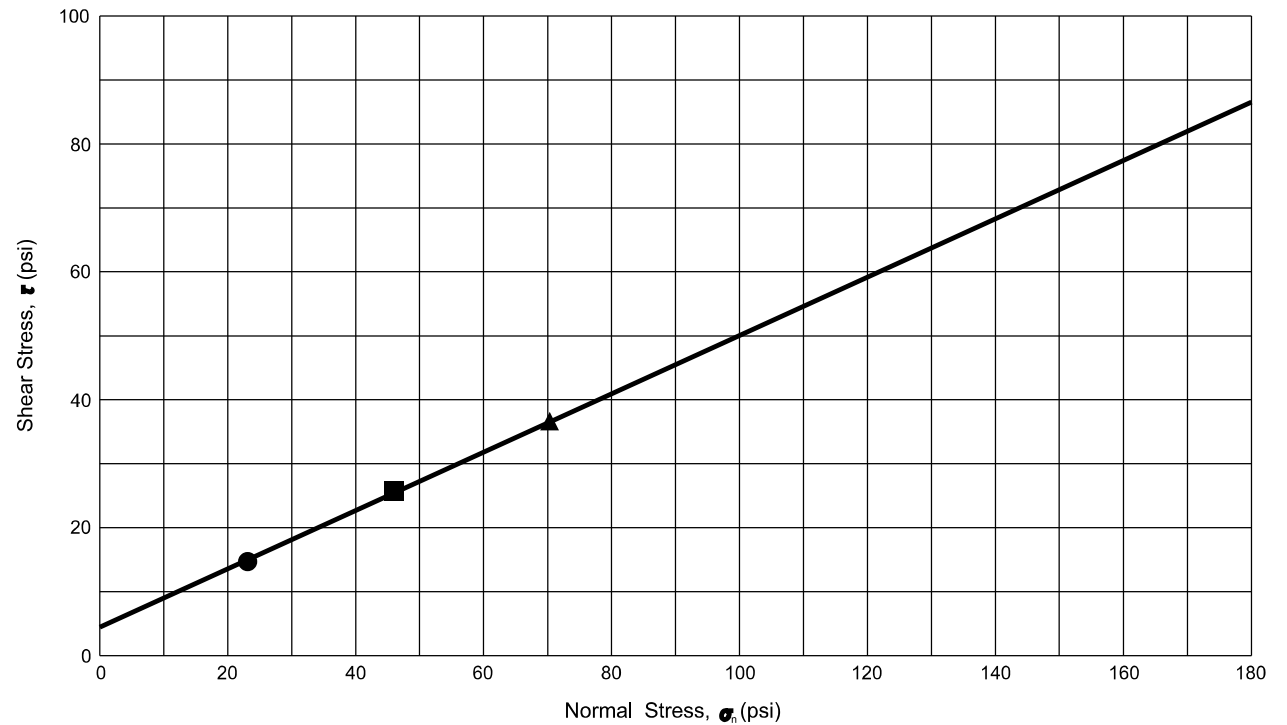
| Test No. or Symbol | Sample Size (inches) | Sample Data | | Degree of Saturation (%) | Normal Stress $\sigma_n$ (psi) | Maximum Shear Stress $\tau$ (psi) | Strain Rate (inches/minute) | Shear Strength Parameters | |

MATERIAL: CLAYEY SAND W/GRAVEL, SC (TEST PERFORMED ON -3/8" MATERIAL)

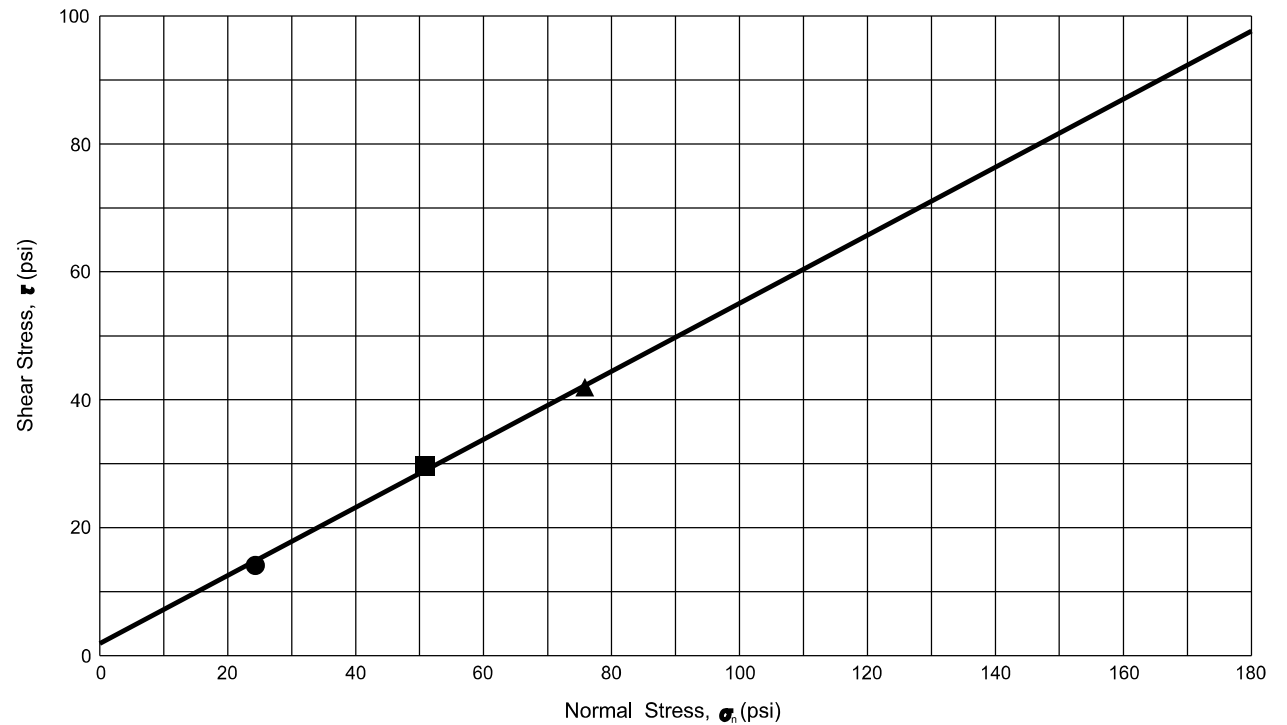
| Test No. or Symbol | Sample Size (inches) | Sample Data | | Degree of Saturation (%) | Normal Stress $\sigma_n$ (psi) | Maximum Shear Stress $\tau$ (psi) | Strain Rate (inches/minute) | Shear Strength Parameters | |

MATERIAL: CLAYEY SAND W/GRAVEL, SC (TEST PERFORMED ON -3/8" MATERIAL)

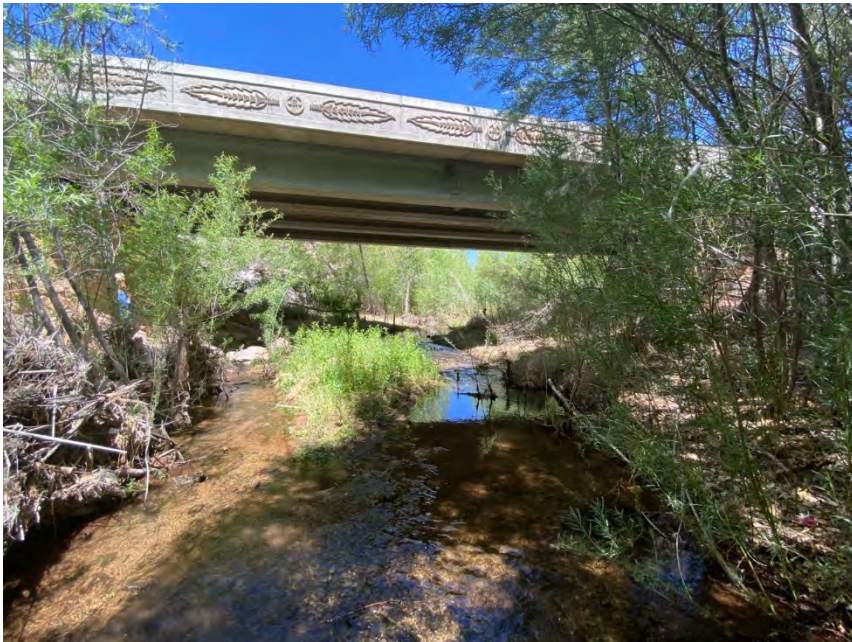
### Photo No. 2

View of the Santa Clara River looking upstream towards the Gunlock Rd bridge where the replacement pipe will be hung from (facing northwest)
