## Appendix E. Other Supporting Information

# Biological Assessment for Woodruff Creek Watershed Agricultural Water Management Project

*Rich County, Utah*

The USDA Natural Resources Conservation Service and  
The Woodruff Irrigating Company

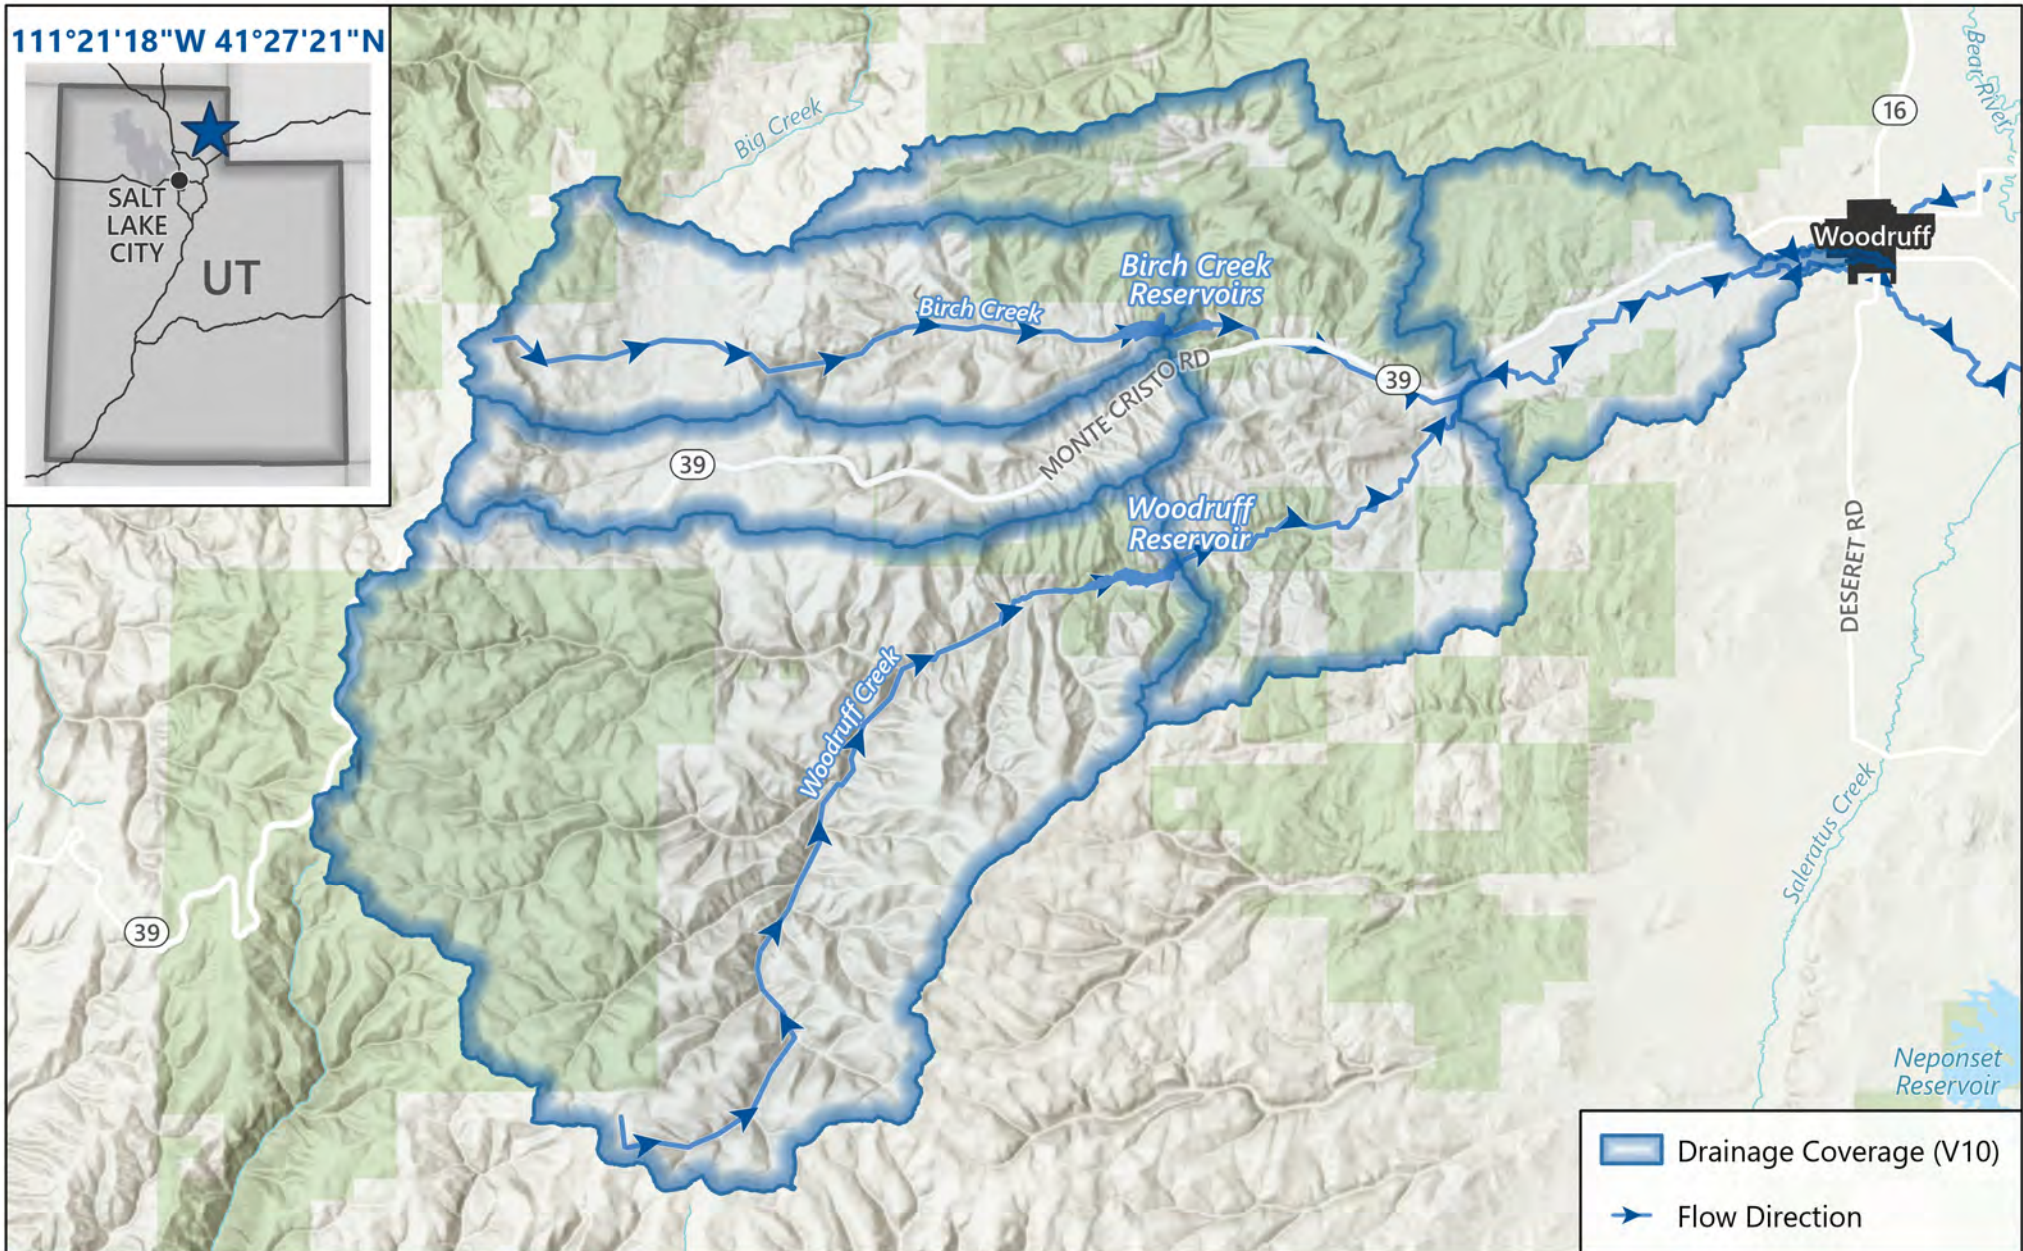
## APPENDIX A: DRAINAGE COVERAGE

## **Appendix A – Drainage Coverage Map**

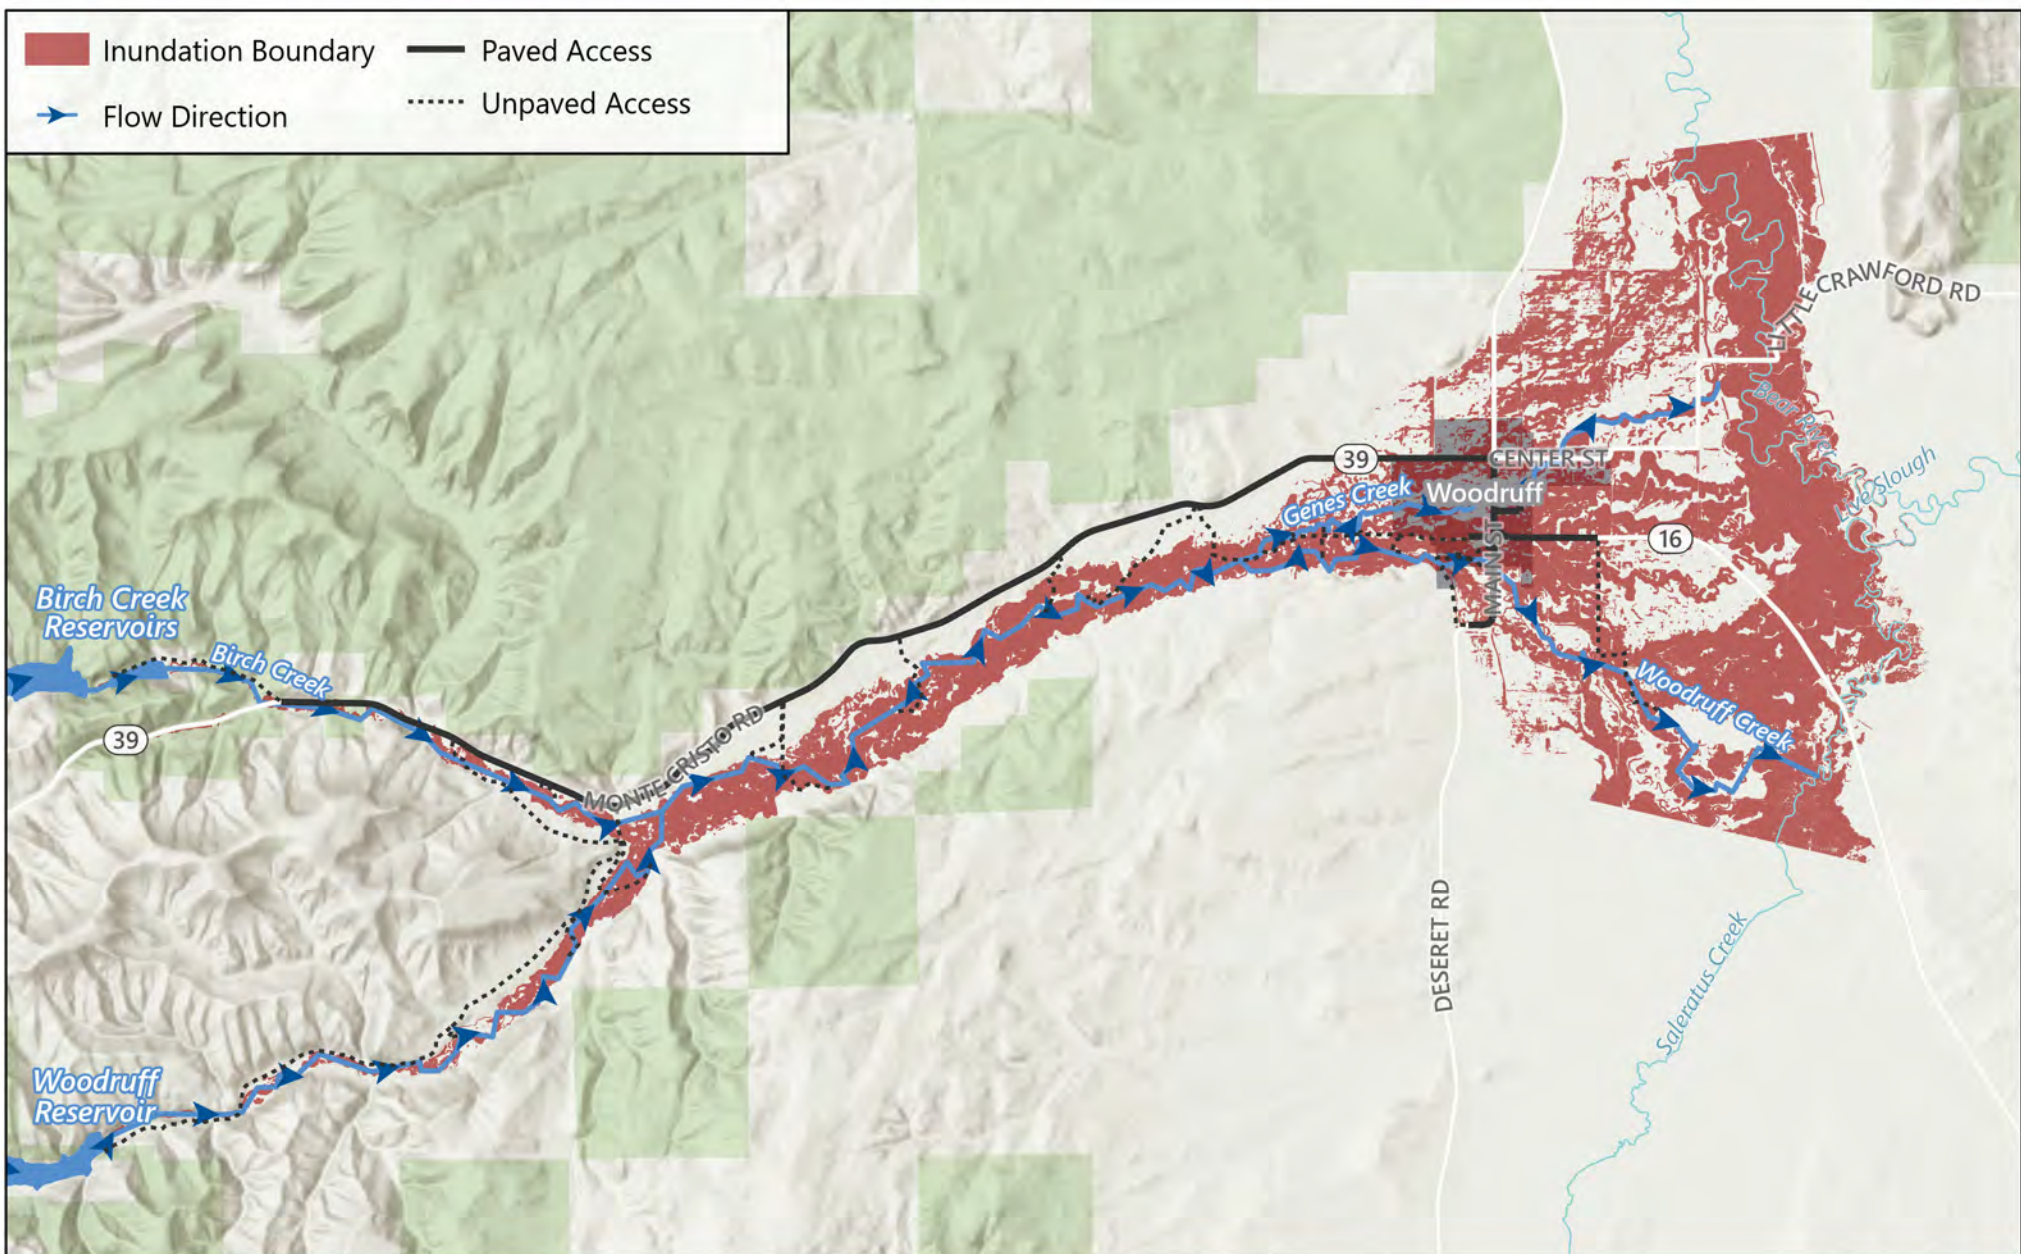
## APPENDIX B: INUNDATION BOUNDARY

## **Appendix B – 100-Year Flood Inundation Map**

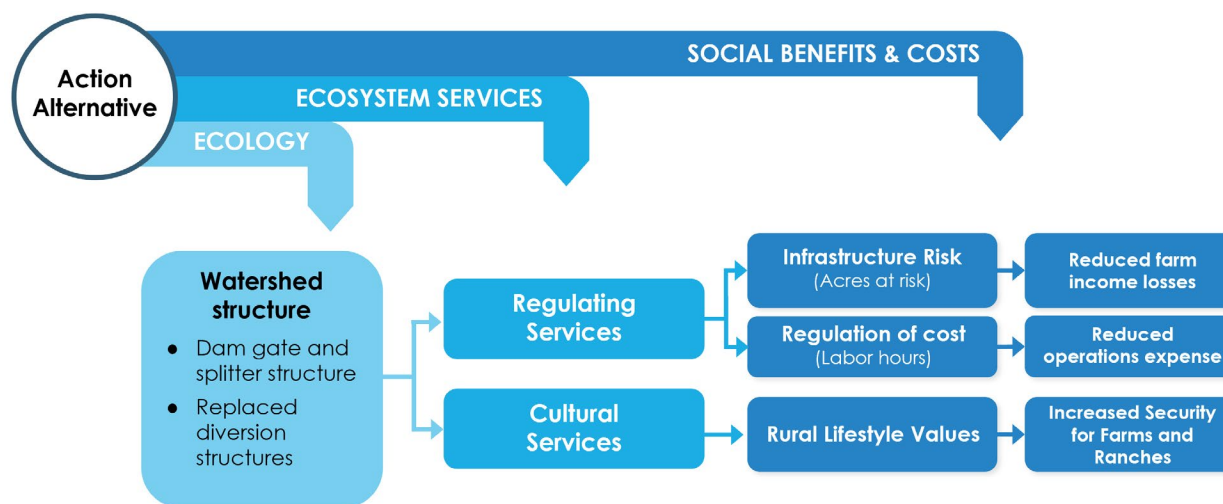
**Figure 2. Description of Alternatives Evaluated Part of the Woodruff Creek Watershed Plan-EA and Anticipated Impacts on Ecosystem Services**

As Figure 2 shows, the Action Alternative would change the ecological structure of the watershed through the construction of the works of improvement described in Table 2.

The change in watershed structure would primarily impact regulating services by reducing the risk of infrastructure failure, thereby reducing expected losses of farm income. The change in watershed structure would also regulate operational expenses by reducing the number of labor hours required for ditch riders to manage and repair diversion structures and operate the reservoir control gate and splitter. Additionally, the improvement in water management would impact cultural services by supporting rural lifestyle values and providing increased security to farmers and ranchers by protecting their ability to earn a livelihood.

**3.3. Ability to Characterize, Quantify, and Monetize Services.** The regulating ecosystem services described in Figure 2 can be characterized, quantified, and monetized using publically available information and accepted methodologies that relate biophysical values to economic values. The methods to quantify and value regulating ecosystem service evaluated as part of this analysis are described in more detail in Section 4. Cultural values are more difficult to quantify and are evaluated qualitatively.
