United States Department of Agriculture  
Natural Resources Conservation Service

# Huntsman Lake Dam Rehabilitation Project

Pohick Creek Watershed, Fairfax County

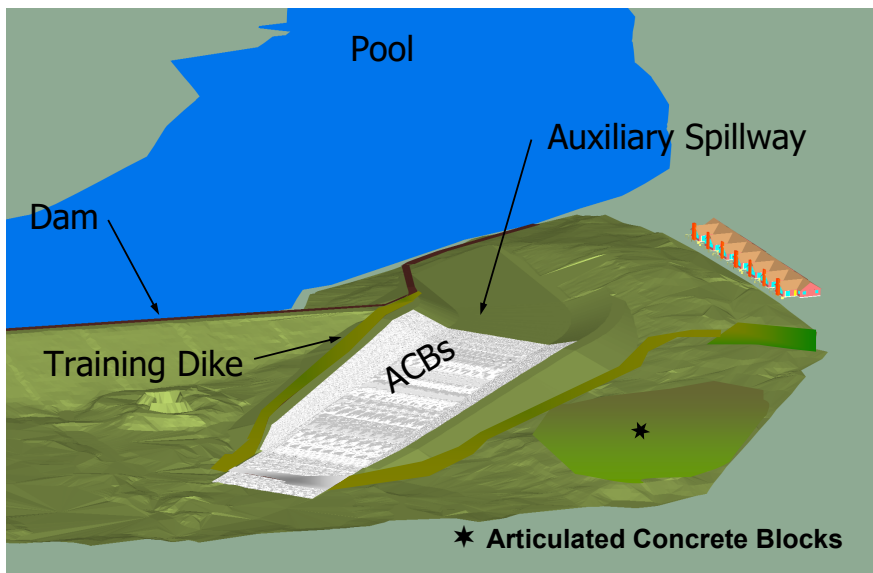
Schematic of proposed solution using articulated concrete blocks.

The drawing above is a computer-generated rendition of the proposed solution to the auxiliary spillway problem. The plan includes the following rehabilitation items:

- The training dikes will be extended to the valley floor to direct the water away from the back of the dam.
- To prevent erosion, the auxiliary spillway and the inside of the training dikes will be lined with articulated concrete blocks that are cabled together. The blocks will be completely covered with soil and vegetated with grass. It will look a lot like the existing spillway. Although the picture shows the blocks as they will be installed, they will not be visible once the project is completed. After construction, the areas that are not covered with grass will be planted with trees.

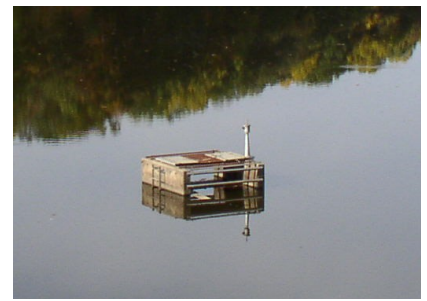
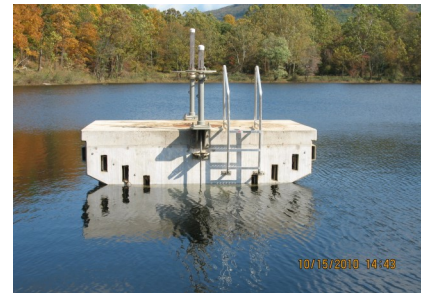
Above: Existing riser at Huntsman Lake.  
Below: Example of closed top riser.

- During a storm that delivers more than 11 inches within 24 hours, the soils in the auxiliary spillway will erode and could cut completely through the auxiliary spillway, which would cause the dam to lose all its storage capacity; and
- The principal spillway riser does not meet current safety criteria because of the open top.

The principal spillway riser will be replaced to improve public safety and to prevent clogging by floating debris.
