**Henry's Fork Salinity Control Area  
Monitoring and Evaluation Report  
2020**

## Wildlife/Wetland Replacement Assessments and Replacement Projects

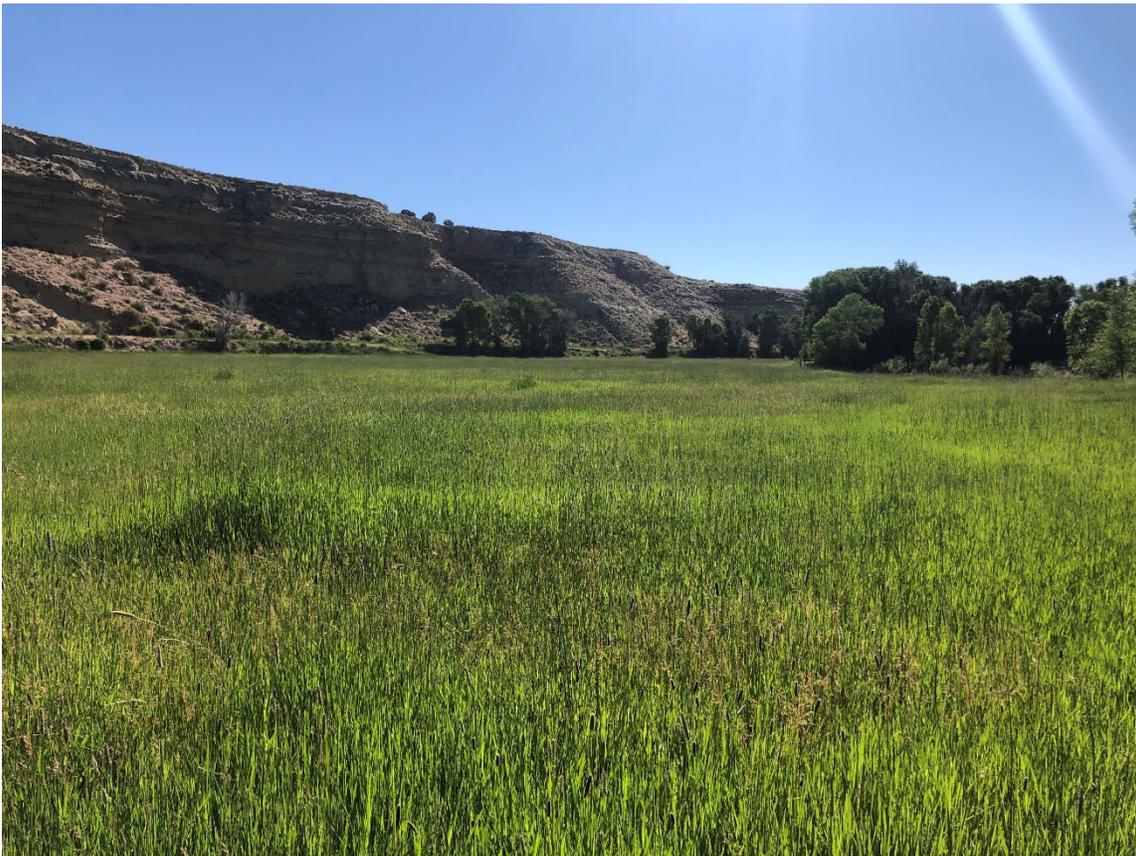
Photo 1: The north field facing northeast showing thick scouring rush and hay grasses July 2019.

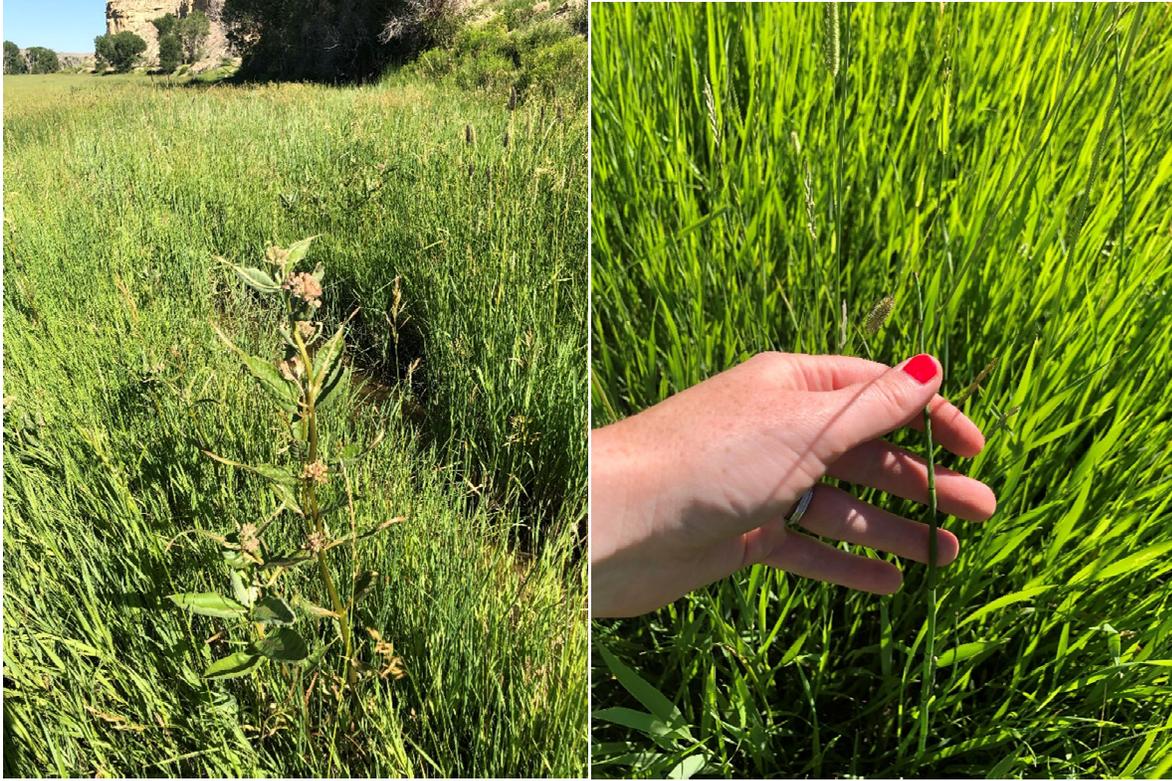
Photo 2: Milkweed and scouring rush located in the north field, July 2019.

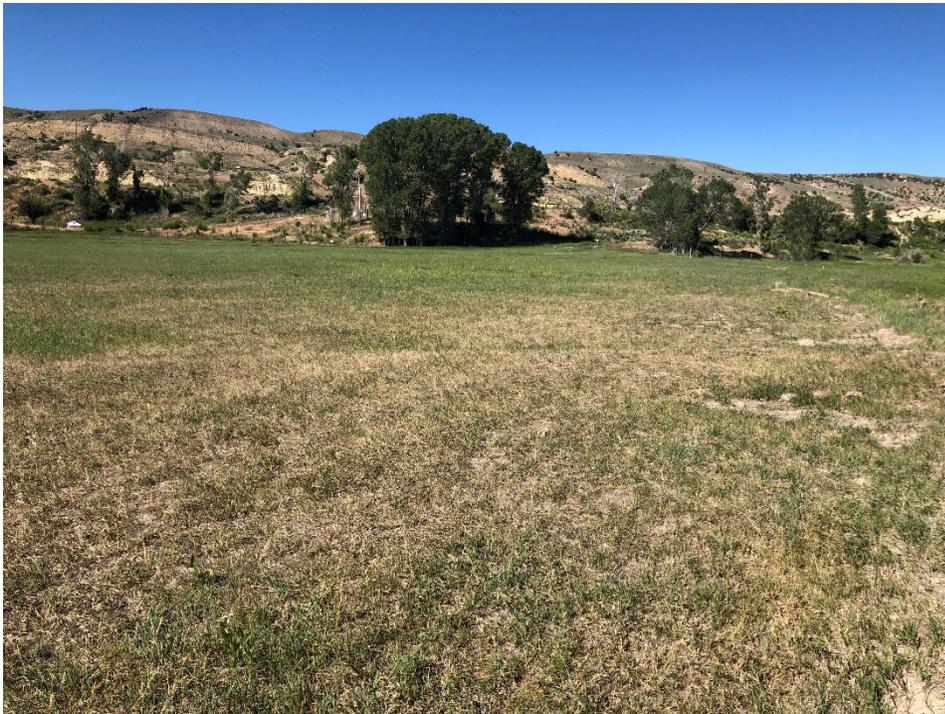
Photo 3: The south field facing south showing a mix of mostly hay grasses and bare soil, July 2019.

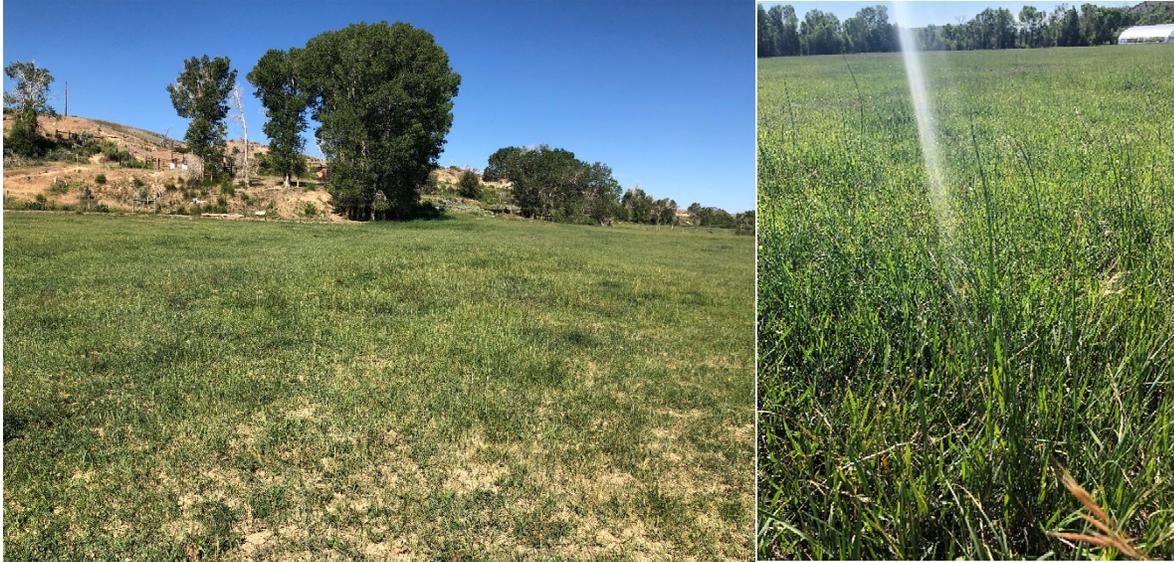
Photo 4: The southwestern section of the south field that contained wetland characteristics at the toe of the slope, such as scouring rush patches, July 2019.

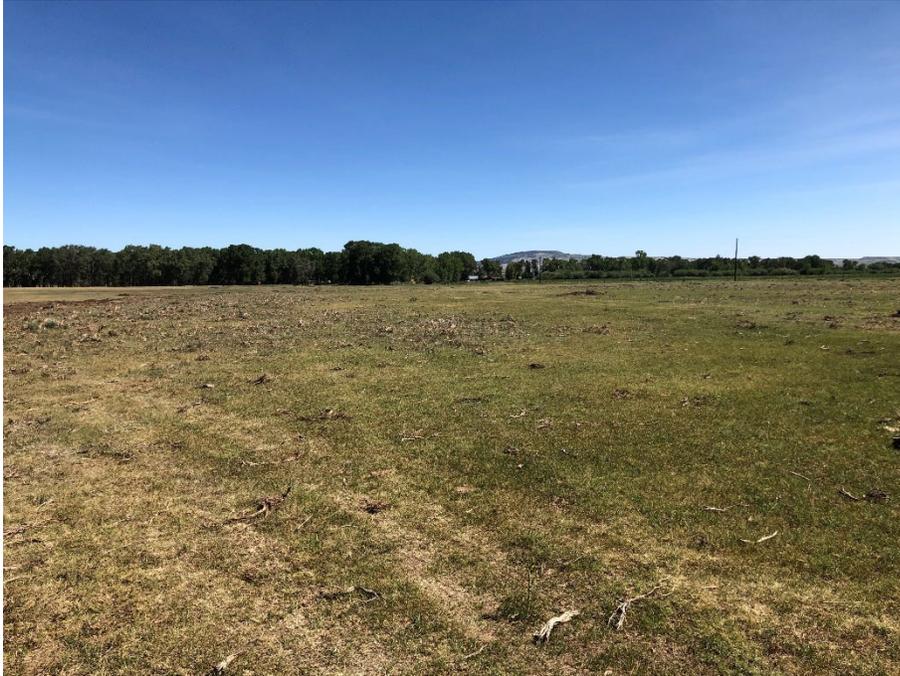
Photo 5: Southern end of the western field that contained upland habitat and no wetland characteristics, July 2019.

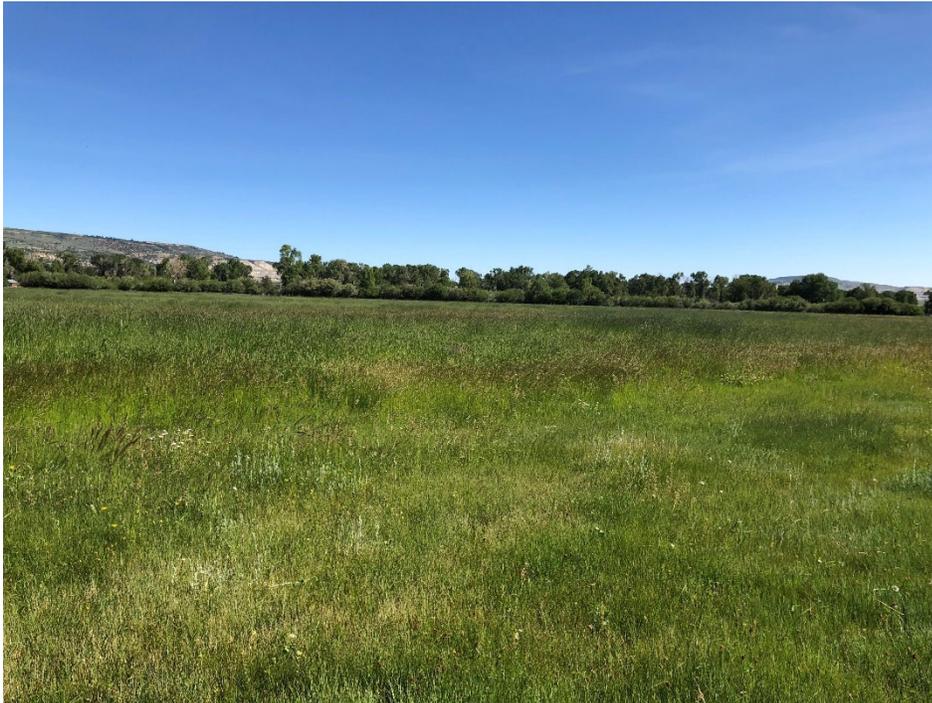
Photo 6: Southern end of the eastern field facing north, July 2019.

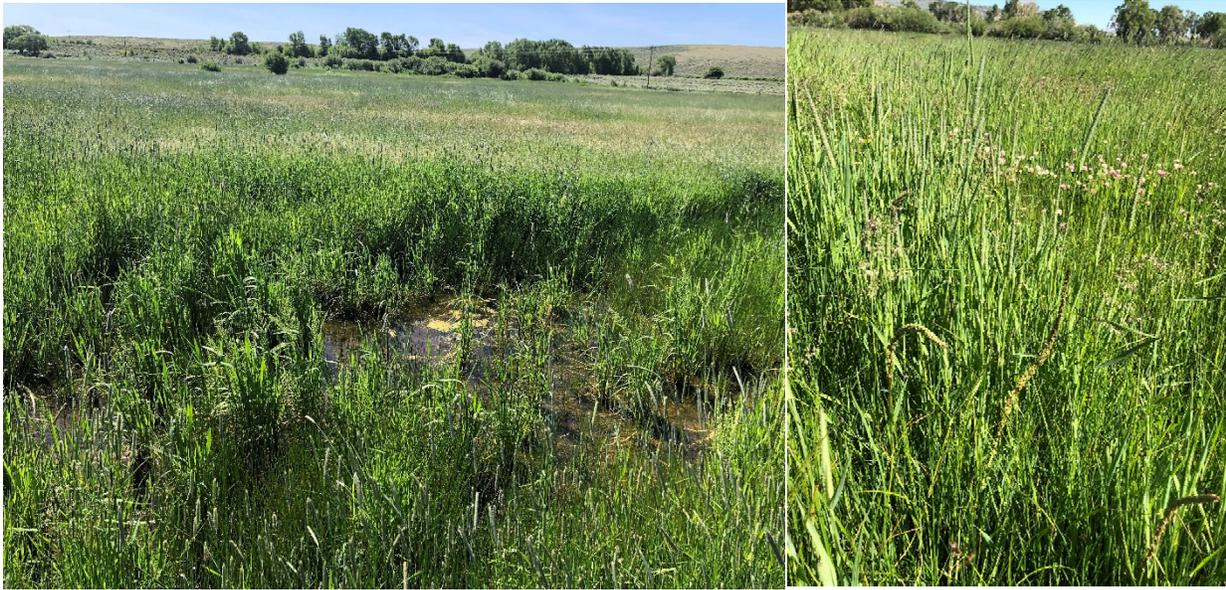
Photo 7: Ponding in center of the eastern field with timothy grass and arrowgrass abundant, July 2019.

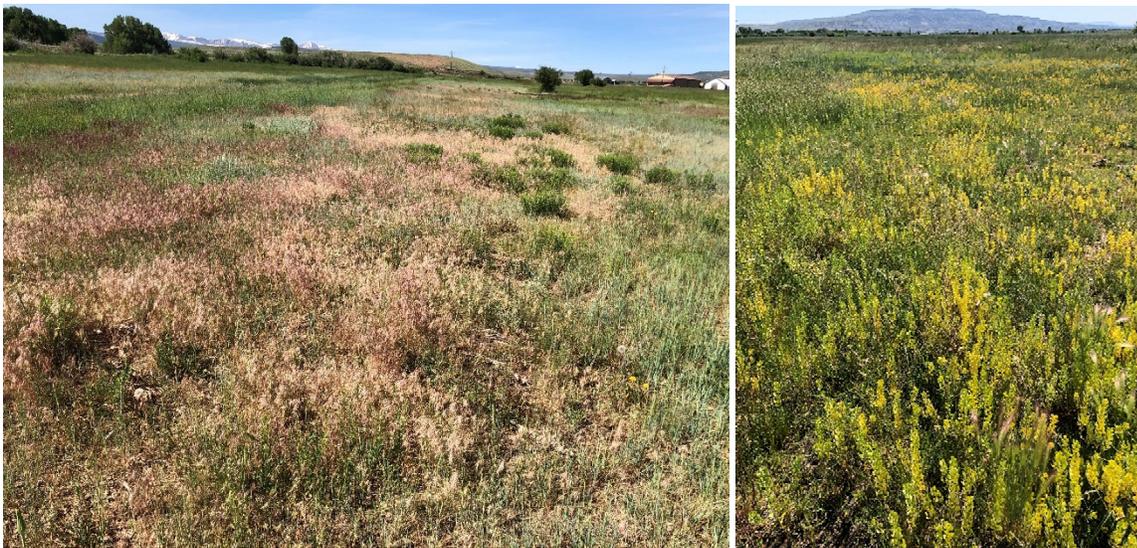
Photo 8: View of the southeast section of the eastern field that was not included in the wetland assessment- cheatgrass, pennycress and white-top dominant, July 2019.

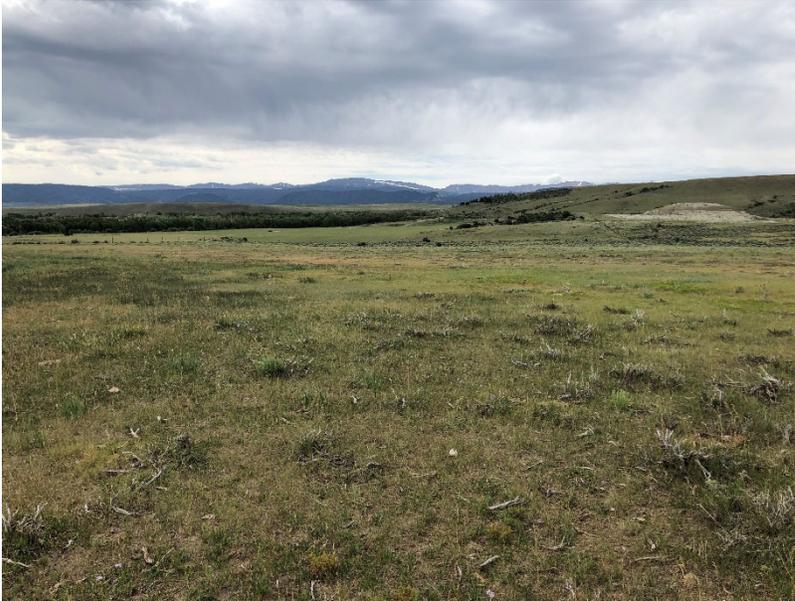
Photo 9: Center of northern field facing south contains mostly upland habitat with patches of wetland vegetation, July 2019.

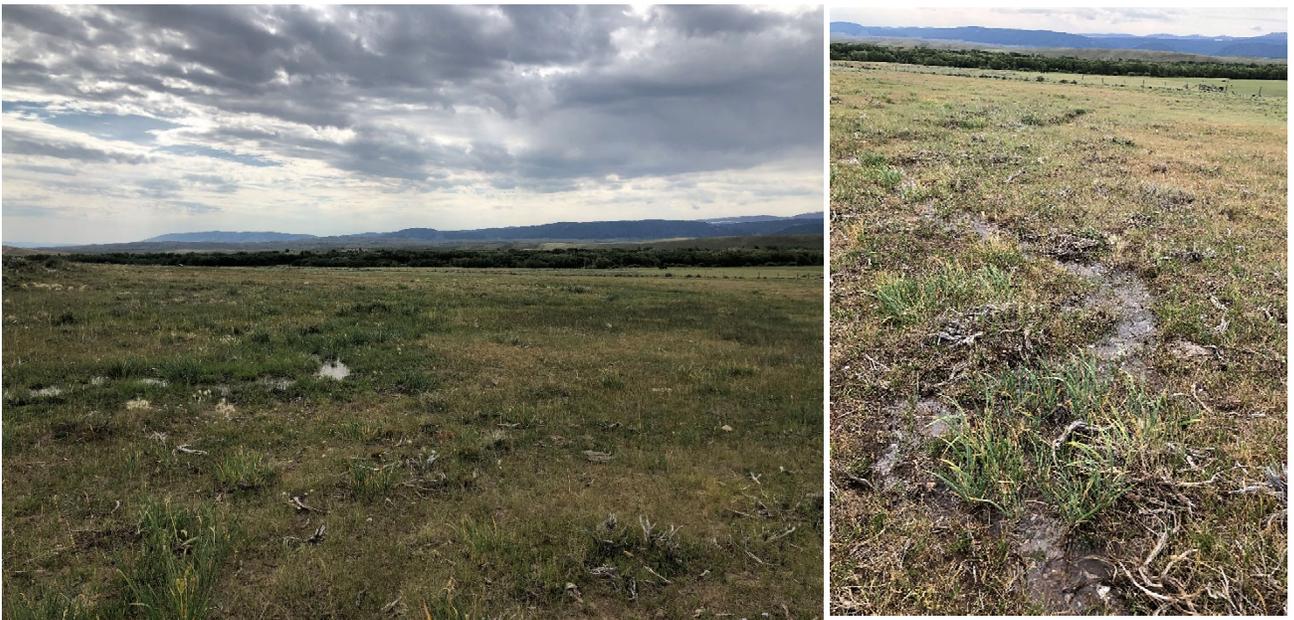
Photo 10: Wetland area assessed in northern field near ditch, July 2019.

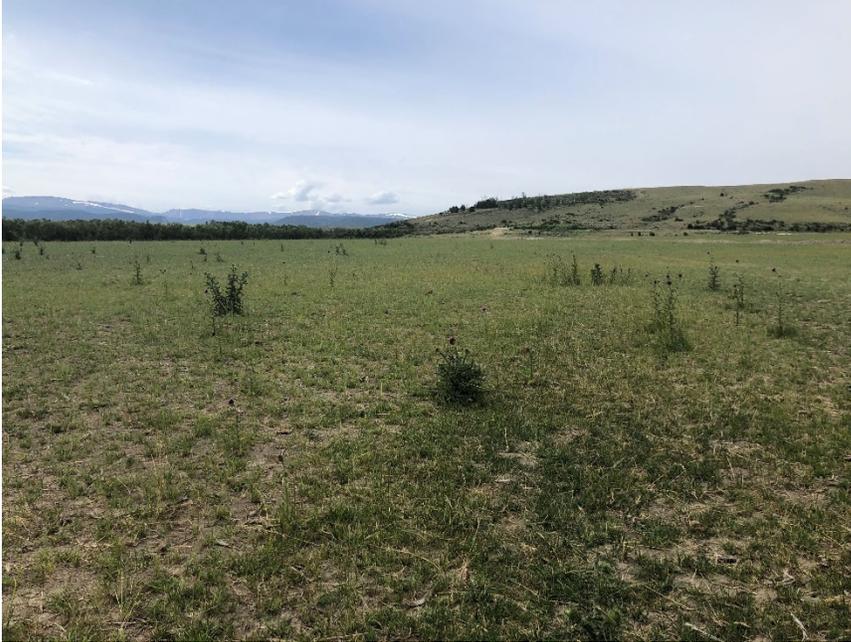
Photo 11: The southern field facing south- contained no wetland values, July 2019.

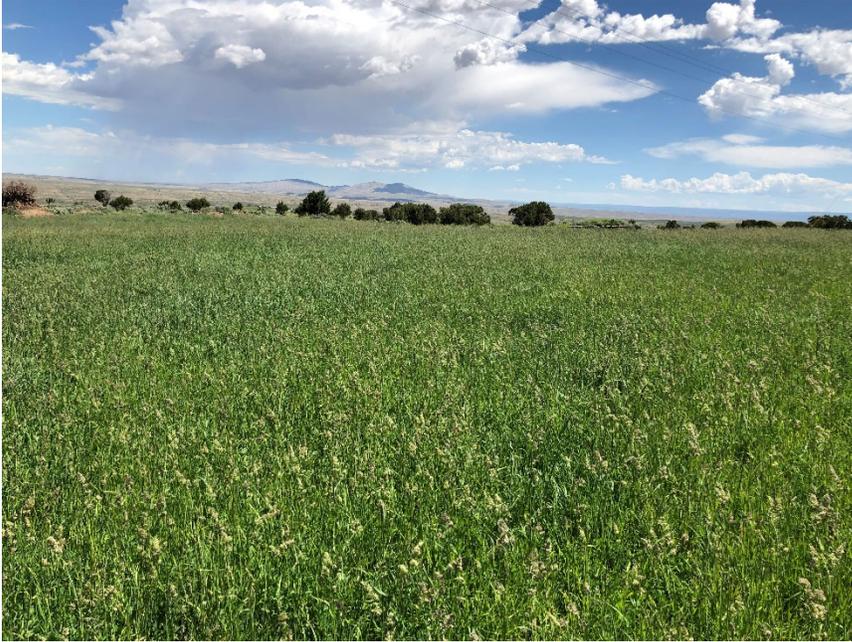
Photo 12: Southern field facing East with hay grasses, July 2019.

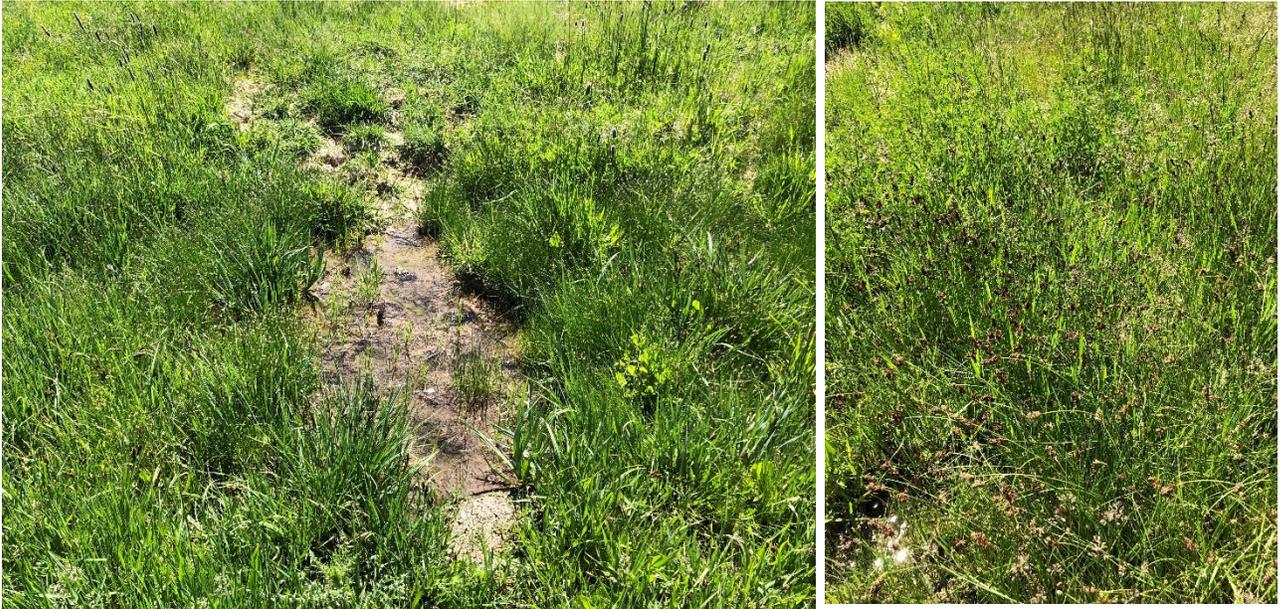
Photo 13: Southern field standing water in draw depression- sedges and rushes surrounded the area, July 2019.

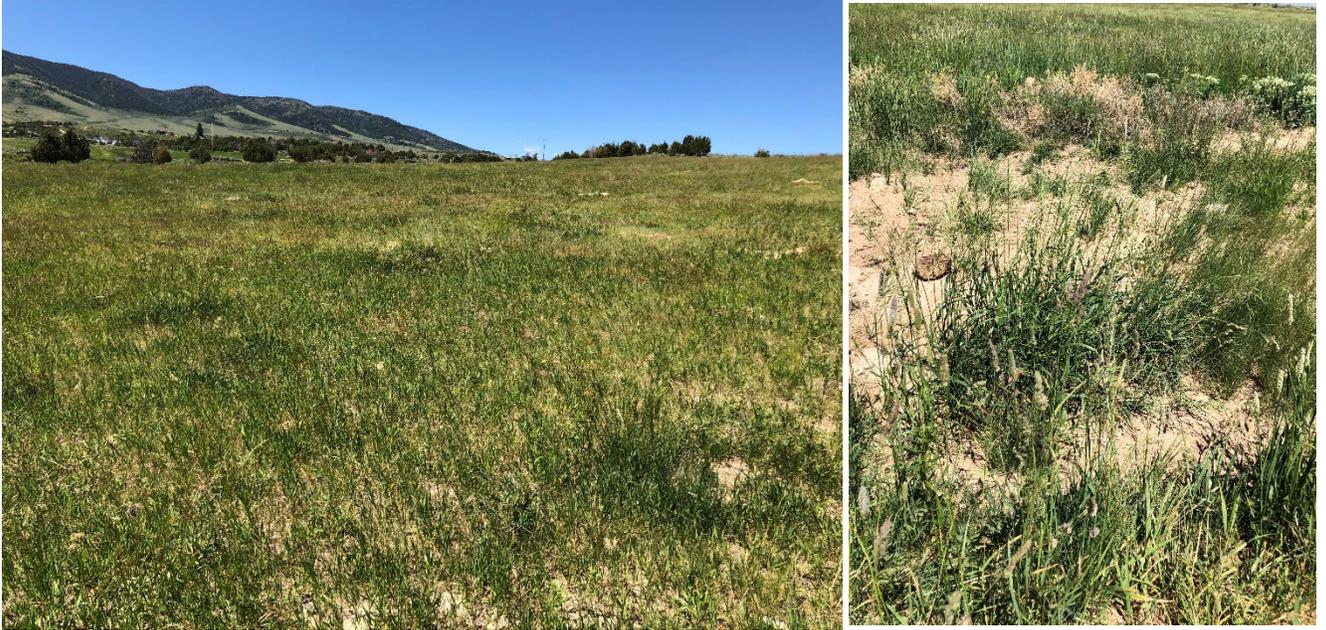
Photo 14: The north field contained hay grasses and bare soil throughout most of the sloped field, July 2019.

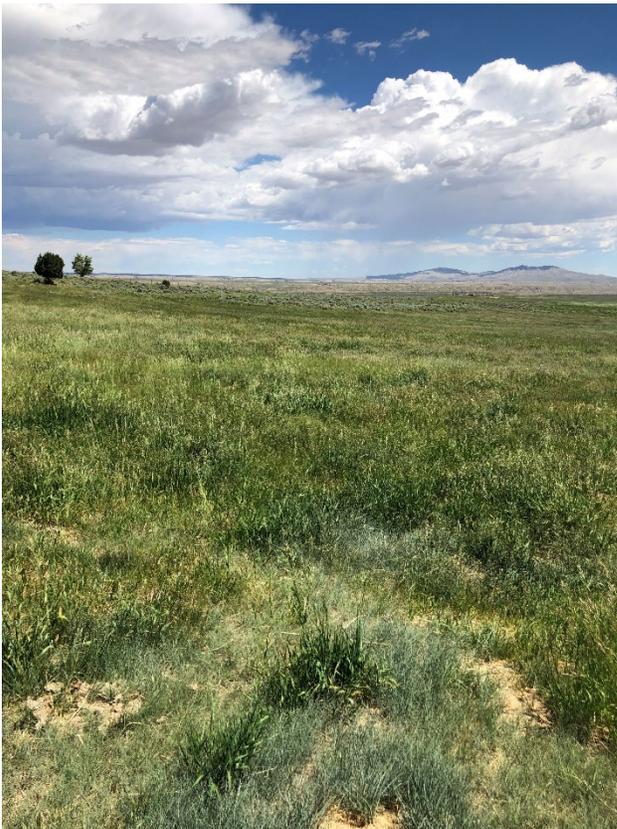
Photo 15: The south toe of the north field contained some wetland characteristics, such as rushes and wild iris, July 2019.

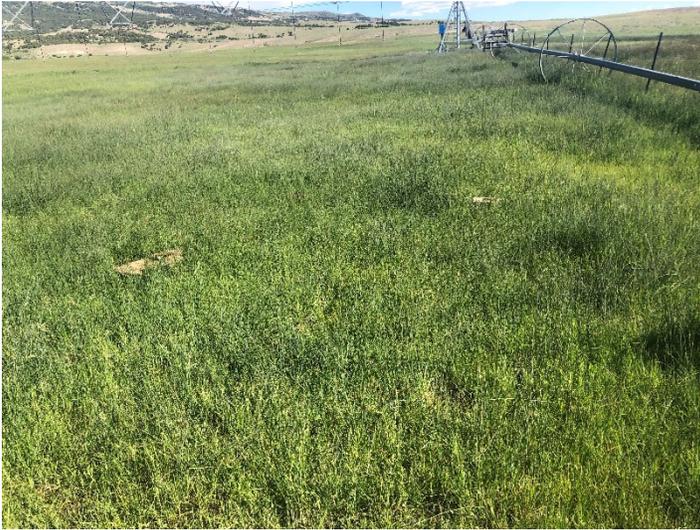
- R. Slagowski Pivot was installed in November 2015. A site visit was completed July 2019. There appeared to be wetland characteristics still present on the 5 acres previously assessed. Since the conditions had not changed noticeably, photos were taken and the follow-up assessment was postponed for the following year.

Photo 16: Rushes, sedges, arrowgrass still present on south side of pasture, July 2019.

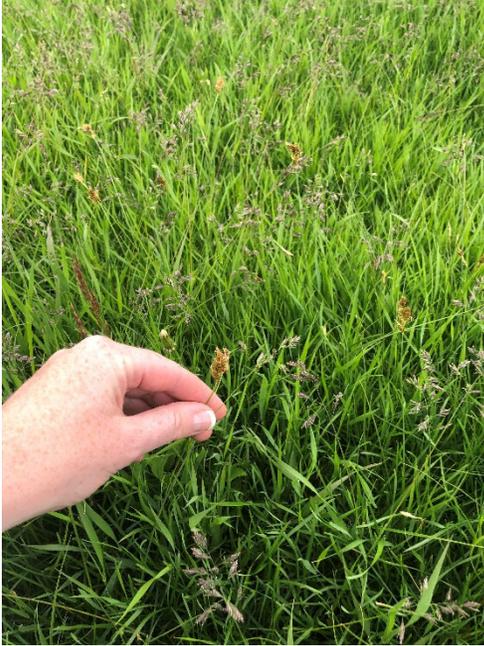
- D. Slagowski pivot was installed in September 2016. A site visit was completed in June 2019. There appeared to be wetland characteristics still present on the 1.02 wetland acres previously assessed. Since the conditions had not changed noticeably, photos were taken and the follow-up assessment was postponed for the following year.

Photo 17: Sedges, rushes and standing water still present on south eastern edge of pasture, June 2019.

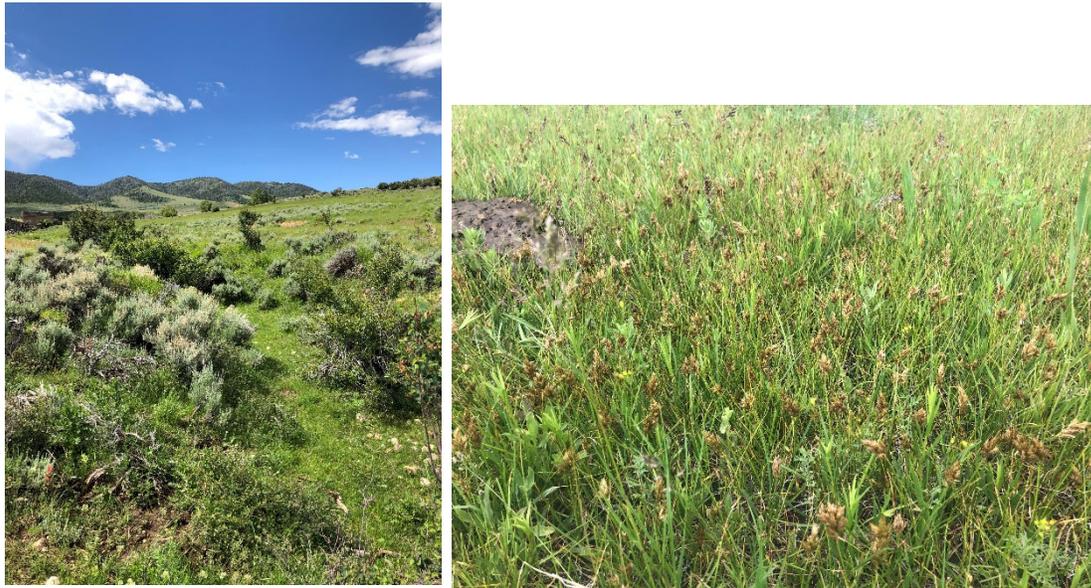
- Crowther pivot was installed in September 2016. A site visit was completed in July 2019. There appeared to be wetland characteristics still present on the 2.95 wetland acres previously assessed. Since the conditions had not changed noticeably, photos were taken and the follow-up assessment was postponed for the following year.

Photo 18: Seasonal scrub-shrub wetland habitat still present in the ravine located on the middle of the pasture and rushes, sedges and standing water still present along eastern irrigation ditch and depressions, June 2019.

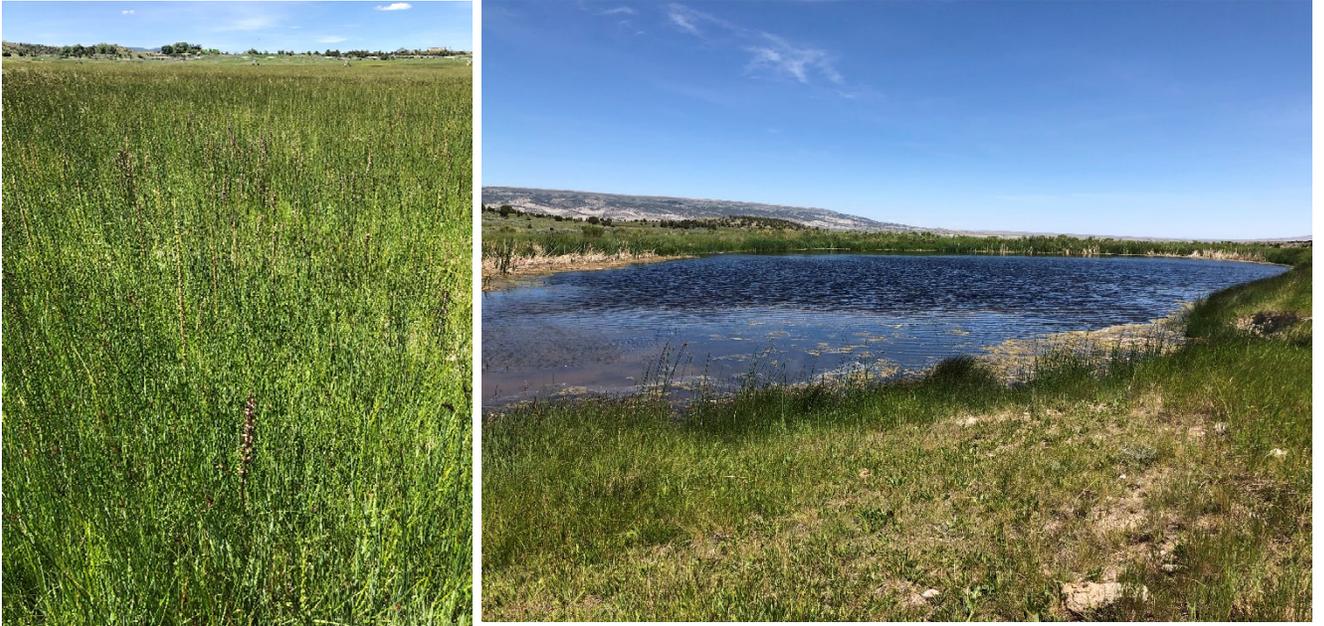
- Beck pivots were installed in September 2016. A site visit was completed in July 2019. There appeared to be wetland characteristics still present on the 83.5 wetland acres previously assessed. Since the conditions had not changed noticeably, photos were taken and the follow-up assessment was postponed for the following year.

Photo 19: The wetland characteristics throughout both fields and the pond remain the same, July 2018.

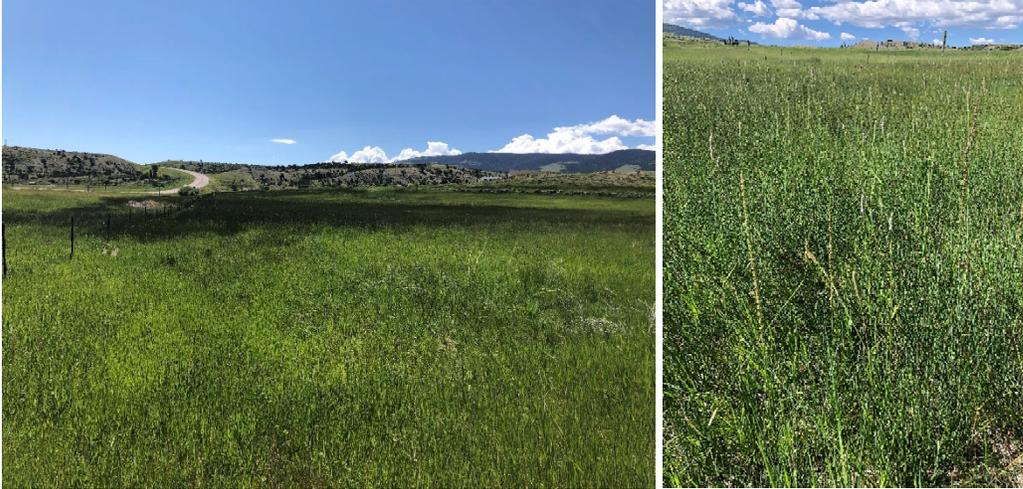
- Thomas pod-lines were installed in September 2016. A site visit was completed in July 2019. The majority of the pasture had switched from mostly dry upland habitat with hay grasses to alfalfa. There appeared to be wetland characteristics still present on the 1.3 wetland acres previously assessed at the northeastern toe of the slope. Since the conditions had not changed noticeably, photos were taken and the follow-up assessment was postponed for the following year.

Photo 20: The northeastern toe of the pasture still has standing water and moist soils, timothy, common arrowgrass, sedges and rushes, July 2019.

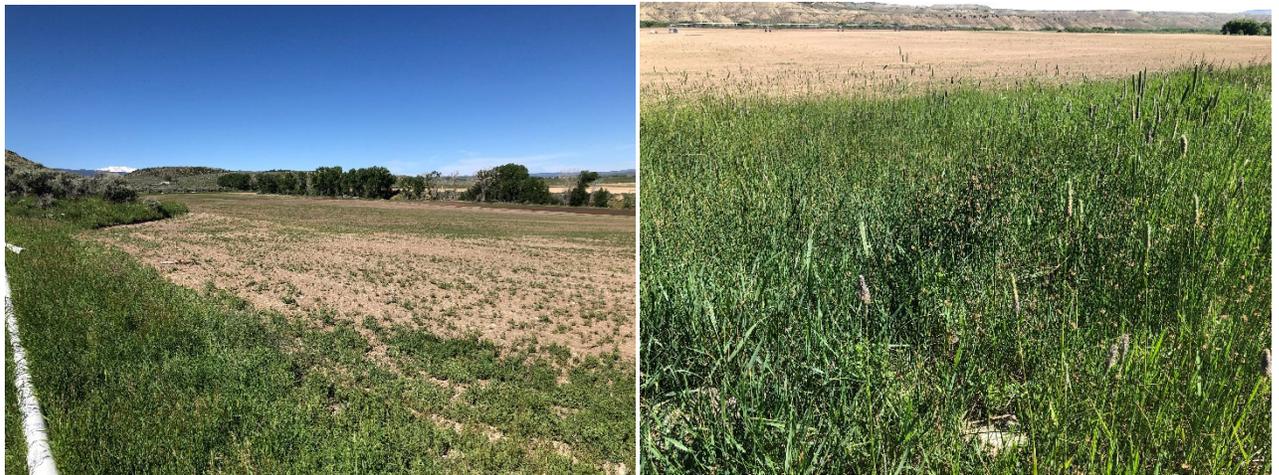
- Anderson pivot and gated pipe were installed November 2017. A site visit was completed in June 2019. The gated pipe field had recently been tilled and re-seeded and the pipe had not been installed yet, so no assessment was made at this time. The pivot field still contained wetland vegetation along the irrigation ditch and western edge of the pivot. No noticeable changes were found, so photos were taken and a follow-up assessment will occur next year.

Photo 21: The gated pipe field was recently tilled and not operating so could not be compared. Wetland characteristics such as sedges and rushes were still present on the southwestern edge of the pivot field, June 2019.

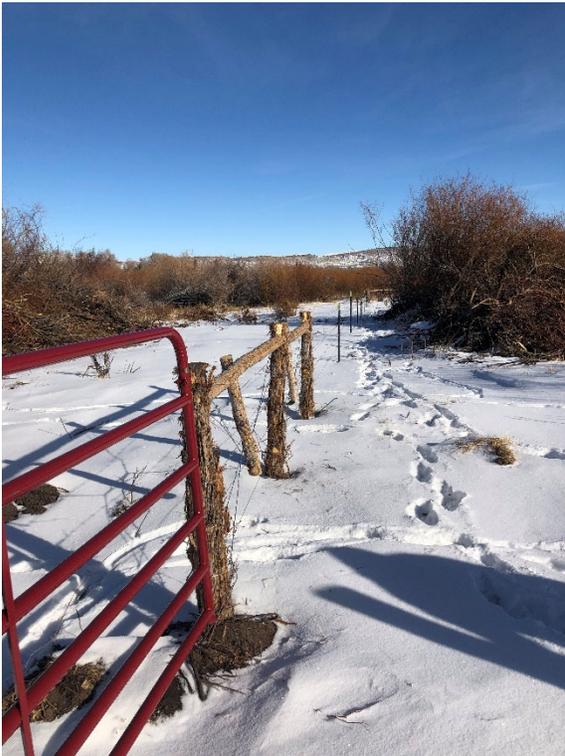
The House Pasture riparian area on Beaver Creek was fenced in January 2019. This pasture is similar to the Molly Bullock pasture with wetland characteristics consisting of willows, cottonwoods, and riparian grasses. Approximately 15 acres were fenced with an estimated 57 habitat values present. Monitoring will occur annually to document changes. It is estimated that the habitat values will increase by 50-100 pts. TU/NRCS, FWS and the Wyoming Game and Fish Dept. surveyed two of the fenced areas and one pasture that was not fenced in August 2019. No wetland assessment was completed as this was the first year it was all in place, but vegetative monitoring results are promising. There were numerous riparian species that increased and showed regrowth. Vegetative monitoring will occur annually to document changes. Several planned projects are moving forward as funding is received. The Interstate Canal diversion improvement project is still moving forward and final designs are almost complete. Construction is planned for fall 2020. The mainstem diversion improvement project is also moving forward. Conceptual design bids and cost estimates should be completed this summer. Once those are in hand, then fundraising can occur for implementation. Below are photos documenting the changes found in the Molly Bullock riparian fence areas and the House Pasture fence. For photos of the diversion projects, please see the 2019 Monitoring and Evaluation Report.

Photo 22: Approximately 15 acres of riparian corridor in the House Pasture on Beaver Creek were fenced using wildlife-friendly barbed wire, January 2019.

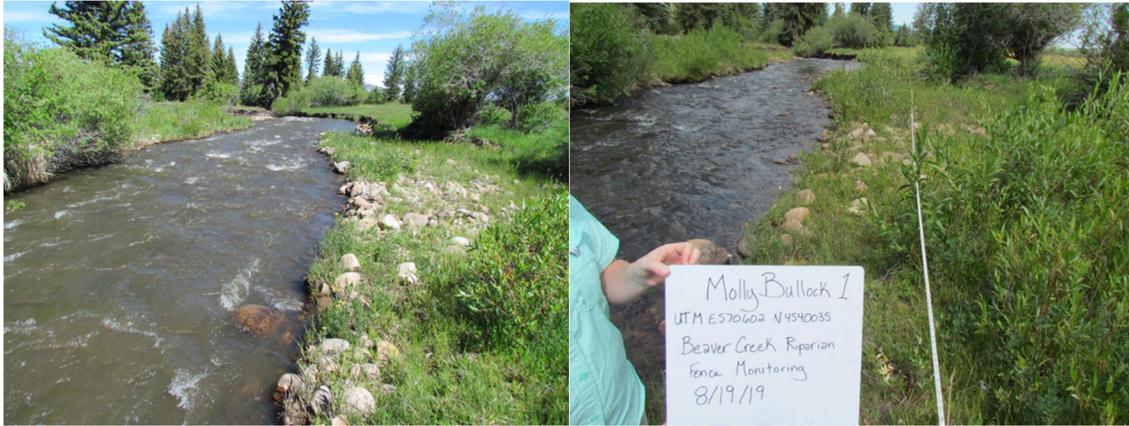
Photo 23: Photopoint for the Beaver Creek Molly Bullock pasture comparing June 2017 prior to fencing on the left and August 2019 after fencing on the right.
