Dam Rehabilitation Fact Sheet

Roaring Fork Lake, Cherrystone Creek Watershed

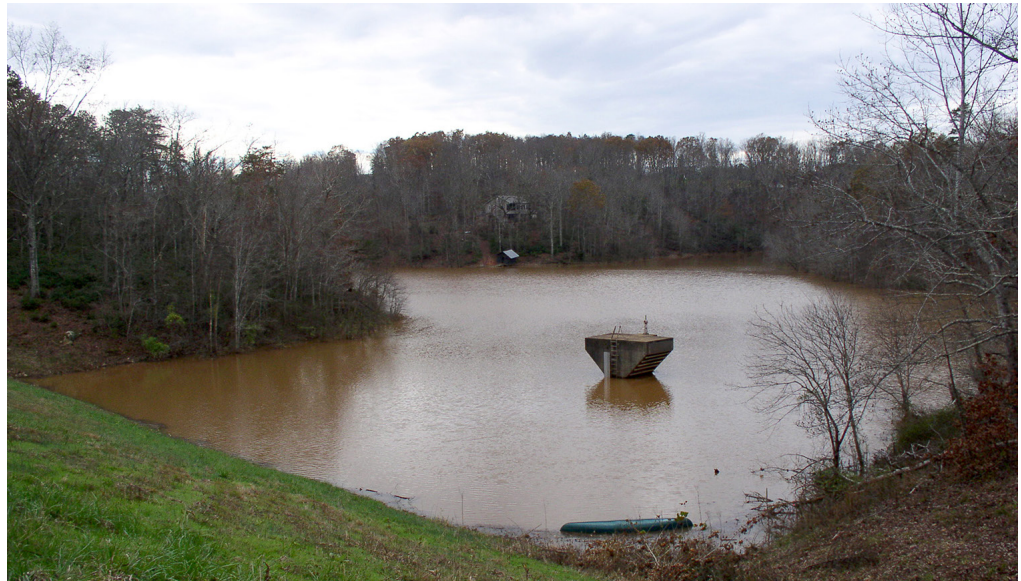
Roaring Fork Lake, looking at the pool and riser. The lake has 115 acre-feet of sediment storage and 1,070 acre-feet of floodwater storage.

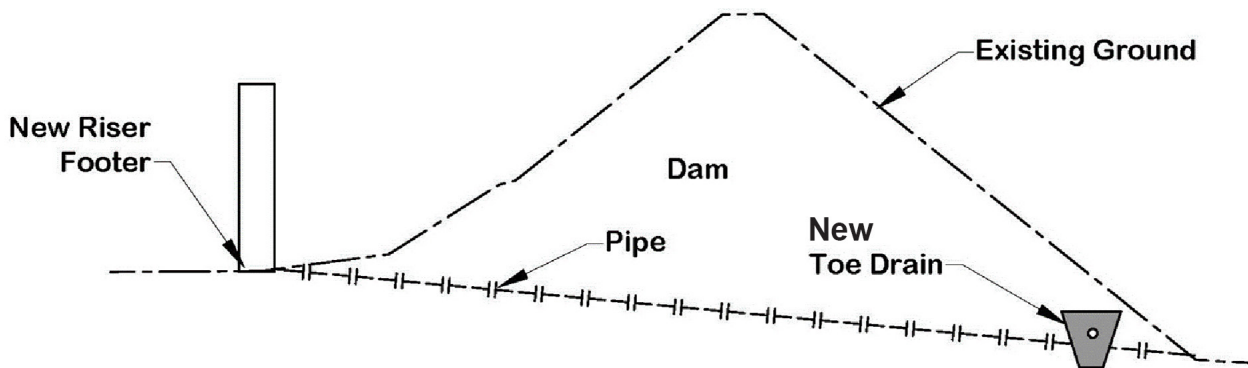
Proposed Alternative for Upgrading Riser Footer and Installing Toe Drains

- A 200-foot-wide roller-compacted concrete (RCC) chute auxiliary spillway will be installed over the top of the embankment. The elevation of the concrete chute will be the same as the existing auxiliary spillway crest, which will ensure no change to the level of flood protection downstream.
- The existing auxiliary spillway will be blocked with an earthen berm.
- The footer of the principal spillway riser will be enlarged to meet seismic criteria.
- New toe drains will be installed.
- The lake will be drained during construction to access the riser footer and to allow removal of the carp and white suckers.*
