Virginia Water Resources Progress Report 2020

Natural
Resources
Conservation
Service

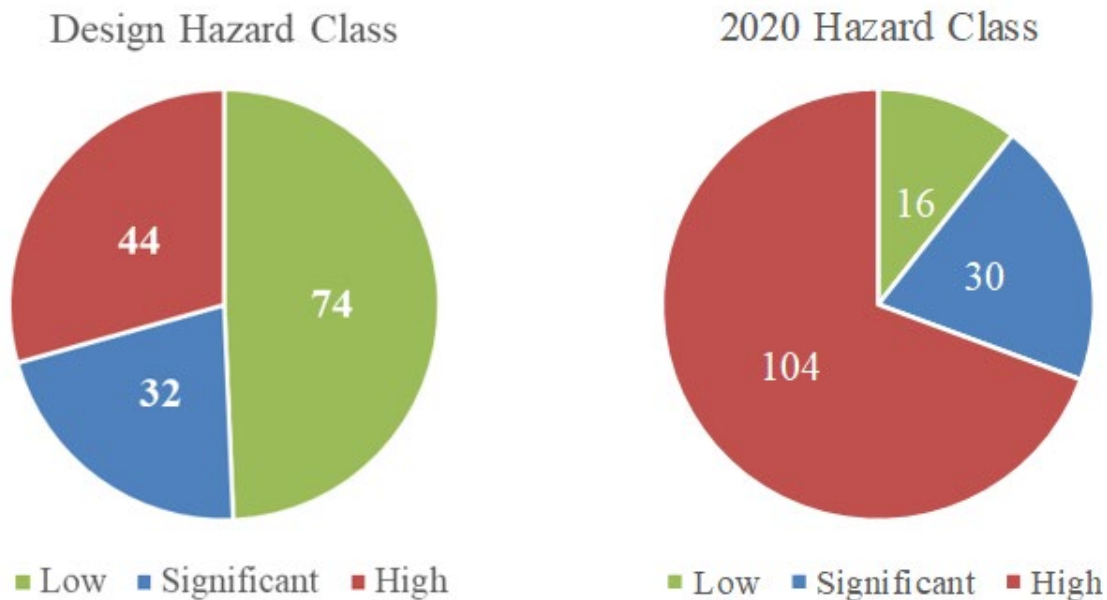
Figure 9. Comparison of as-designed hazard class with 2020 hazard class.

Hazard class changes have become common as the population of the State has increased and homes and businesses have been built in the potential breach inundation zone in place of the original agricultural land use. Most of the rehabilitation need is due to a change in hazard classification from Low or Significant hazard to High hazard. Figure 9 shows the number of dams in each hazard class as designed and as identified in 2020.

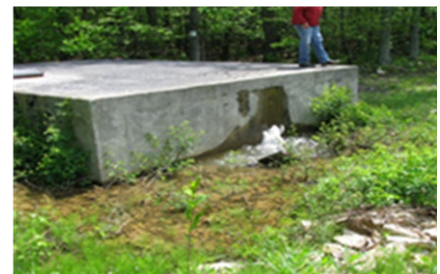
Figure 3. Water flowing from broken seal at distribution box.

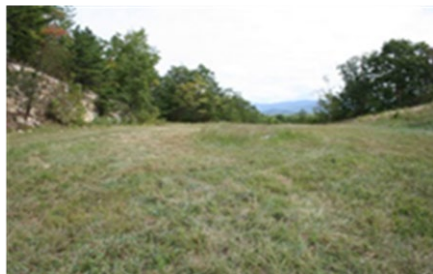
Figure 4. Original vegetated earth auxiliary spillway, looking downstream.

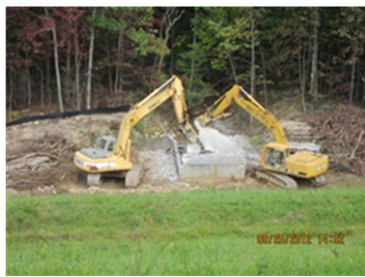
Figure 12. Demolition of concrete distribution box.

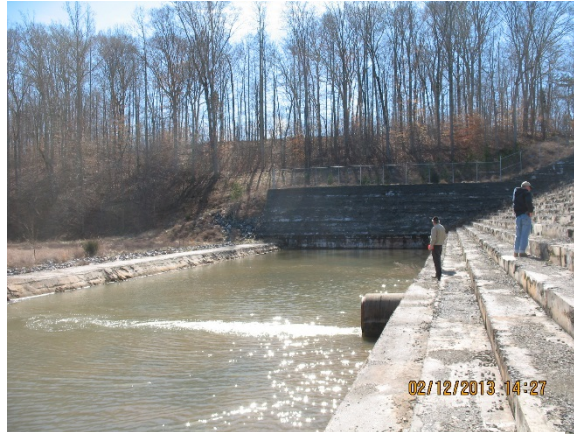
Figure 1. RCC stepped spillway at Marrowbone No. 1.

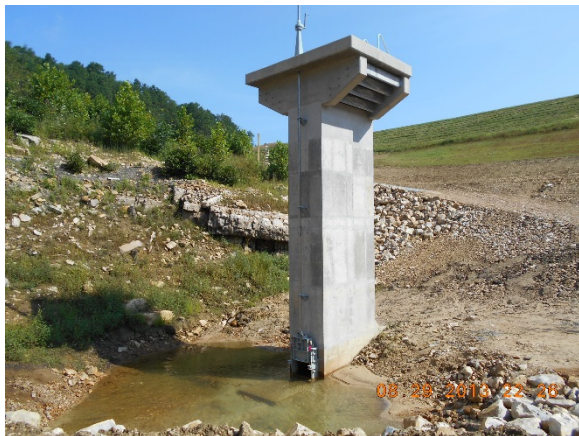
Figure 2. New riser at South River No. 10A.

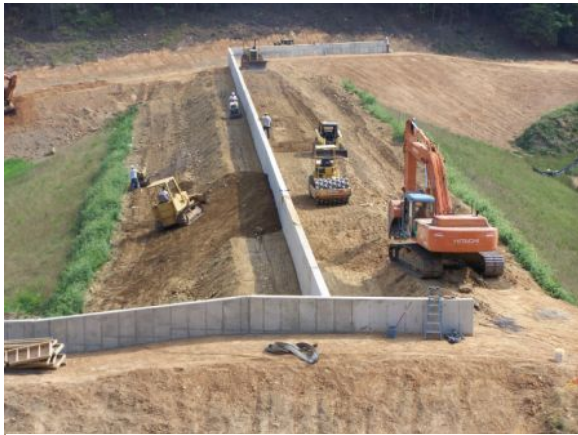
Figure 4. Parapet wall at South River No. 23.

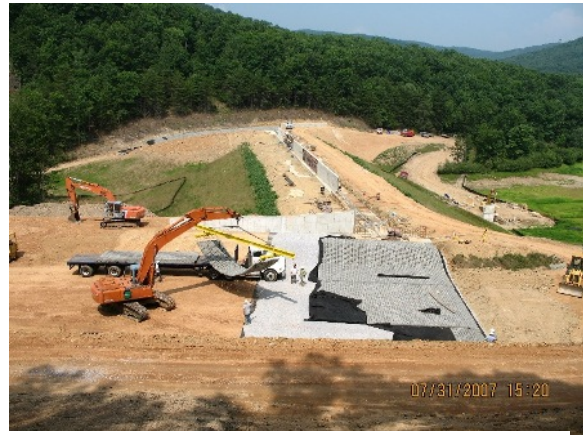
Figure 5. ACB installation at South River No. 23.

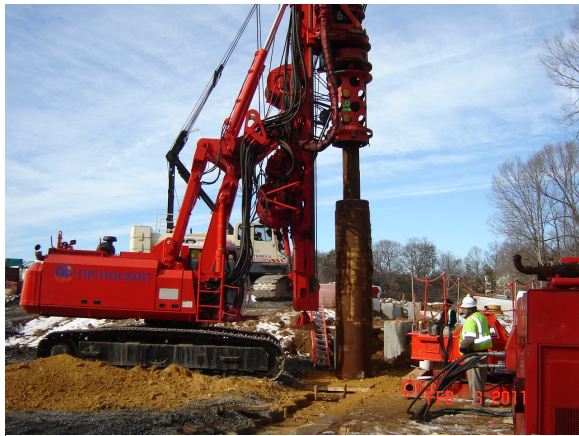
Figure 6. Secant pile wall installation at Pohick Creek No. 2.

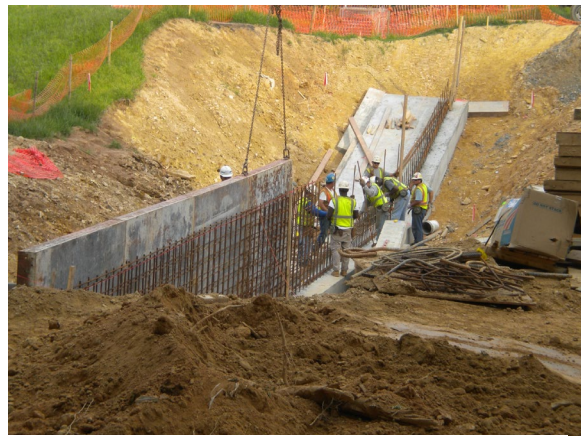
Figure 7. Cutoff wall installation at Pohick Creek No. 2.

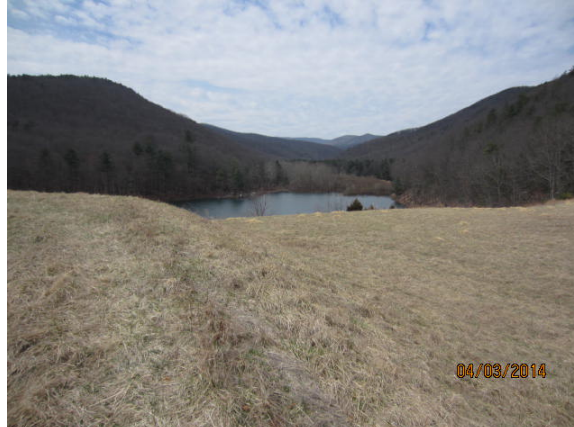
Figure 8. Inlet of existing auxiliary spillway at Upper North River No. 77.

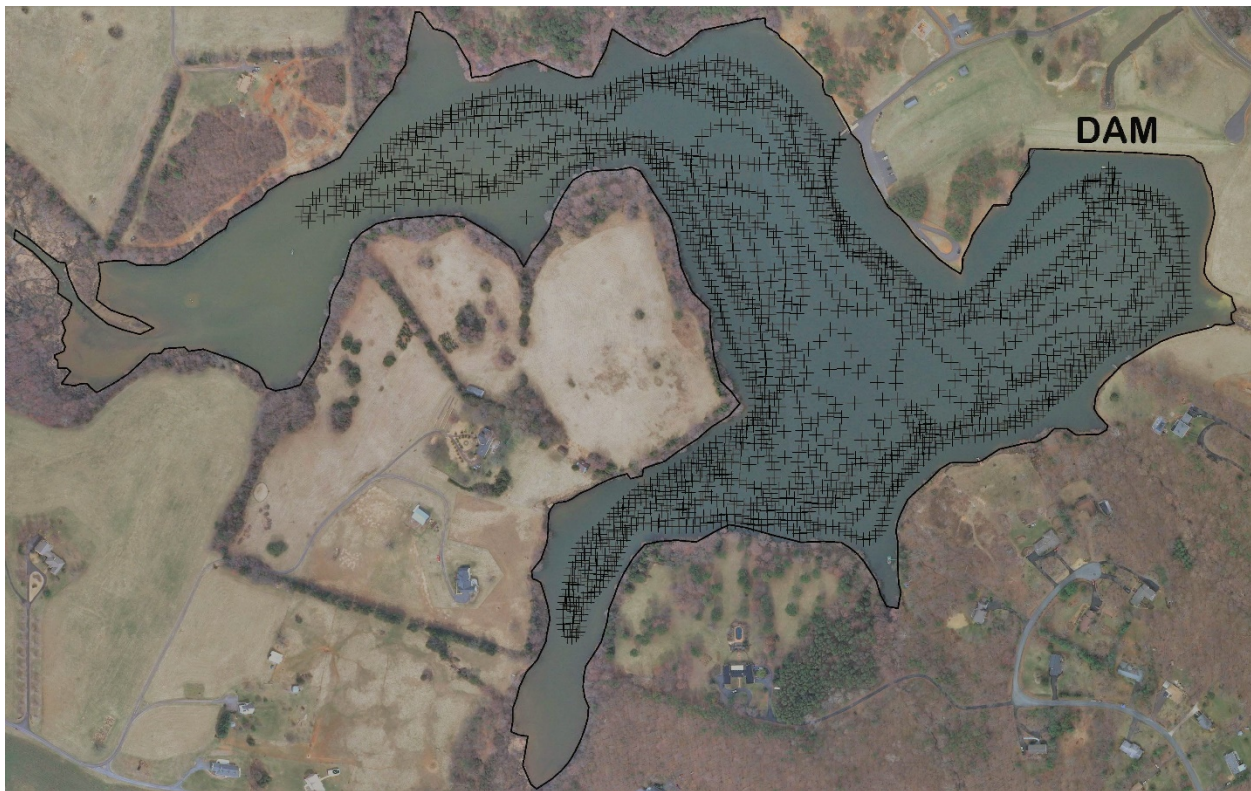
Figure 3. Data points in Lake Pelham for sediment survey.

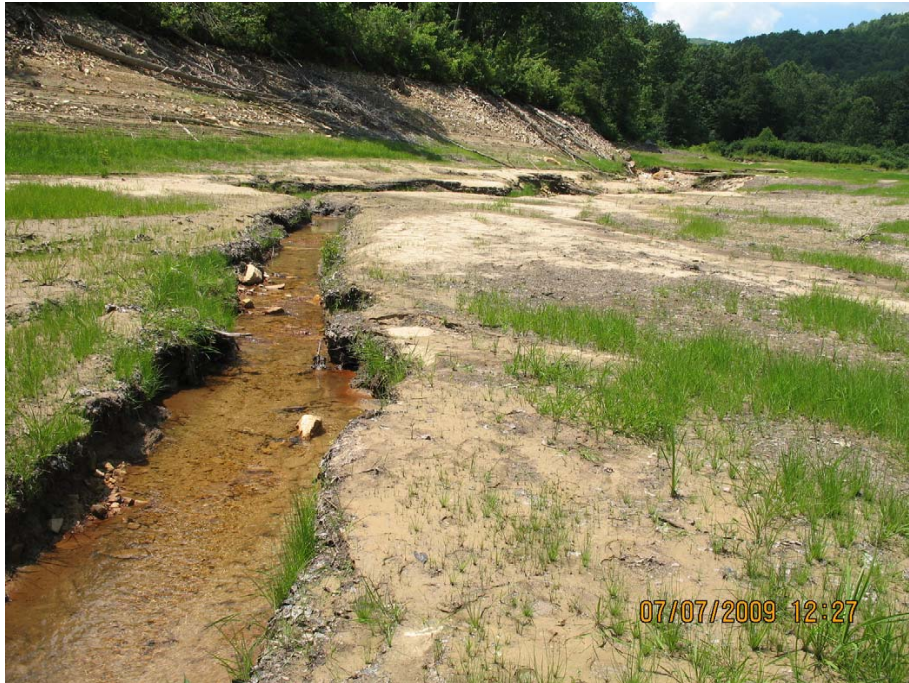
At the request of NRCS, the Sponsors lowered to pool to Gate 2 (elevation 1834.0 feet) after the first topographic survey. The water level was then 28 feet below normal pool. In July 2009, additional topographic surveys were performed to document the top of the sediment exposed by this lower water surface elevation. The incised streams were also surveyed, and a lower limit of sediment was identified by the exposed layer of cobbles and rocks.
