**Final Supplemental Watershed Plan No. 4 and
Environmental Assessment for the Santa Cruz
River Watershed - Site 1 Dam
Rehabilitation Project**

Santa Cruz River Watershed
Rio Arriba County, New Mexico

Title and Document Status: Final Supplemental Watershed Plan No. 4 and Environmental Assessment (Plan-EA) for the Santa Cruz River Watershed - Site 1 Dam Rehabilitation

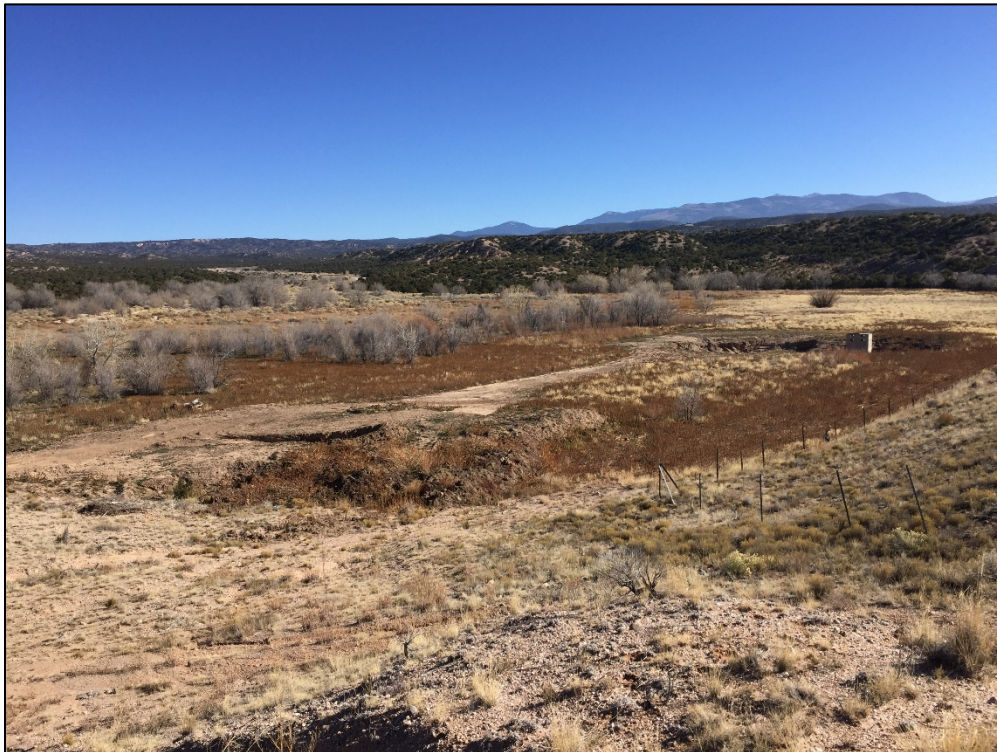
Figure 1-1. Basin
(Standing on the dam embankment looking east across the basin)

The basin is located upstream of the dam embankment and has a volume of approximately 548.7 ac-ft at the dam crest elevation of 6,354.4 feet. The upstream drainage area feeding into the basin is approximately 8.34 square-miles. The basin is normally empty except during seasonal high runoff and extreme weather events. Figure 1-1 below depicts the existing basin conditions.

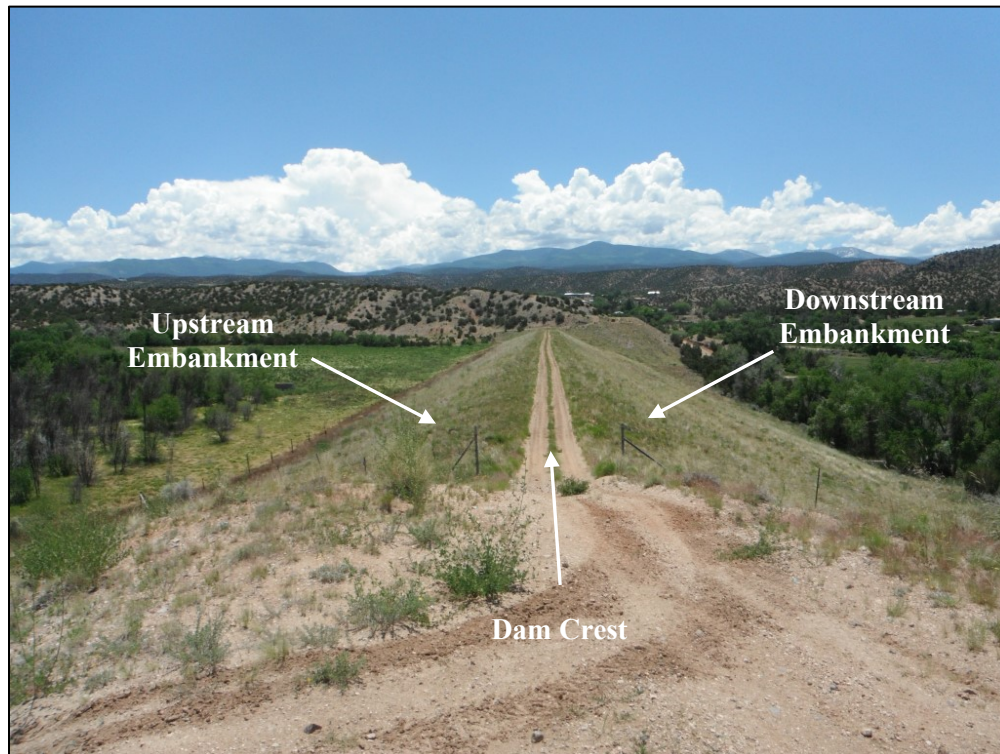
Figure 1-2. Dam Embankment
(Standing on the dam embankment looking southeast across the dam crest)

The dam embankment is constructed of earthfill and sits at an approximate elevation of 6,354.4 feet (Figure 1-2). It has a structural height of approximately 67 feet, a crest width of approximately 18 feet, and is about 1,082 feet long. The embankment has 3H:1V side slopes upstream and 2H:1V side slopes downstream. The dam embankment has stability berms that have a 4H:1V side slope on the upstream side and a 2.5H:1V side slope on the downstream side. Rill erosion has been observed near the groins on the downstream embankment face (Figure 1-3).

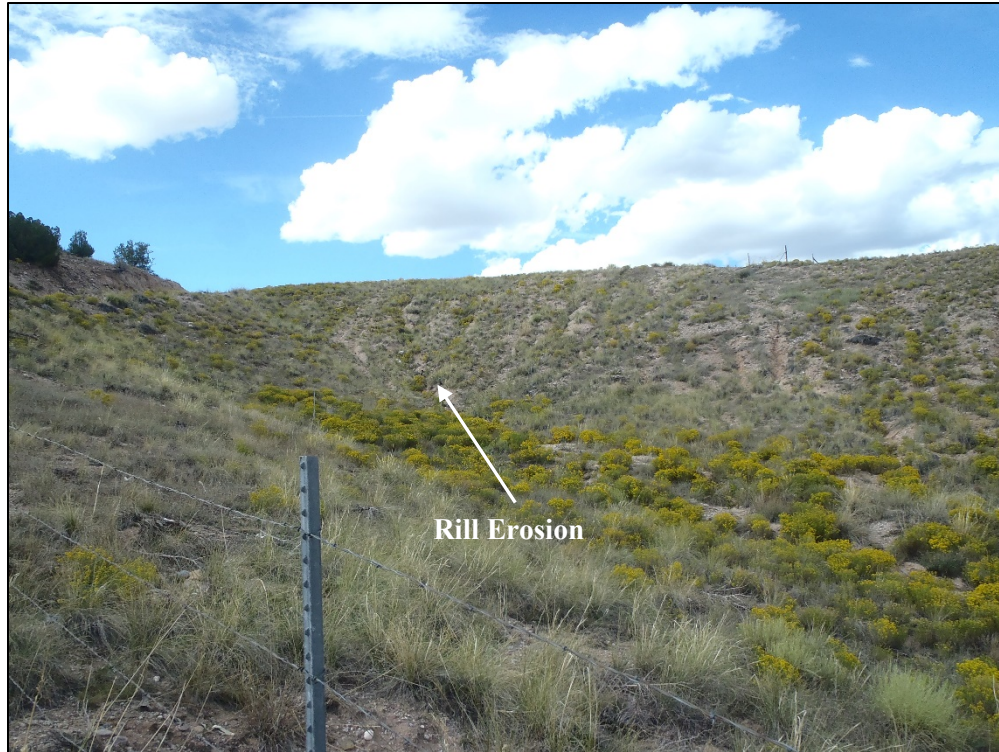
Figure 1-3. Embankment Groin Rill Erosion
(Looking at rill erosion on one of the downstream embankment groins)

2. **Embankment – Surface Erosion (NRCS and New Mexico Criteria):** TR-60 and New Mexico Dam Safety require that sufficient surface erosion protection be included on the upstream and downstream faces. Embankment surfaces are not currently protected from erosion and surface erosion and gullies have been observed on the upstream and downstream embankment faces.

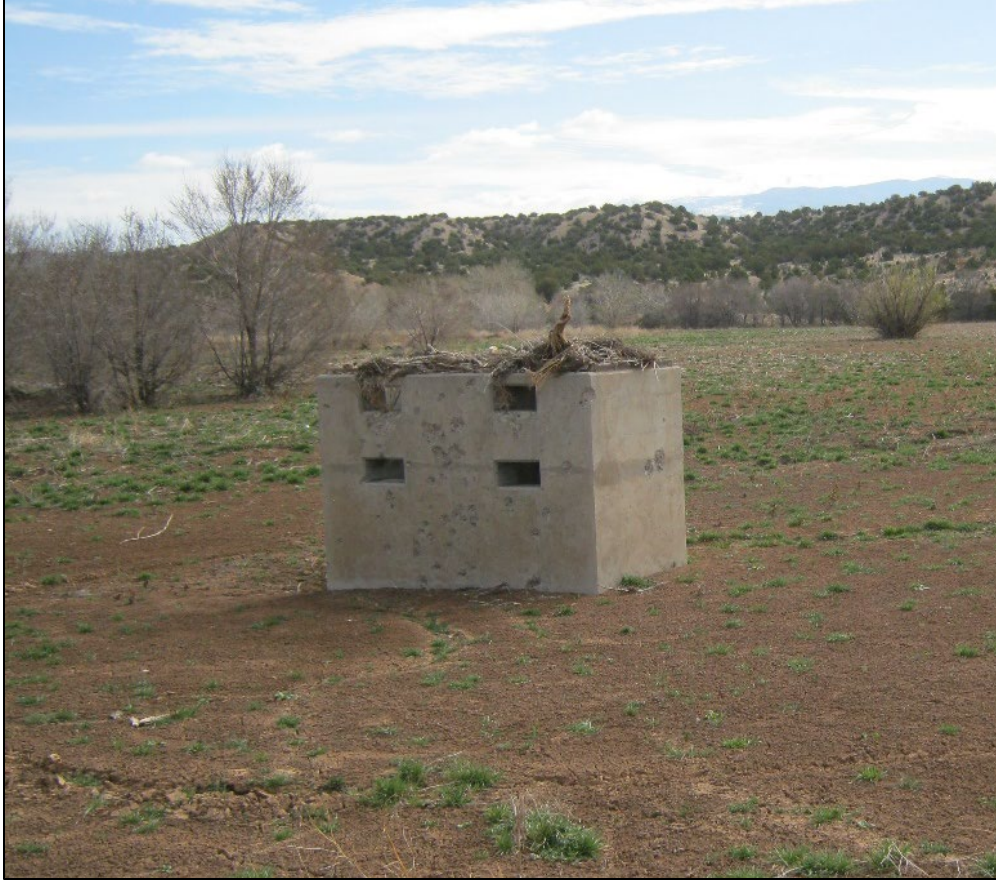
Figure 1-4. Principal Spillway Riser 2
(Looking east at principal spillway Riser 2)

The principal spillway consists of two connected concrete risers with one conduit through the dam embankment. The risers are in series and the upper riser (Riser 1) is a 2.5-foot by 2.5-foot structure that is approximately 11 feet tall (invert to crest) with a crest elevation of 6,316.8 feet. Riser 1 is connected to Riser 2 with a 24-inch-diameter corrugated metal pipe (CMP). Riser 2 is a 2.5-foot by 7.5-foot structure that is approximately 34 feet tall with a crest elevation of 6,339.5 feet (Figure 1-4). A 30-inch-diameter reinforced concrete conduit extends approximately 350 feet from Riser 2 through the dam embankment, and discharges on the downstream side (Figure 1-5). A plunge pool exists at the discharge point, and a channel extends approximately 85 feet from the plunge pool to the Acequia de la Cañada Ancha (the acequia) (defined also as a water irrigation ditch) downstream (Figure 1-6). When the dam was constructed, pipes were installed to bypass flows from the plunge pool over the acequia and into the natural drainage channel (arroyo) located downstream of the acequia. These bypass pipes have since been removed by acequia group members and flows from the plunge pool now enter directly into the acequia.

In 2015 sediment in the basin was shown to be at an average elevation of 6,334 feet. At this sediment elevation Riser 1 is buried under approximately 17 feet of sediment and was not operable. The aerated sediment elevation of the structure is approximately 6,336.6 feet, and sediment was only about 2.6 feet lower than the sediment pool elevation in 2015. In 2017 a pit was excavated from the area around Riser 1 to locate and expose the riser crest and around Riser 2 to expose additional ports. Approximately 75% of the excavated area was infilled with sediment during a rain event in August 2018.

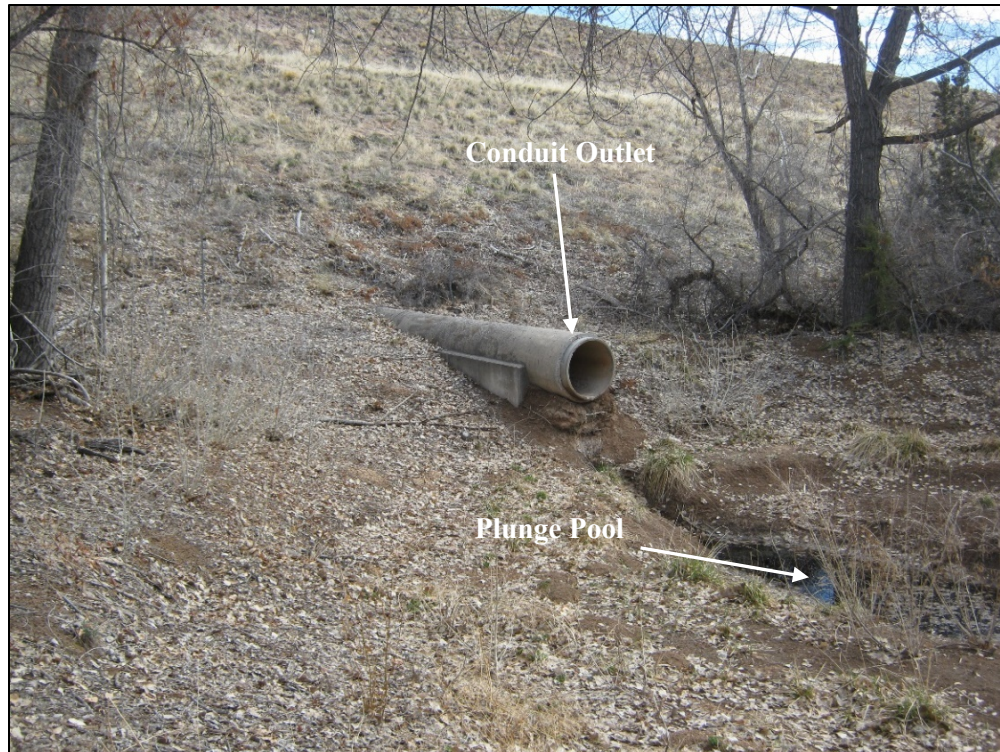
Figure 1-5. Principal Spillway Conduit Outlet
(View of principal spillway conduit discharge point and plunge pool)

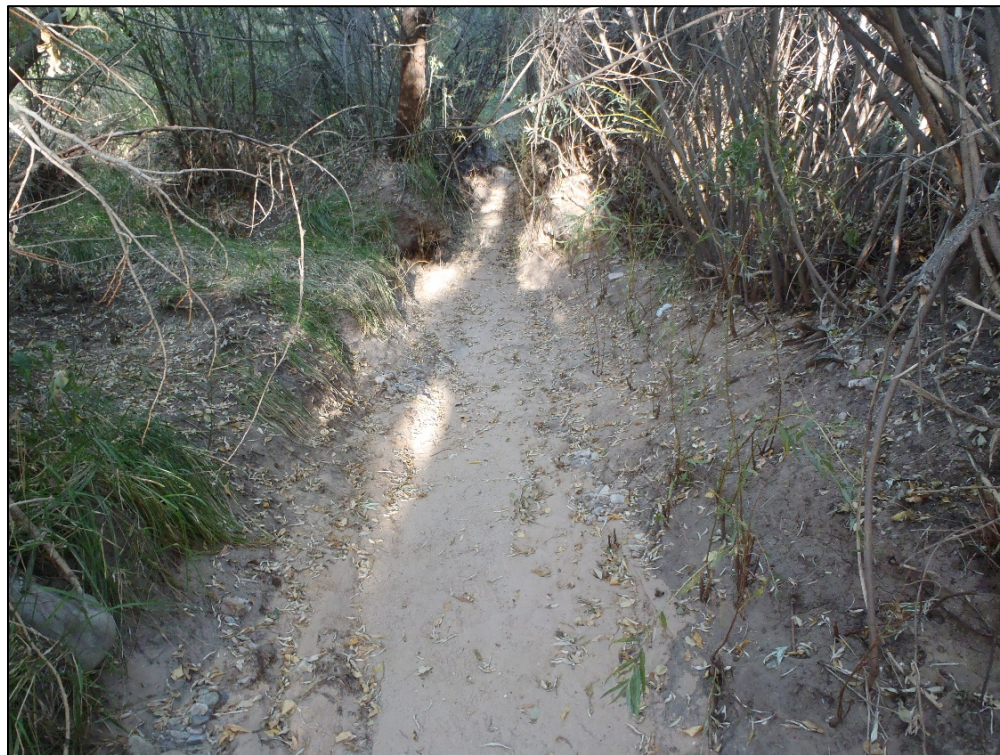
Figure 1-6. Principal Spillway Conduit Outlet Channel
(Looking at the channel from the plunge pool to the Acequia de la Cañada Ancha)

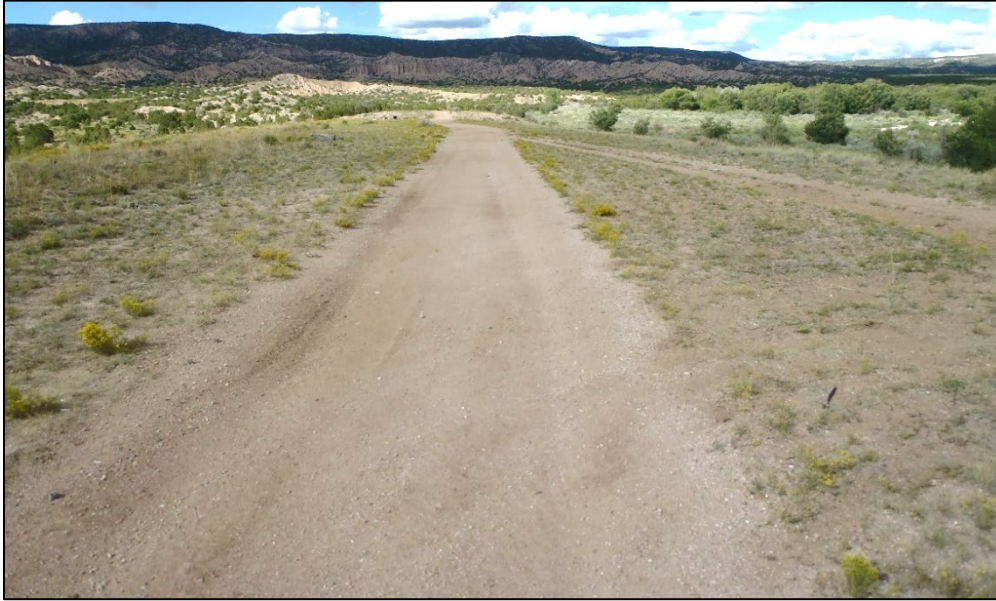
Figure 1-7. Auxiliary Spillway
(Looking northeast across the auxiliary spillway)

The existing auxiliary spillway is an earthen spillway that is approximately 600 feet wide with a crest elevation at approximately 6,349.6 feet (Figure 1-7). It extends down approximately 150+ feet before intersecting with the Cañada de Ojito drainage. The purpose of the auxiliary spillway is to prevent dam embankment overtopping and relieve additional forces on the dam embankment during high water and flood conditions. Based on a hydrology analysis conducted for the structure (Attachment 2 of Appendix D), the auxiliary spillway can currently discharge approximately 10,250 cfs without overtopping the dam embankment. Rill erosion and erosion from the Cañada de Ojito drainage has been observed along the auxiliary spillway exit slope (Figure 1-8).

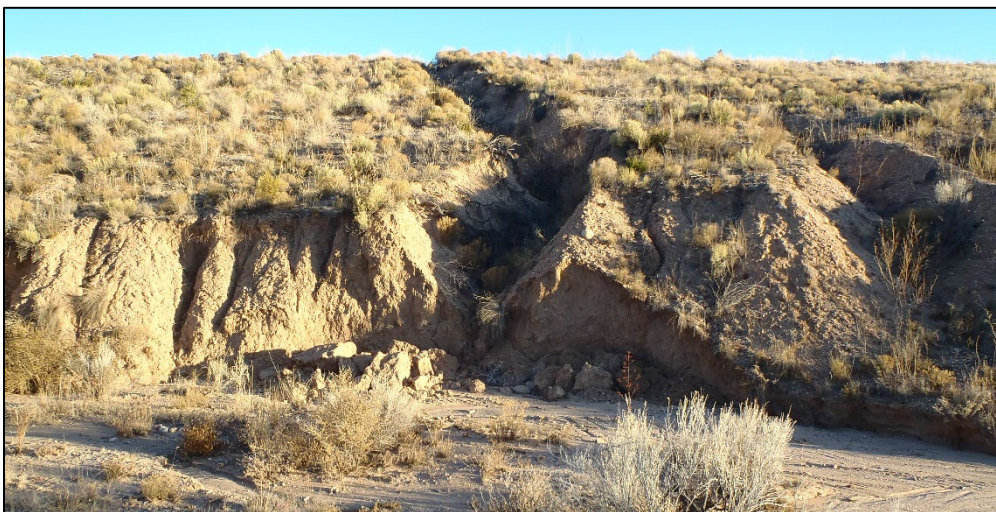
Figure 1-8. Auxiliary Spillway Rill Erosion
(Standing in the Cañada de Ojito drainage looking southeast at auxiliary spillway exit slope erosion)

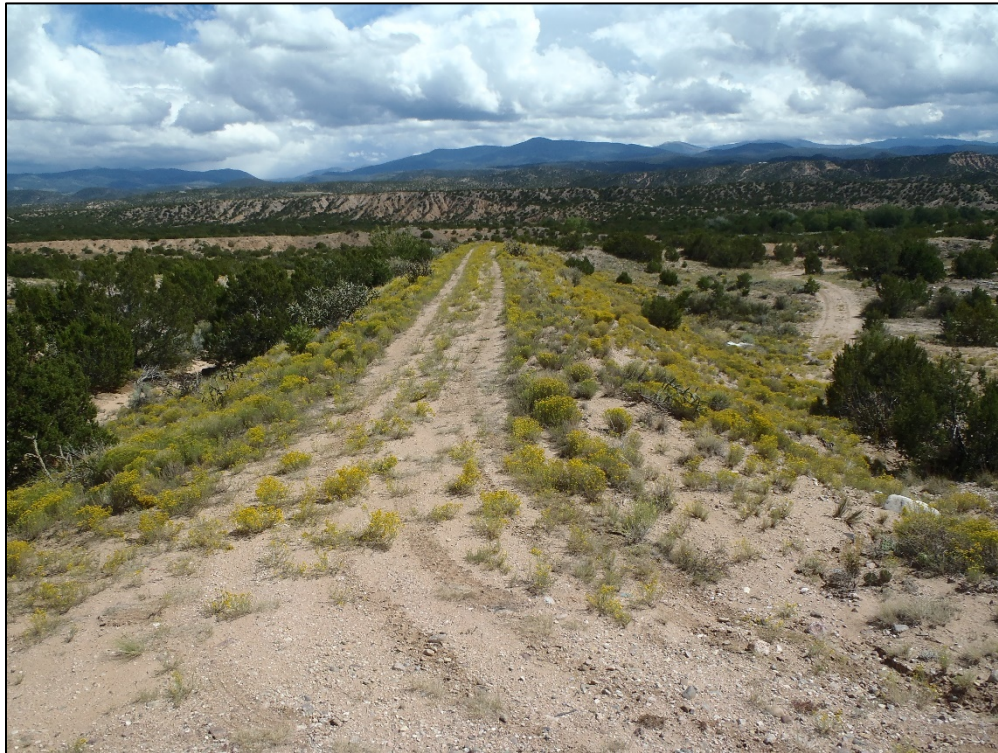
Figure 1-9. Retaining Dike
(Looking north across the retaining dike crest)

A retaining dike extends approximately 550 feet north from the north end of the auxiliary spillway (Figure 1-9). The retaining dike acts like a saddle dam, which is a dam constructed in a low spot or “saddle” to contain a reservoir. This dike is at an approximate elevation of 6,354.0 feet and helps confine flood flows in the basin. The dike has 3H:1V side slopes upstream and 2H:1V side slopes downstream. Rill erosion has been observed on the downstream and upstream dike embankment faces.

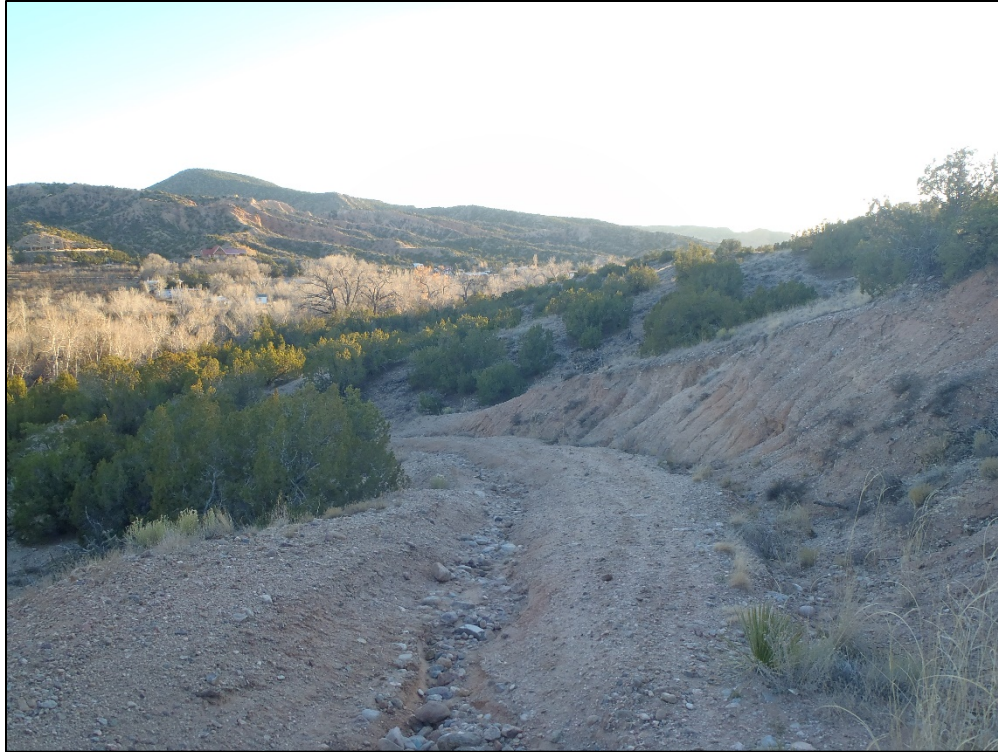
Figure 1-10. Access Road
(Looking south (downhill) at the access road)

Access to the basin is obtained from a dirt access road extending approximately 2,300 feet generally northeast from Road 100 to the top of the dam. A portion of the access road extending from the base of the dam to the top of the dam is at a grade that is not traversable by most vehicles. Additionally, the condition of the road in that portion combined with the grade makes the road impassable to most 4-wheel drive vehicles (Figure 1-10). The access road crosses the acequia and is not equipped with a stabilized crossing point. The access road crossing through the acequia is also not traversable by most 4-wheel drive vehicles (Figure 1-11).

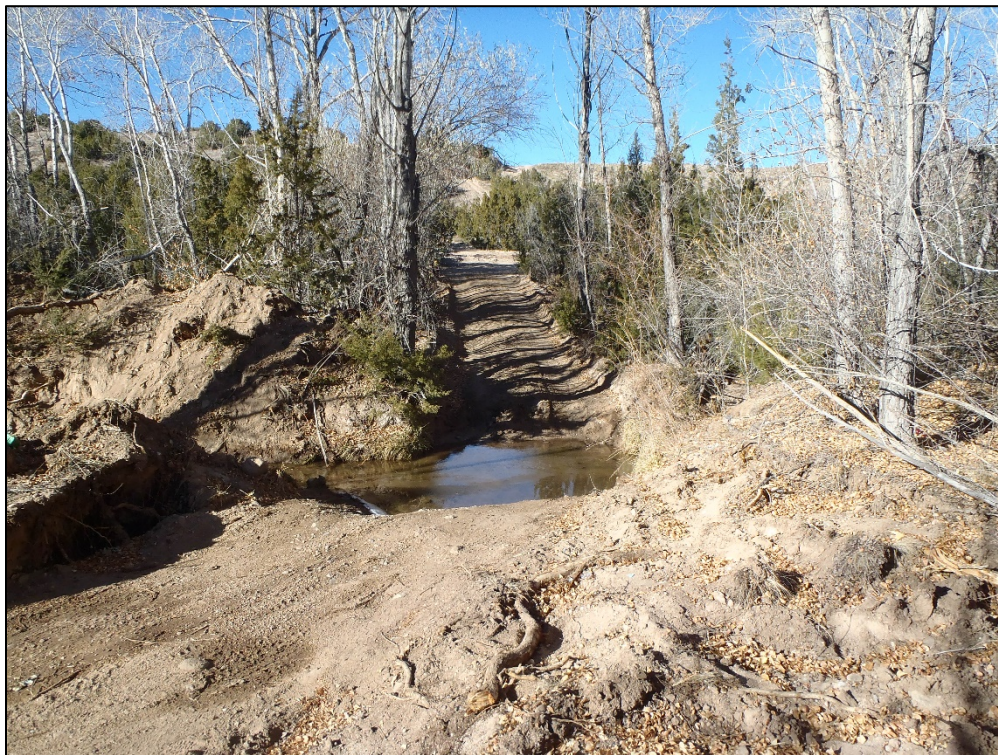
Figure 1-11. Access Road at Acequia
(Looking north (uphill) at the access road crossing at the acequia)
