# TONGUE RIVER WATERSHED PLAN

## Appendix D-8: Project Benefits Report

**May 6, 2021**

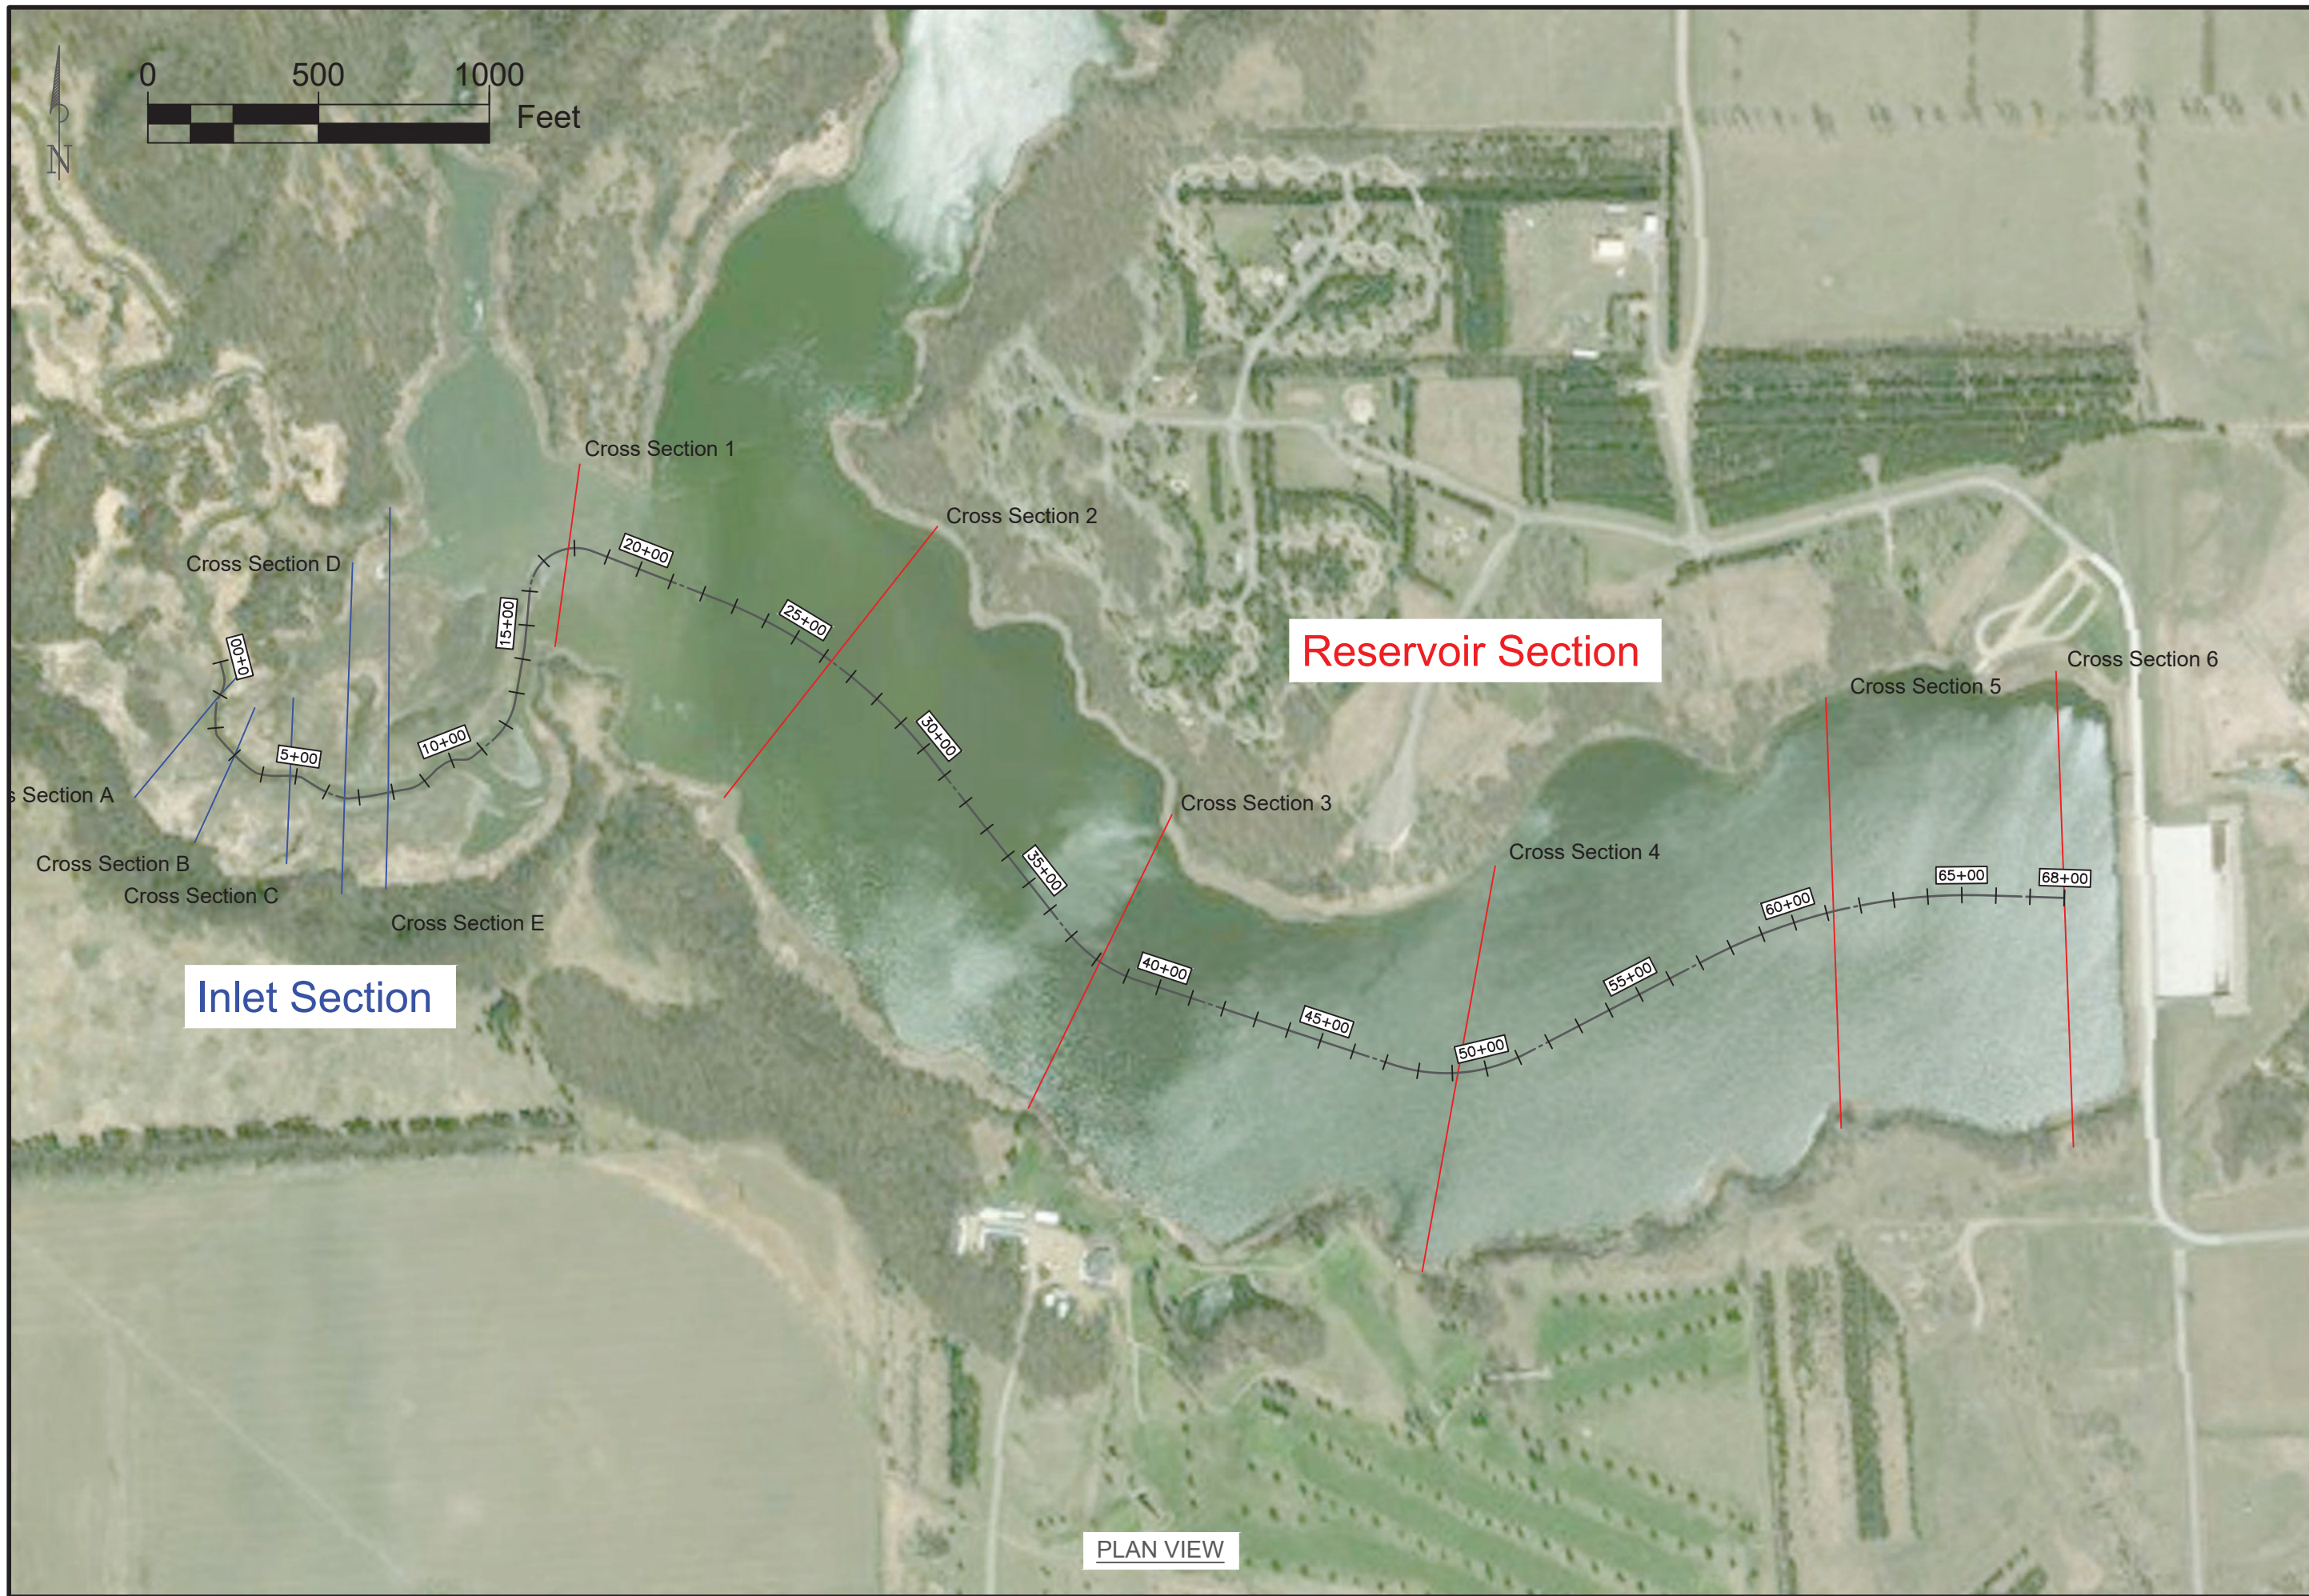
TONGUE RIVER PLAN/EA  
APPENDIX D-8 FIGURE 1

RENWICK DAM SEDIMENT SURVEY  
PLAN VIEW

Eleven cross sections from the 2002 survey were repeated in 2020, to evaluate the extent to which upstream river channel incision and widening had impacted the reservoir. NRCS completed the survey on cross sections A through E, and cross section 1 on foot with RTK GPS, and Houston Engineering completed the survey of cross sections 2-6 utilizing barge mounted acoustic imaging equipment. Figures 1 through 3 depict the location of the surveyed cross sections and overlays the 2020 versus 2002 sediment. River erosion through the project reach was noted as a major concern in 2013, which was the year of a major basin flood event. Therefore, 2013 is considered initiation of extreme project reach erosion. The total sediment accumulation is estimated to be 255.4 acre-feet over the 8 years of major erosion, for an average of 27.2 acre-feet/year. This is a sharp increase in comparison to the 3.45 acre-feet/year for prior 51 years. Aerial views of the significant reservoir delta expansion can be found in Appendix D-1, Figure 6. Note that the north arm of the reservoir was not included, nor was the entire delta expansion area, so the 255.4 acre-feet is somewhat of an underestimate. The estimated reservoir sedimentation due to river incision and widening is 23.8 acre-feet/year, as the difference between the 2002-2020 rate (27.2 acre-feet/year) and natural watershed sedimentation (3.45 acre-feet/year). Reservoir sediments originating from river incision and widening are predominately from the bed of the river (incised up to 8 ft in some locations, channel widening (up to 40 ft in some locations), erosion on outer meander bends, and landslides on steep upland slopes that have been undercut. The project reach (General Reaches 4 and 5) was identified to have much greater erosion potential compared to other reaches, as documented in Appendix D-1; therefore the project reach accounts for majority of sediment delivered to Renwick in the 2003-2020 time period. As noted in Appendix D-1, the floods of 2009 and 2013 would have dramatically increased the rate of that incision process, therefore the majority of the sediment was likely delivered in the latter half of that time period.

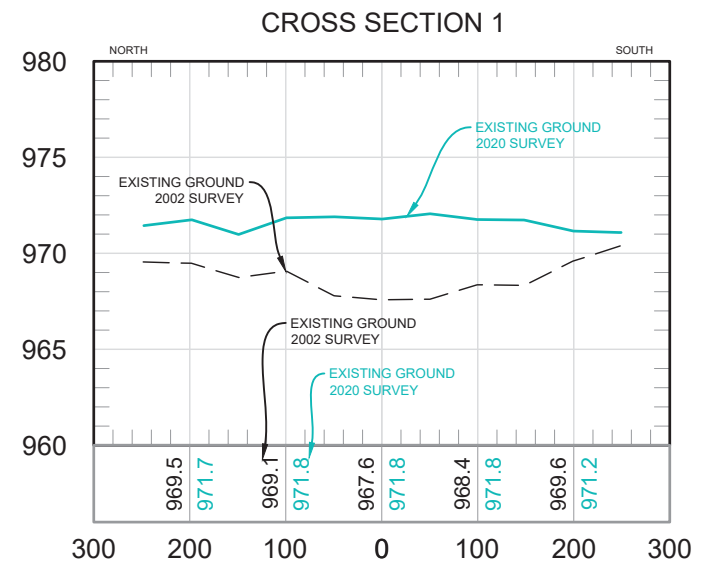
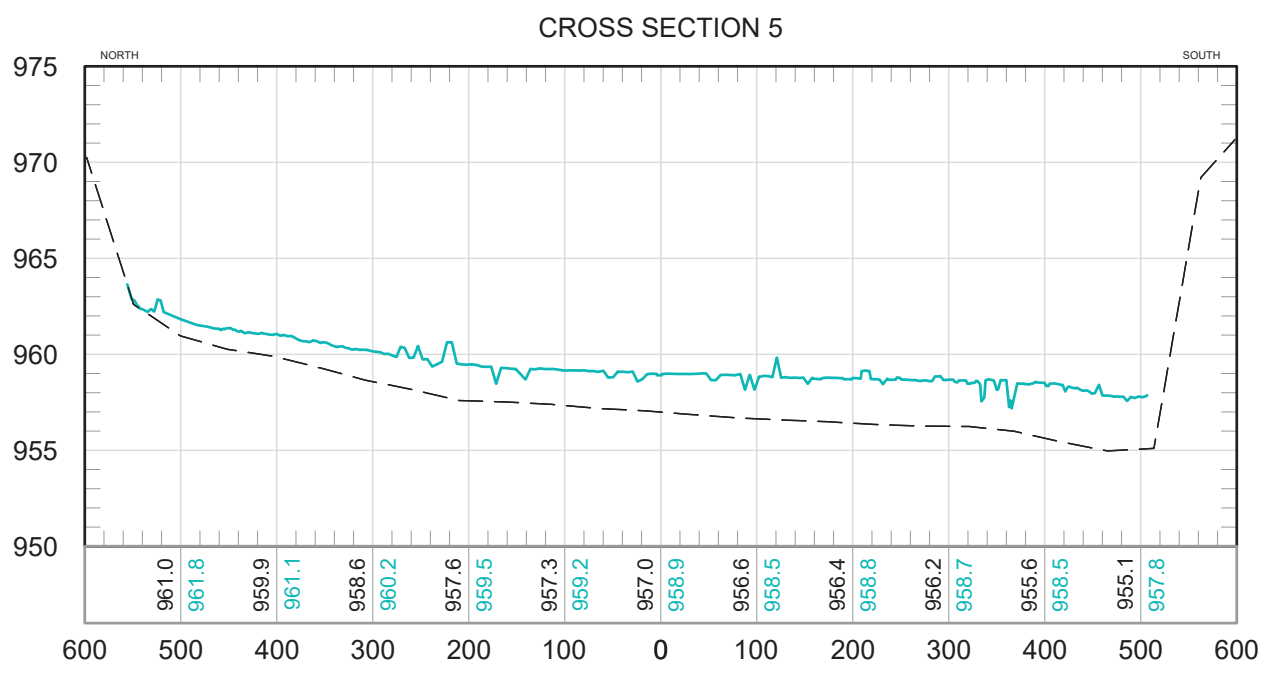
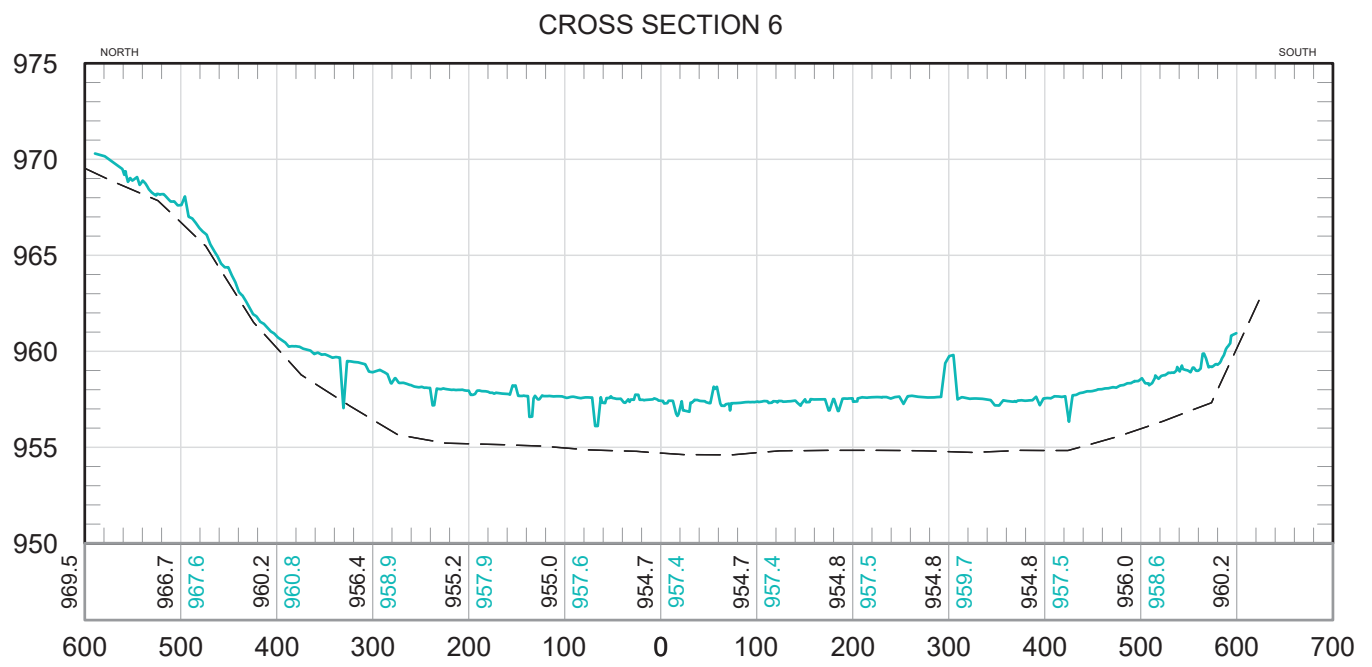
TONGUE RIVER PLAN/EA  
APPENDIX D-8 FIGURE 3

RENWICK DAM SEDIMENT SURVEY  
CROSS SECTIONS - RESERVOIR

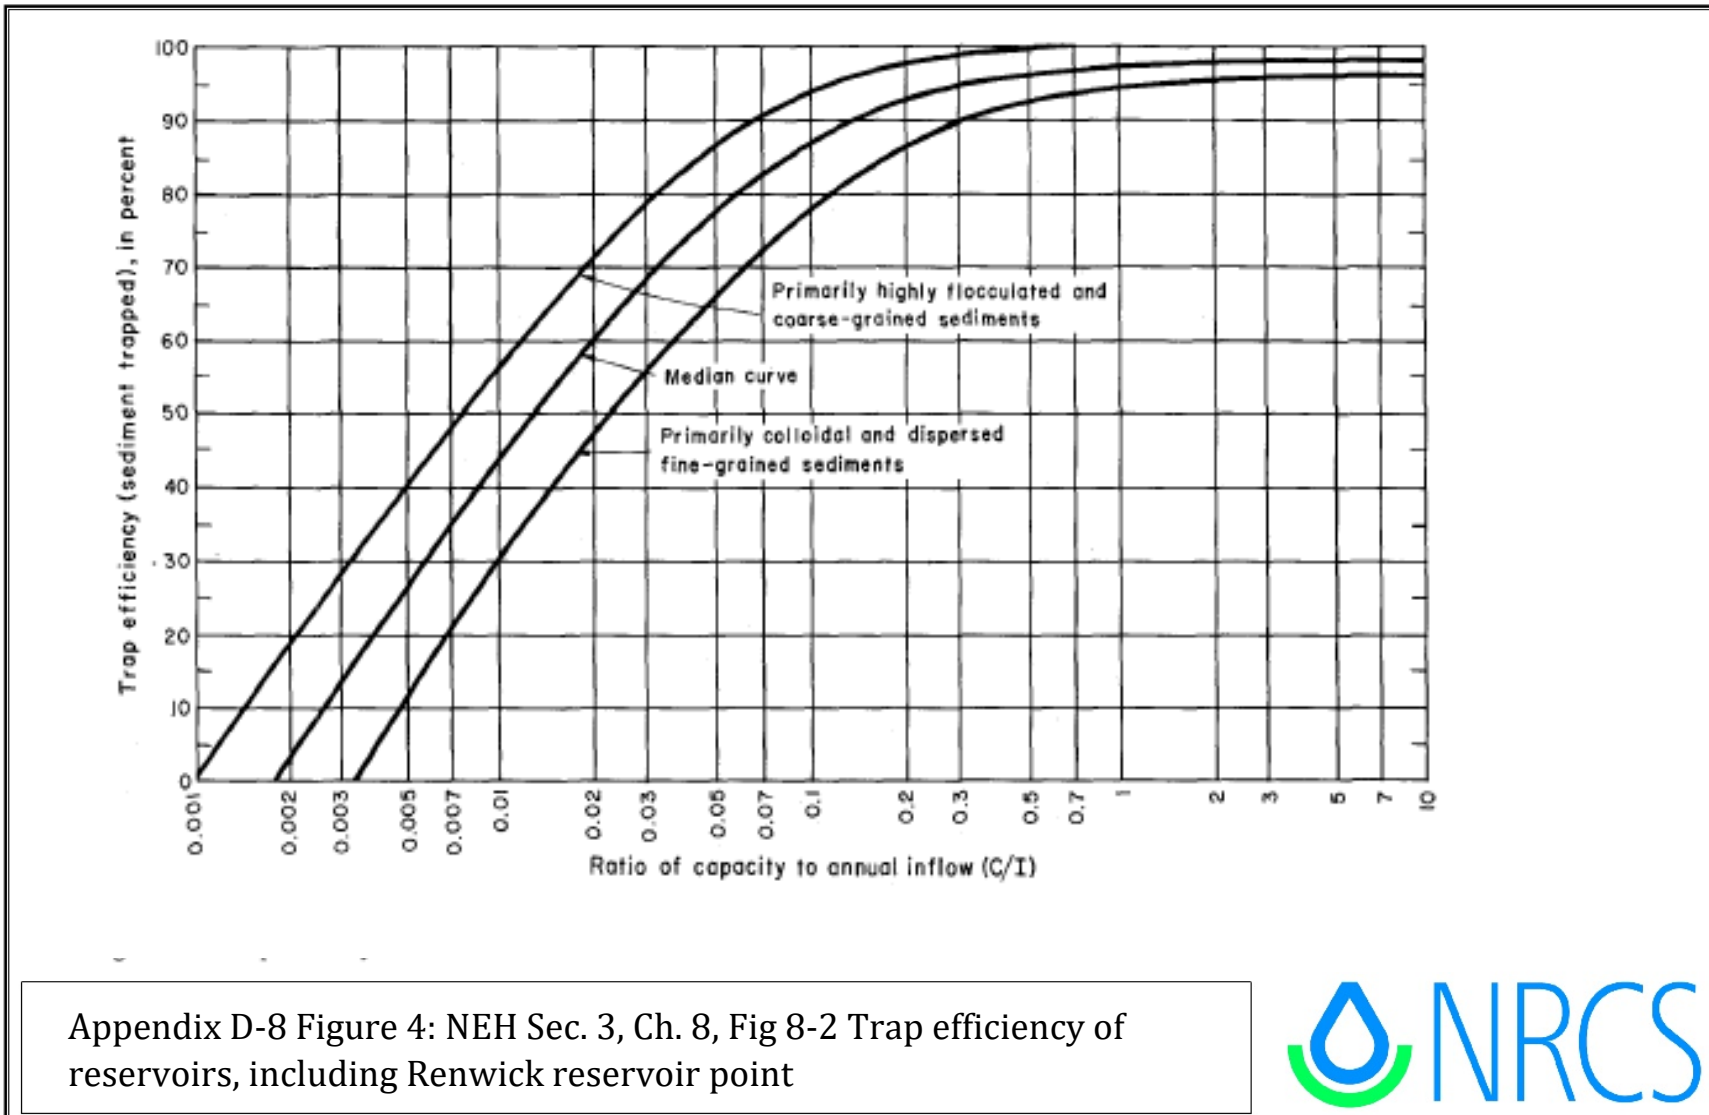
Appendix D-8 Figure 4: NEH Sec. 3, Ch. 8, Fig 8-2 Trap efficiency of reservoirs, including Renwick reservoir point

In order to translate watershed erosion to reservoir sedimentation there are two important parameters: reservoir sedimentation trap efficiency and unit weight of sediment. National Engineering Handbook (NEH) Section 3, Chapter 8 (NRCS 1982) adopted the Brune method for trap efficiency, which is based on reservoir Capacity-Inflow ratio (C/I). The capacity, or active storage between principle and auxiliary spillways, is 4,071 acre-feet at Renwick, while annual inflow volume is 19,276 acre-feet from USGS gauge 05101000. Therefore, C/I = 2.1 with median curve resulting in Trap efficiency (T) ~94% as shown in Figure 4. The volume-weight relationship range

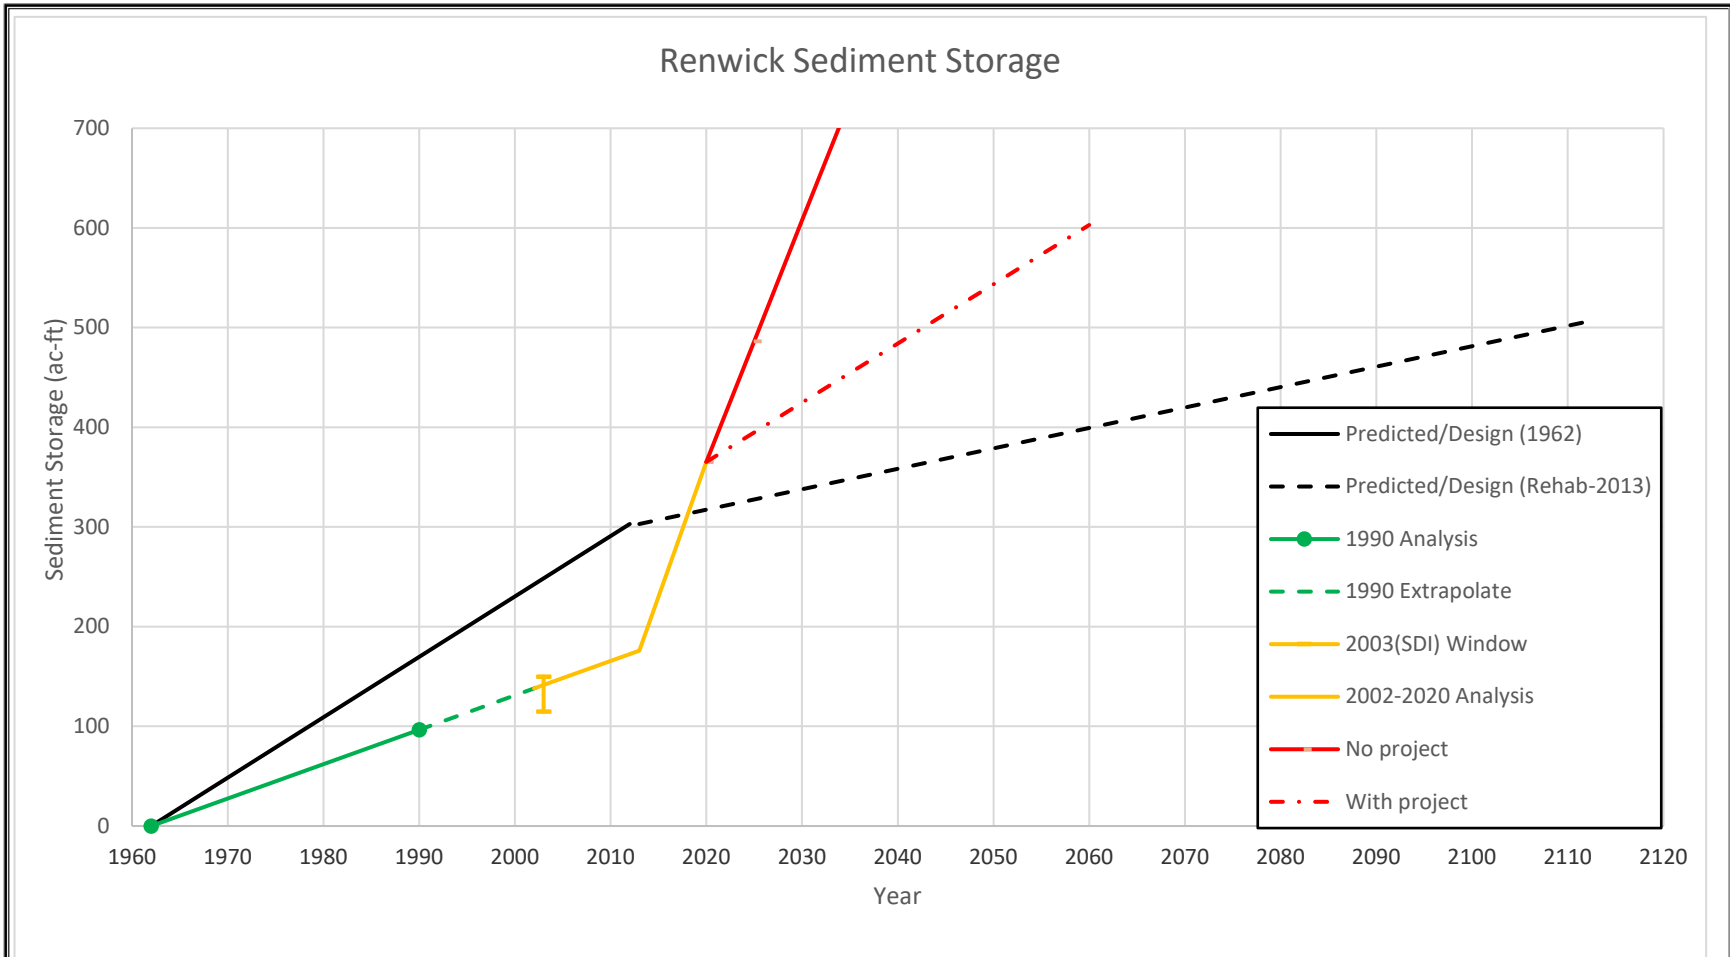
Appendix D-8 Figure 5: Renwick sediment storage design, historic, and projected (with and without project)

Using the available Renwick sediment surveys (1990, 2003, and 2020), the historic sediment storage is plotted with predicted/designed storage from original dam construction (1962) and rehabilitation (2013) in Figure 5. Figure 6 shows the current rate of sedimentation (27.2 acre-feet/year) extrapolated as the “No project” condition if the channel incision is allowed to continue working upstream. The “With Project” condition assumes the project reach is stabilized, through either Alternative 1 or 2 of the plan, and incision is not allowed to progress upstream, reducing sediment delivery to the historic watershed rate plus the current beyond project river erosion (6.7 acre-feet/year). Those estimates are similar and slightly more than original design sedimentation rate of 6.1 acre-feet/year (303 acre-feet / 50-years). Results are detailed in Table 3 below and summarized in Figure 7. Key findings are as follows:

- The designed sediment pool, which was planned to have capacity through 2113, filled 72% between 2003 and 2020.
- If the upstream channel is not stabilized, the sediment pool is projected to be full in ~2027, after which sediment will begin to encroach upon the permanent pool design volume intended for recreation.

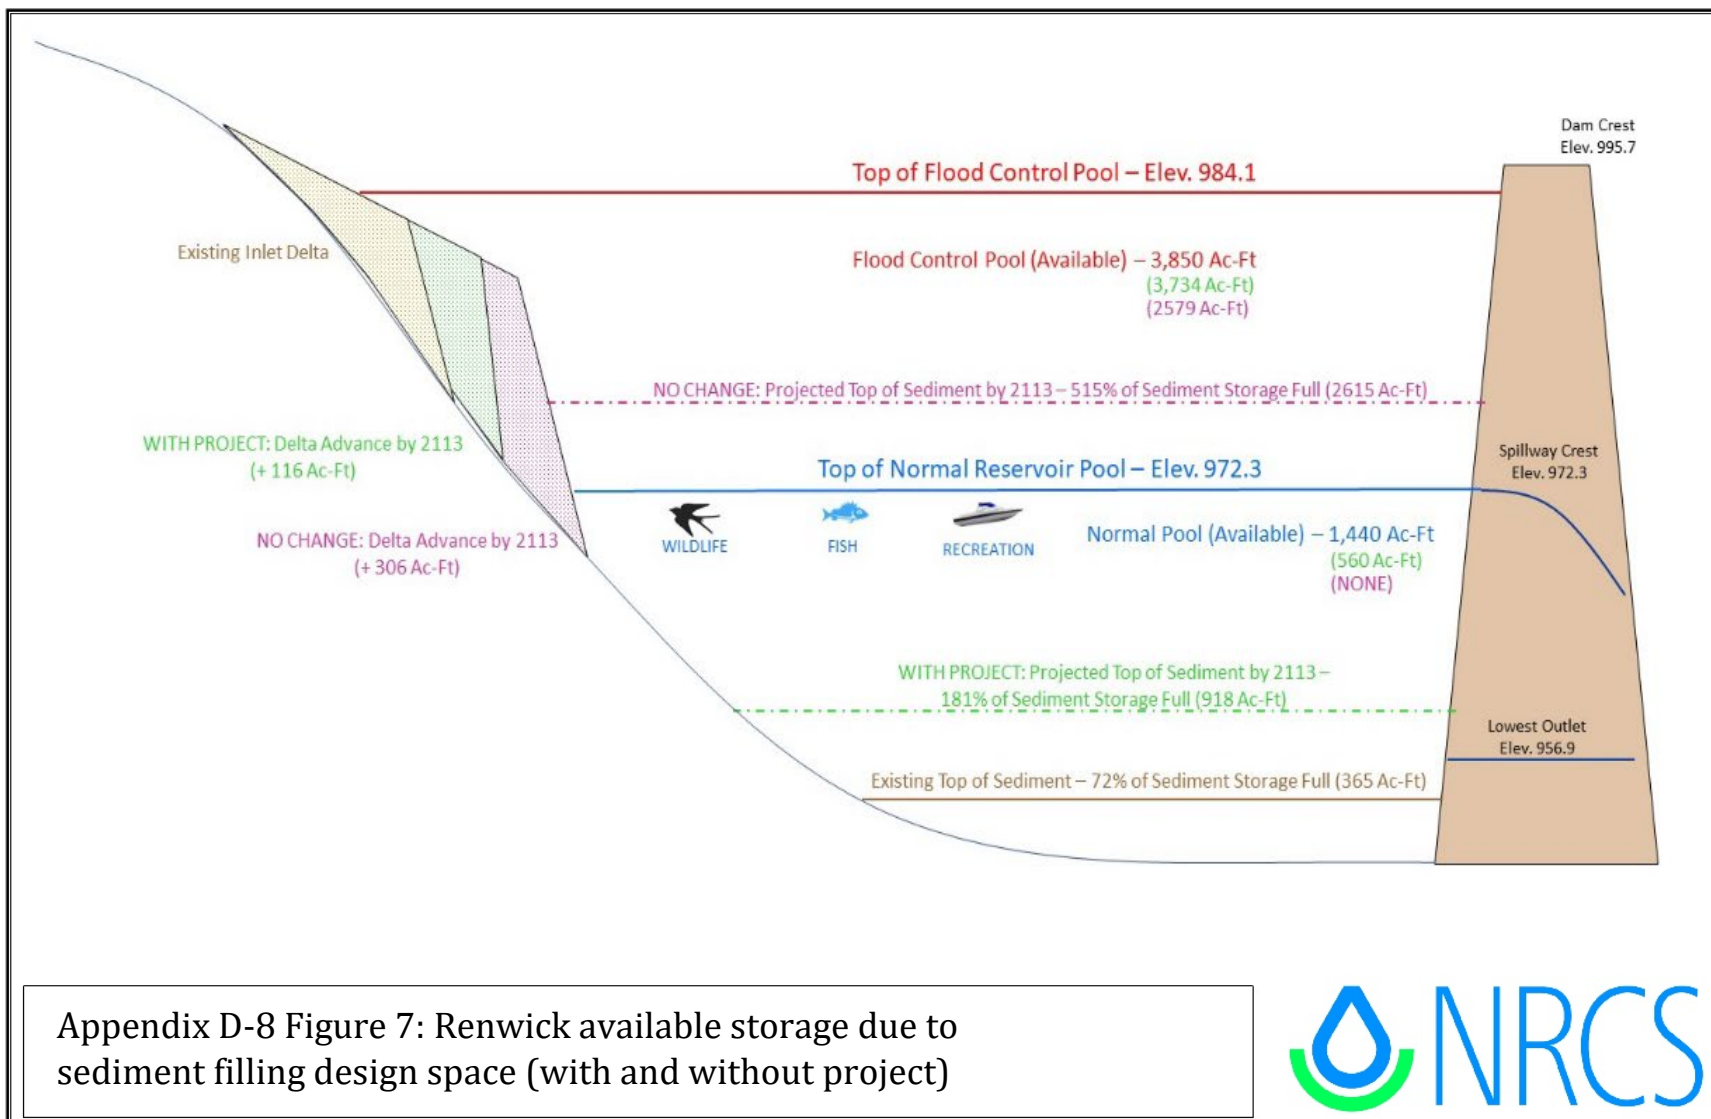
Appendix D-8 Figure 7: Renwick available storage due to sediment filling design space (with and without project)

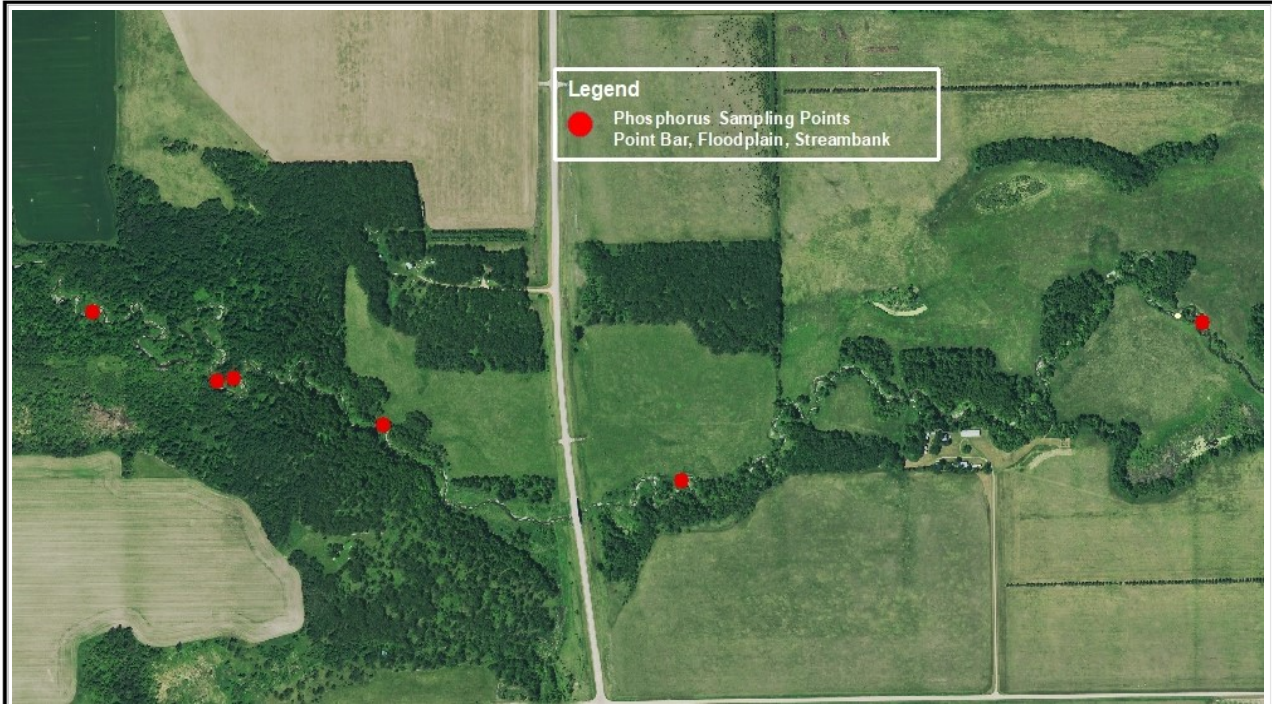
Figure D-8-15 Sediment Core with Total Phosphorus Concentration Locations

In order to derive an estimate of TP delivered from upstream channel incision and widening, six borings were taken on riverbanks through the project reach as identified in Figure 15. A total of 29 samples were collected at various depths, the results of which indicate the average TP concentration to be ~750 ppm with generally decreasing concentration with depth. Concentration plots by depth are shown in Figure 16. Based on the 21.9 ac-ft per year of erosion due to channel banks (3.4), channel thalweg (3.5) and widening beyond channel (15.0), which were described in the previous Flood Control Benefits section; annual TP transport volume due to channel incision and widening is estimated at 70,000 lbs as show in Table 10.

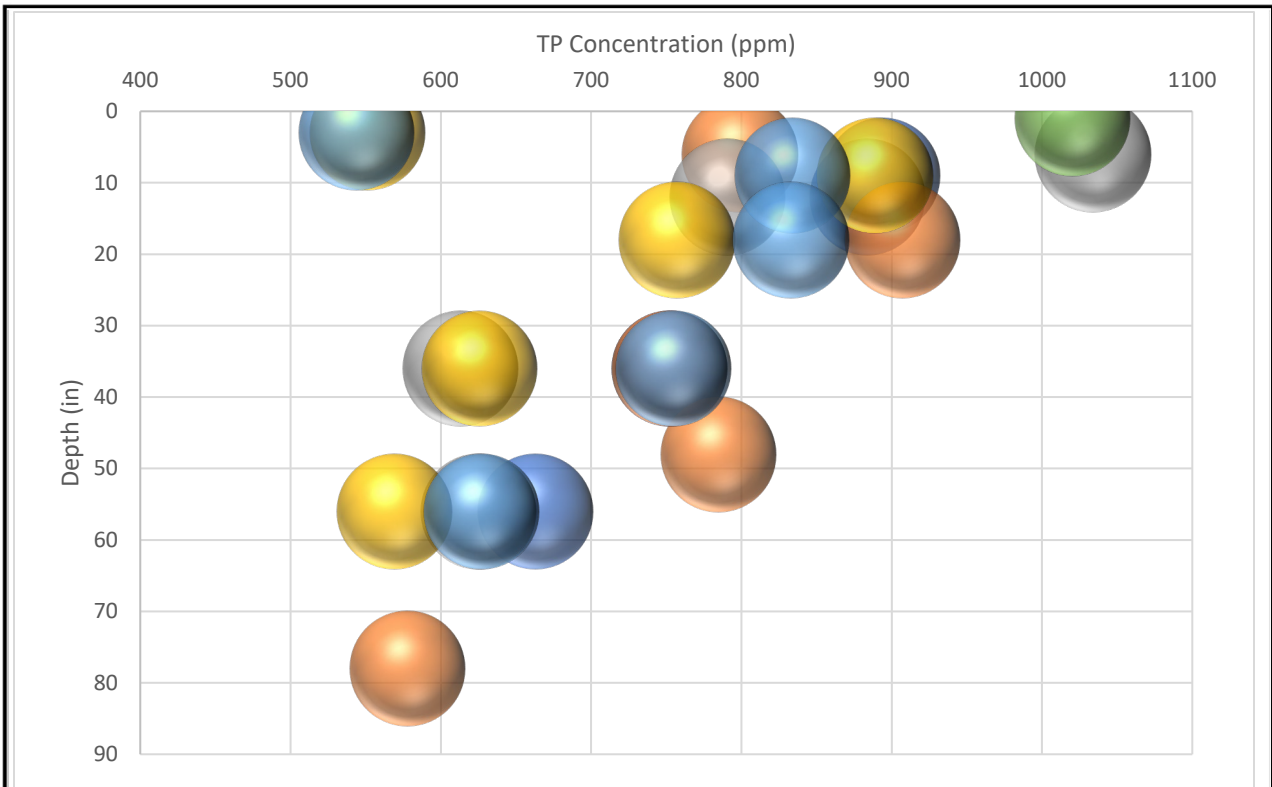
Figure D-8-16 Sediment Core with Total Phosphorus Concentration by Depth

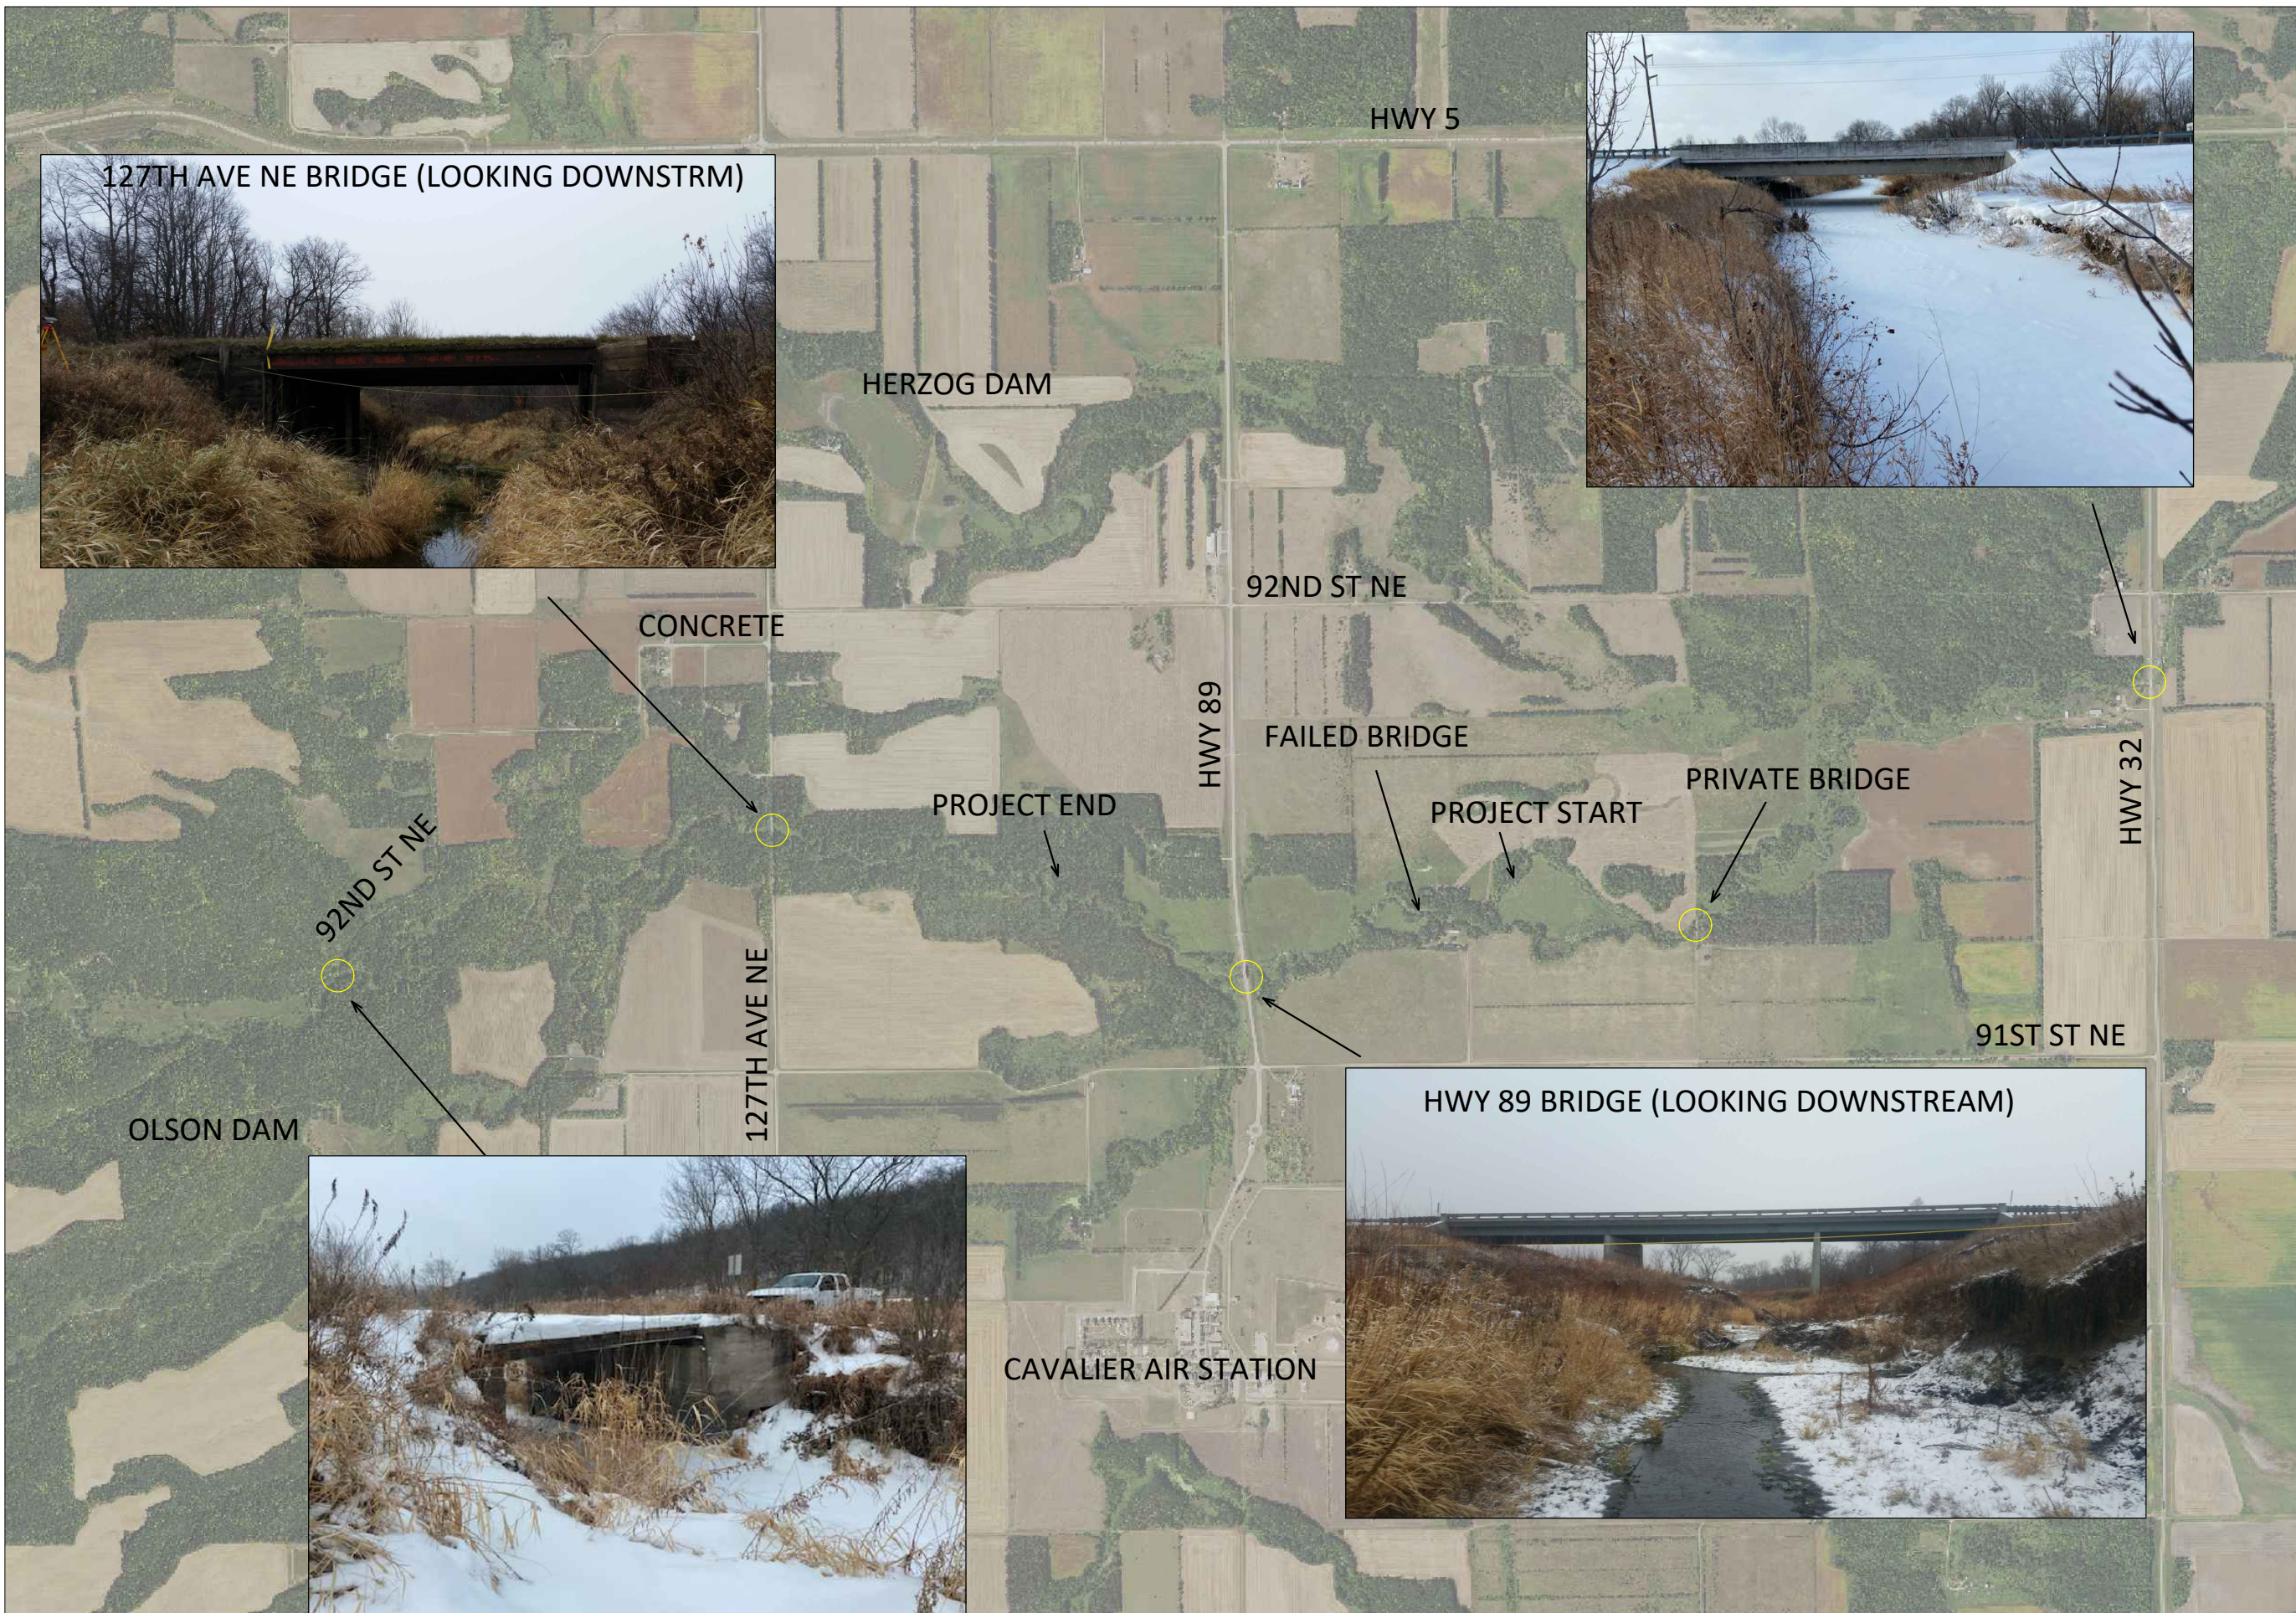
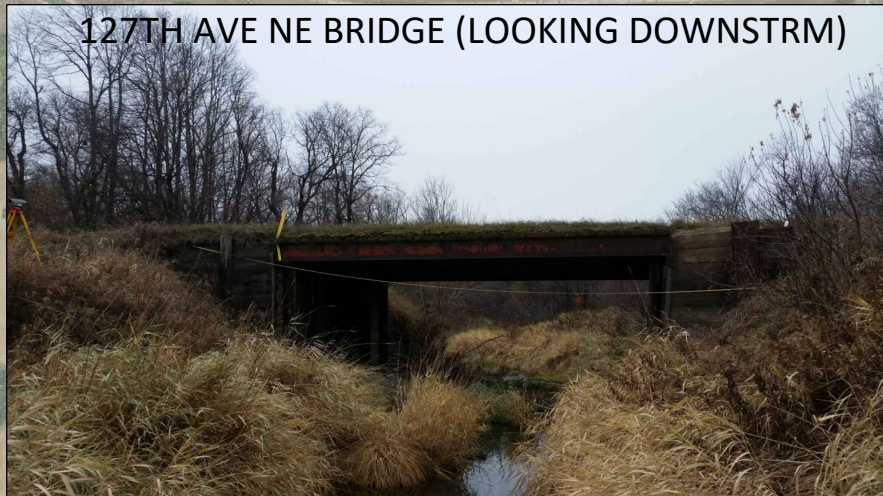
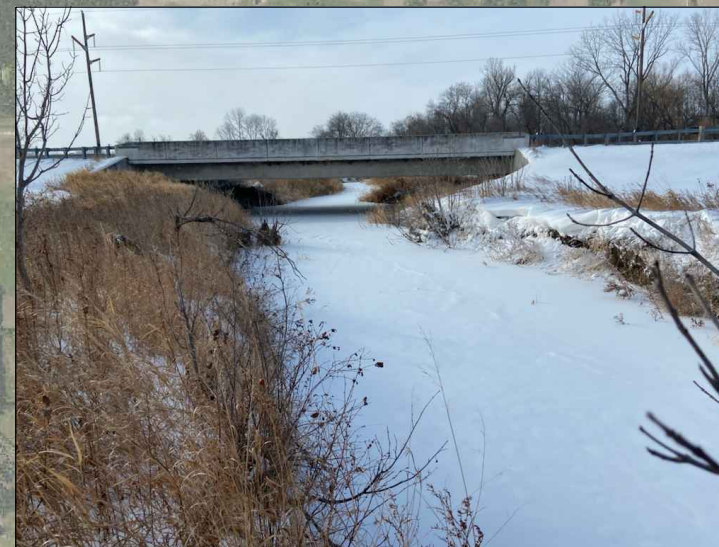
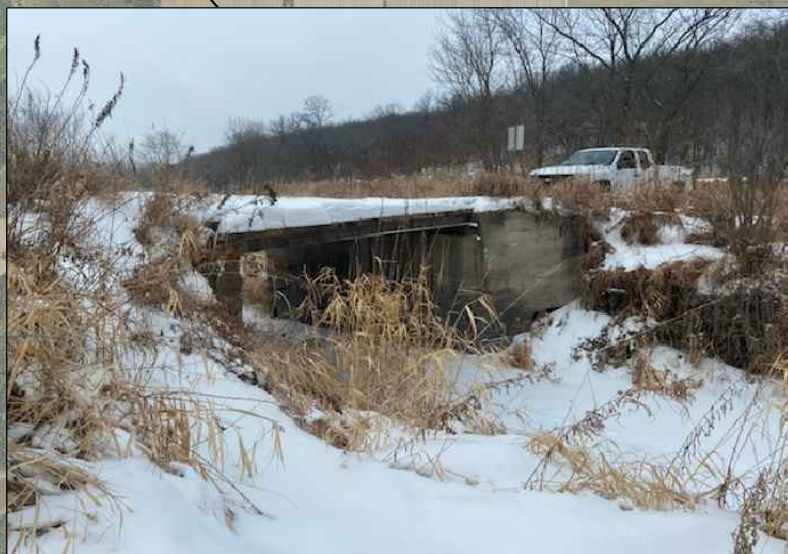
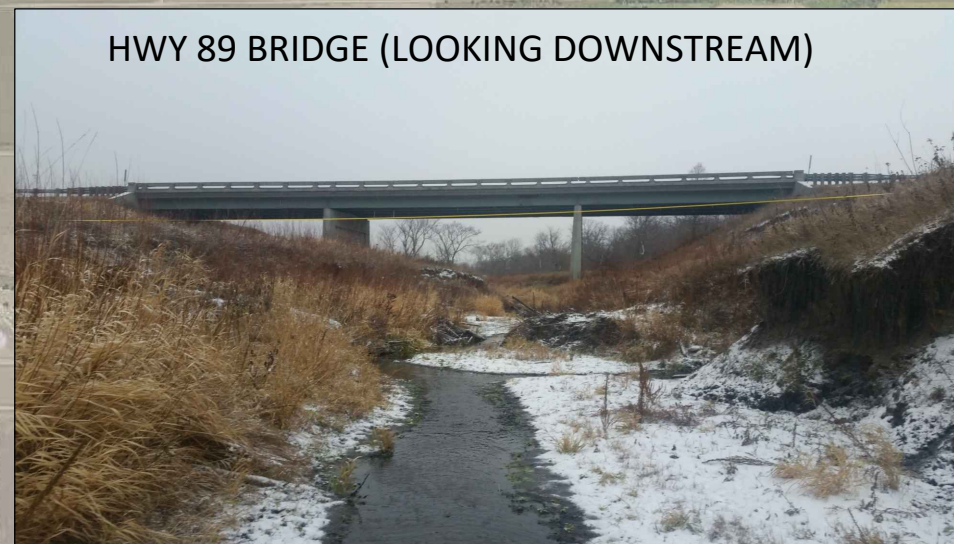
If the channel incision process on the Tongue River is not halted, through implementation of either Alternative 1 or Alternative 2 of the plan, two existing bridges will be impacted. Unlike the existing bridges downstream of the currently incised reach, both are short span bridges due to their location on low daily traffic load township roads. As a result, each would require replacement with longer span bridges and/or specially designed abutments and wingwalls. A private farm road bridge downstream of Hwy 89, failed due to channel incision and widening in approximately 2014 (rough recollection of the owner) and was never rebuilt. Another private farm road bridge in that reach has just long enough span to maintain stability. The Highway 89 bridge construction project was partially funded by the U.S. Air Force, as it is the access to the Cavalier Air Station, hence the reason it is a very long span bridge with significant clear height from the channel. While the footings have been exposed due to the channel incision process, they do not appear to be in danger of undercutting. Highway 32 is a major state highway, therefore that bridge has a relatively long span as well. The two bridge crossings upstream of Hwy 89, however, are short span bridges that would be in jeopardy of failure from incision and related widening. Figure 21 shows the locations of the bridges and includes photos.

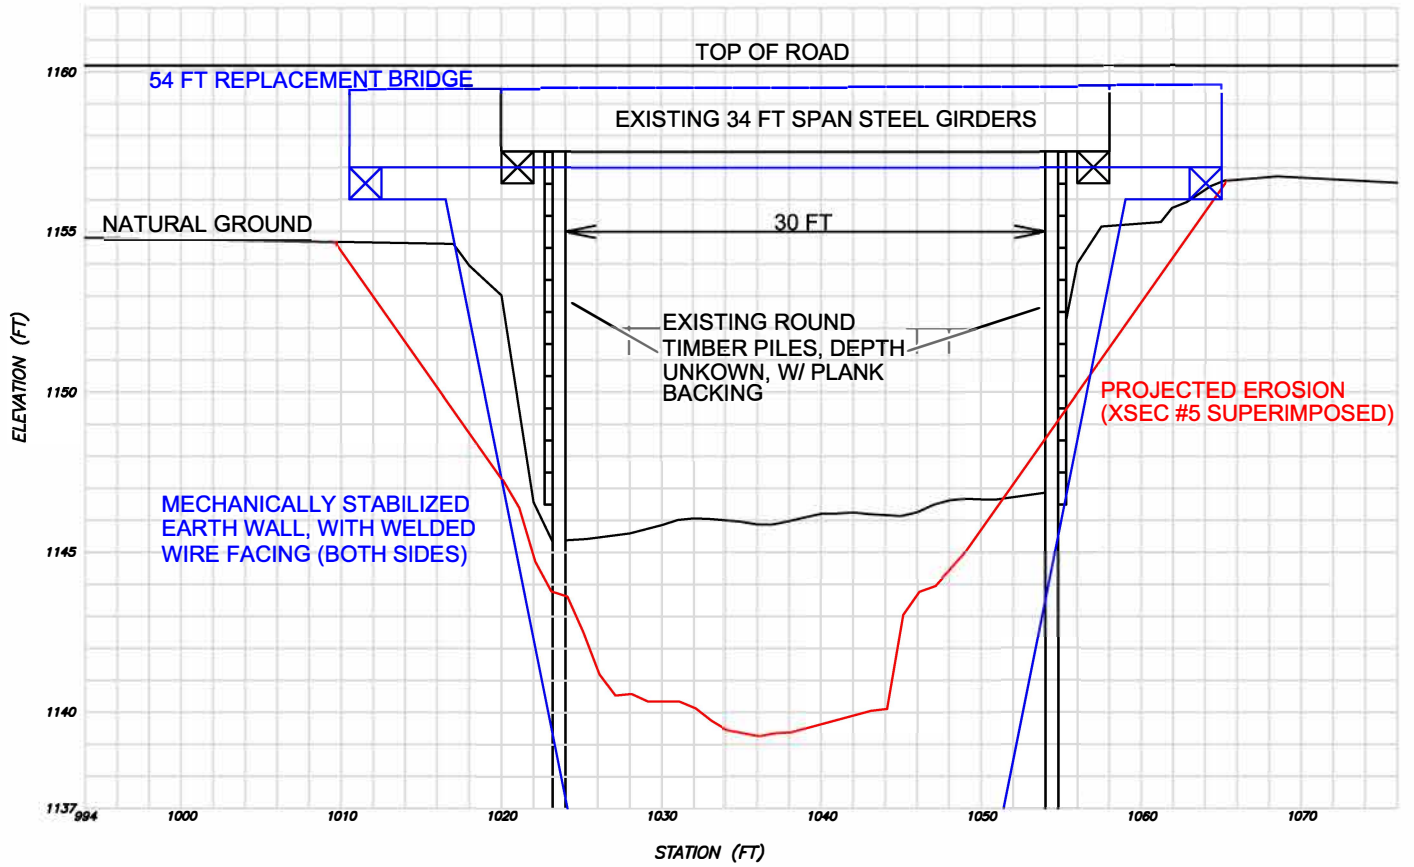
# RIVER / BRIDGE CROSS SECTION @ 127TH AVE NE

The Tongue River crossing on 127<sup>th</sup> Ave NE (County Road 6) is approximately 1 river mile above the end of the proposed river restoration/stabilization project. The existing bridge is a ~34 ft span steel girder bridge, with unknown decking (likely corrugated steel) covered by gravel. The abutments and wingwalls consist of round timber piles with timber plank backing. Original design drawings for the bridge could not be located, but it is in good condition. As described in Appendix D-1, monitoring indicates that this 1-mile reach has already experienced 1-2 feet of incision. Over the course of the next 5-15 years, depending on the occurrence and magnitude of larger peak flow events, the channel would be expected to cut another 6 feet at the bridge. Similar to the downstream channel, it would widen in the process as well. This would have the effect of destabilizing the road fill and undercutting the existing timber abutment and wingwalls. Figure 22 shows the estimated projected profile and typical downstream cross section superimposed over the current channel and bridge section. Redesign of the bridge could be accomplished in a number of ways, however a mechanically stabilized earth wall (example: Hilfiker welded wire retaining wall) , with rock foundation excavated below the anticipated scour depth, would be a rationale choice to reduce the span length required for a new bridge to limit construction costs. An approximate layout for a new 54 ft modular steel bridge is shown on Figure 22, and a construction cost estimate is provided in Table 14.
