# TONGUE RIVER WATERSHED PLAN

## Appendix D-8: Project Benefits Report

**May 6, 2021**

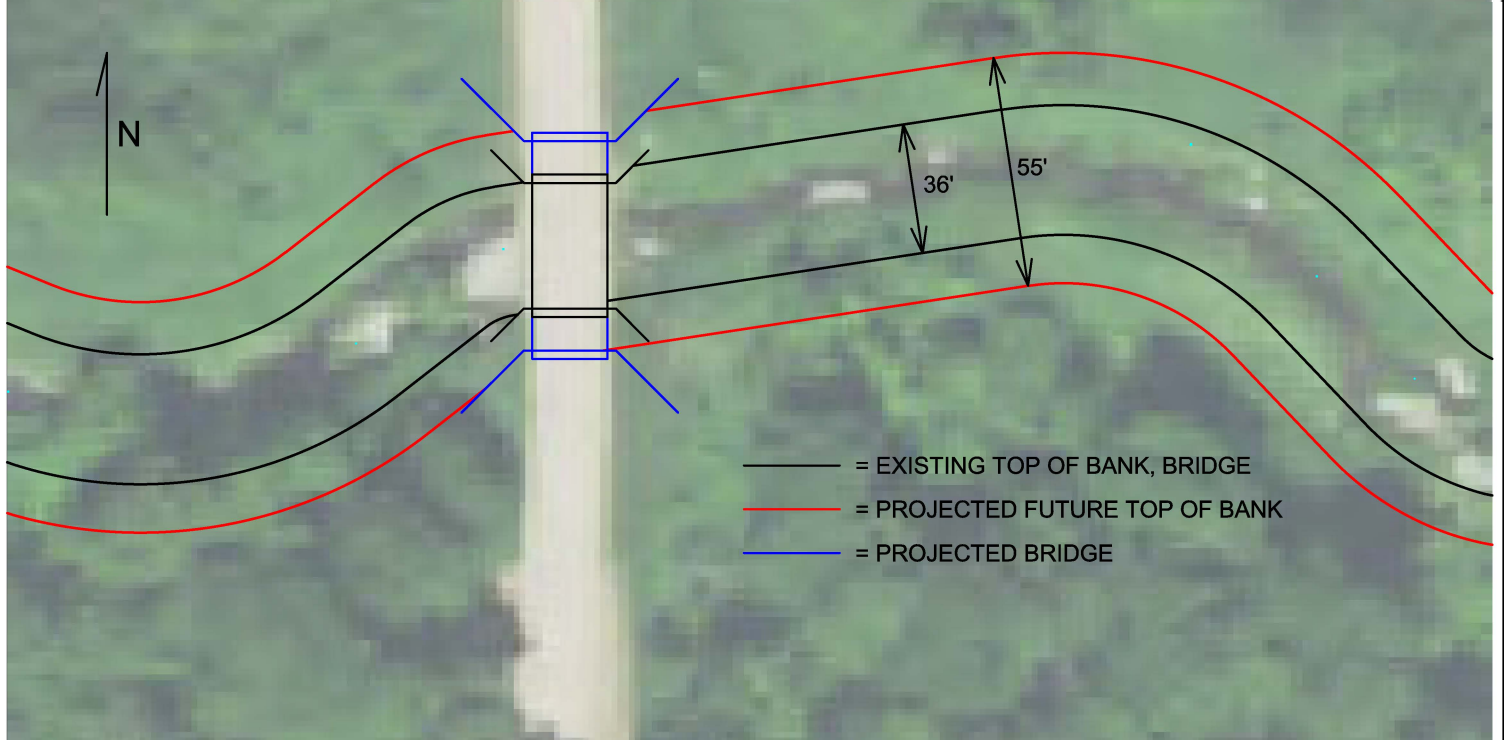
# RIVER / BRIDGE PLAN VIEW @ 127TH AVE NE

The Tongue River crossing on 127<sup>th</sup> Ave NE (County Road 6) is approximately 1 river mile above the end of the proposed river restoration/stabilization project. The existing bridge is a ~34 ft span steel girder bridge, with unknown decking (likely corrugated steel) covered by gravel. The abutments and wingwalls consist of round timber piles with timber plank backing. Original design drawings for the bridge could not be located, but it is in good condition. As described in Appendix D-1, monitoring indicates that this 1-mile reach has already experienced 1-2 feet of incision. Over the course of the next 5-15 years, depending on the occurrence and magnitude of larger peak flow events, the channel would be expected to cut another 6 feet at the bridge. Similar to the downstream channel, it would widen in the process as well. This would have the effect of destabilizing the road fill and undercutting the existing timber abutment and wingwalls. Figure 22 shows the estimated projected profile and typical downstream cross section superimposed over the current channel and bridge section. Redesign of the bridge could be accomplished in a number of ways, however a mechanically stabilized earth wall (example: Hilfiker welded wire retaining wall) , with rock foundation excavated below the anticipated scour depth, would be a rationale choice to reduce the span length required for a new bridge to limit construction costs. An approximate layout for a new 54 ft modular steel bridge is shown on Figure 22, and a construction cost estimate is provided in Table 14.
