**UNITED STATES
DEPARTMENT OF AGRICULTURE
WASHINGTON, D. C.**

Flow of Water in Channels Protected by Vegetative Linings

By W. O. REE, *associate hydraulic engineer*, and V. J. PALMER, *associate agricultural engineer, Division of Drainage and Water Control, Research, Soil Conservation Service.*

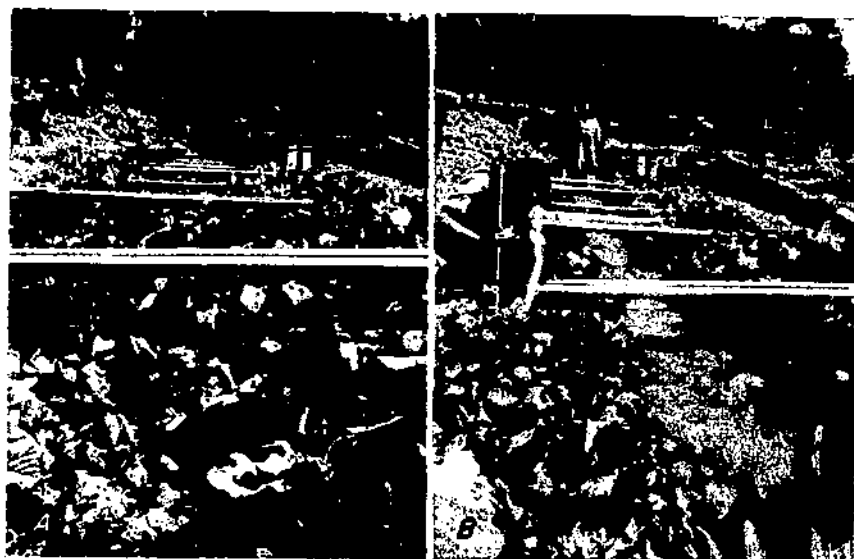
FIGURE 36.—Kudzu channel B2-9 in November 1938, 9 months after the plants were set out: A, Before testing; B, during test 1, experiment 1.

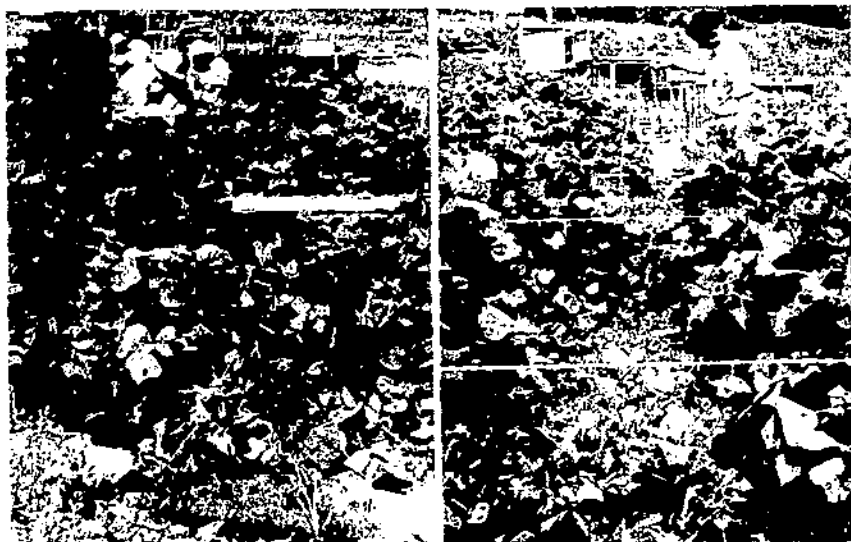
FIGURE 37. Kudzu clump of B2 9-5, August 1939: (A) View during test 1 of experiment 2; (B) view 2 1/2 months after test 2. After surface measurements; (B) clump in a condition of overgrowth, * 2.

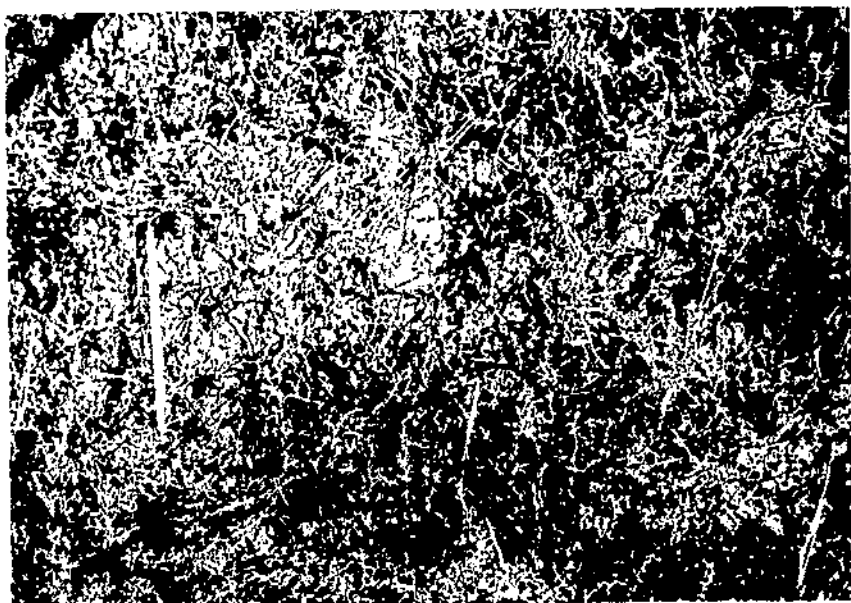
FIGURE 16. Lespedeza channel B2-2 after test 2, November 20, 1937.

There was very little scour during tests 1-3 (fig. 16). During test 4 considerable erosion took place, owing partly to thawing of the ground.

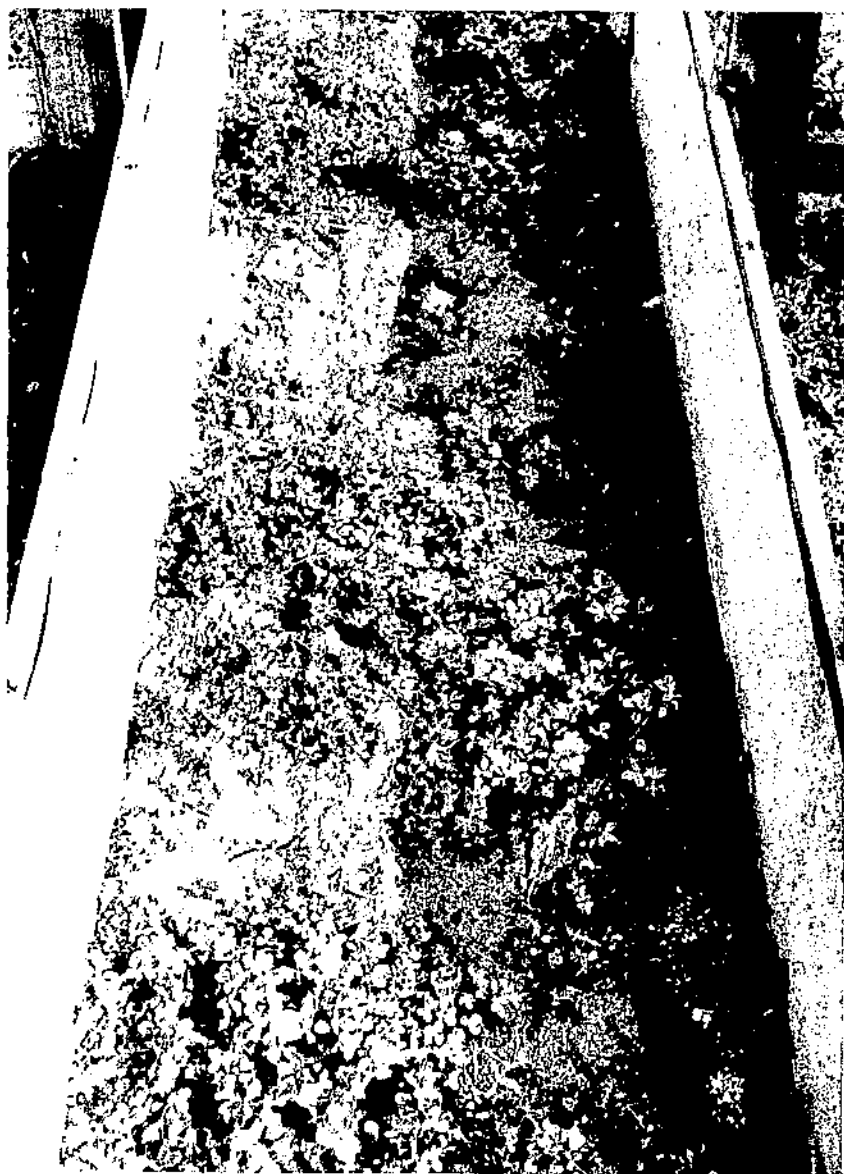
Scoop was considerable, reaching depth of 4 inches in some places, and about 15 percent of the plants were washed out (fig. 48).

FIGURE 18. Lospedeza channel B2-11B after testing.

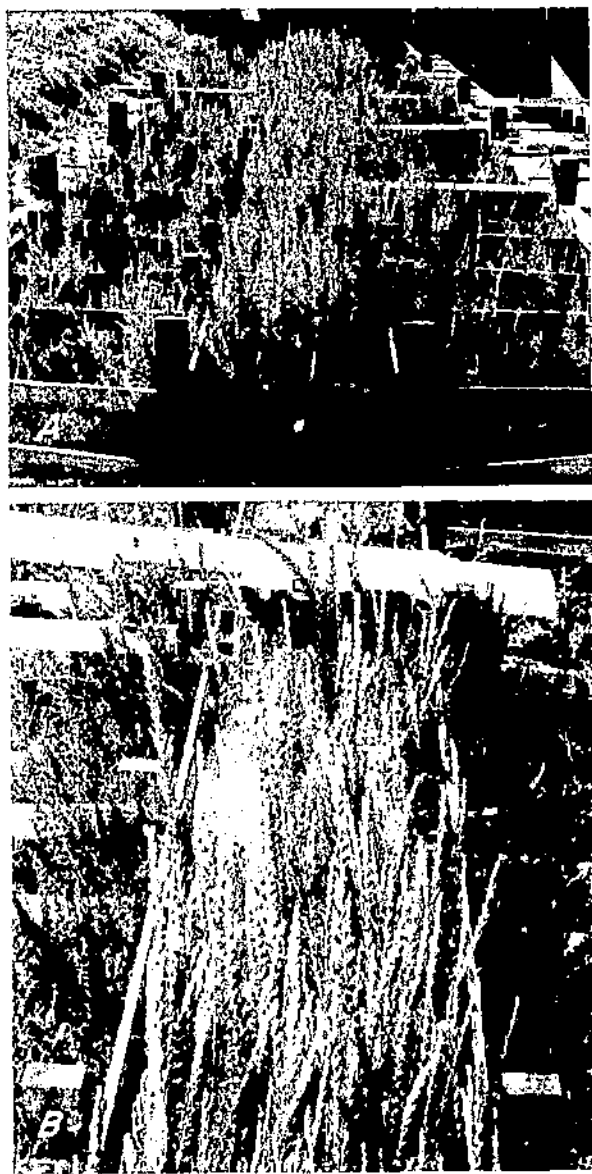
Experiment 1, June 1941, vegetation green and uncut.—Stems, on average, 22 inches long, and not yet woody (fig. 55, A). Density 80 stems per square foot. Sheet-metal side walls had not affected plants, having been erected about 2 weeks before tests. Soil slightly disturbed where walls had been installed.

FIGURE 55. *Sericea lespedeza* channel B2-10B (A) before testing and (B) during test 3.

Stems remained erect during test 1; bent slightly during test 2; bent further, and a third of them became submerged, during test 3 (fig. 55, *B*). All but a few were submerged during test 4, and all were submerged during test 5. Water surface rough. Value of n was lower for test 1 than for test 2 because foliage did not occur in abundance on stems to height of about 0.15 foot above ground line. At completion of tests, value of n was still decreasing rapidly as depth and velocity of flow increased.

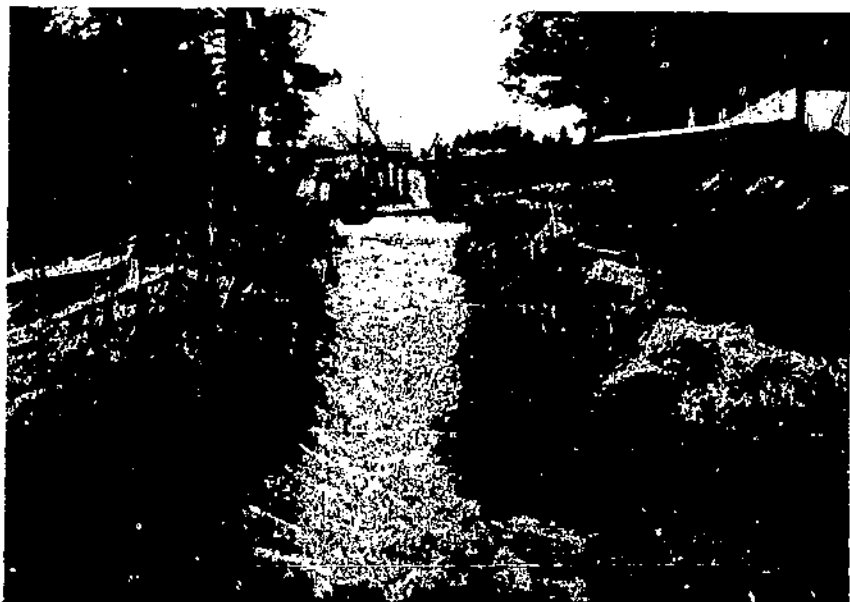
FIGURE 61.—Sudan grass channel B2-3.

Vegetation was submerged during all tests. Water surface rough (fig. 61).

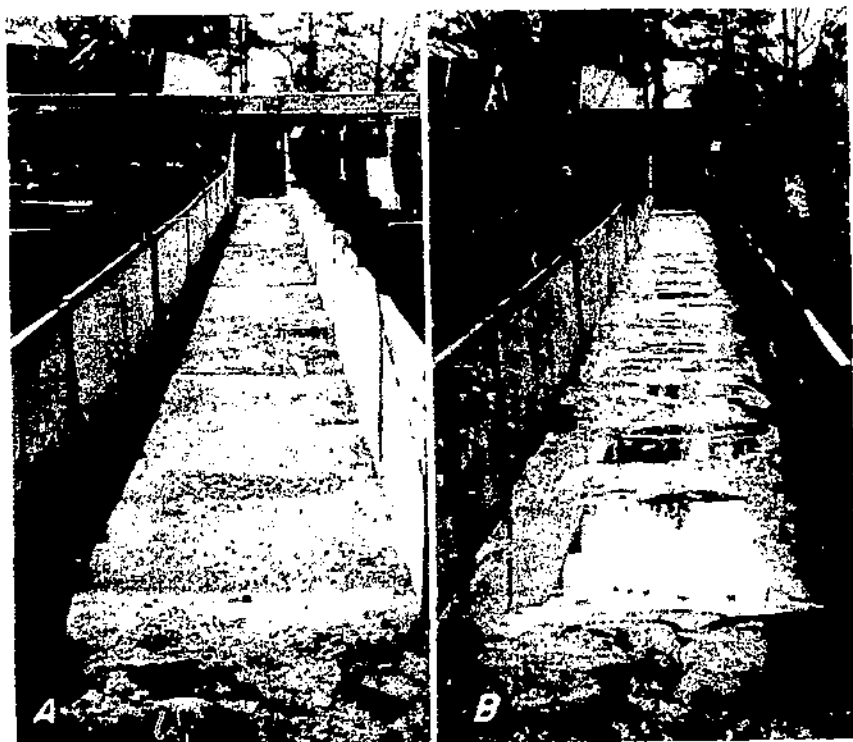
FIGURE 68.—Bare channel B2-13C (A) before testing and (B) after only 8 minutes of test 1.
