# Technical Soil Services

### **Hammonton, New Jersey, Major Land Resource Area (MLRA) Soil Survey Office (SSO)**

## **SPSD Staff Evaluate Potential Coastal Bay Island Restoration Sites**

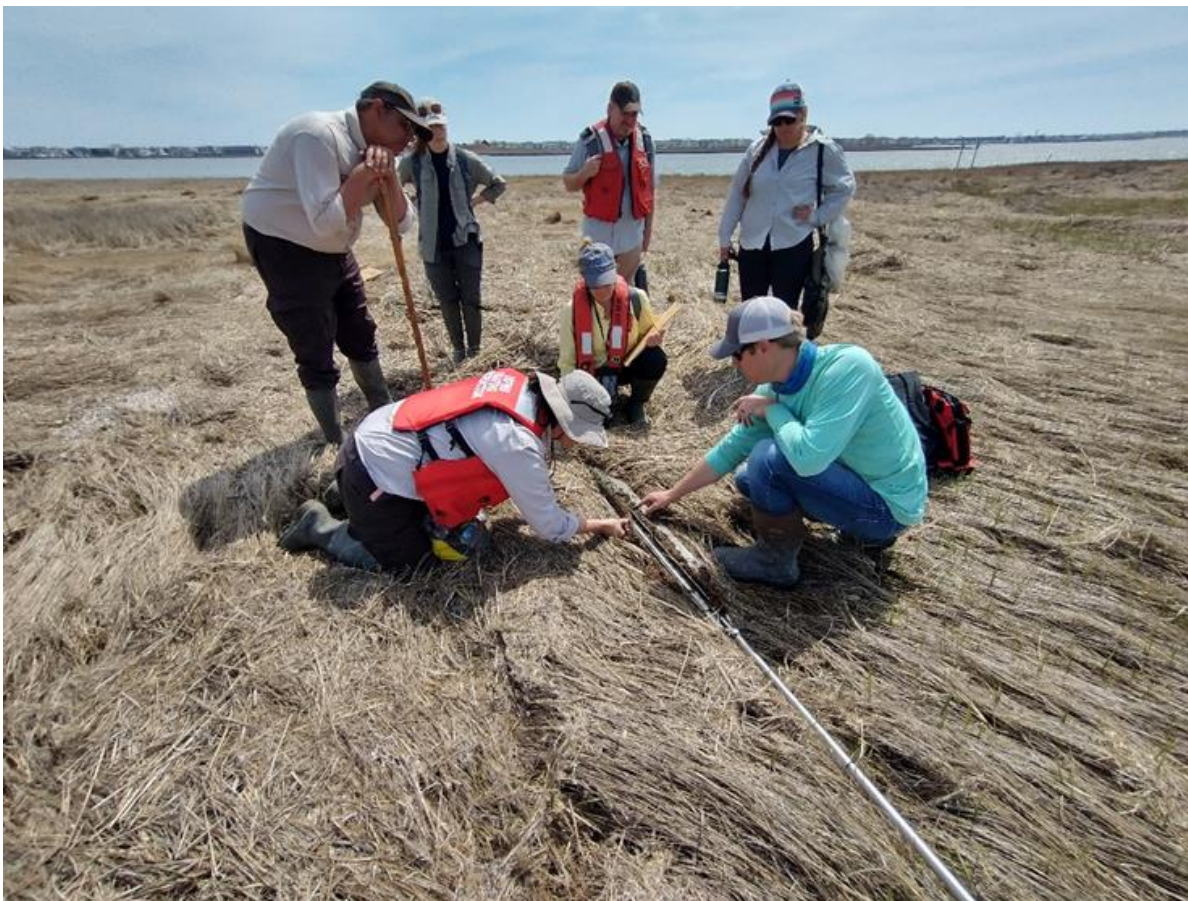
*Figure 1. SSO Leader, David Steinmann (right), describes and explains the soil profile from a Macauley auger to the project team. The soil is a Pawcatuck series, a Terric Sulphemists. (Photo courtesy of Bill Shadel, The Nature Conservancy.)*

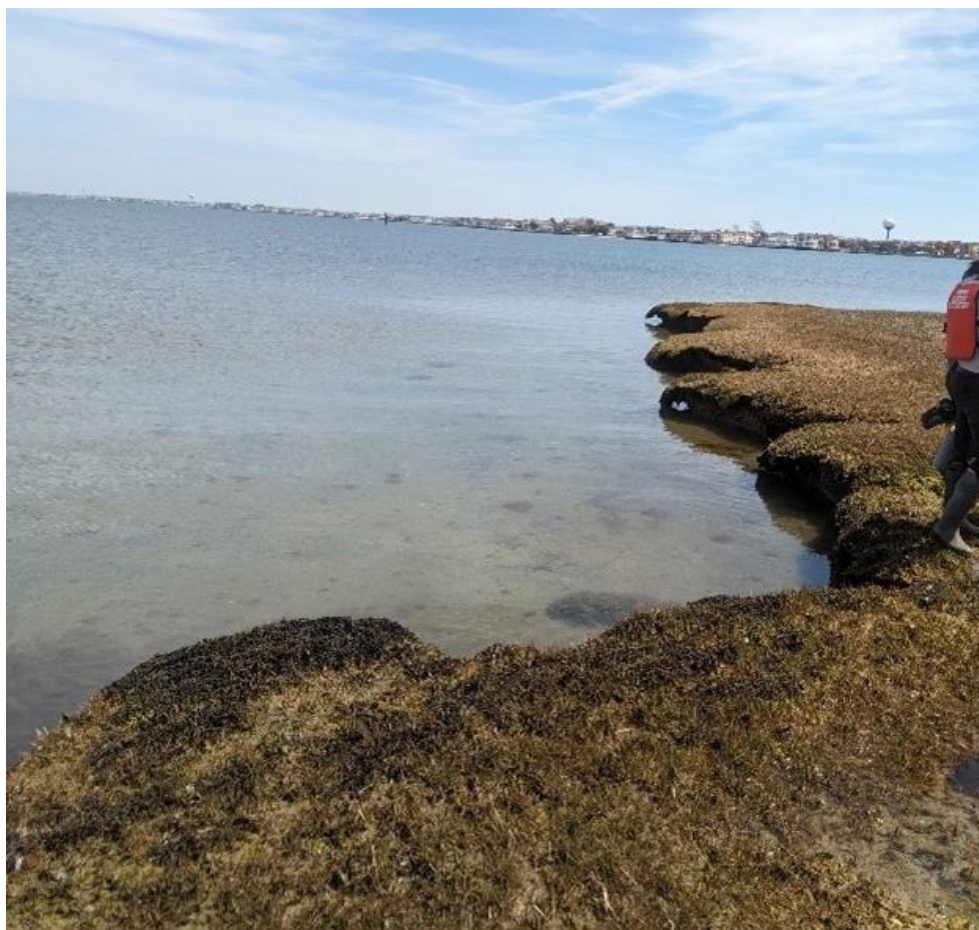
The project team first conducted a preliminary evaluation at West Marshelder Island in Spray Beach to formulate project ideas. This island developed on a flood tidal delta flat landform; a subaqueous landform associated with an inlet that deposits marine sands during each incoming tide. As sand continues to deposit and elevation builds, this subaqueous landform becomes a subaerial tidal marsh island landform that is associated with the [Pawcatuck](#), [Purnell](#), or [Boxiron](#) soil series. The island exhibited large areas of high marsh vegetation, and the soils, described by SSO staff as the Pawcatuck and Boxiron soil series during the site visit, showed stratified layers of organic soil material and sand, new deposition. The project team agreed the accretion of new soil material on the surface and elevation of the island were acceptable and above sea level rise attributes for the area. The island, however, receives a significant amount of wave erosion on the northern and western sides, due to northwestern winds and long fetch across the Barnegat Bay. The project team agreed the significant erosion in this area was an issue to combat at this specific island.

*Figure 2. The eroded northern bank of West Marshelder Island. The marsh island edge is actively being undermined by water action, leaving the organic surface to fall into the bay. Eventually this organic surface will break off and wash into the bay. (Photo courtesy of Danielle McCulloch, USFWS.)*

Based on the preliminary site visits, the project team concluded that each island would undergo a different type of restoration project. Two potential restoration practices discussed include beneficial use of dredge materials and erosion or shoreline protection with living shorelines using oyster reefs to stabilize the eroded edges.

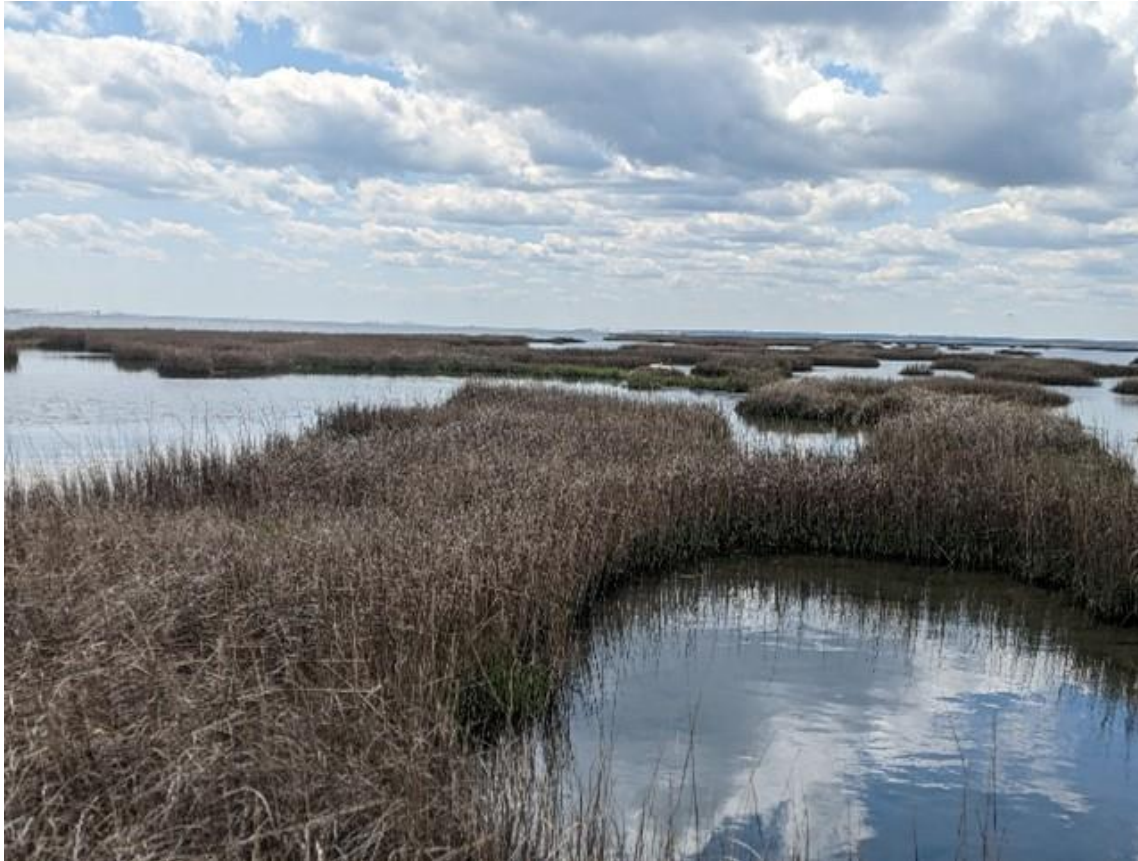
High Bar A, B, and C Islands in the Barnegat Light section of the bay were the next stop. These islands developed on top of a flood tidal delta subaqueous landform but are located much closer to the active Barnegat Inlet. Multiple soil descriptions indicated the soils on this island were dominantly Purnell soils. Initial vegetation observations attributed to low marsh and large areas of marsh are drowning with pools and ponds scattered across the island. The project team attributed the cutoff of sediment source, new deposition, and higher tidal fluxes to the modifications to the inlet and bay in the 1950s, resulting in this drowning marsh. Due to these factors, the project team discussed the beneficial use of dredge material for thin layer deposition to raise the surface elevation of the marsh as one of the few actions to take on this island.

*Figure 3. A photo of a drowning marsh on High University Coastal Research Center Bar Islands A, B, and C. (Photo courtesy of Kim McKenna, Stockton University Coastal Research Center.)*

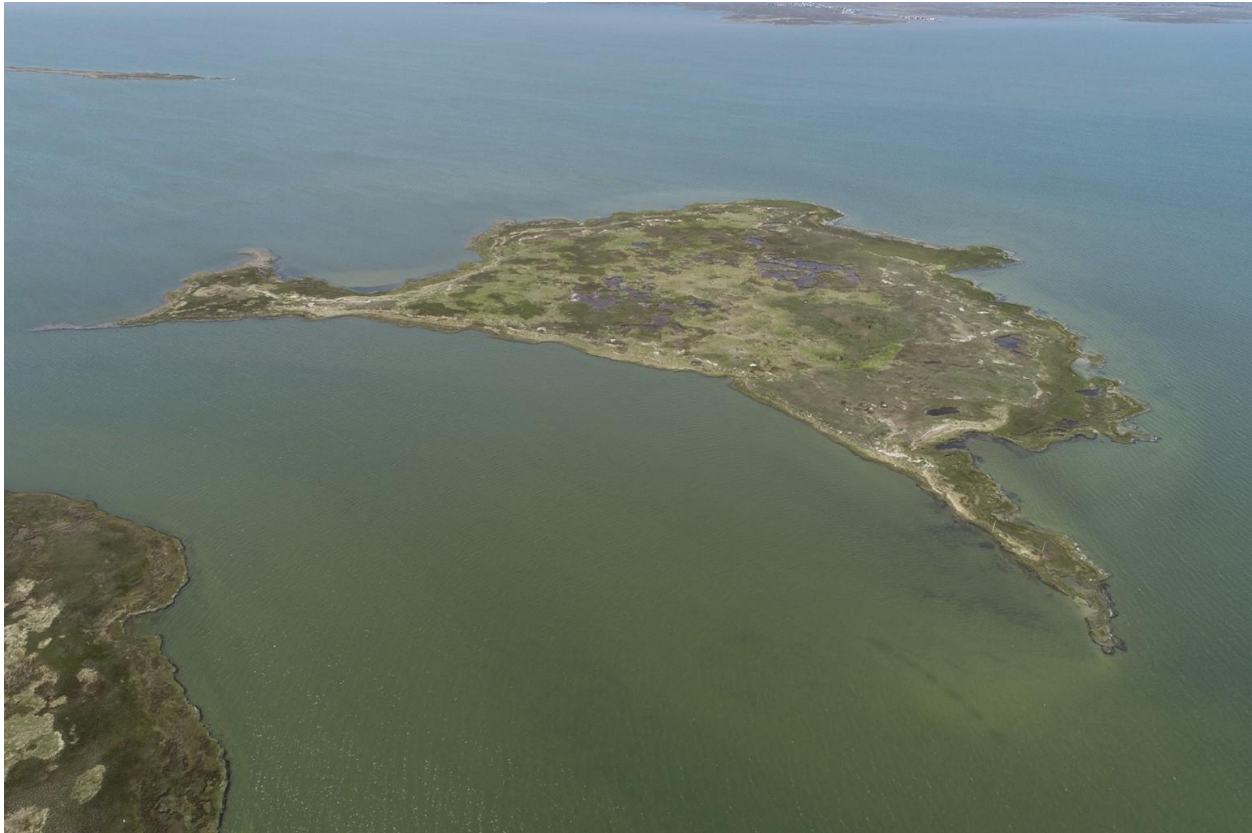
*Figure 4. Drone shot of West Marshelder Island looking west across Barnegat Bay. The top and right side of the island is the most erosive with long wind fetch across the open bay. (Photo courtesy of Bill Shadel, The Nature Conservancy.)*
