Preliminary Geotechnical Evaluation Report

Cart Creek Impoundment, Site 1
NE Quadrant of 86th Street NE & 131st Avenue NE
Mountain, North Dakota

Houston Engineering, Inc.

Project B1904637

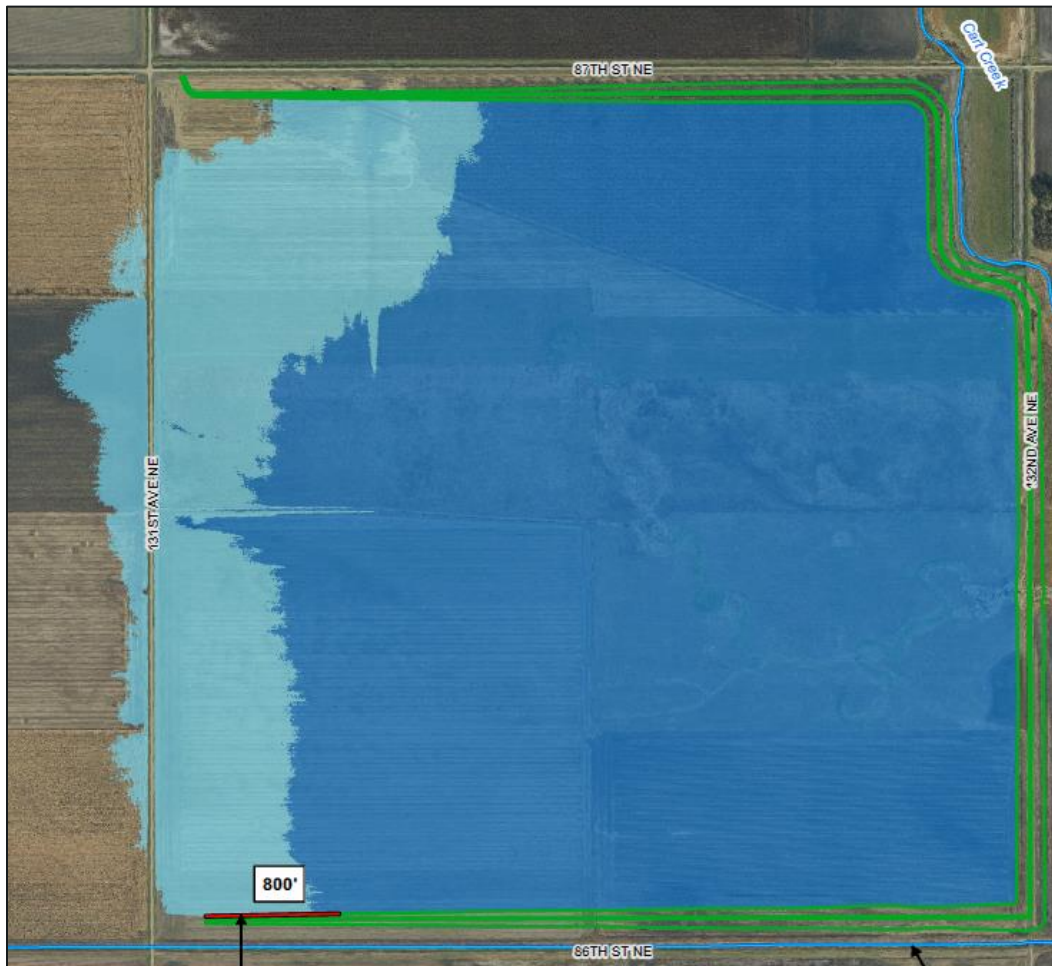
Figure 1. Site Layout

The project will include constructing about 3 miles of dam that would retain water as it flows down the existing grade in the field toward Cart Creek. The top of the impoundment dam is currently planned to be at elevation 983.2. The embankment height gradually increases from none to about 15 feet as the existing grades lower from the west to the east. The preliminary cross section for the dam is a 10 foot wide top with 4H:1V (Horizontal:Vertical) side slopes. The preliminary design also contains a clay core with 1.5H:1V clay core. Soil within the pool area is anticipated to be used for the embankment construction. The project location and site layout are shown in Figure 1.

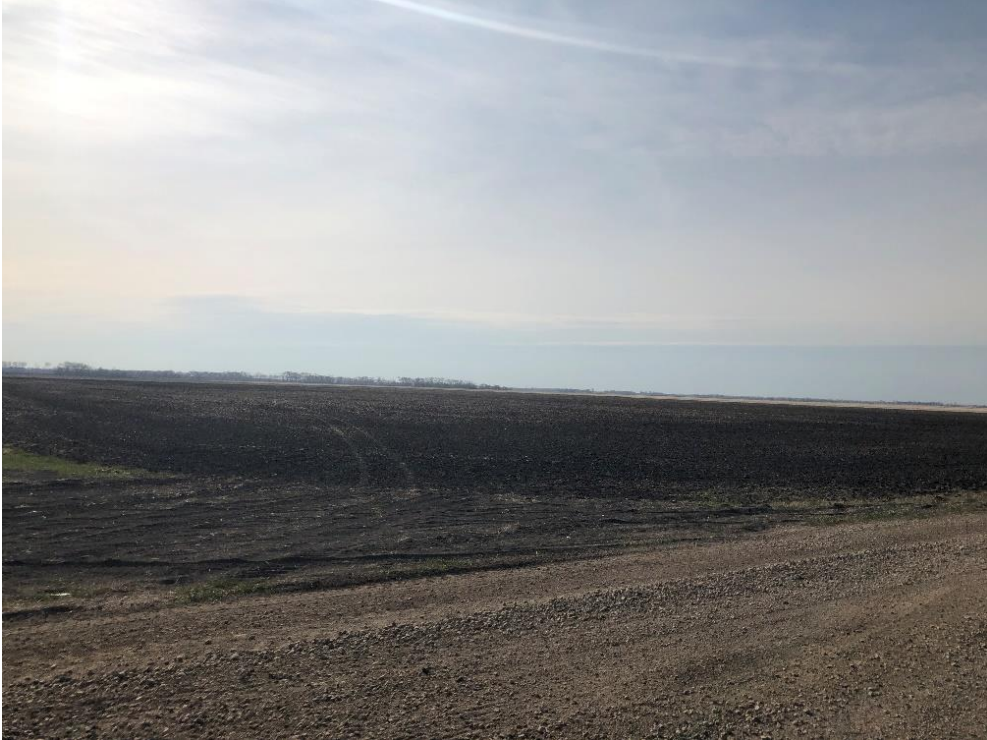
Photograph 1. Northwest corner of the impoundment area.

We performed a site reconnaissance on May 8, 2019. During our reconnaissance, we observed the general area and took notes and photographs documenting the general condition of the topography, vegetation, visible geologic hazards and surficial drainage conditions. Based on our observation, the area is generally flat and appears to have been used as farm fields with some portions being plowed and seeded and other portions appear to be fallow for the year. A drainage channel runs from the west to the east near the center of the area. The field along the north side of the site has drain tile installed below it that collects into an outflow channel on the east side. The roadways on the perimeter are generally about 2 to 4 feet above the field grade. We did not observe surficial erosion, natural streams other than Cart Creek, springs or mining in the immediate vicinity of the site. Some of our observations are illustrated by the following photographs.

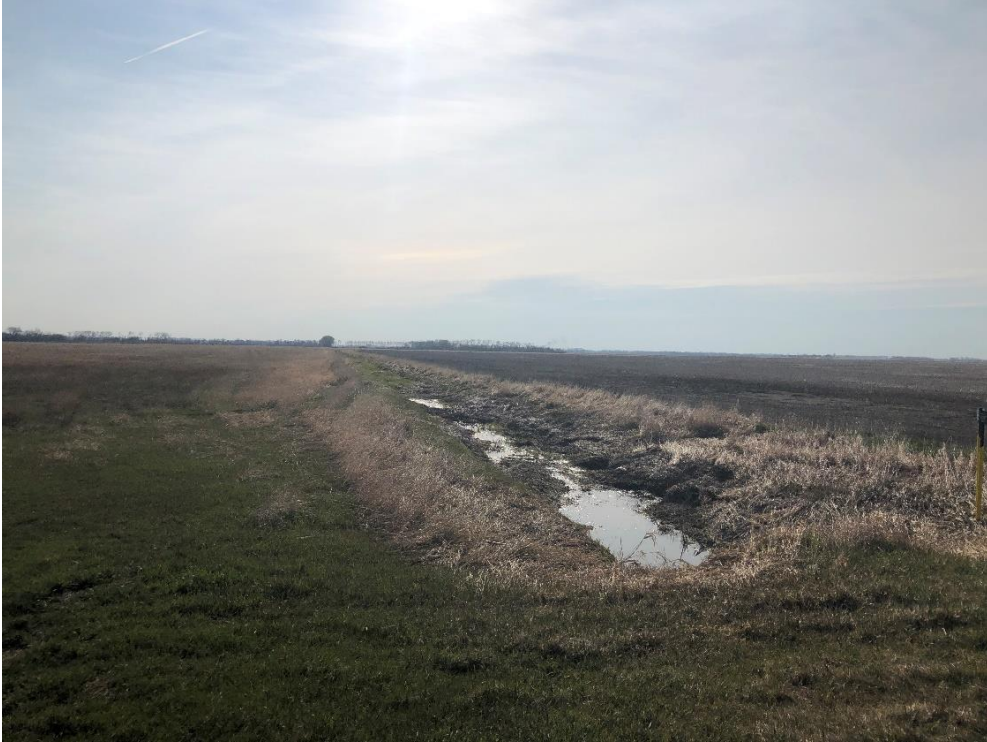
Photograph 2. Drainage channel looking east from west side.

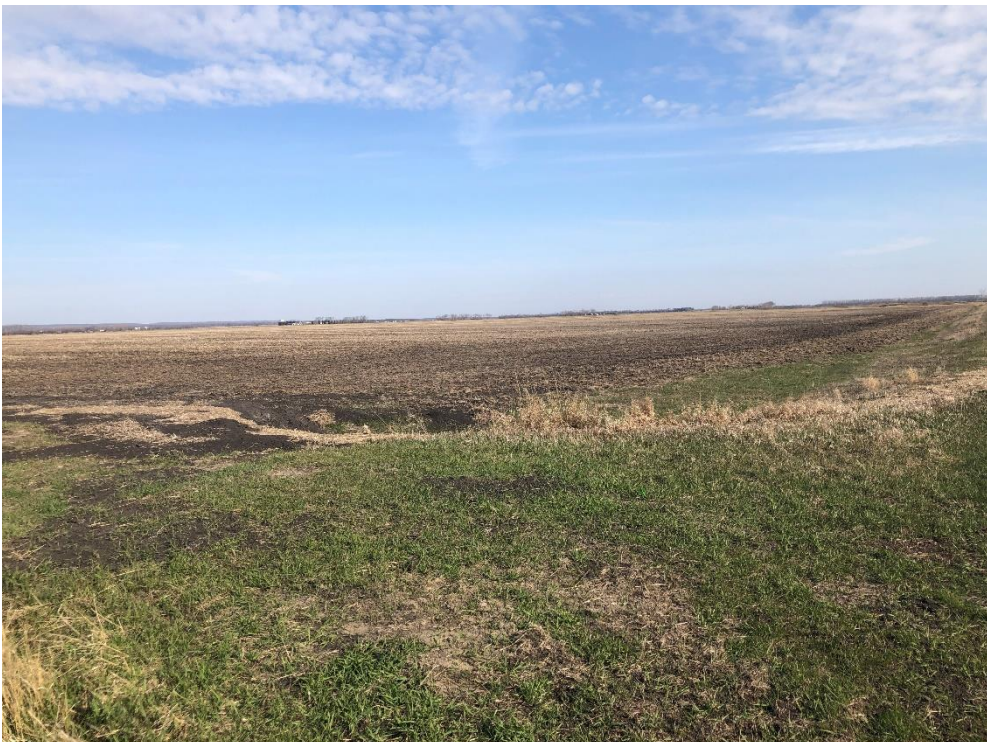
Photograph 3. Southeast corner of the impoundment area.

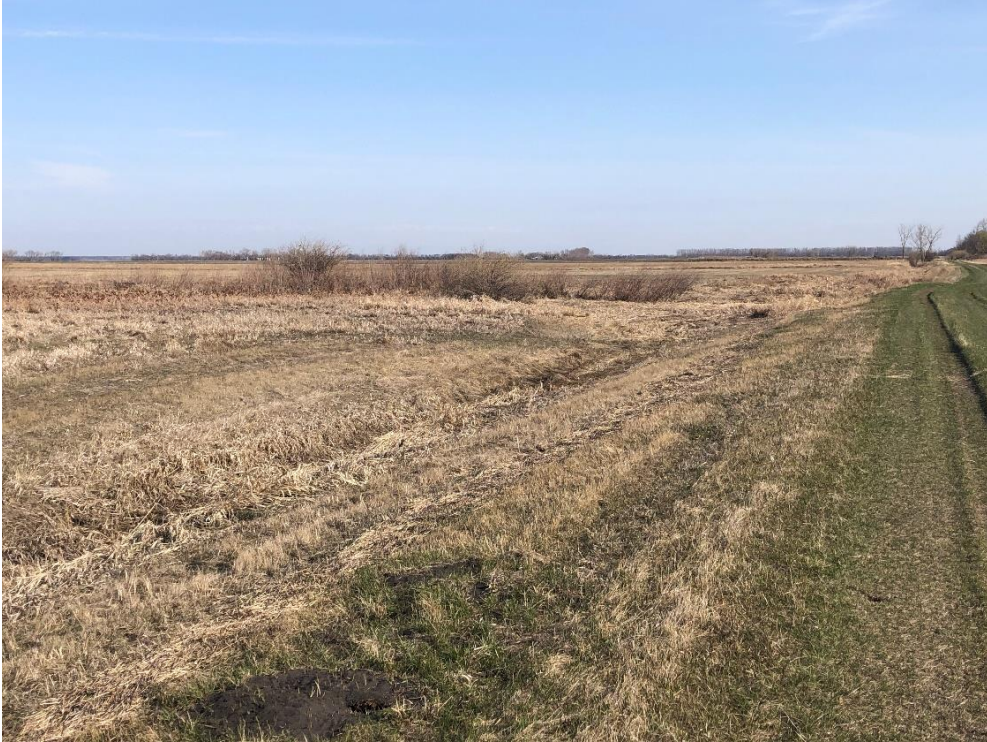
Photograph 4. Looking north at east end of drainage channel.

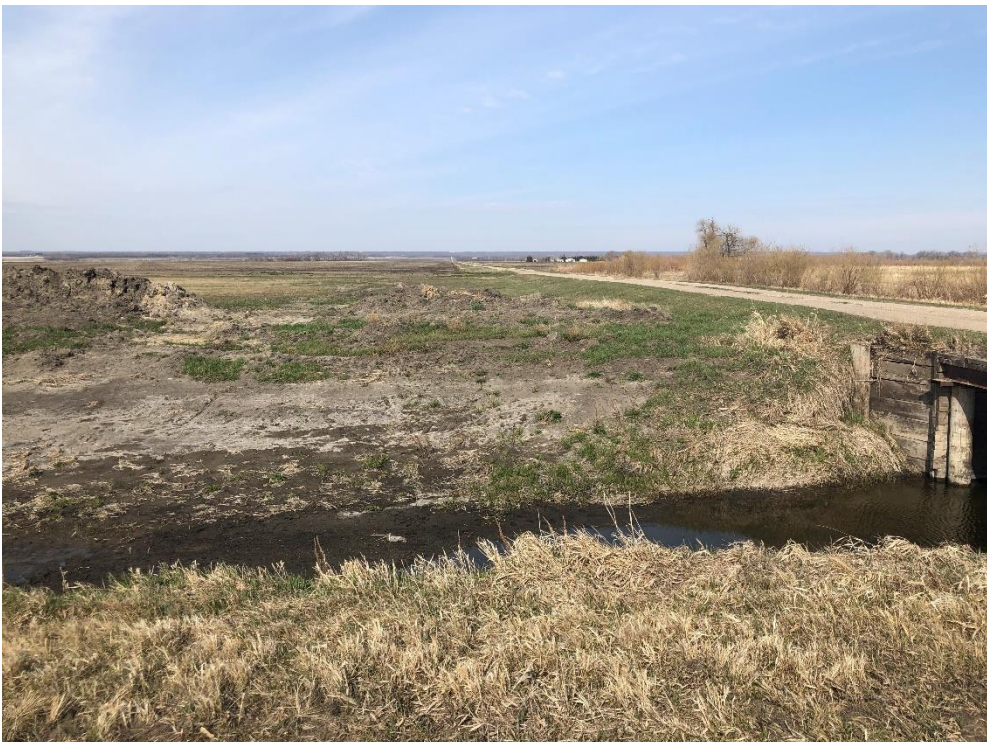
Photograph 5. Looking north over Cart Creek at the northeast corner of the impoundment area.
