SOIL AND PLANT SCIENCE DIVISION

Technical Soil Services

Soil and Plant Science Division (SPSD) Assists Lake Mattamuskeet National Wildlife Refuge (NWR) in Understanding Tundra Swan Mortalities in Hyde County, North Carolina

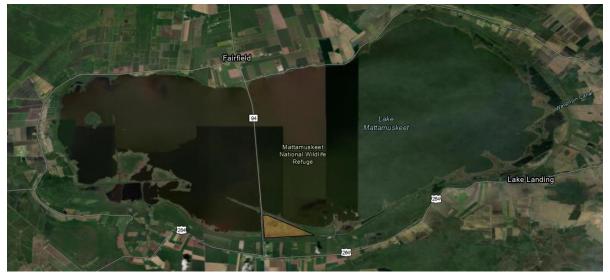
Figure 2.—An Earthstar Geographics Image of Lake Mattamuskeet NWR and the Impoundment of interest in the south side of lake.

In the fall of 2024, the Lake Mattamuskeet NWR contacted the Special Projects Region to request assistance in understanding potential causes for a swan mortality event that occurred at the refuge (Figure 2). Autopsies had shown swan fatalities due to lead toxicosis, a lethal ingestion of lead. The impoundment where the event occurred was historically used for waterfowl hunting as early as 1934, when it was acquired by the federal government. Lead shot was used by waterfowl hunters before the ammunition

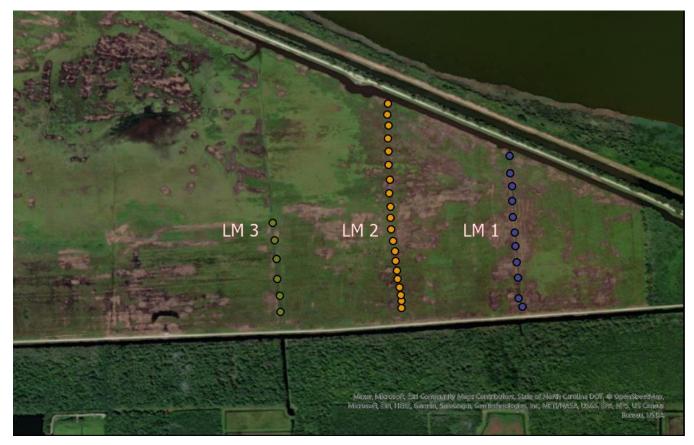
Figure 3.—An Earthstar Geographics image of the transects samples. LM 1 and LM 3 were recently cleaned ditches and LM 2 is a control where no ditching occurred.

The NWR selected three transects in the waterfowl impoundment where the mortality event occurred. Two transects in which the ditches were recently cleaned and potentially exposed relict lead shot, and one that was not ditched to be the control. Samples were collected at 40 spots along the first transect, 20 on the second (the control), and 24 along the third transect (Figure 3). Subsamples were taken at a depth of 0 to 15 centimeters and another from 15 to 30 cm. These depths were chosen because most waterfowl forage only to a depth of 15 cm, while swans are capable of foraging to a depth of 15 to 30 cm.

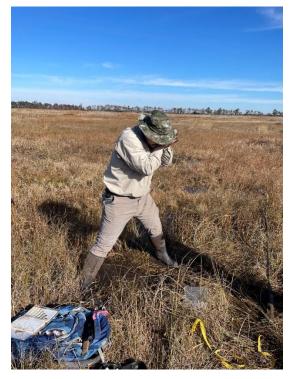
Image 1.—Braden Fleming listens for a reaction to 30% hydrogen peroxide to indicate the presence of reduced sulfides during a confirmation description.

While on site, SPSD soil scientists also performed two confirmation pedons to see if a terrestrial update may need to be added to the Lake Mattamuskeet CZSS, but both pedons correlated to the mapped series of Engelhard (Coarse-silty, mixed, semiactive, nonacid thermic Humaqueptic Fluvaquents) (Image 1; Image 2).

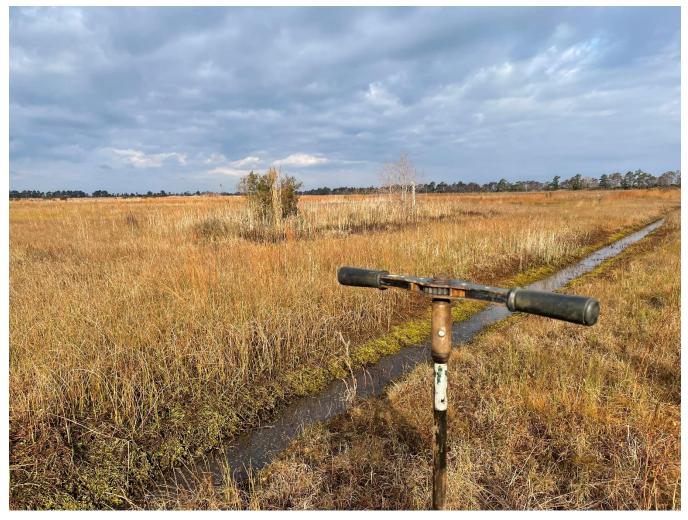
Image 2.—A landscape view of the impoundment and one of the recently cleaned ditches being sampled.
