Project 22138

**RE:** Brush Creek Site 12 Dam Rehabilitation Planning – Second Public Meeting Notes

# Brush Creek Site 12 Plan-Environmental Document

## Second Public Meeting

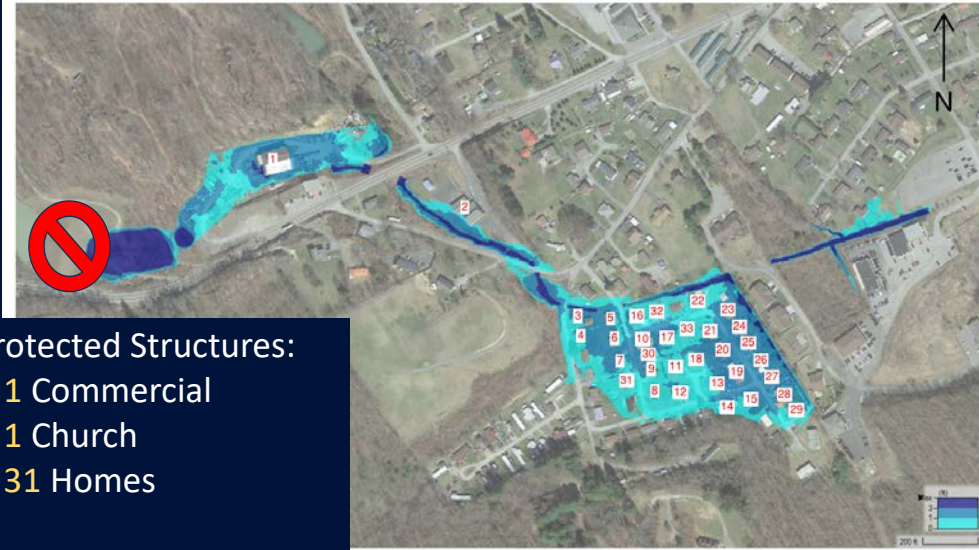
## Benefit – No Dam 100-year Flood

Inundation Limits and Depths for 100-year Event

### Protected Structures:

- 1 Commercial
- 1 Church
- 31 Homes

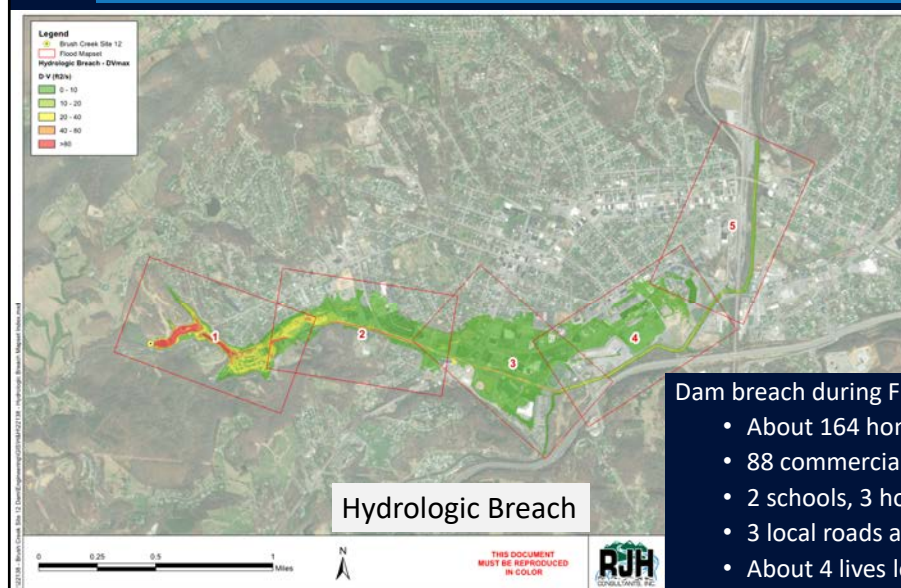
## Dam Breach Inundation

### Dam breach during FBH would impact:

- About 164 homes and 724 people
- 88 commercial buildings
- 2 schools, 3 hospitals, 3 sports facilities
- 3 local roads and minor highways
- About 4 lives lost

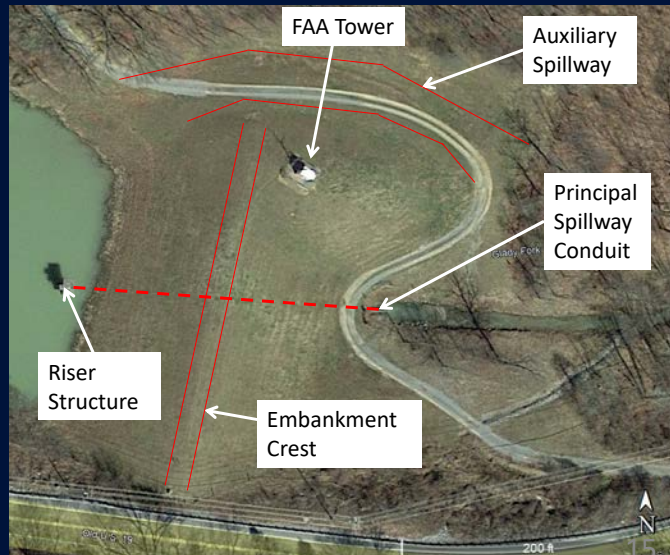
## Dam Components

### Embankment

- Inadequate Seepage Protection

### Auxiliary spillway

- Predicted to erode during ASH
- Predicted to breach during FBH

### Principal Spillway

- Inadequate Seepage Protection
- Inadequate Structural Capacity

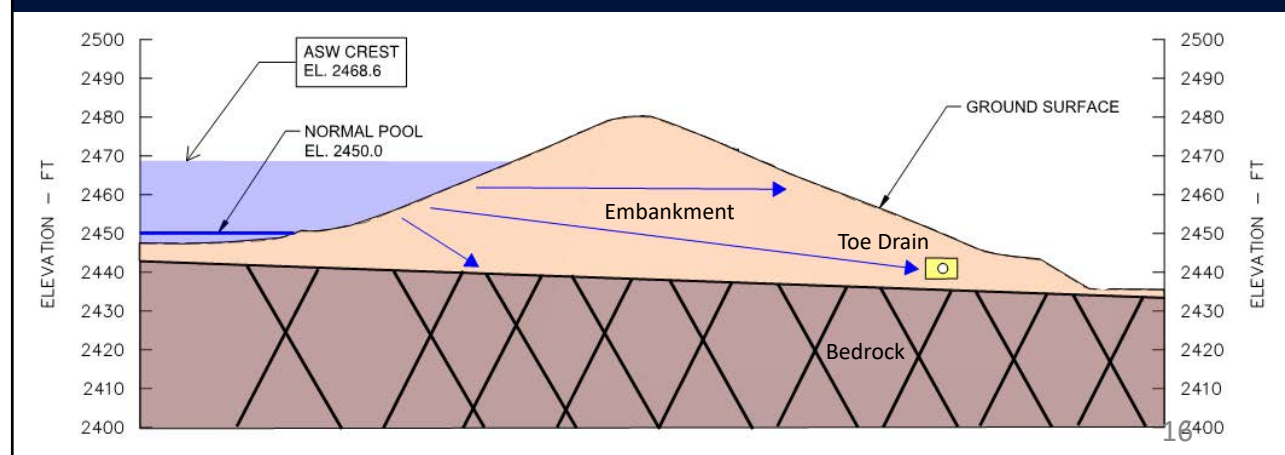
## Primary Dam Safety Deficiencies

### Embankment: Inadequate Seepage Protection

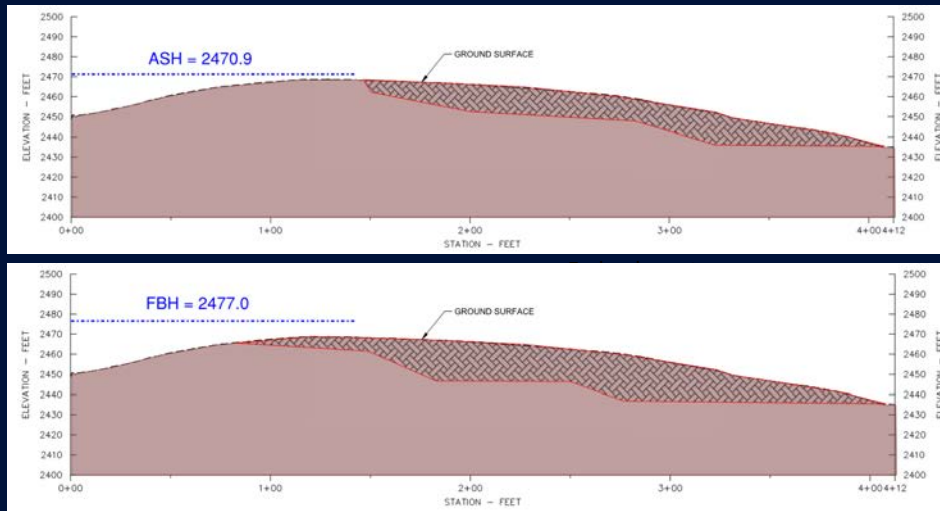
# Primary Dam Safety Deficiencies

## Auxiliary Spillway: Erosion during ASH and breach during FBH

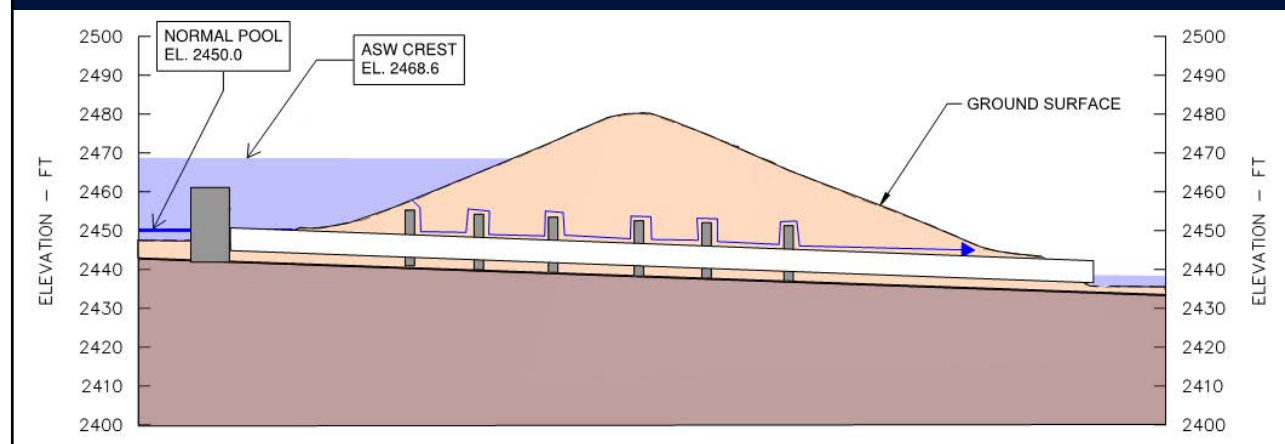
# Primary Dam Safety Deficiencies

## Principal Spillway:

Inadequate Seepage Protection, Inadequate Structural Capacity, Downstream Submergence

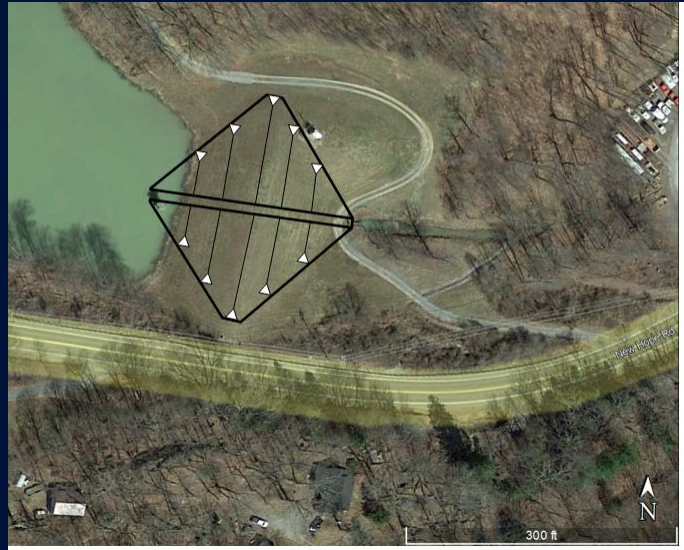
## Alternative 2 (Decommissioning)

- Breach dam and stockpile material onsite
- Demolish principal spillway and dispose of offsite
- Reclaim reservoir area to stabilize sediment
- Purchase downstream properties and demolish structures in 100-yr or 500-yr inundation area

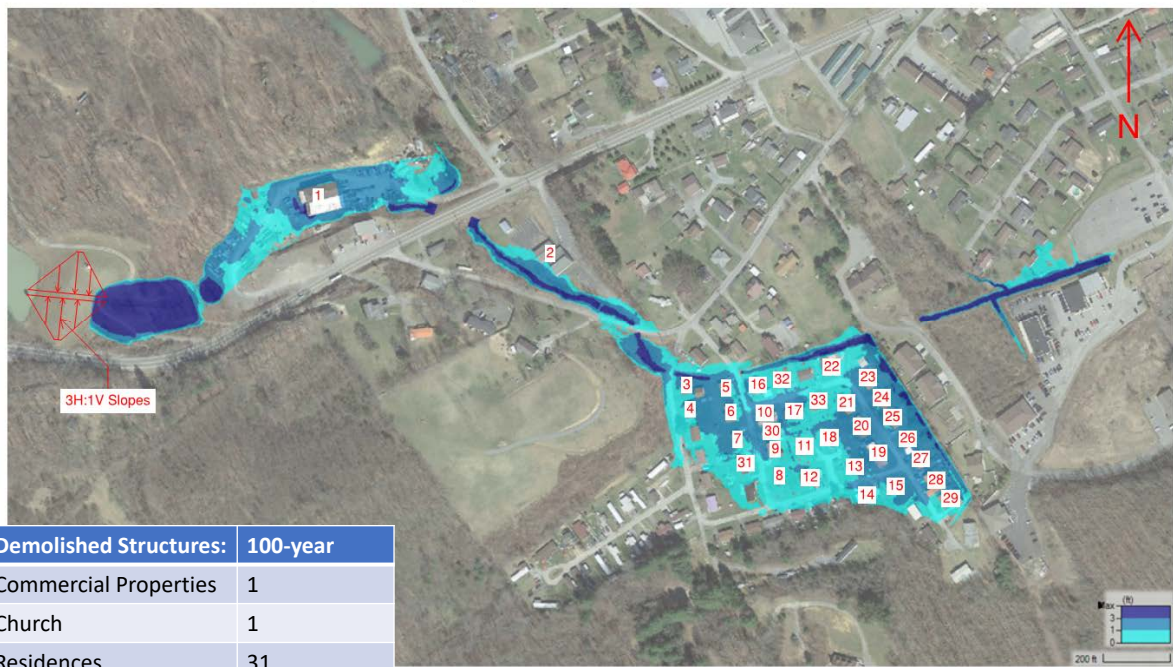
Inundation Limits and Depths for 100-year Event

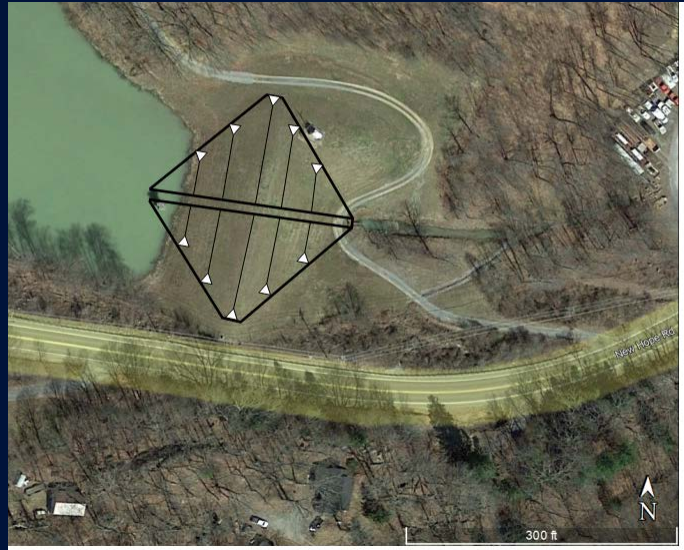
## Alternative 3 (Nonstructural)

- Breach dam and stockpile material onsite
- Demolish principal spillway and dispose of offsite
- Reclaim reservoir area to stabilize sediment
- Construct downstream improvements to flood proof structures for 100-year or 500-year event

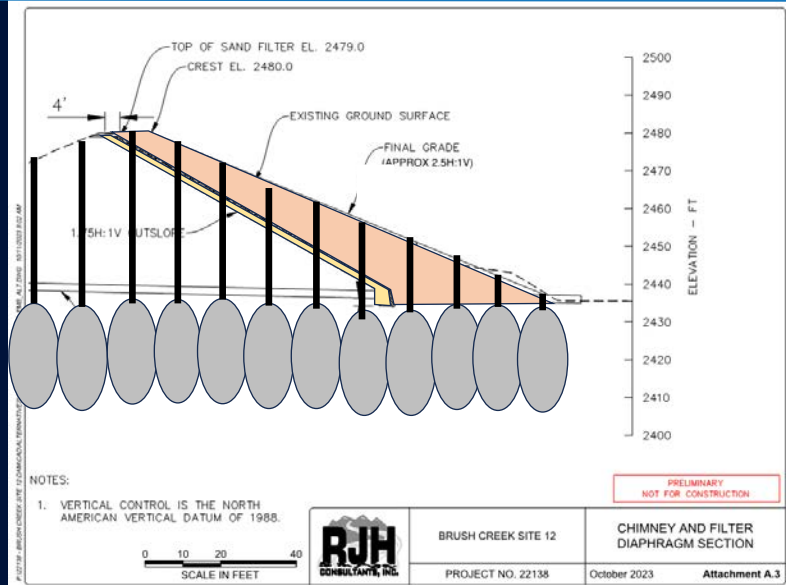
## Mitigate Embankment Seepage Deficiencies: Foundation Grouting and New Filter

- **Options Considered but Eliminated from Detailed Study:**
  - Foundation blanket grouting: Technically Risky
  - Upstream Liner: Questionable whether it satisfies intent of NRCS design criteria
- **Potential Options:**
  - New Embankment Dam
  - New RCC Dam

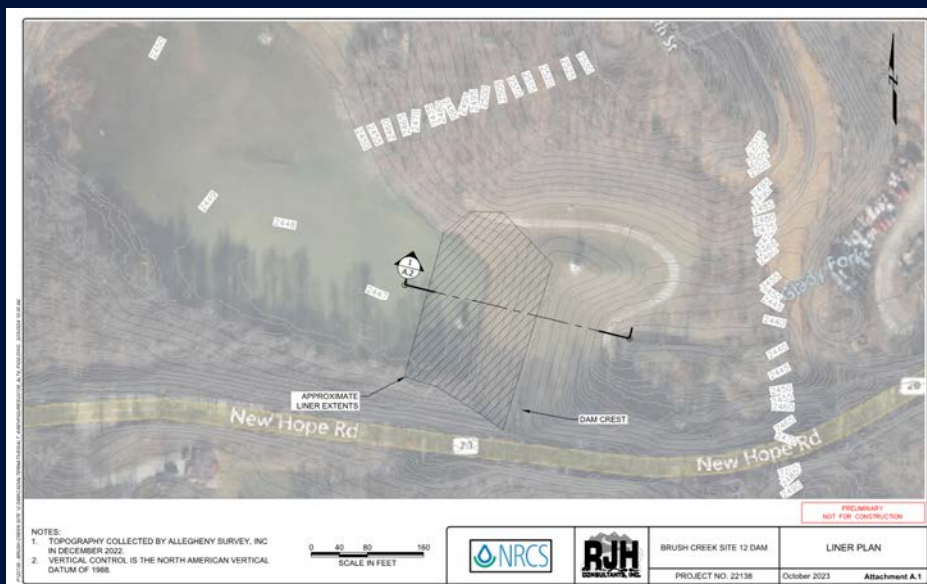
## Mitigate Embankment Seepage Deficiencies: Upstream Liner

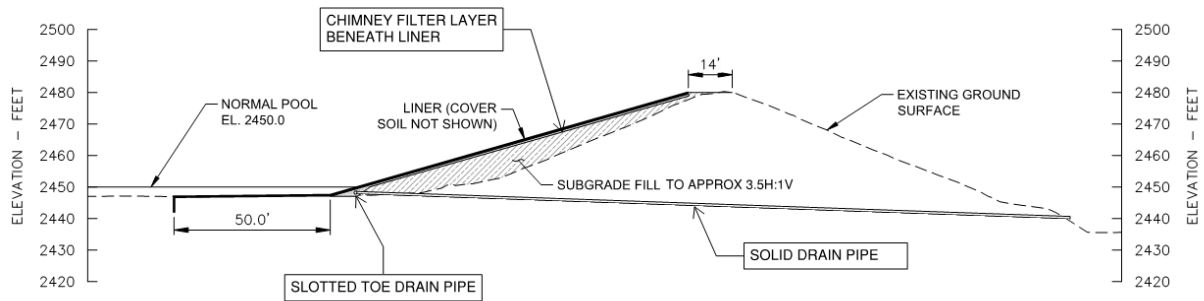
## Mitigate Embankment Seepage Deficiencies: Upstream Liner

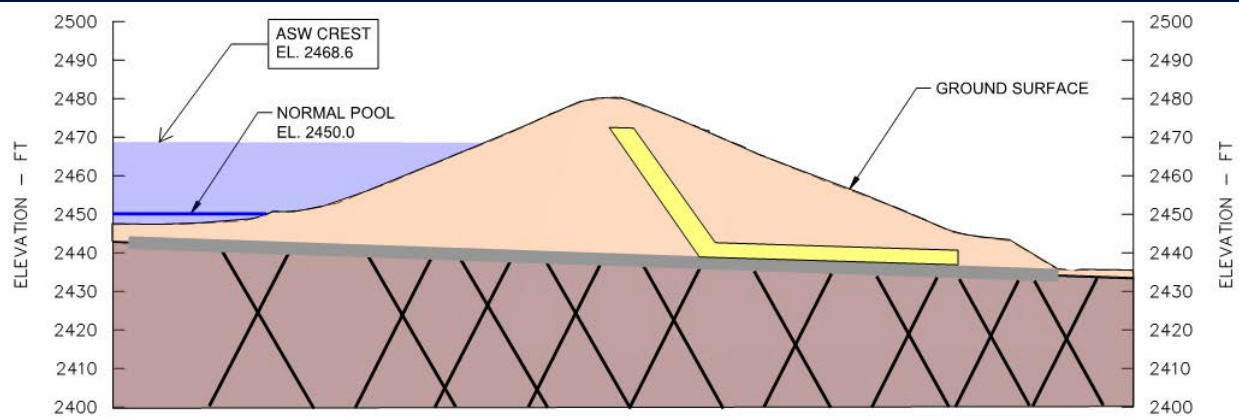
## Mitigate Embankment Seepage Deficiencies: Reconstruct New Embankment with Slush Grouted Foundation and Filter Protection

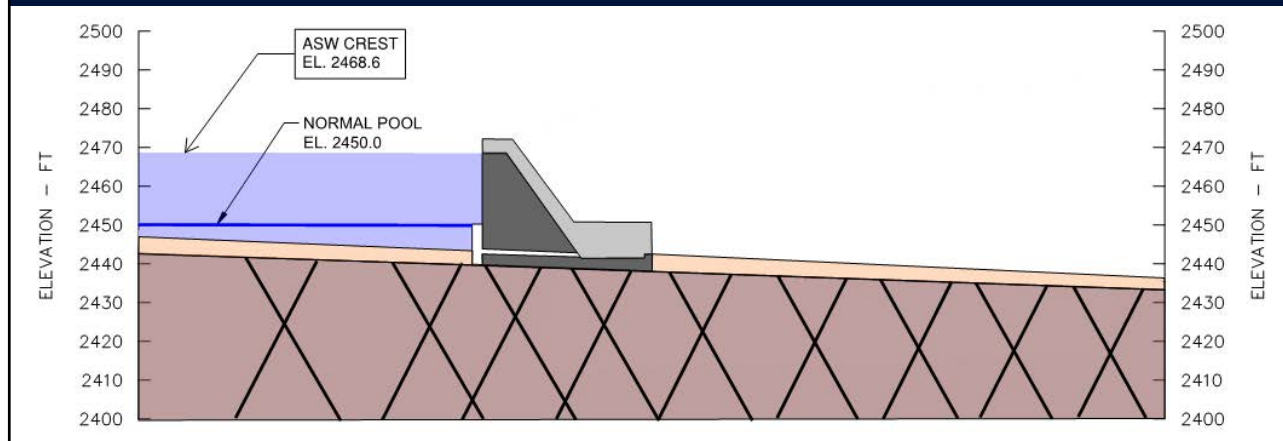
## Mitigate Embankment Seepage Deficiencies: Reconstruct New RCC Dam

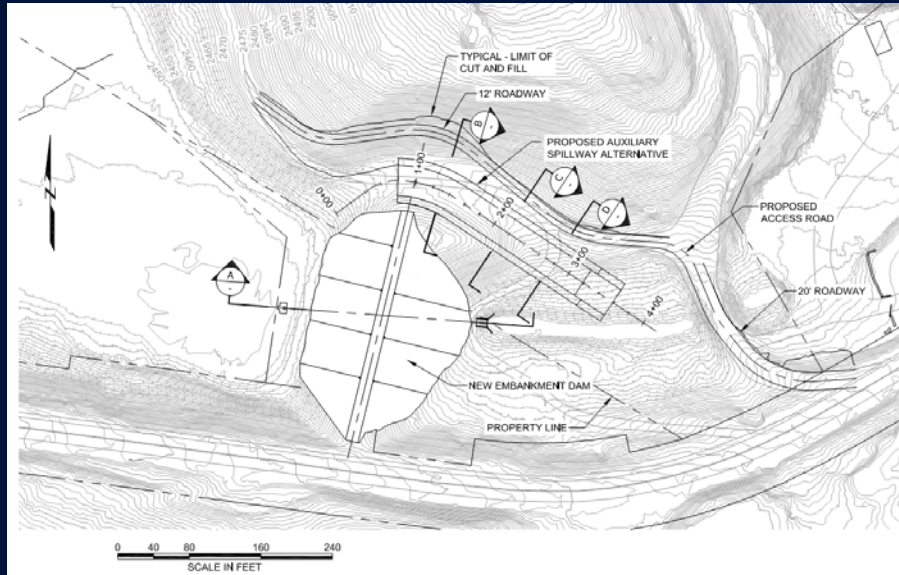
## New Embankment Dam: Site Plan

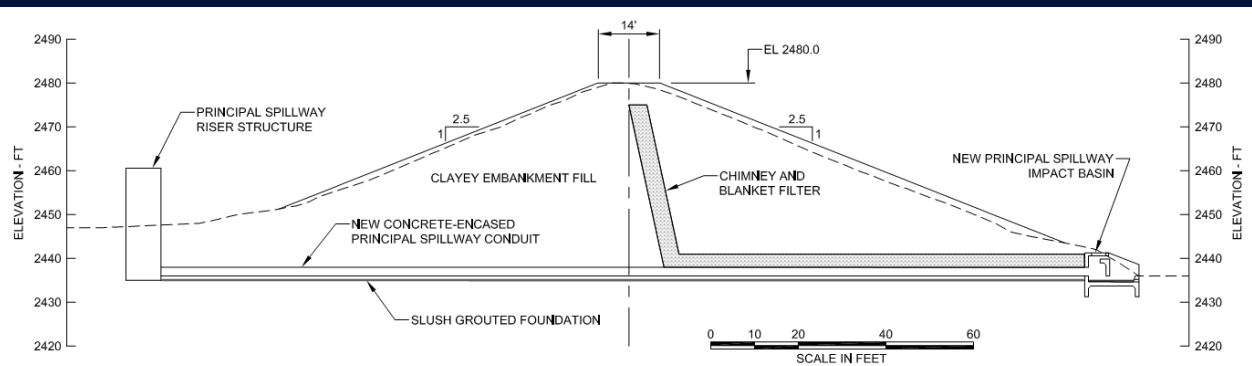
## New Embankment Dam: Typical Embankment Section

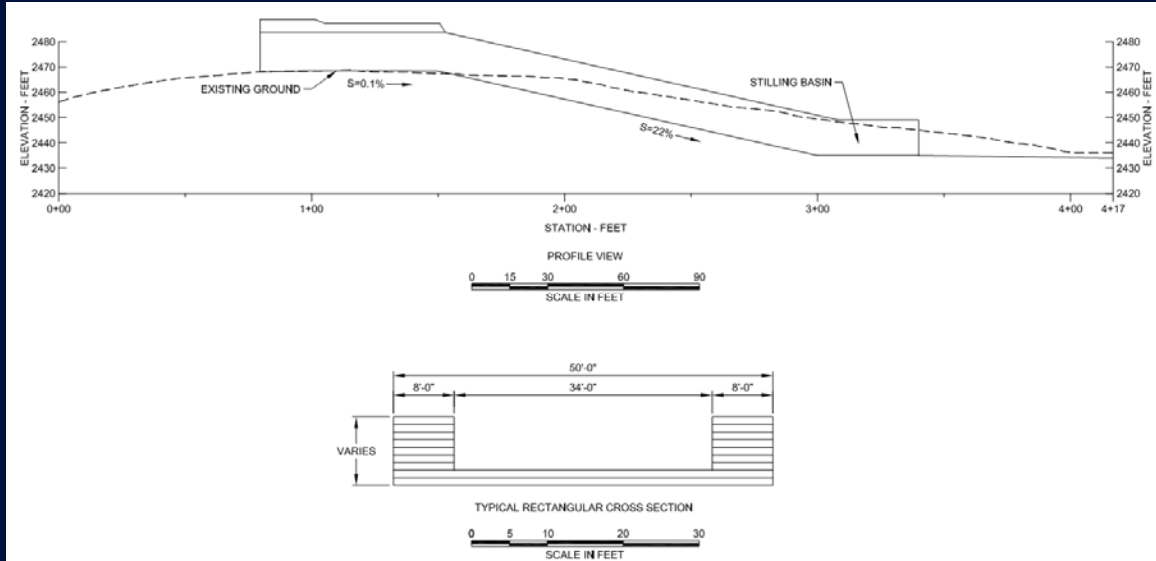
## New Embankment Dam: Spillway Chute Profile and Typical Section

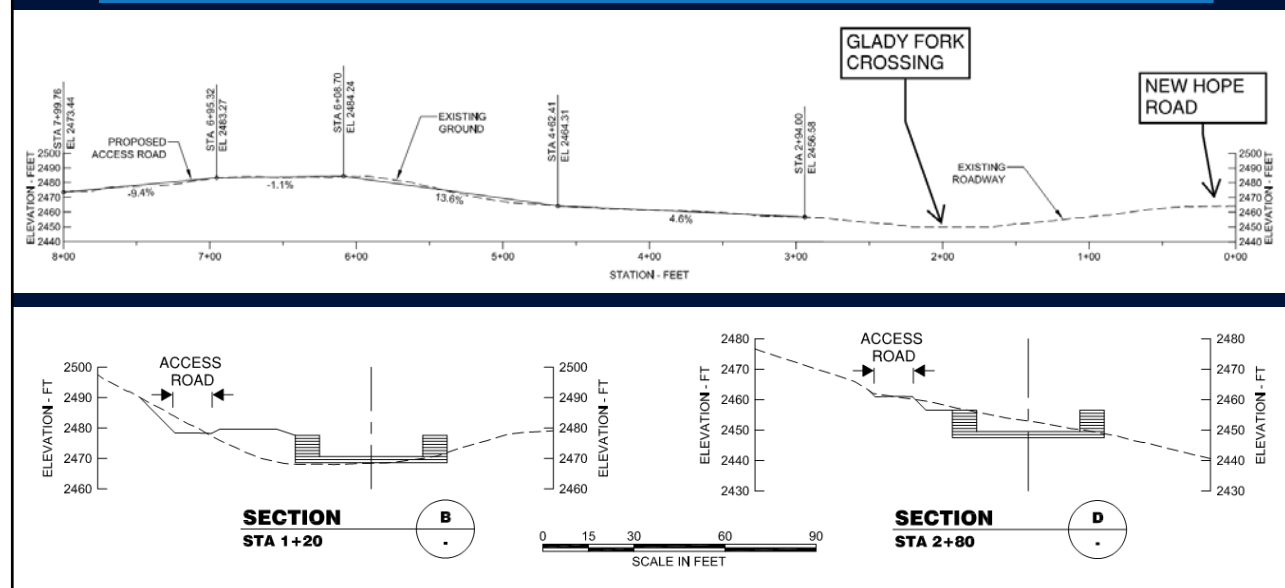
## Access Road Profile and Typical Sections

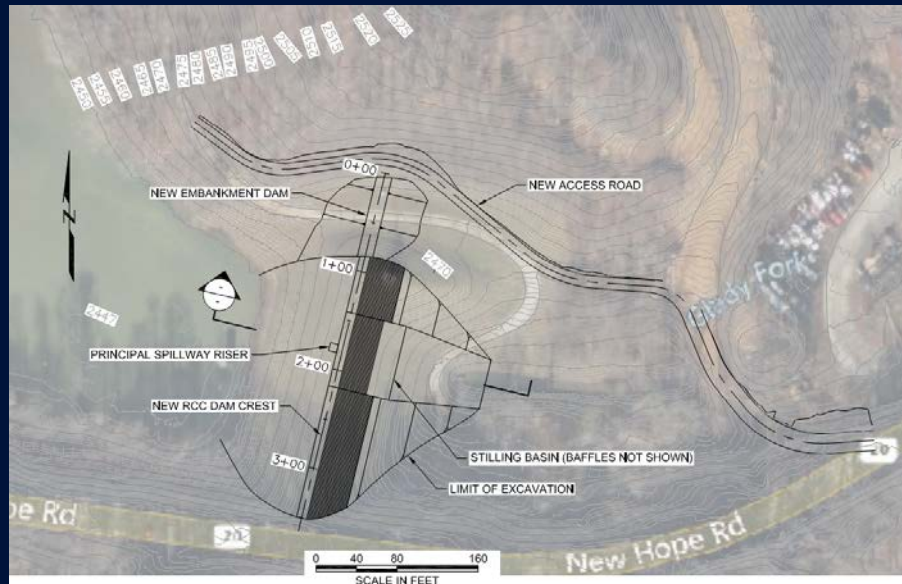
## New RCC Dam: Site Plan

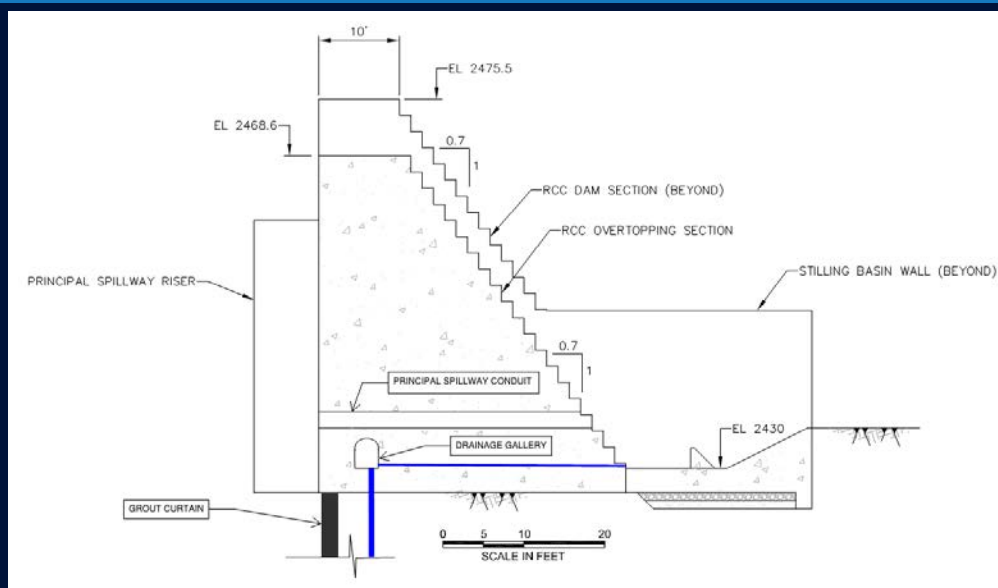
## New RCC Dam: Typical Dam Section
